**Waste Remediation Services (WRS) Ltd**  
**Symes Manawapou Landfarm**  
Monitoring Programme  
Annual Report  
2020-2021

Technical Report 2021-79

Monitoring Programme

Annual Report

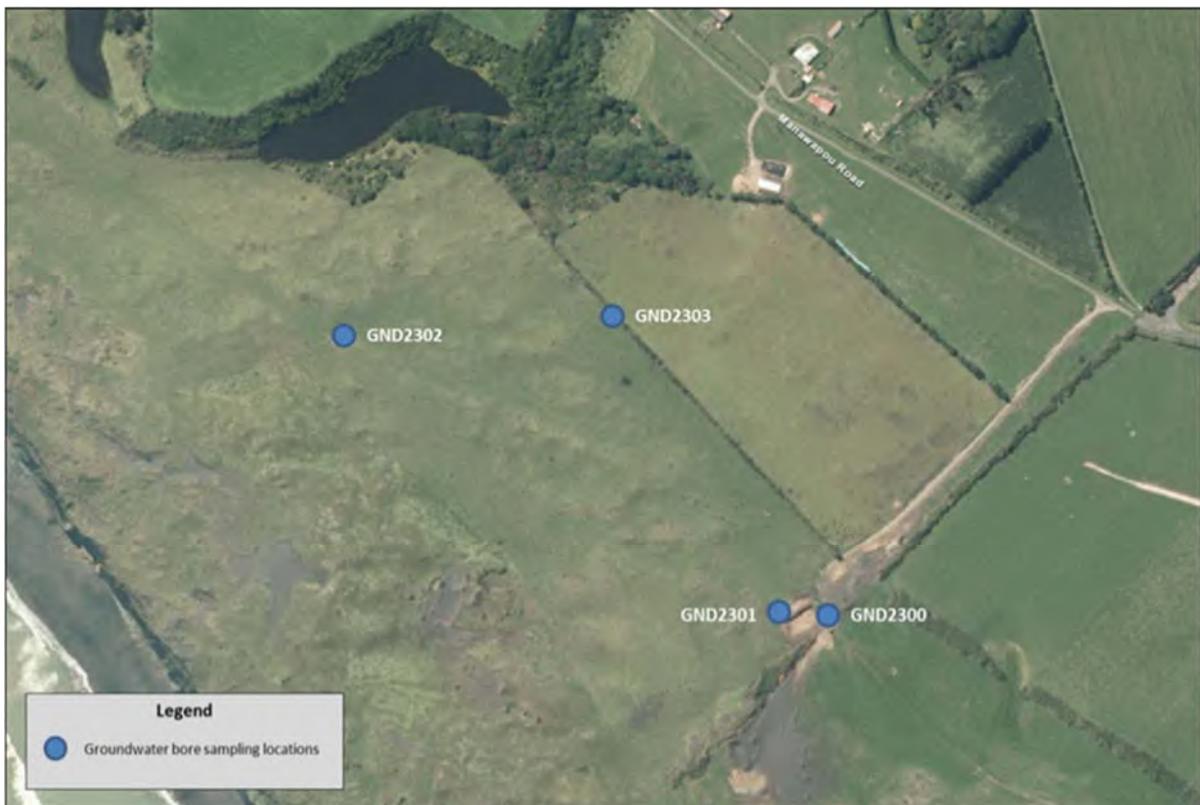
Figure 2 WRS Symes Manawapou Landfarm groundwater monitoring locations

The Symes Manawapou Landfarm contains four groundwater monitoring bores (Figure 2). The bores were installed as part of the consent and have been monitored since October 2012. They were installed to assess the quality of the groundwater; in close proximity to the storage cells in the case of GND2300 and 2301, and the landfarming exercise, in the case of GND2302 and 2303.

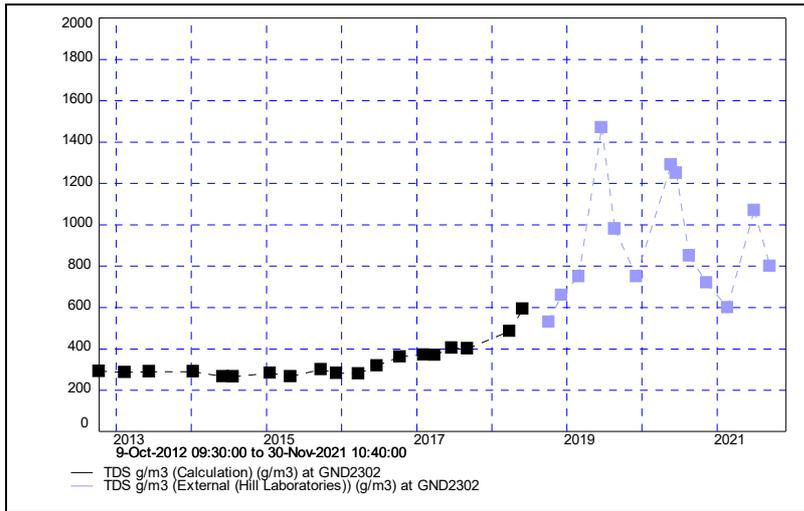
Figure 7 Long term TDS g/m<sup>3</sup> monitoring GND2302 2012-2021

- TDS in similarity to EC, demonstrated a reduction during the summer months, prior to an increase in the final monitoring round. The long term record (Figure 7) suggests a steady increase in this parameter. The results do not exceed the consent condition 22, which allows up to 2,500 g/m<sup>3</sup> of this analyte. TDS, in comparison to EC has recorded a reducing peak concentration since June 2019. Further monitoring will assess this location over time.

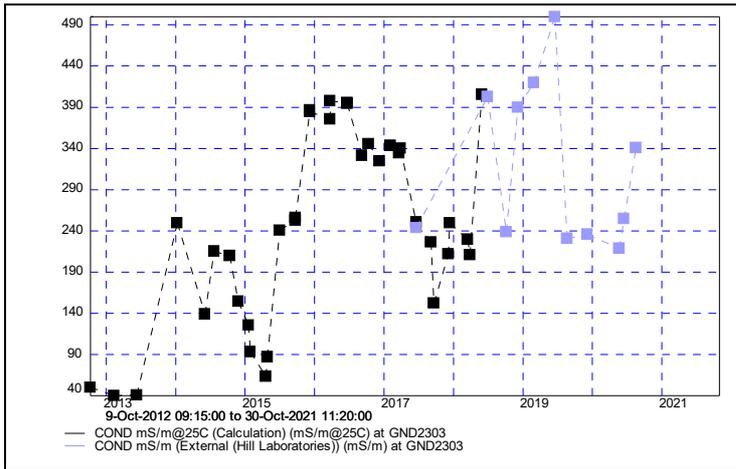
Figure 9 Long term EC mS/m @25°C monitoring GND2303 2012-2021

This monitoring well has recorded some elevated saline impacts to groundwater over the past ten years (Figures 9-11). TDS in particular (Figure 10) has been found to be in breach of consent 7795-1.1, condition 22 on seven occasions in the past 20 monitoring rounds (peaking at 3,900 g/m<sup>3</sup> in June 2019).

The increase noted in EC, TDS and chloride appear to correspond loosely with landfarming dates undertaken by the Company over time. Area M1408 was finalised in at the end of August 2014, with elevation in these parameters noted to occur throughout 2015. Area M1610 was landfarmed in October 2016, while area M1810 was initiated in June 2017 through to October 2018.

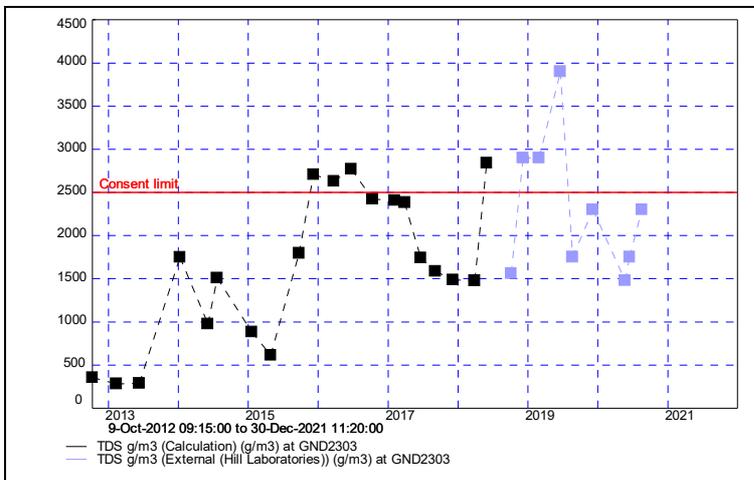
Figure 10 Long term TDS g/m<sup>3</sup> monitoring GND2303 2012-2021

The previous five monitoring rounds have been below this limit, however, the last monitoring round recorded a concentration (2,300 g/m<sup>3</sup>) very close to the limit (2,500 g/m<sup>3</sup>). It is noted that subsequent sampling rounds have not been possible due to the damaged well.

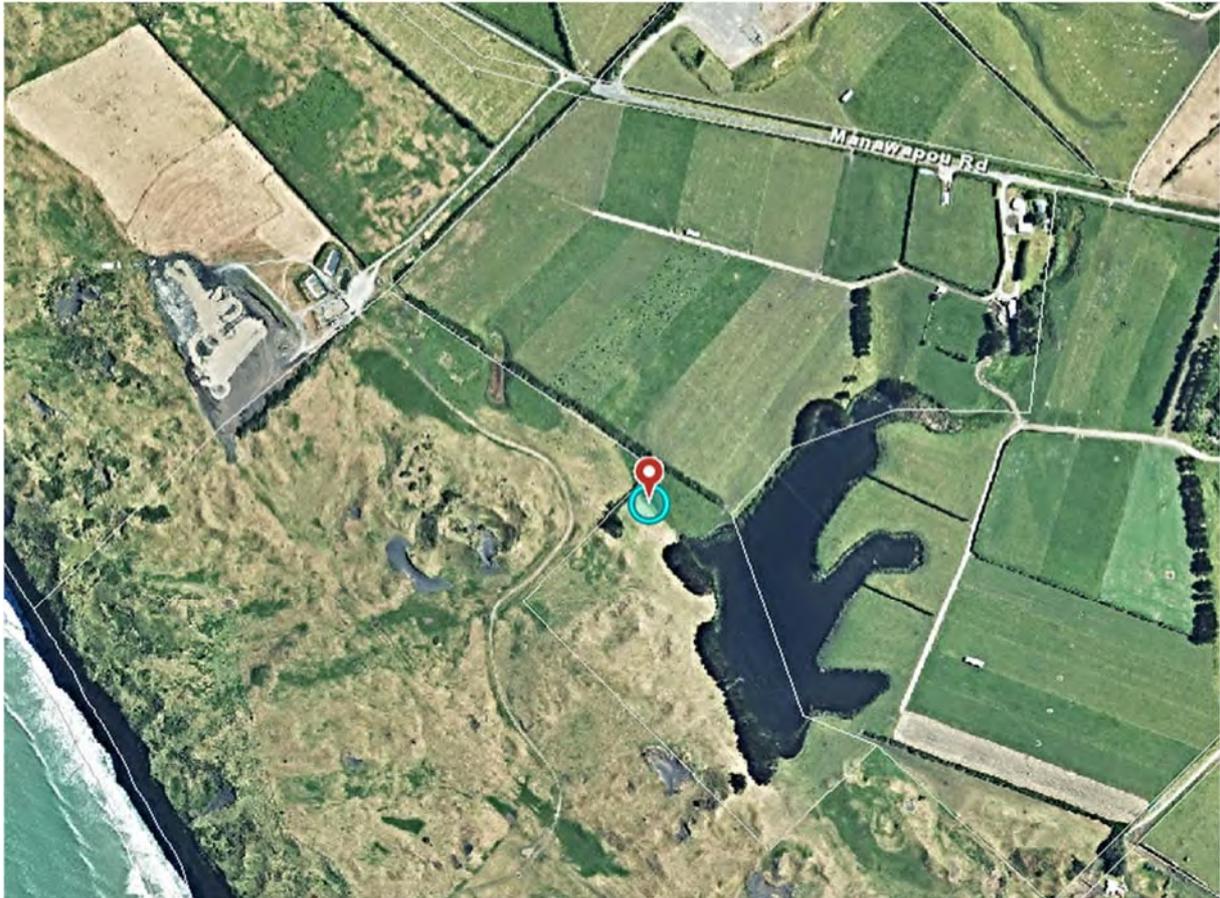
Figure 12 Sample location Lake Taumaha

A surface water sample (Table 6) was collected from Lake Taumaha (Figure 12) this monitoring period.

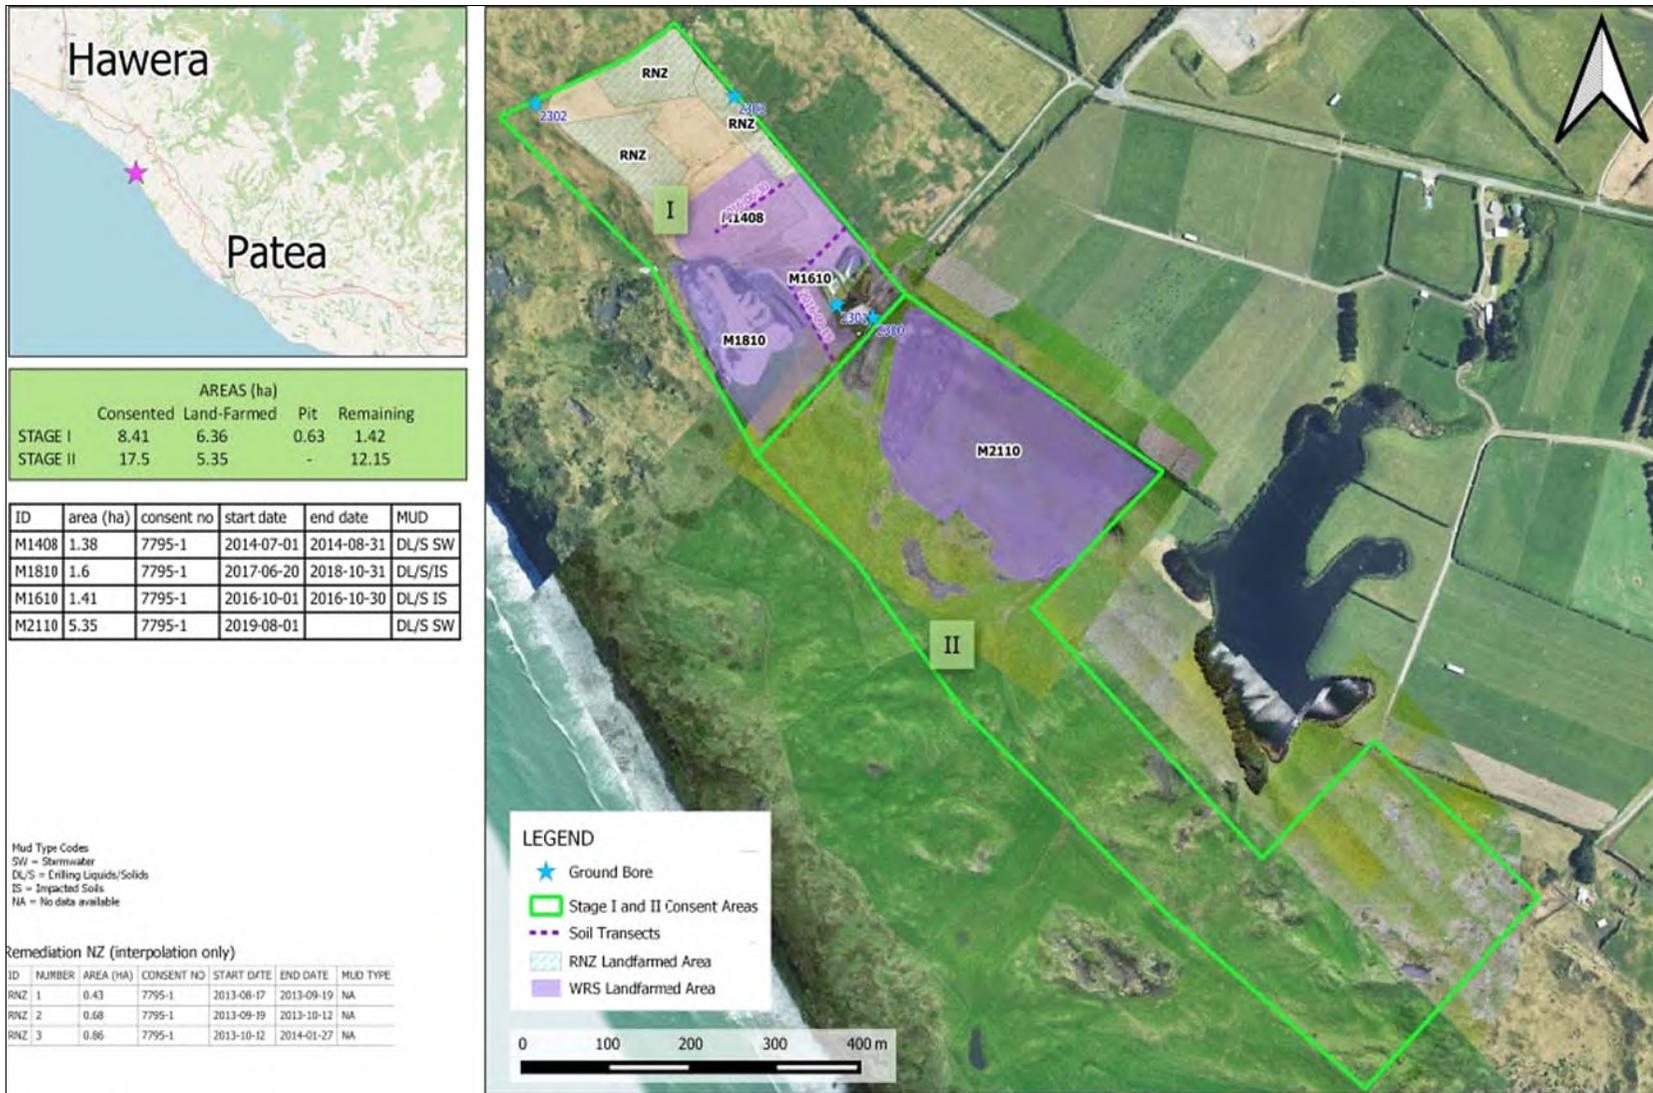
Figure 13 WRS provided map of landfarmed areas

All previously landfarmed areas (RNZ, M1408, M1610, and M1810, Figure 13) have been surrender-assessed and found to be within criteria that would enable them to be removed from the consent. However, the Company has not yet elected to have these removed.

One area (M2110, 5.35 ha, Figure 13) was landfarmed during this monitoring period. This remains under operation as noted by the inspector during the 2021-2022 monitoring period. Once this area has been completed and seeded, soils samples will be collected.

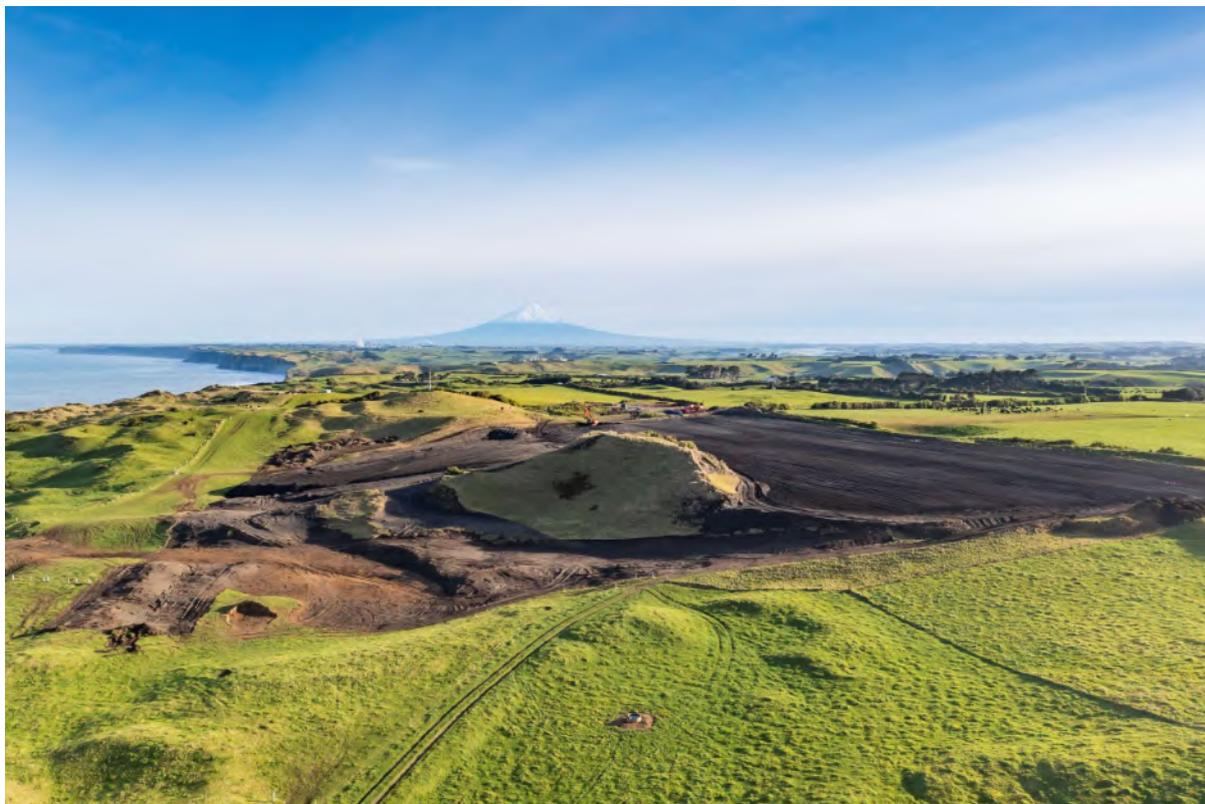
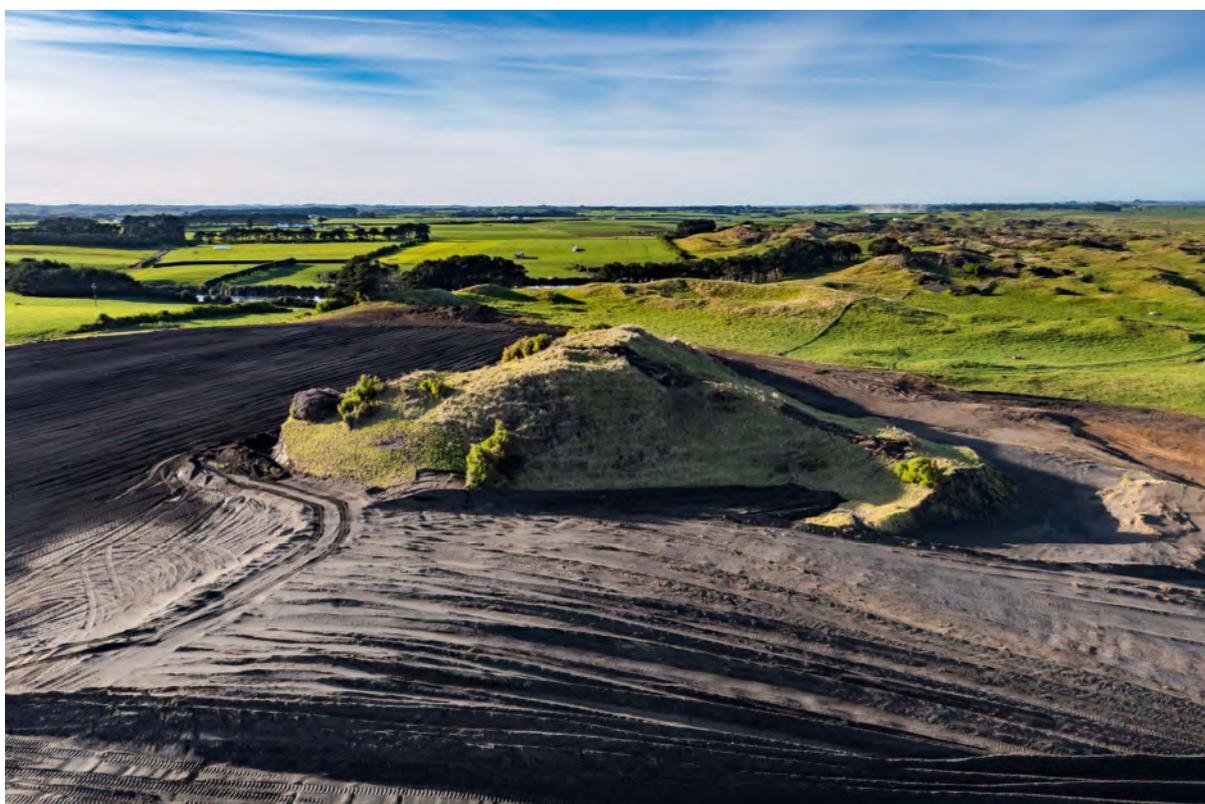
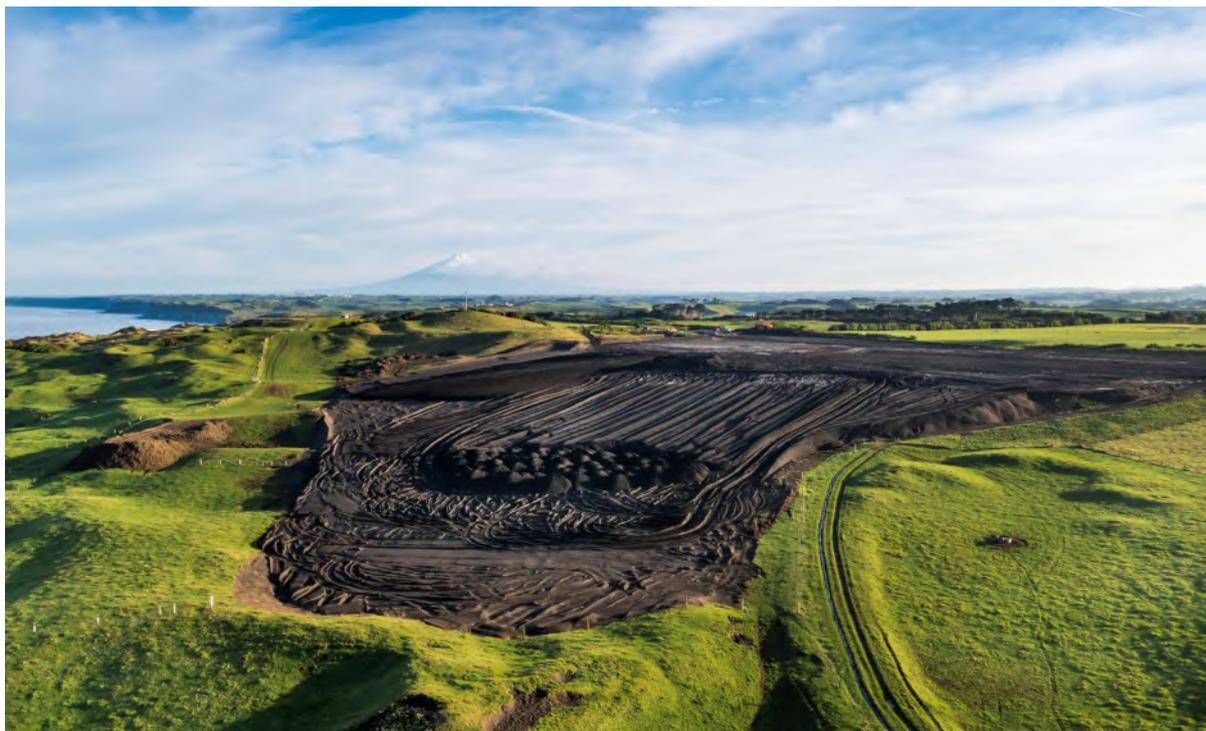
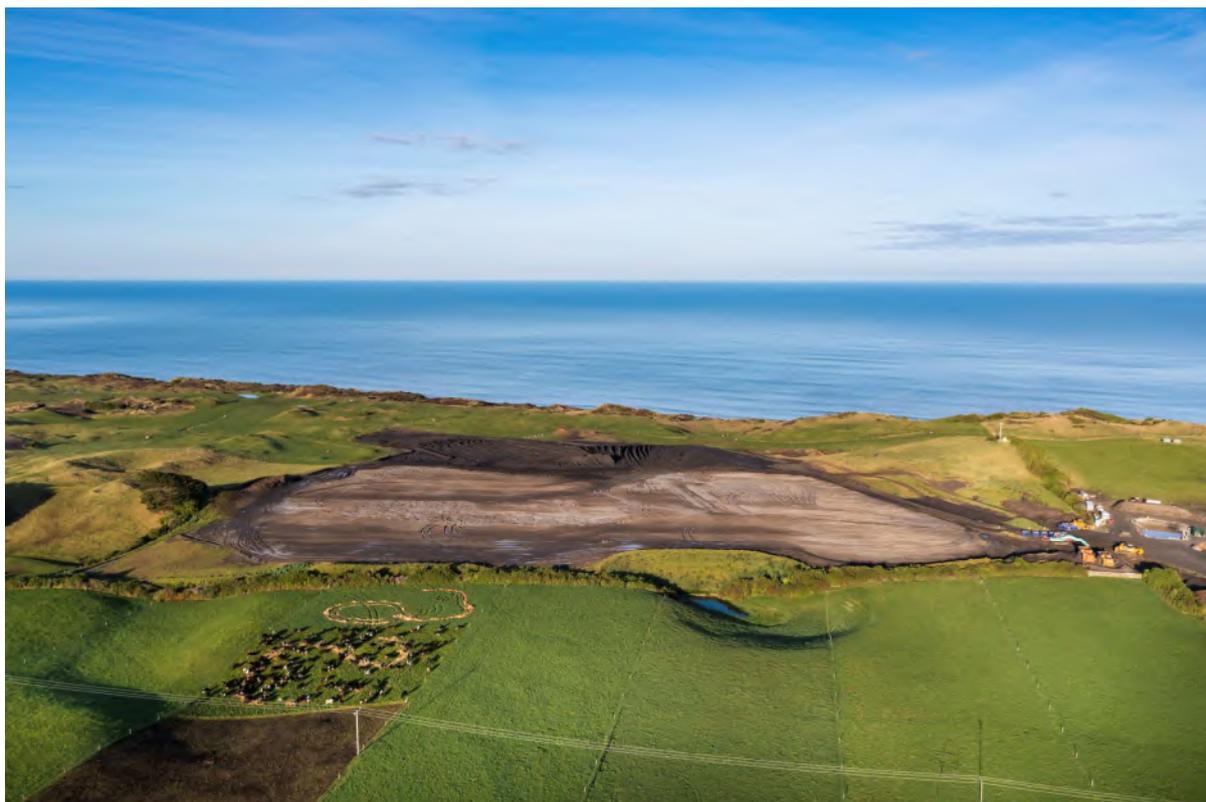
During and after waste application and incorporation, Manawapou disposal site spreading area M2110

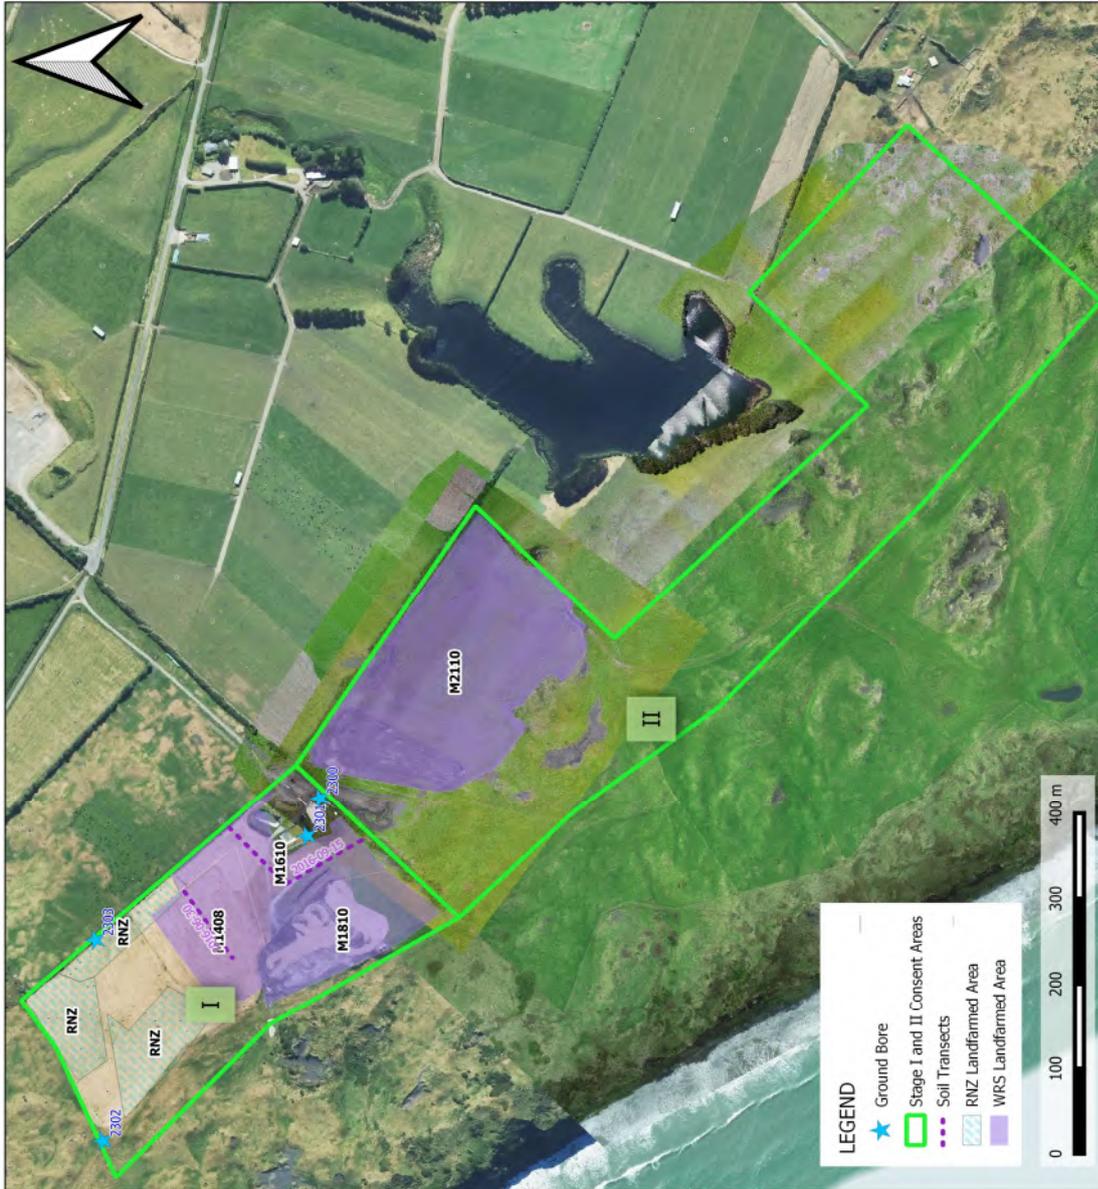
Appendix B Manawapou Site Map

AREAS (ha)				
	Consented	Land-Farmed	Pit	Remaining
STAGE I	8.41	6.36	0.63	1.42
STAGE II	17.5	5.35	-	12.15

ID	area (ha)	consent no	start date	end date	MUD
M1408	1.38	7795-1	2014-07-01	2014-08-31	DL/S SW
M1810	1.6	7795-1	2017-06-20	2018-10-31	DL/S/IS
M1610	1.41	7795-1	2016-10-01	2016-10-30	DL/S IS
M2110	5.35	7795-1	2019-08-01		DL/S SW
