BTW Company Limited
Oeo Landfarm
Monitoring Programme
Annual Report
2012-2013

Technical Report 2013-54

June 2014

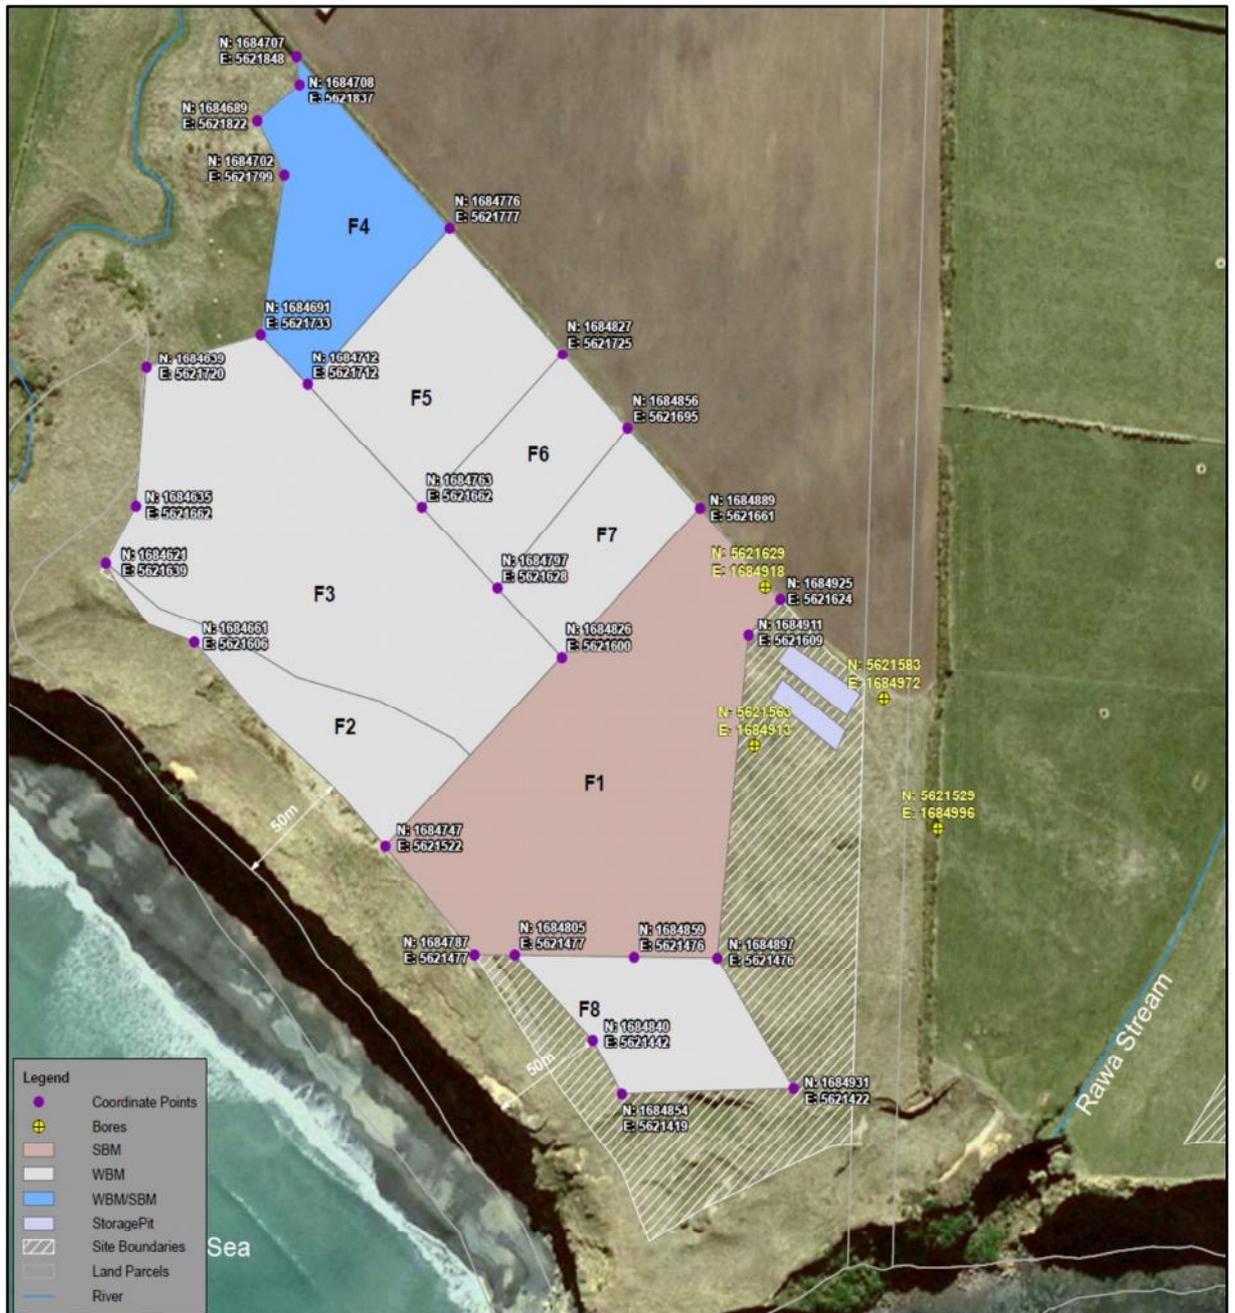
Figure 2 Oeo Landfarm site plan June 2013 showing spreading areas F1-F8

There were eight disposals during the monitoring period of approximately 4278 m³ of water/synthetic based cuttings and fluids. The waste was spread over an area of approximately 61,047 m² (areas F1 through to F8, Figure 2). No hydraulic fracturing wastes have been disposed of at this site.

Spreading areas F1 and F3 were spread at a thickness of 50 mm as average TPH concentrations were greater than 50,000 mg/kg dry weight. The remaining areas were spread at the 100 mm rate as TPH concentrations were less than 50,000 mg/kg dry weight.

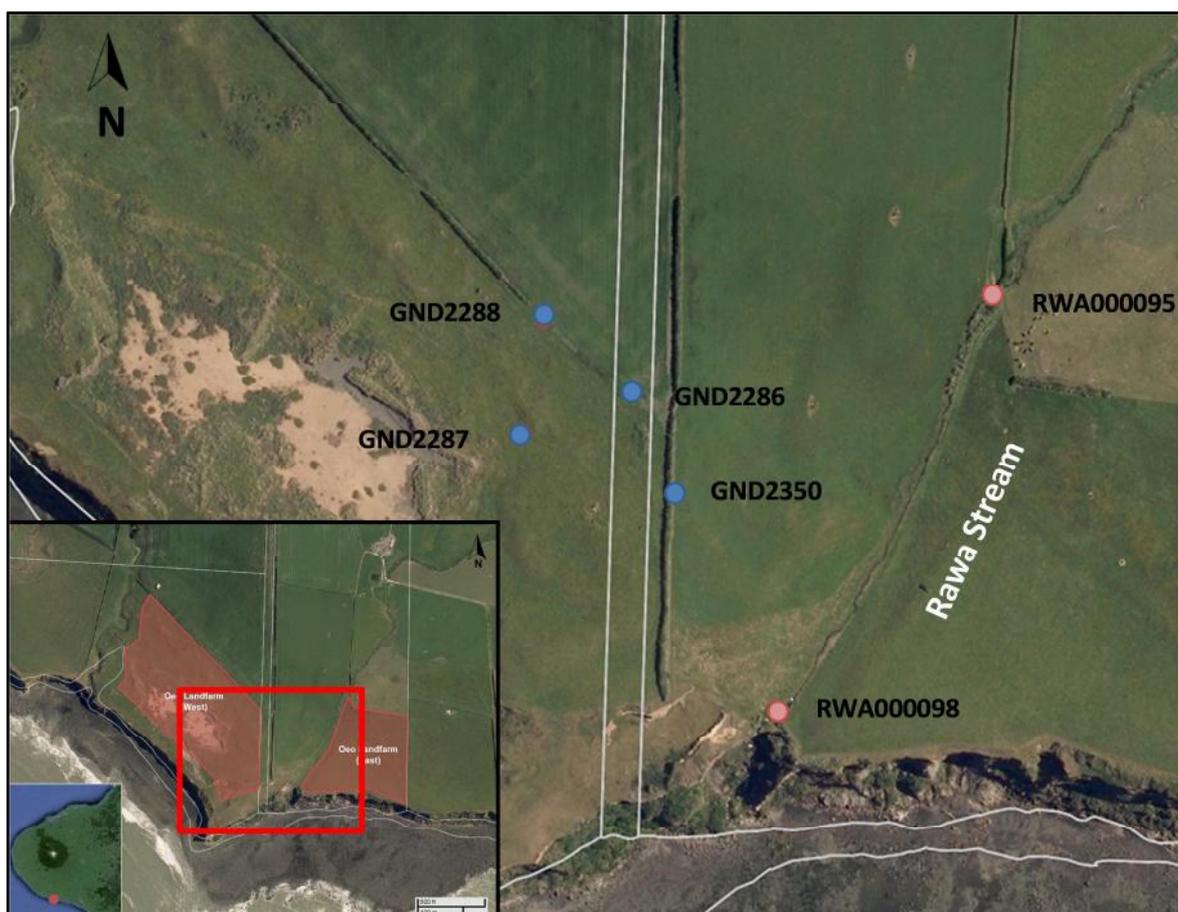
Figure 3 Site map showing groundwater and surface water sampling sites and overall site map (inset)

No hydrocarbons have been detected in wells GND2286 or GND2350.

Three bores were installed at the site (locations identified in Figure 3, Section 2.3.2). The initial sampling of these bores revealed measurable but very low levels of petroleum hydrocarbons in bores GND2287 and GND2288, which were located near pit C. Subsequent sampling has shown that hydrocarbon concentrations have returned to background, verifying that pit liners have been working effectively at this site, and that the impacts on groundwater were localised, short-lived, of negligible consequence, and related to the absence of adequate pit liners in the initial site setup. The contents of the third pit was farmed and the pit reinstated shortly after the completion of the groundwater monitoring wells.

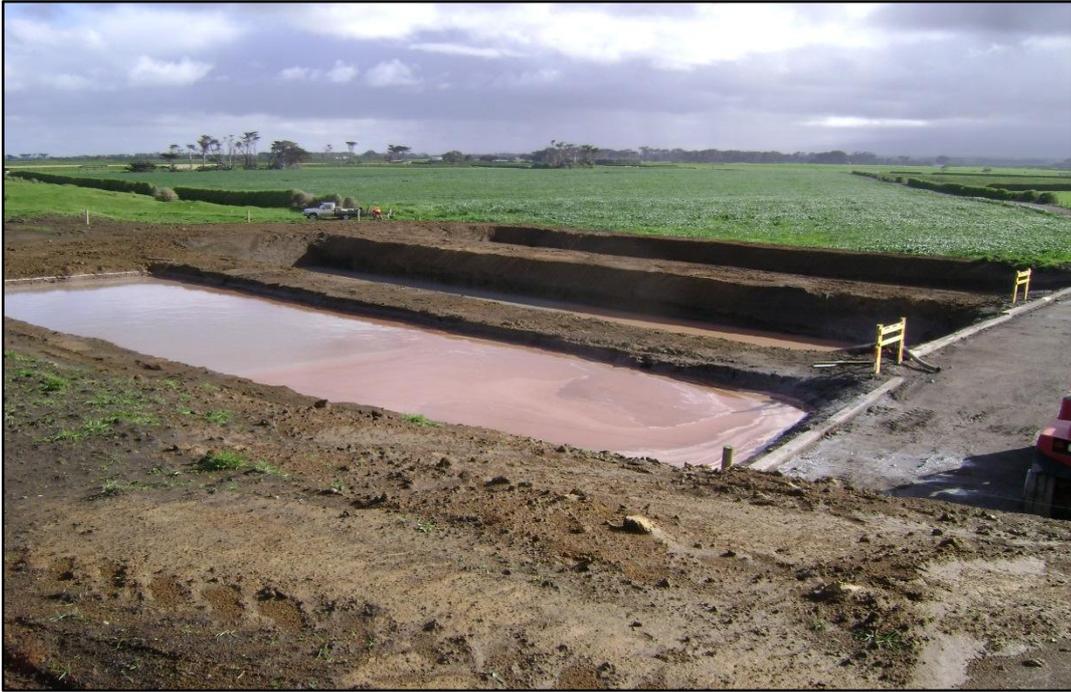
Photo 2 Oeo landfarm initial storage pit arrangement

The initial stockpiling of material at the site utilised three unlined drilling waste pits (Photo 2). The Council advised BTW, along with other landfarming operators, that all storage pits required high grade synthetic liners that were fit for the purpose of storing solids and liquids on site for several months. The Company were cooperative on this matter and lined two of the pits immediately, following the spreading of material into area F1 (Photo 3). The Company were also advised that the Council expected monitoring wells to be installed at the site in proximity of the storage facilities.

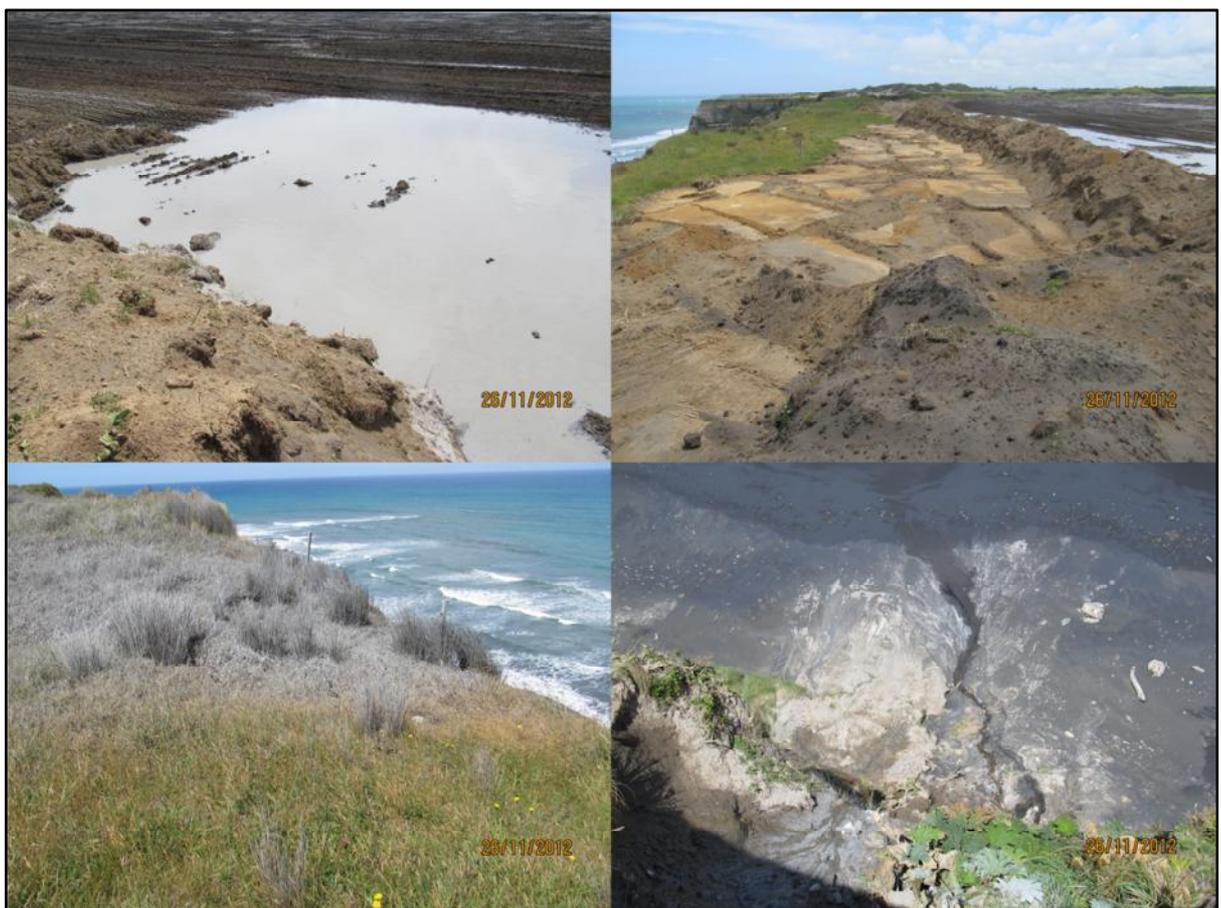
Figure 4 Oeo landfarm photos showing (clockwise from top left) ponding liquid in area F2, makeshift bunding in buffer zone, mud on beach below cliff, and mud staining of grass

During a routine monitoring inspection it was observed that drilling mud had ponded at the seaward side of area F2, breached the makeshift bund, run across the grass beyond the site boundary, and had discharged over the cliff face onto the beach 30-40 m below the cliff. The earthworks contractors had scraped back some topsoil from outside of the consented area to create a bund to prevent any further runoff.

Special condition 7 of consent 7613-1 stipulates that for the purposes of landfarming, drilling wastes shall be applied to land *“in a rate and manner such that no ponded liquids remain after one hour, for all wastes”*.

Special condition 10 states that *“no discharge shall take place within 25 metres of surface water or property boundaries”*.

Unauthorised Incident 23149 was non compliant with these two consent conditions. The following enforcement action was undertaken by the Council:

Investigations conducted by the Council and the Company suggested there were several contributing factors to the UI. The three primary contributors were poor weather conditions, the presence of a shallow iron pan (impeding drainage in the subsoil), and lack of contractor awareness.

An abatement notice was issued requiring that the ponded liquid around the site be incorporated into the soil and that the conditions of the resource consent are complied with for all future operations.

An infringement notice was also issued to the Company for the unauthorised discharge of drilling mud onto land in such a manner that the material may have entered the Tasman Sea.

Re-inspection found that the abatement notice was being complied with. A letter of explanation was received from the Company. An infringement notice was issued to the Company. A letter of explanation was received from the contractor and accepted.

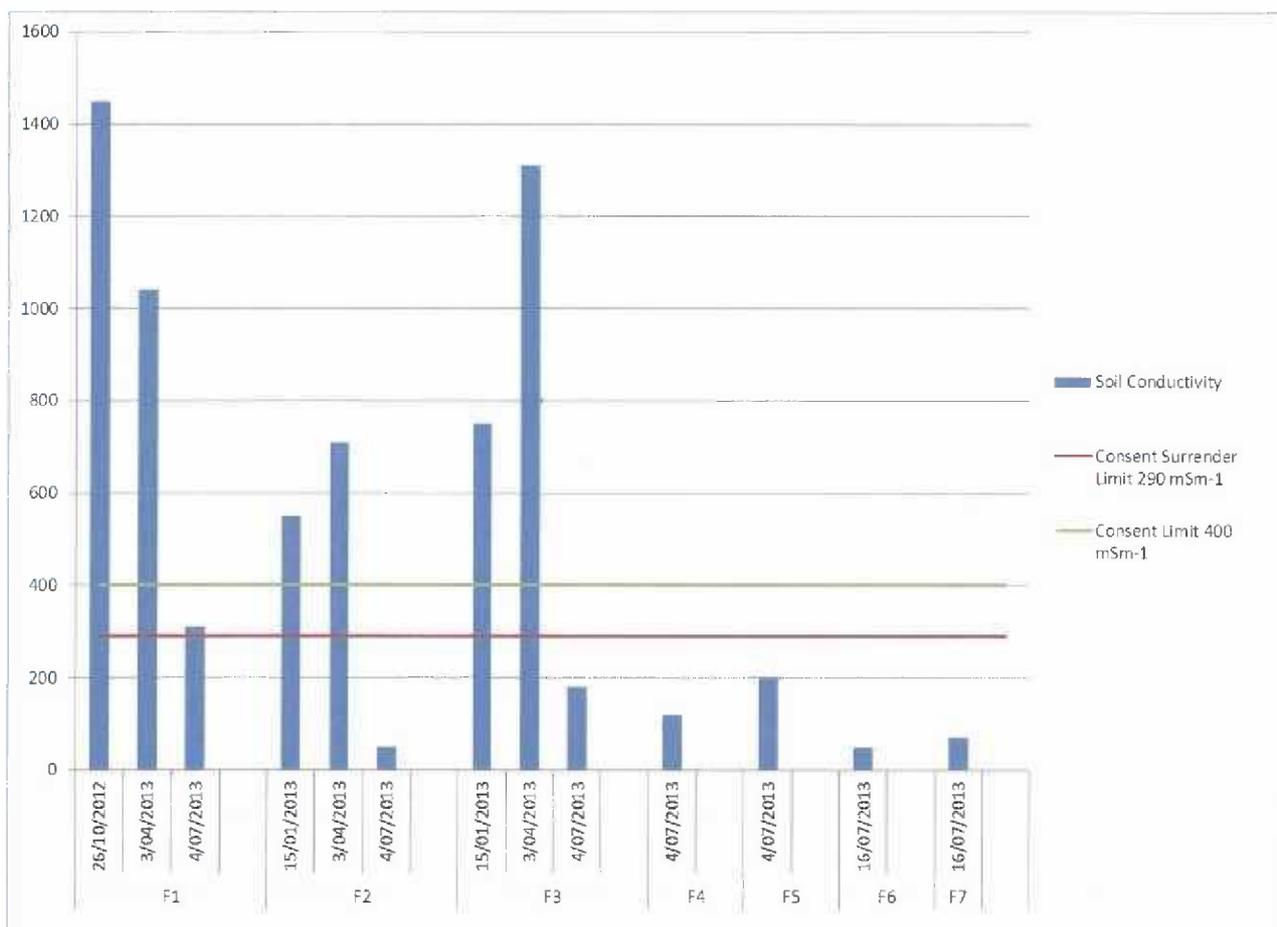
Figure 1 Soil Conductivity analysis – Oeo Landfarm

While initial monitoring of soil conductivity at the site F1 to F3, showed exceedance of the consent limit, follow up results have shown decrease in soil conductivity to consent limits, with F2 and F3 being with consent surrender limits. Locations F4 to F7 are also within consent surrender limits.

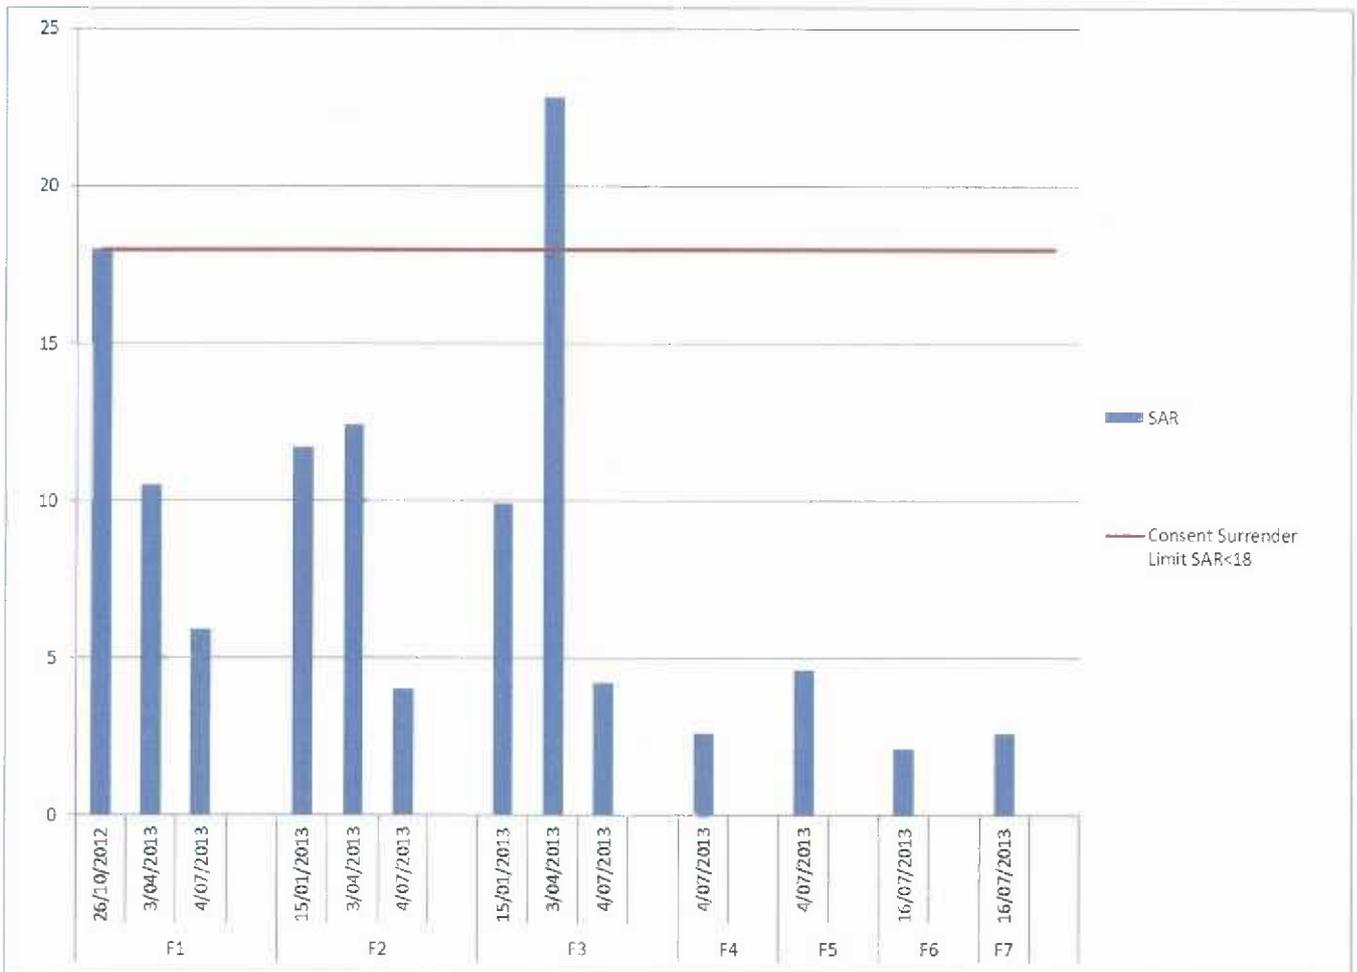
Figure 2 SAR analysis – Oeo Landfarm

As shown in Figure 2 below, all the landfarmed area are currently within the surrender criteria for the consent.

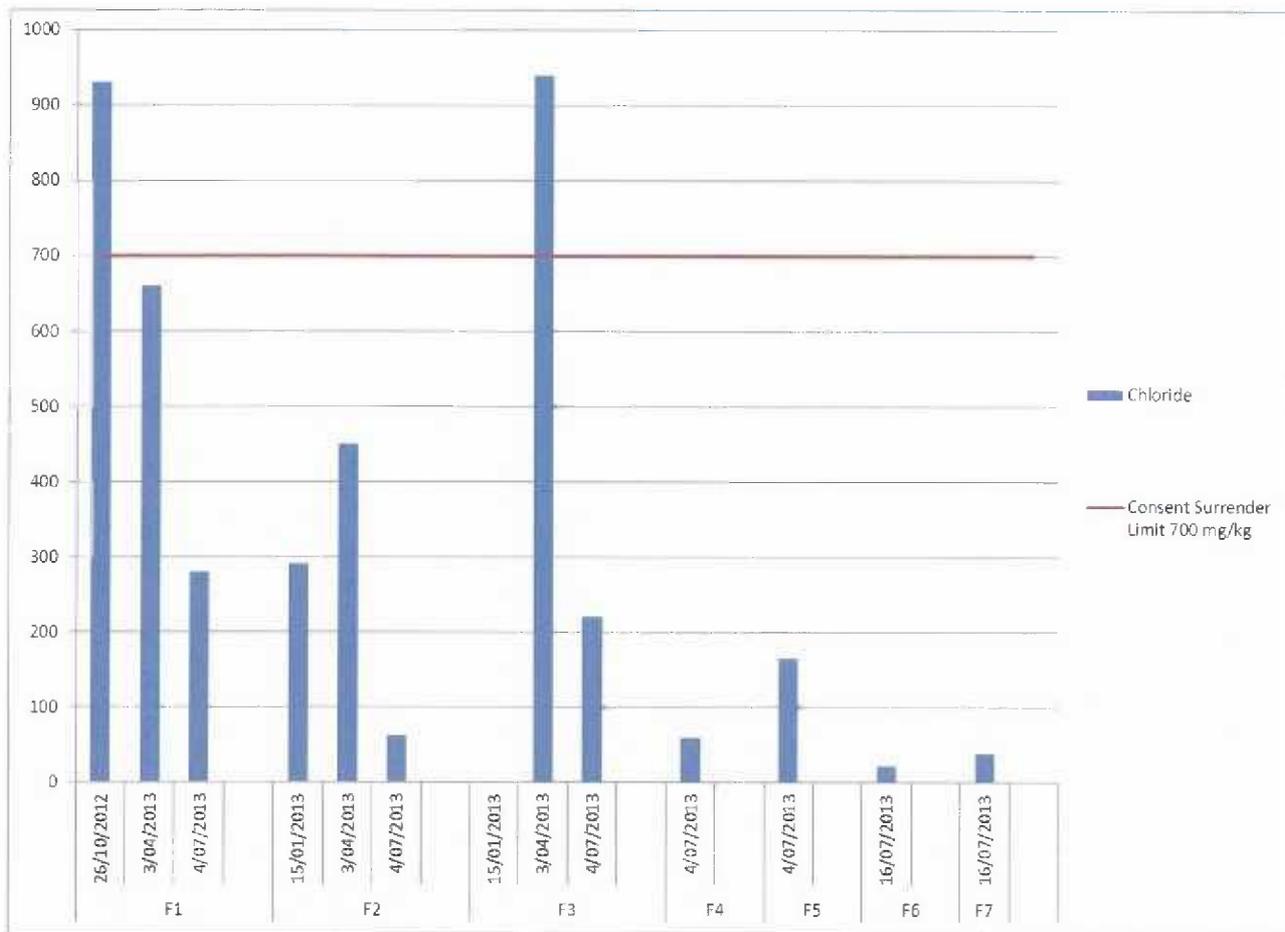
Figure 3 Chloride analysis – Oeo Landfarm

As shown in Figure 3, while initial monitoring results at sites F1 and F3 were elevated, consent surrender requirements for Chloride have now been met for all monitored areas of the landfarm.

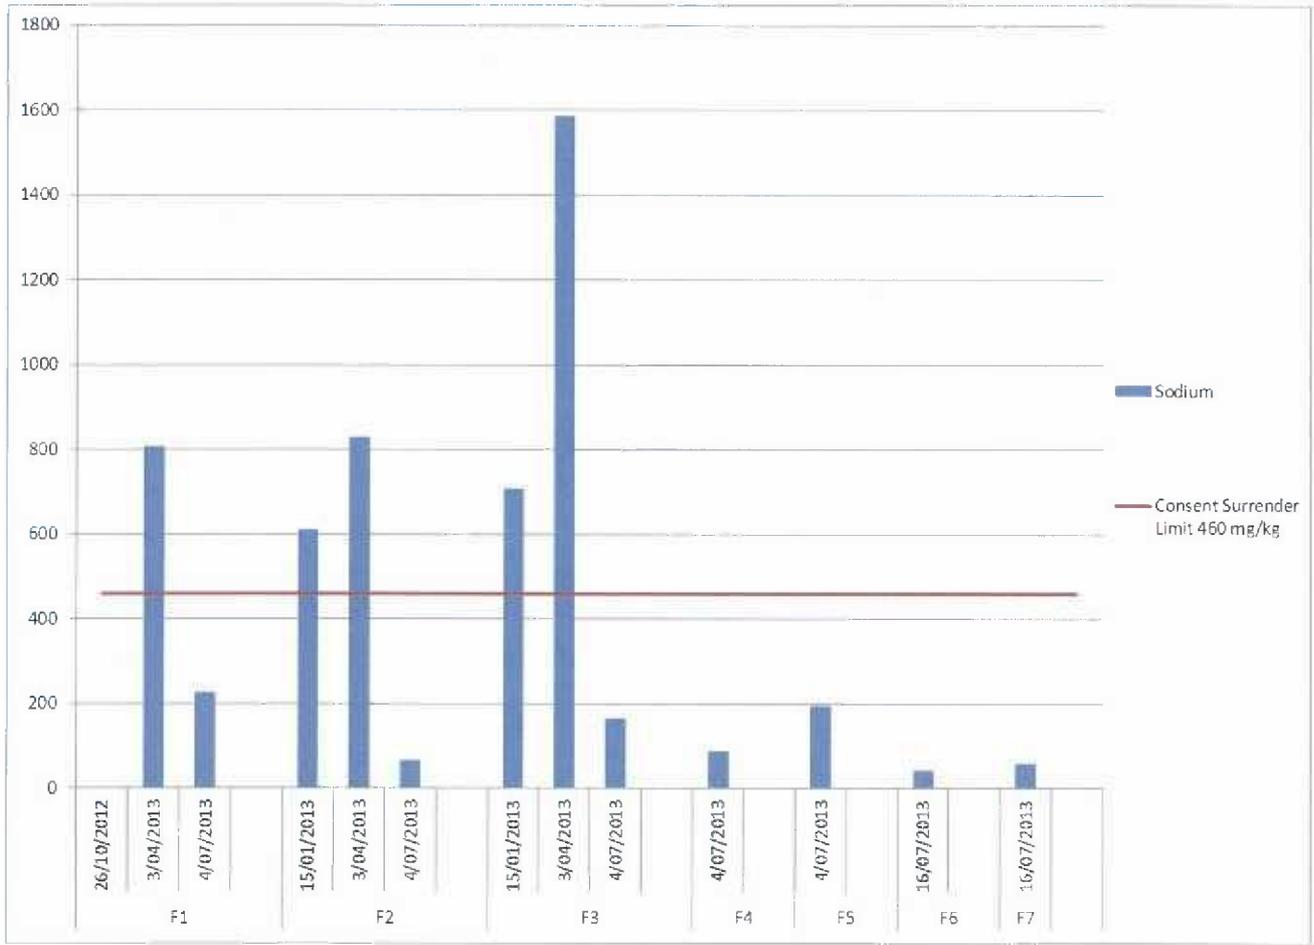
Figure 4 Sodium analysis – Oeo Landfarm

As shown in Figure 4, consent surrender requirements for Sodium have been reached for all monitored areas of the landfarm.

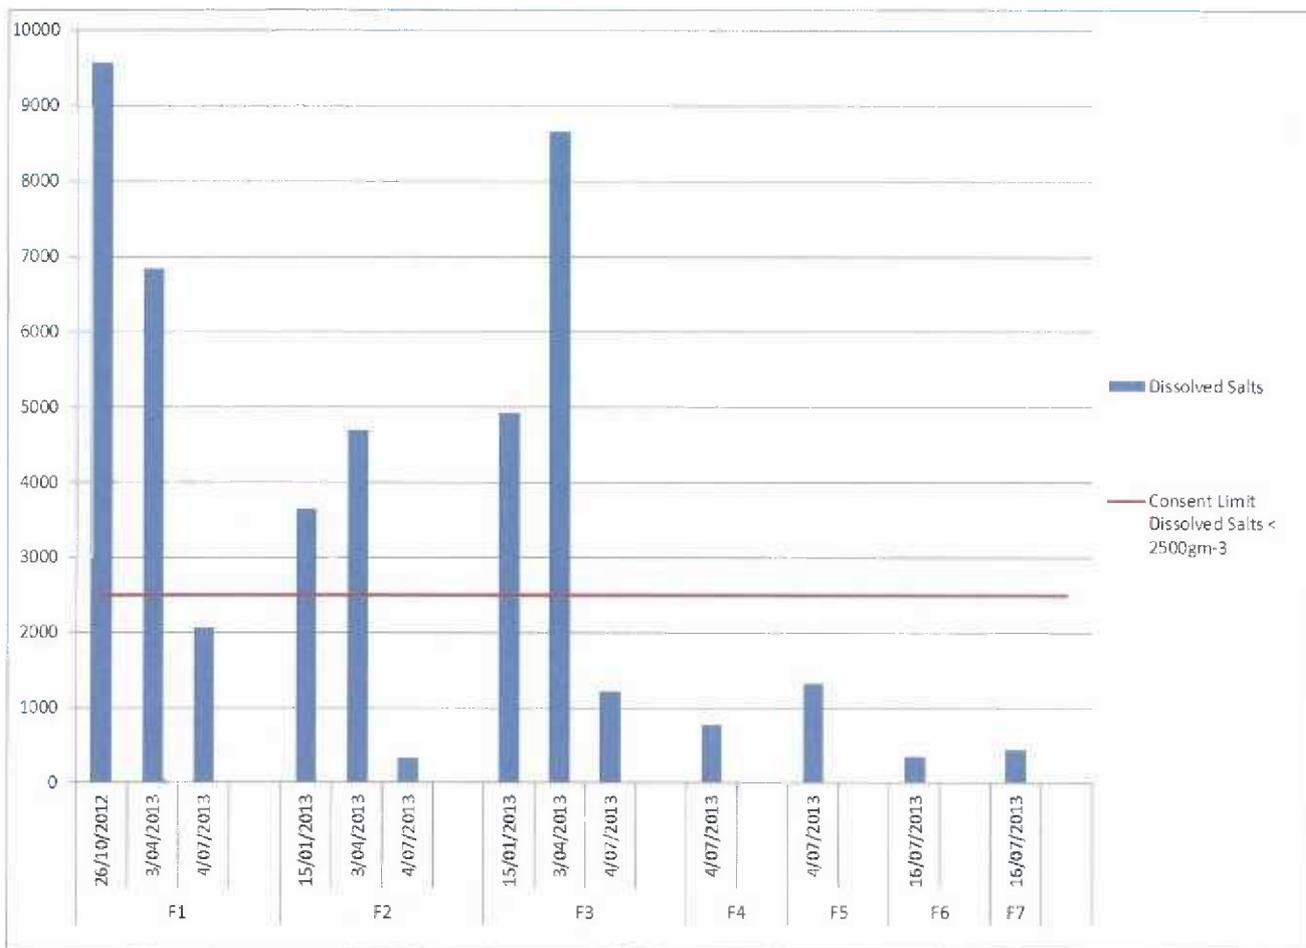
Figure 5 Dissolved Salts analysis – Oeo Landfarm

While initial monitoring results at sites F1, F2 and F3 were elevated, consent surrender requirements for dissolved salts have now been met for all monitored areas of the landfarm, as shown in Figure 5.

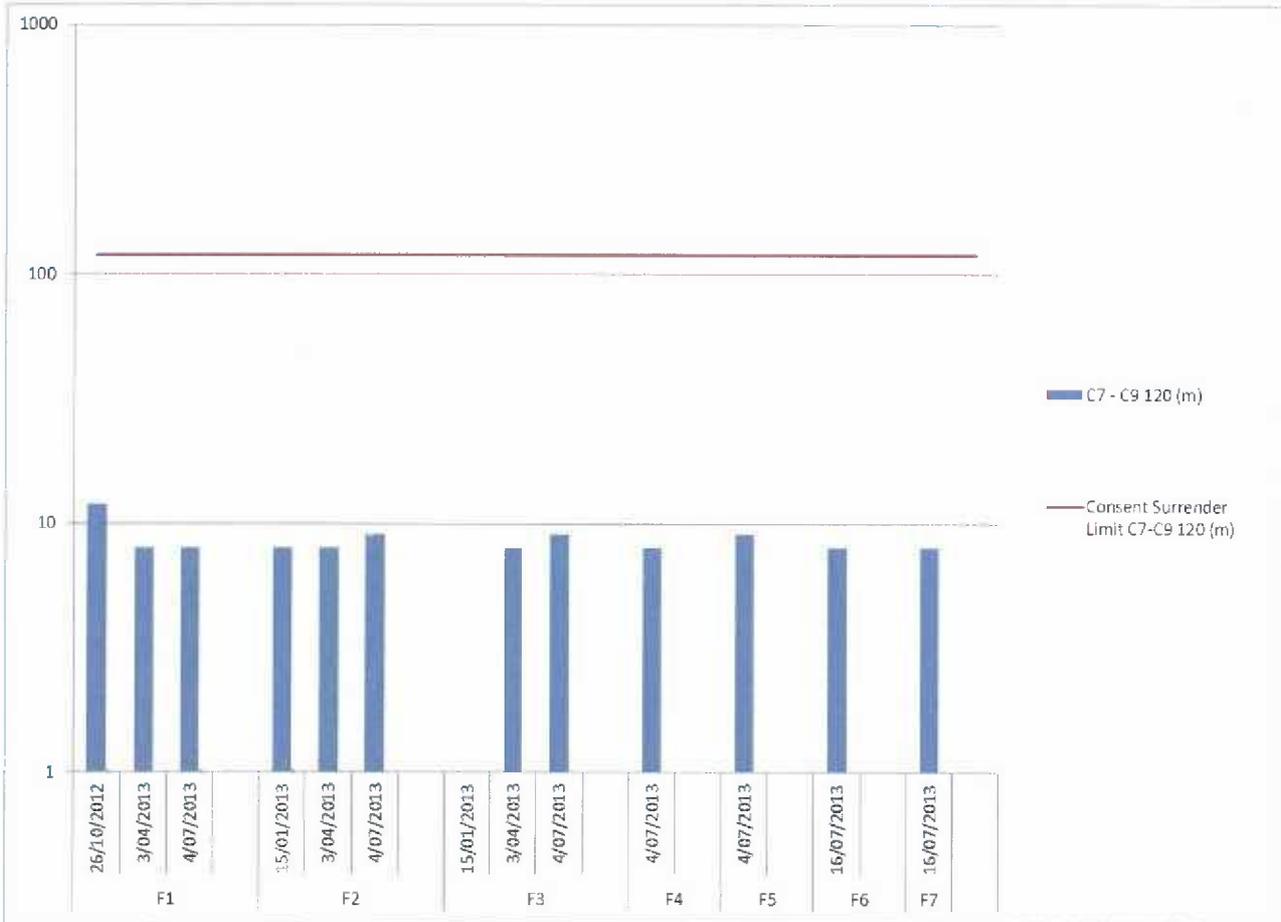
Figure 6 TPH C7-C9 – Oeo Landfarm

As shown in Figure 6, results for TPH C7-C9 at the Oeo landfarm were within the consent surrender limits for all areas.

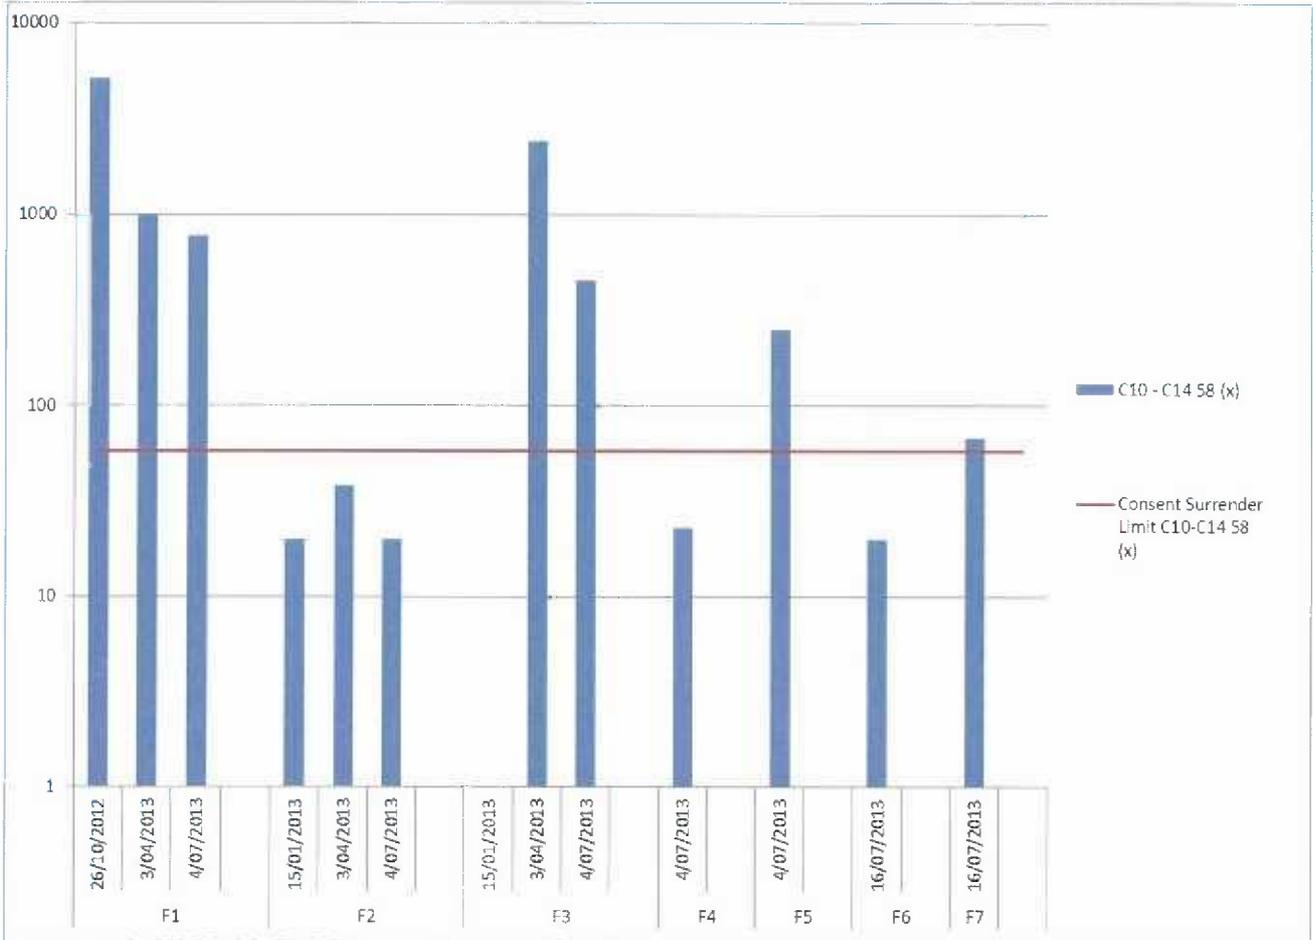
Figure 7 TPH C10-14 – Oeo Landfarm

Results above the consent surrender limits for TPH C10 to C14 58 (x) were encountered for sites F1, F3, F5 and F7 and will require further monitoring.

Area/s not within surrender limits F1, F3, F5 and F7

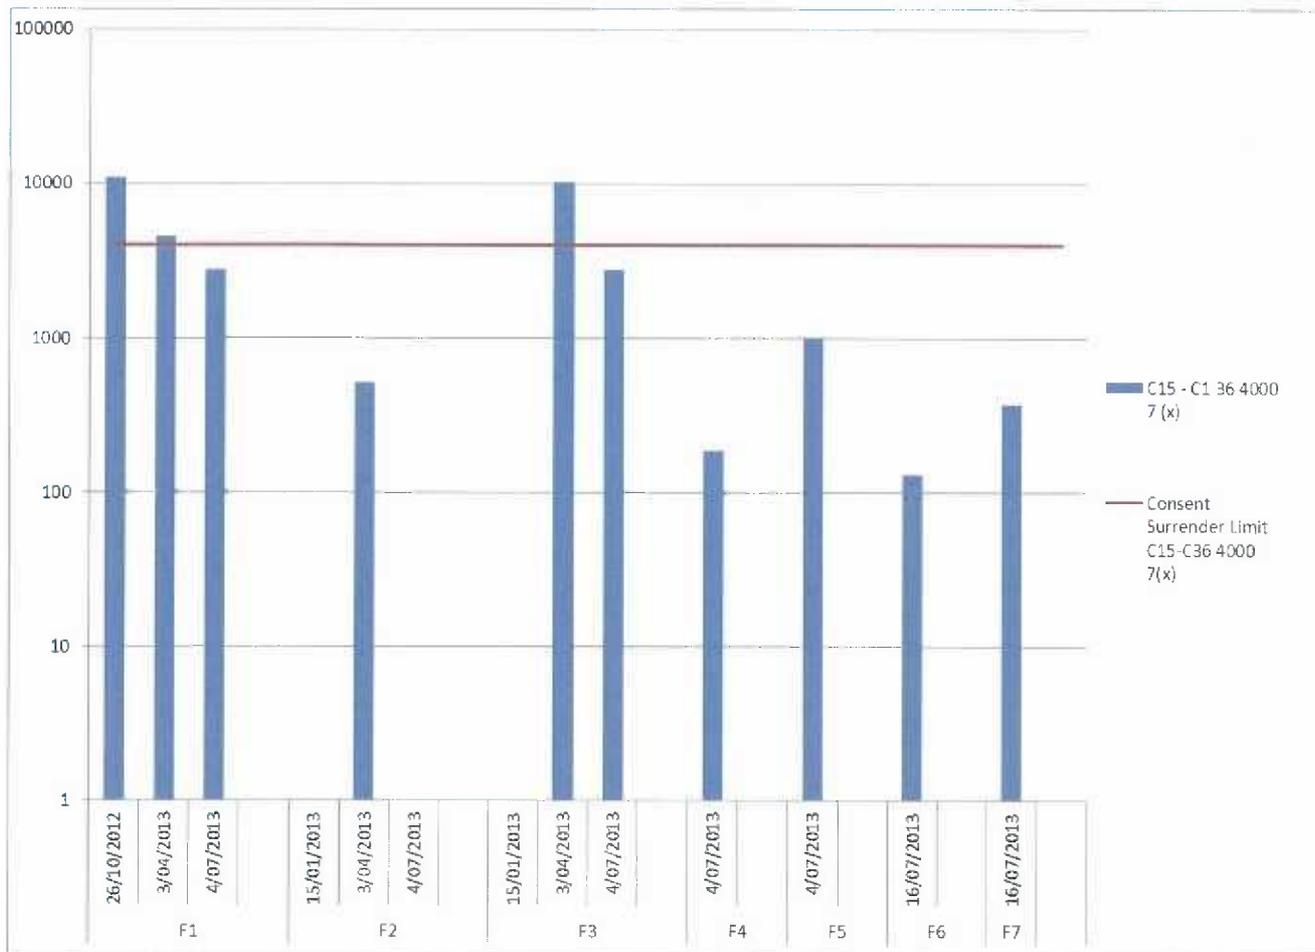
Figure 8 TPH C15-36 – Oeo Landfarm

Figure 8 shows results for TPH C15-C36 for all sites. All areas are now within the surrender criteria for the consent.
