Remediation NZ Limited
Drilling Waste Disposal
Monitoring Programme
Annual Report
2012-2013

Technical Report 2013-67

February 2014

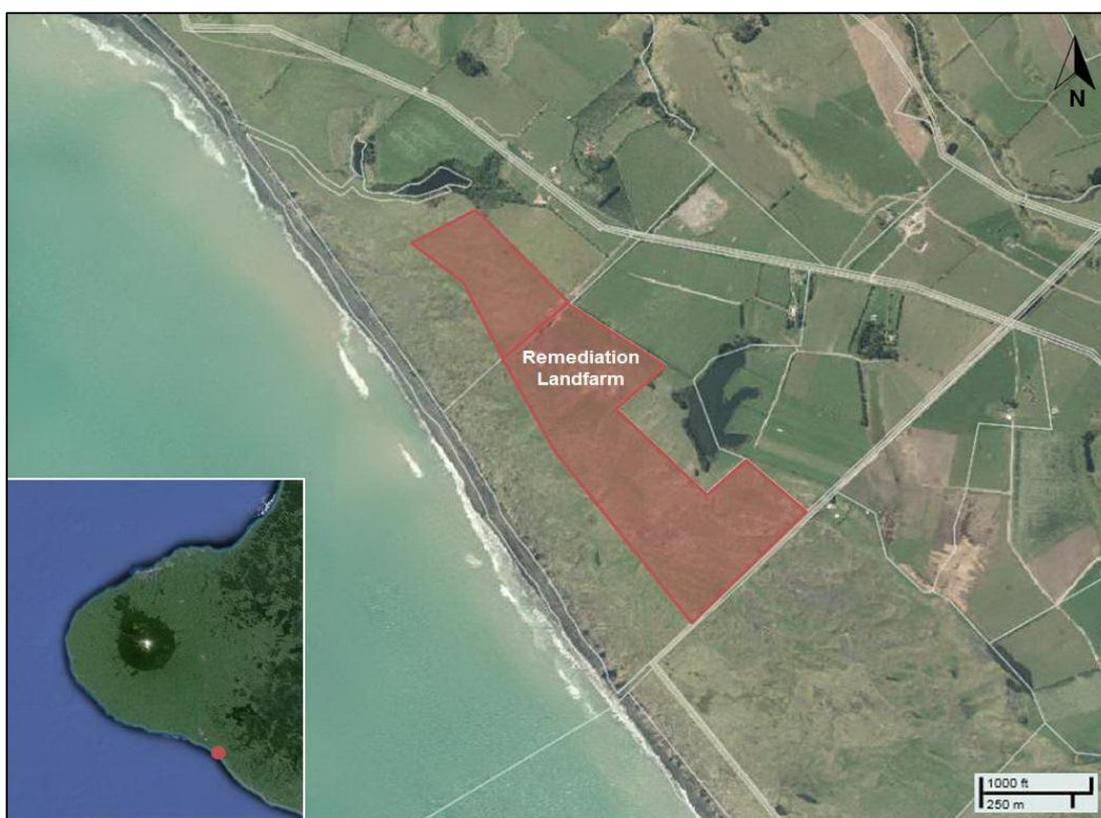
Figure 1 Aerial photograph showing the location and extent of the Remediation Landfarm and approximate regional location (inset)

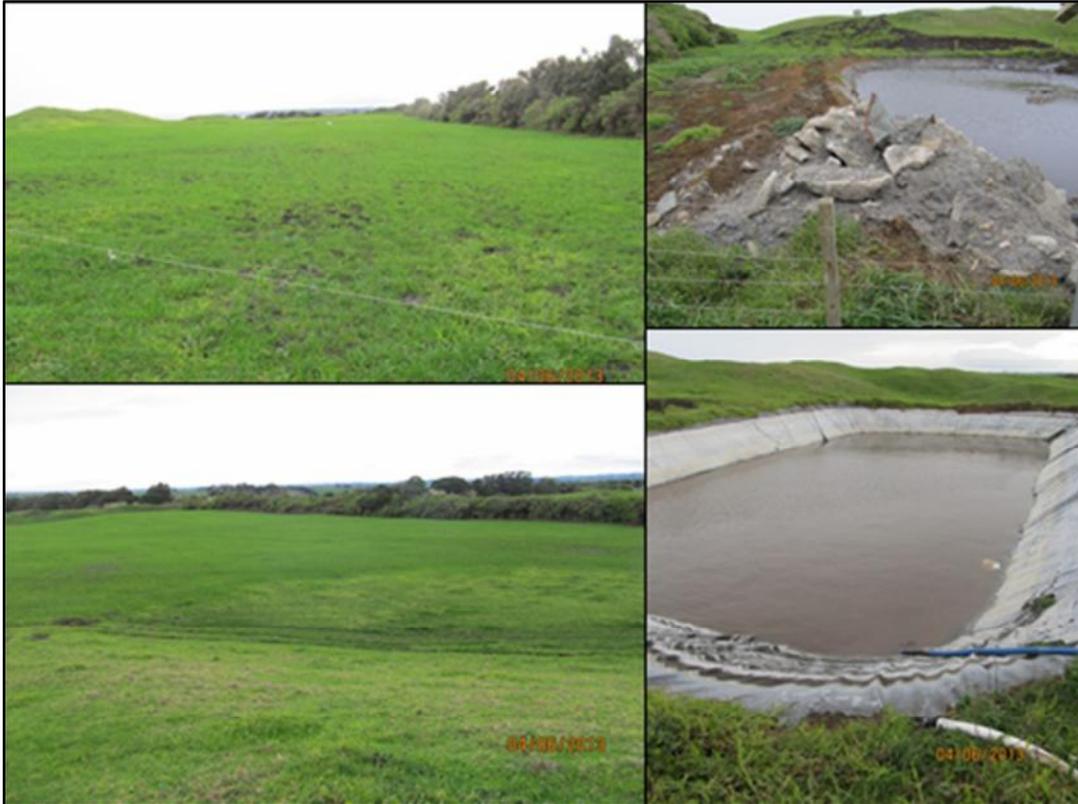
Upon inspection no objectionable odours or visible emissions were detected. All pits on site were found to have plenty of freeboard and the material contained within was essentially free of surface oils and hydrocarbon sheen. It was observed that one liner was found to have a small tear near the top which is above the lowest point of the pit wall, the hole will need to be repaired to prevent wind deteriorating it further. A small pile (approximately 1m³) of gravel/metal was stockpiled adjacent to the pits, no hydrocarbon contamination was found, but it was outlined that if the material originated at a well site it must be stored within the pit. Another pile of concrete and cuttings was observed on the edge of one pit adjacent to the small shed. The area where muds had previously been applied was found to have good pasture coverage and had recently been lightly grazed. Cattle had caused pugging in the soft soil, yet very little mud was identifiable within the soil profile (except in one 2 m² patch which had essentially no pasture strike). Another low point (where the spreading area drains adjacent to the groundwater monitoring bore) had little pasture growth due to the ponding, yet the liquid was free of hydrocarbon sheen and odour. It was outlined to site staff to repair the small hole in the liner and ensure all materials originating from well sites are stored within the pits.

Figure 2 Site activity photos from June 2013 Inspection, clockwise from top left: spreading area S1 looking north, lined pit 1 with cuttings/cement piled outside pit, lined pit 2, area S1 looking inland

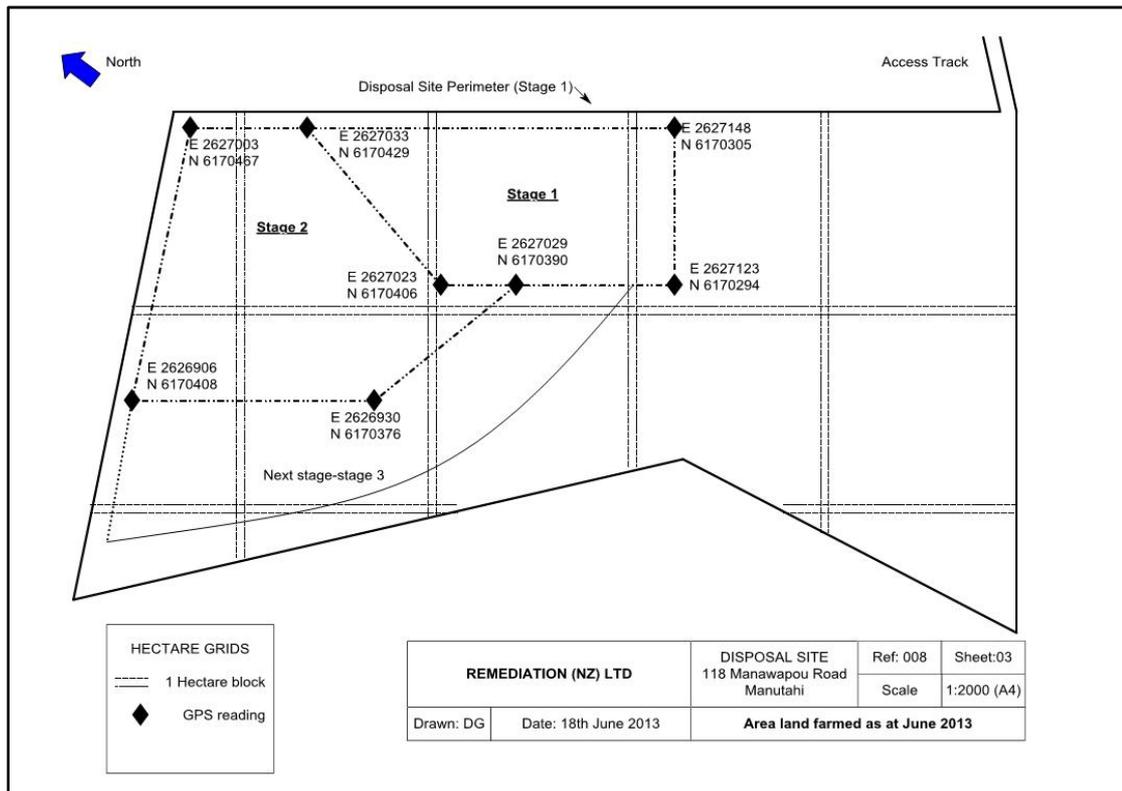
Figure 3 Supplied spreading map showing areas S1 and S2, Remediation Landfarm

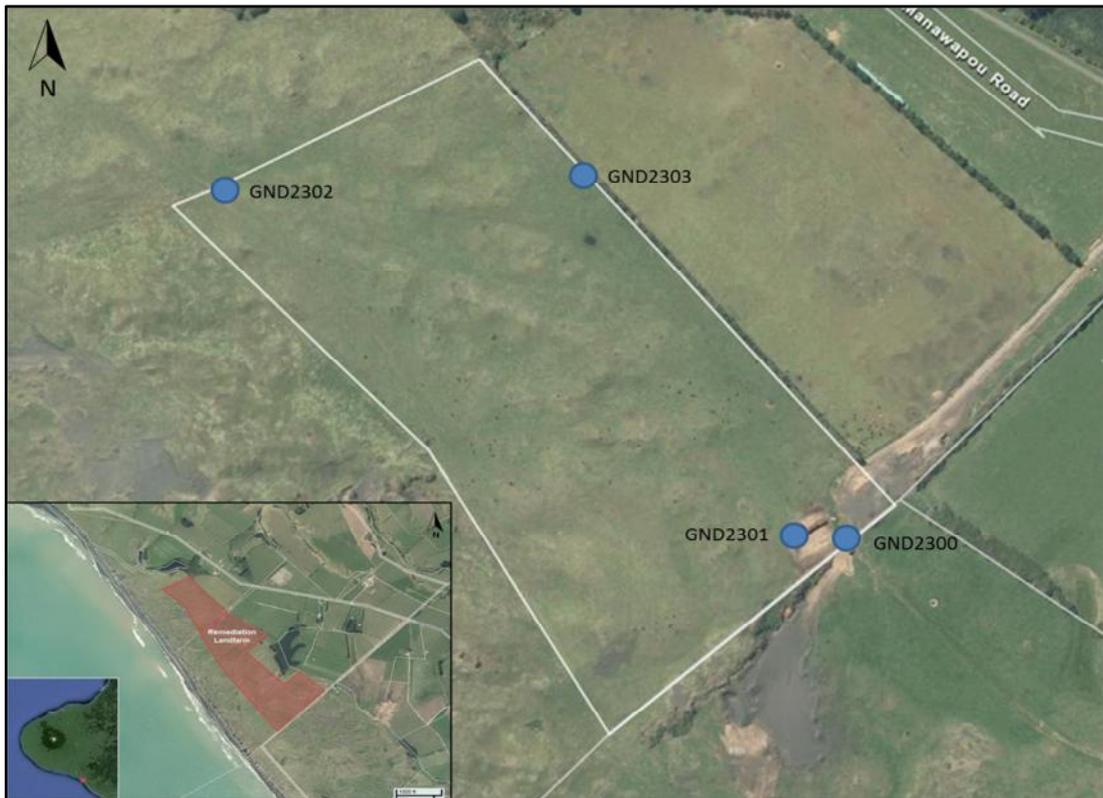
Figure 4 Groundwater monitoring site locations, Remediation landfarm with site map and regional map (inset)

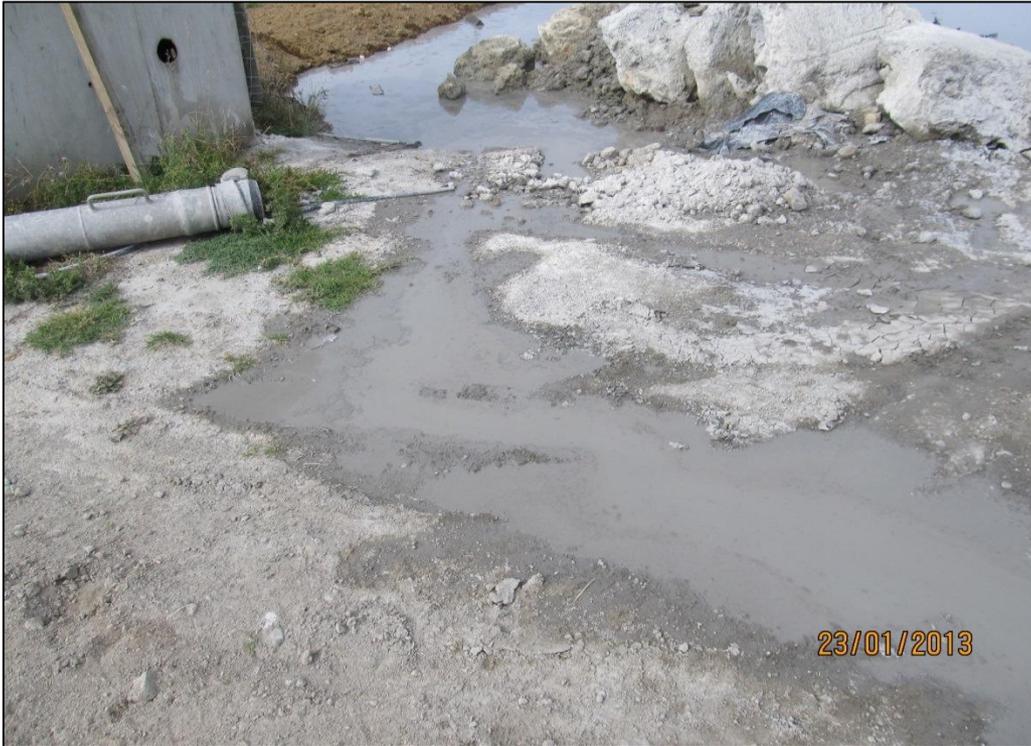
During routine compliance monitoring it was discovered that a lined pit used to contain water based drilling mud had been filled above the level of the liner and that washings from a recent truck delivery had also been discharged onto the unsealed surface around the pit rather than into the pit itself. The findings of the inspection were immediately outlined to the resource consent holder who agreed to have the level of the pit lowered the following day when spreading activities were to commence, and operators were to be made aware that all washings have to be discharged into the pits.

Photo 1 Drilling mud discharge around the pit

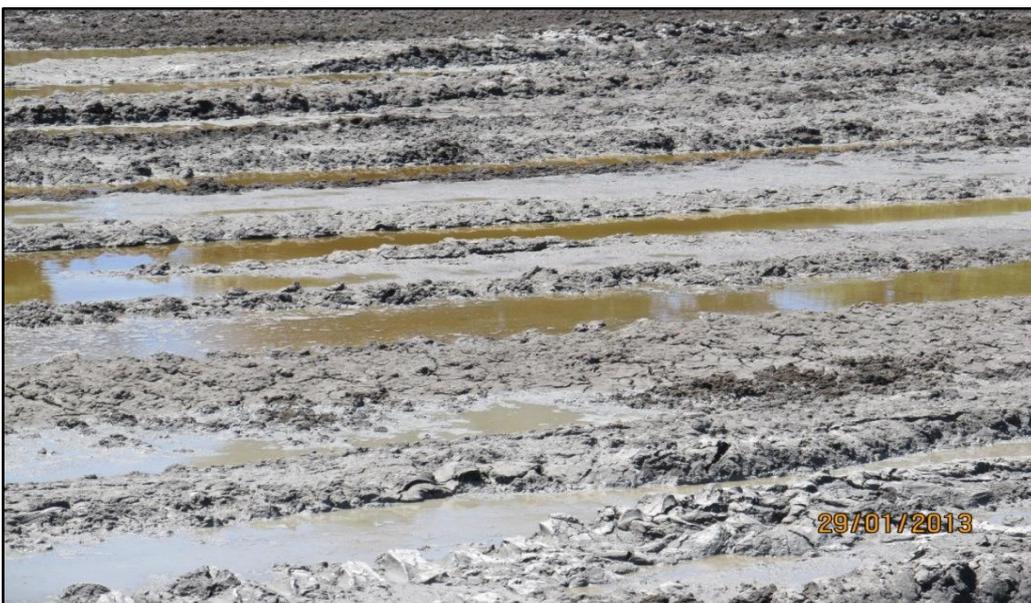
During routine compliance monitoring it was discovered that on the area where muds had been applied, ponded liquid had remained on the surface more than one hour after it was spread. Re-inspection the following day found that although works had been undertaken to incorporate the material into the soil profile, ponded liquid was still present in some areas. A letter requesting an explanation for the consent non-compliance was sent, a letter of explanation was then received, and an infringement notice was issued to the consent holder. A copy of the infringement notice is attached in Appendix III.

Photo 2 Ponding muds in spreading area S2 as observed on 29 January 2013

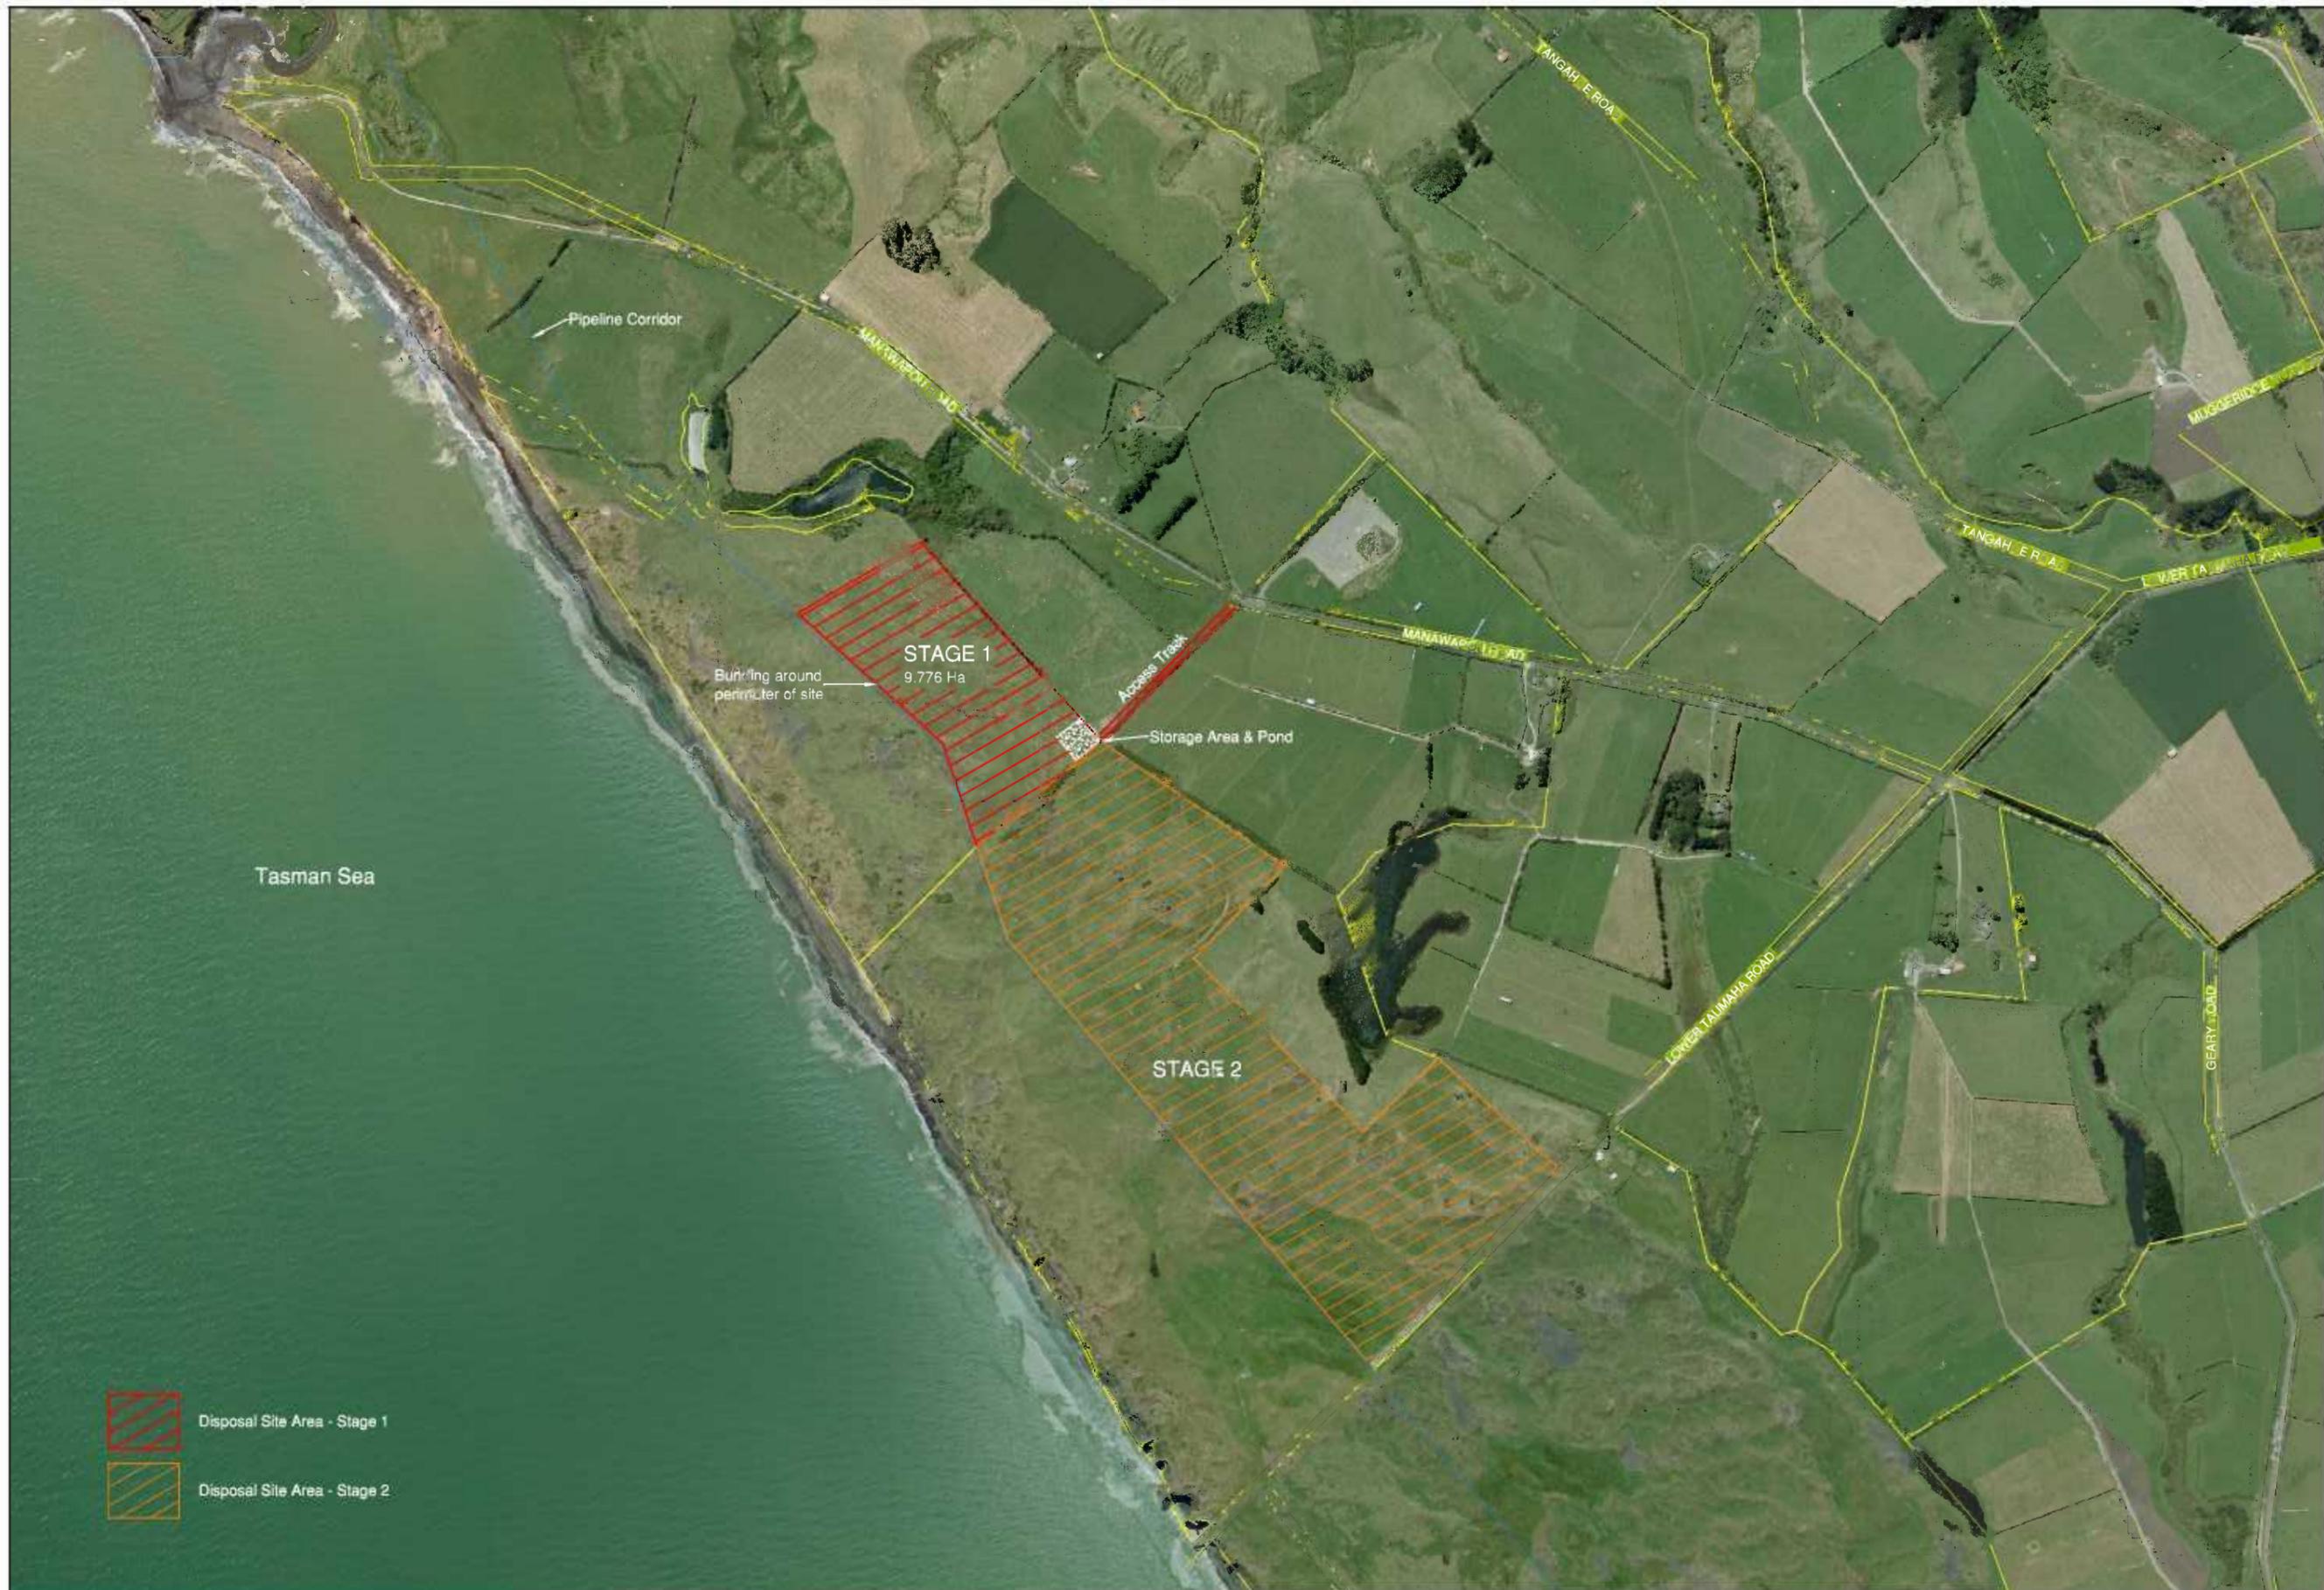
PROPOSED DISPOSAL SITE

- Disposal Site Area - Stage 1
- Disposal Site Area - Stage 2

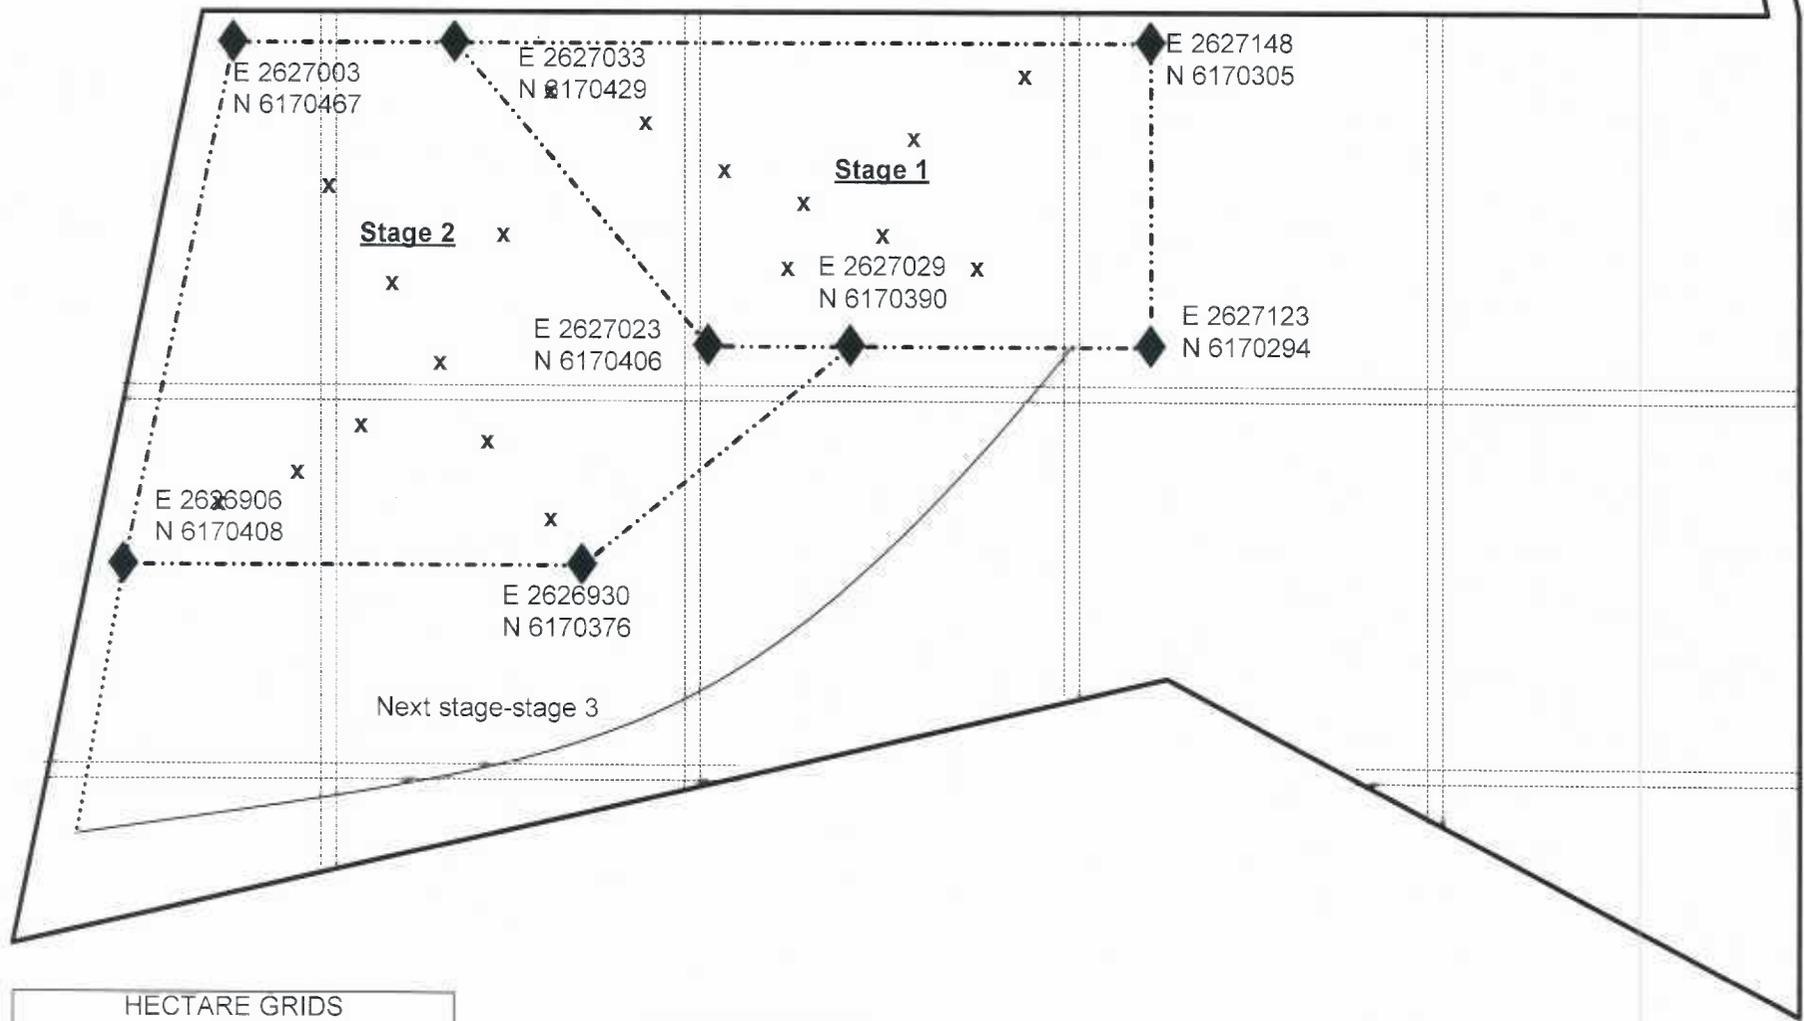
REMEDIATION (NZ) LTD	DISPOSAL SITE 118 Manawapou Road Manutahi	Ref: 008	Sheet:03
		Scale	1:2000 (A4)
Drawn: DG	Date: 25 September 2013	Area land farmed as at June 2013

HECTARE GRIDS	
	1 Hectare block
	GPS reading
	Soil Sampling Site

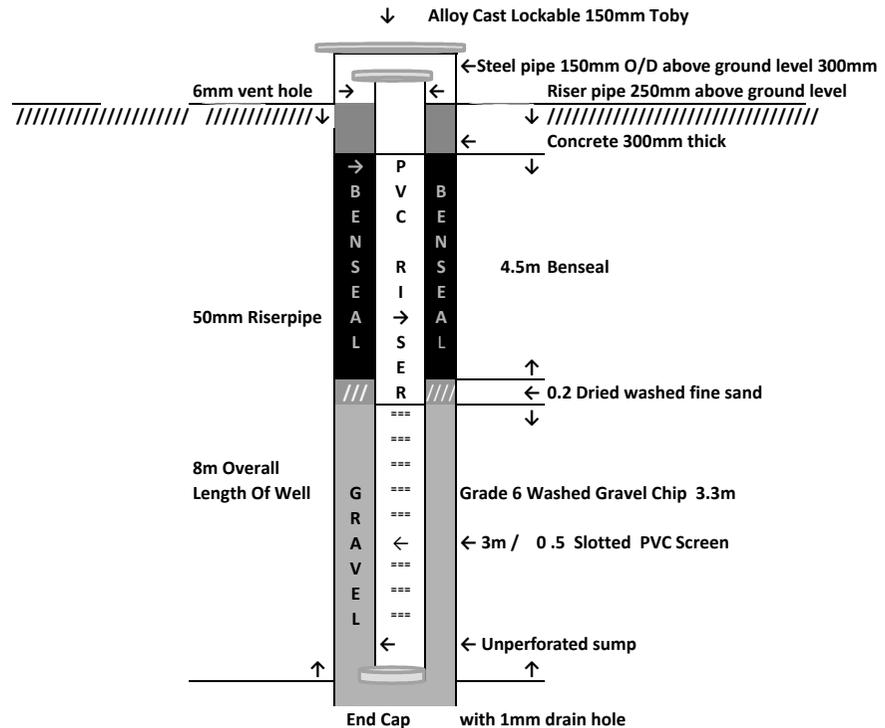
- 0 - 0.5 dark brown sandy soil
 - 0.5 - 2.0 light brown/orange clay- loose -sticky-moist
 - 2.0 to 3.0 light brown /orange clay tight
 - 3.0 to 5.0 light brown / orange sandy clay saturated/soft
 - 5.0 to 7.0 dark brown peaty clay/brow orange clay saturated
 - 7.0 to 7.5 loose saturated sands
 - 7.5 to 10m tight dark grey sands/dry /tight
- Tagged bottom of screen 8.8 top of riser pipe
Water Table 5.404@ dipped by TRC on 9-10-2012
