Waste Remediation Services Limited  
(WRS)  
Symes Manawapou Landfarm  
Monitoring Programme  
Annual Report  
2014-2015

Technical Report 2015-77

March 2016

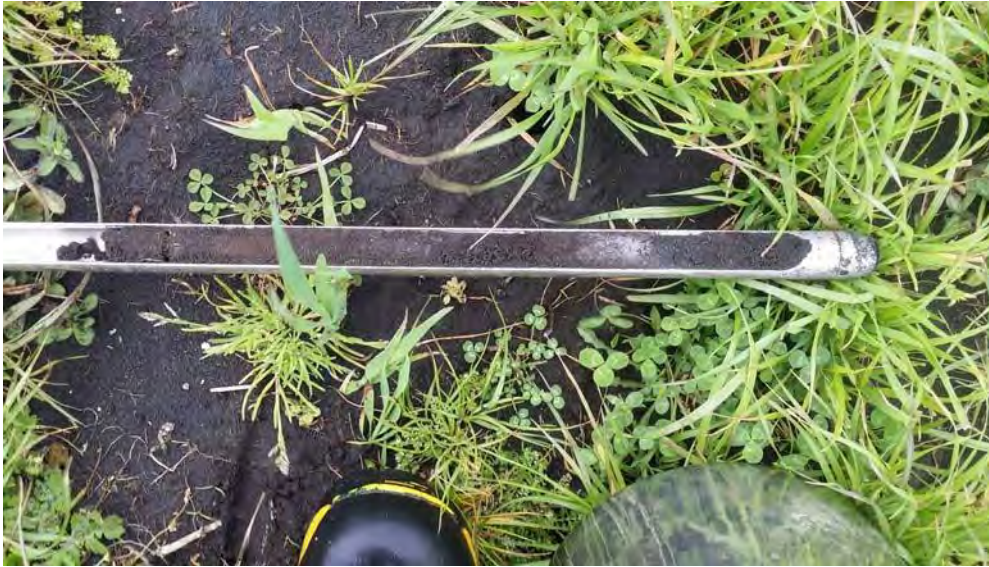
**Photo 3** Soil core collected from the Symes Manawapou Landfarm

The methodology utilised by the Council for collecting soil samples across the land farmed area is adapted from the Guidelines for the Safe Application of Biosolids to land in New Zealand (2003), whereby a soil corer is inserted to a depth of 500 mm +/- to encompass the zone of application, ten soil cores are collected, spaced 10 meters apart. These ten soil cores are then composited to gain one representative soil sample of an application area. An example of a soil core is provided in Photo 3.

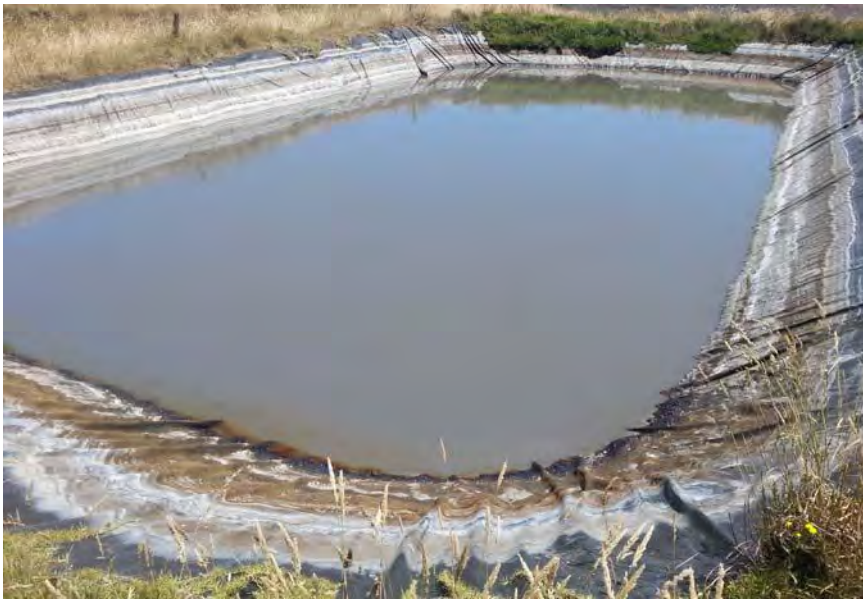
**Photo 4** Lined storage cell

During the monitoring period under review the site received material from TAG OIL's Cheal wellsite's. The material had been delivered from the Cheal E6 and Cheal E7 well sites and was divided into solid and liquid waste. Material was transported to the site by a registered tanker and then discharged into a set, lined, storage cell (Photo 1), of which there are three on this site.

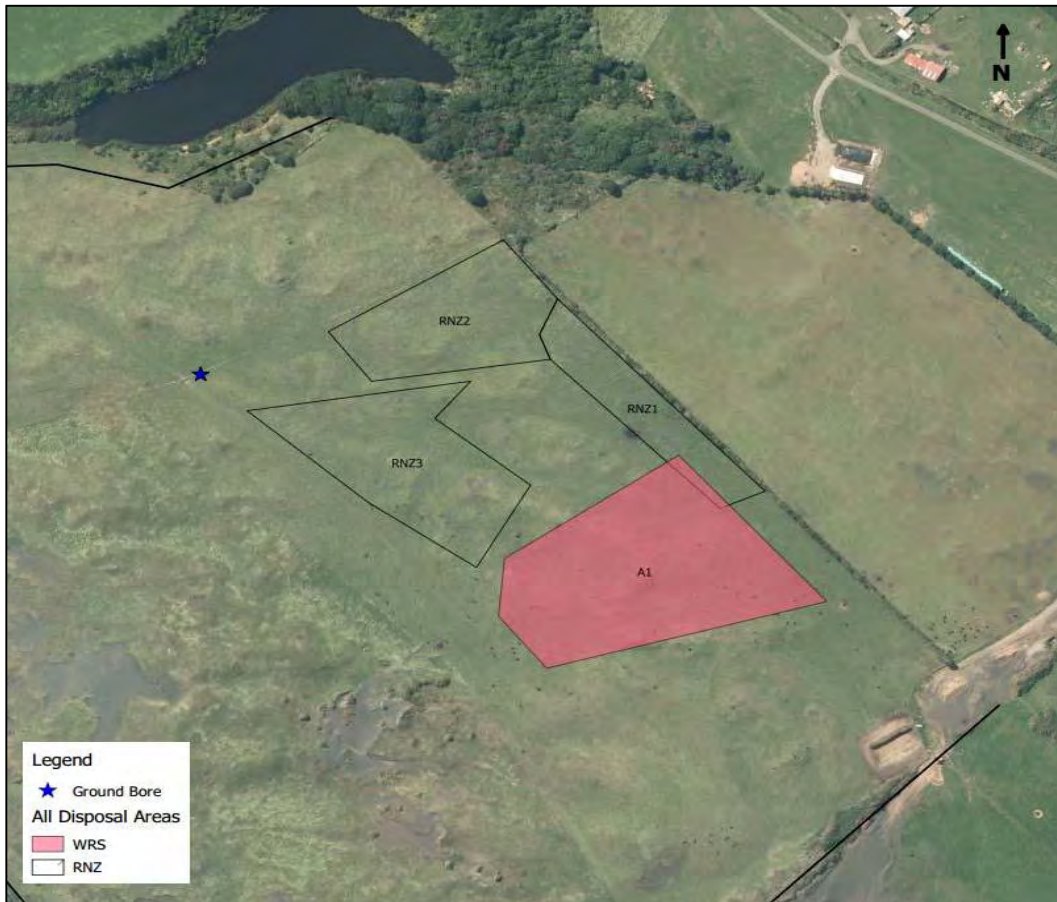
**Figure 2** The Company supplied map detailing previously spread areas RNZ1, 2 & 3 and Spread Area A1 from the 2014/2015 monitoring period

In reviewing the data provided by the Company and specifically the map which indicated the location of the newly spread area (Figure 2), it is possible to discern that that the application of material to land in this period (Area A1) slightly overlapped a previous application area. This was identified by the Council's Investigating Officer, and the Company will be mindful to not allow this to occur in the future as it would constitute a breach in one of the consent conditions<sup>3</sup>. In this instance as the double layering only occurred over a small area, the operator was warned to be mindful of previously spread locations. However, the Council appreciates the transparency of the Company in providing this accurate depiction of the overlap.

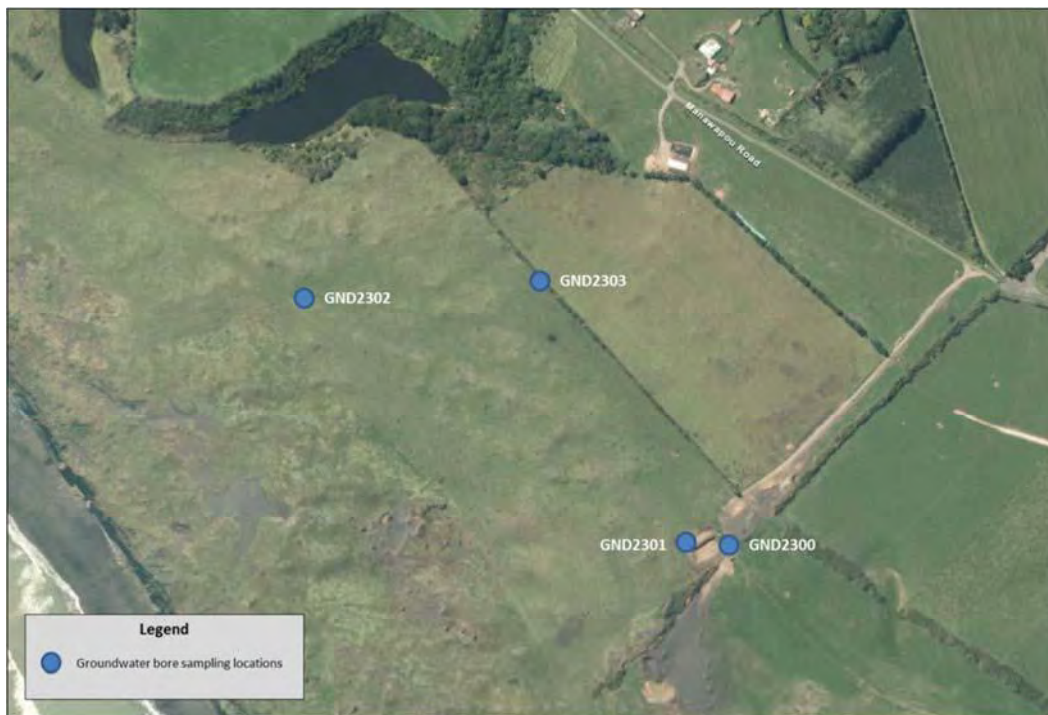
**Figure 4** Groundwater monitoring well locations

Groundwater monitoring bores GND2302 and 2303 are located on the site boundary (Figure 4) to detect any potential offsite migration. Neither of these bores to date has shown any evidence to suggest possible groundwater contamination. As the groundwater analysis at the boundary of the site did not suggest any adverse effects from the exercise of the consent the annual surface water sample of the unnamed lake to the north of the facility was deemed unnecessary.

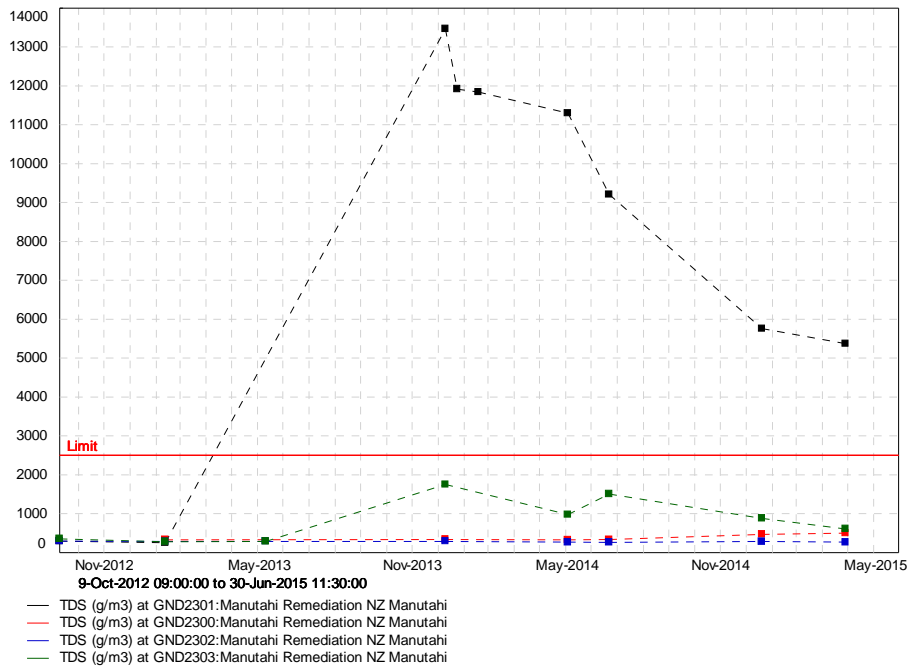
**Figure 5** Historic Total Dissolved Salt Concentration by monitoring well location

Groundwater analysis undertaken by the Council through out the 2014-15 monitoring period detailed one ongoing exceedance. This was in the concentration of Total Dissolved Salts (TDS) ( $>2500 \text{ g/m}^3$ ) in groundwater bore GND2301. This was a breach of special condition 18<sup>2</sup>, Figure 5.

The rationale for the exceedance observed in groundwater bore GND2301 which is situated in the locality of the storage cell area was due to a rip in the liner of cell one which compromised its integrity. This was identified in early 2014 by Council's Investigating Officer. Repairs were undertaken in mid 2014, and as a result the concentration of TDS has shown a decreasing trend since the repair, Figure 5.

In terms of environmental effects associated with the exercise of the consent, a minor legacy issue remains. During the 2013-14 monitoring year a small tear was identified by the Council's Inspectorate Officer in the liner of one of the storage cells. This was subsequently repaired, however, due to the nature of the tear; an increase in the concentrations of total dissolved salts (TDS) was identified within the groundwater monitoring well GND 2301. The historic increase in TDS concentration is detailed in Figure 5.

While the issue had been rectified through the careful repair of the storage liner, the legacy still remains and the Council will continue to monitor this location until it is below the consented requirement of TDS below 2500 g/m<sup>3</sup>. Monitoring of the three remaining groundwater wells indicated that there appears to be no more than minor environmental effects due to activities at the site.

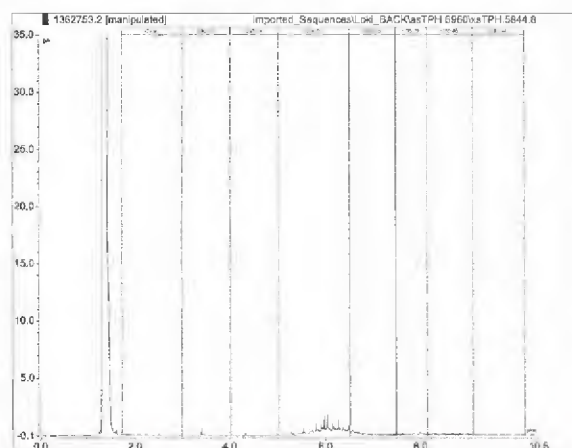
Manawapo Pre-Disposal Liquid 09-Dec-2014

Client Chromatogram for TPH by FID
