TAG Oil (NZ) Ltd
Vanner Landfarm
Monitoring Programme
Annual Report
2015-2016

Technical Report 2016-90

November 2016

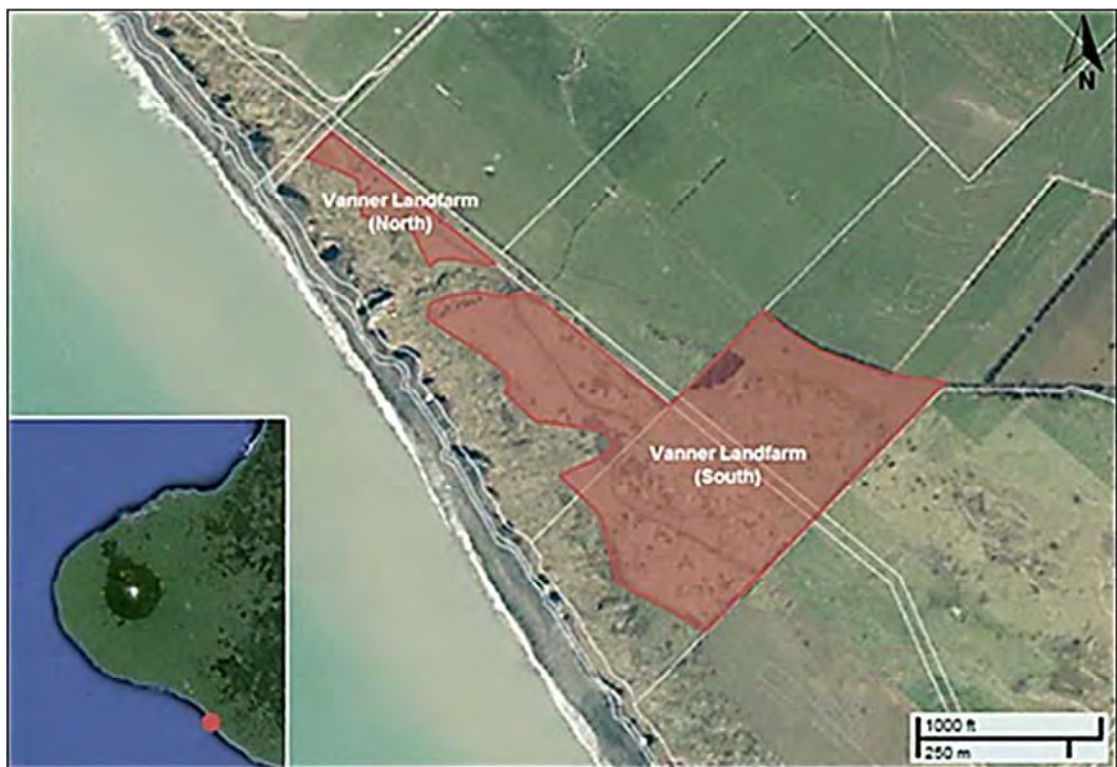
Figure 1 Site location and regional inset

Word descriptor:	Lower Ball Road, Kakaramea, Taranaki
Map reference:	E 1720685
(NZTM)	N 5602731
Mean annual rainfall:	1,043 mm
Mean annual soil temperature:	~15.1°C
Mean annual soil moisture:	~32.9%
Elevation:	~25 m asl
Geomorphic position:	Cliffed / dune backslope
Erosion / deposition:	Erosion
Vegetation:	Pasture, dune grasses
Parent material:	Aeolian deposit
Drainage class:	Free / well draining
Land use:	Active disposal

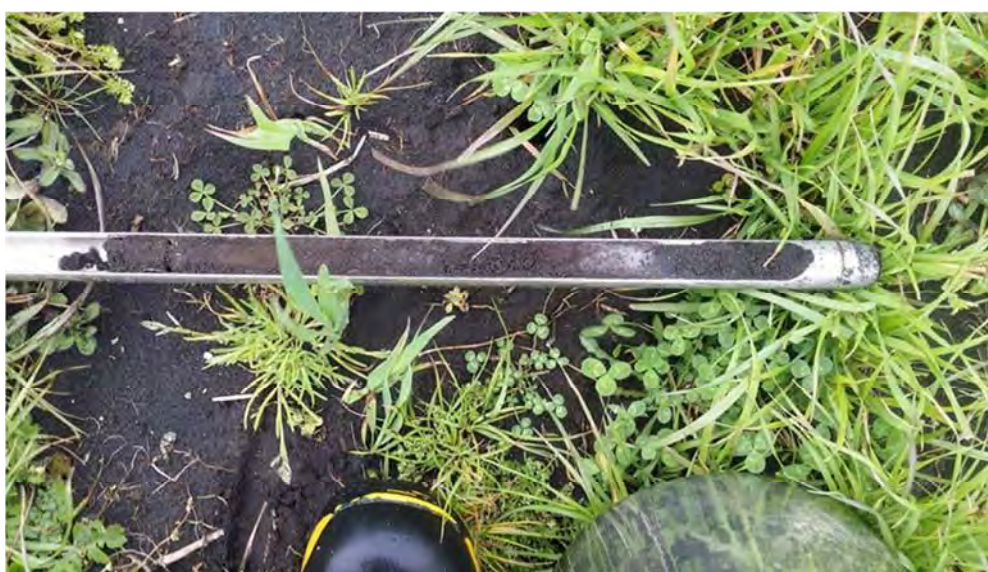
Photo 1 An example of a soil core

The procedure for soil sample collection is adapted from the Safe Application of Biosolids to land New Zealand (2003), whereby ten soil cores (Photo 1) are collected at 10 m intervals across a spread area and then composted to gain one representative sample of the area of application.

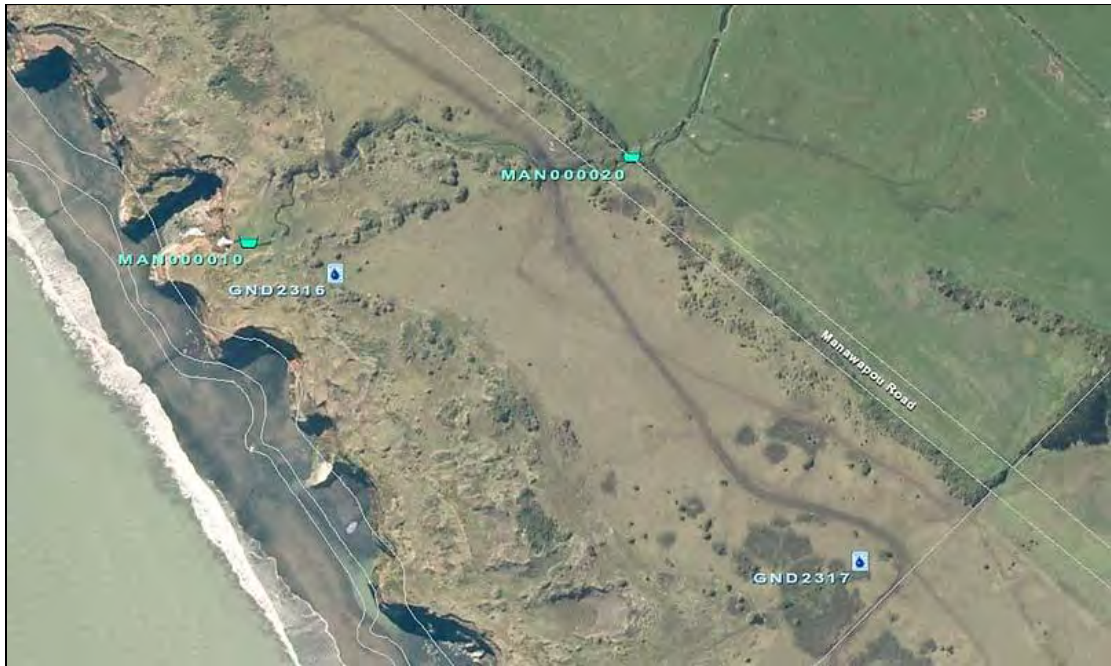
Figure 3 Vanner Landfarm groundwater monitoring well and Mangaroa Stream sample locations

In an active monitoring year the Council would have sampled the two site specific groundwater monitoring wells four times per annum. This was undertaken to understand the seasonal fluctuations which may exist on site and also to ascertain if any adverse effects were permeating from the exercise of the consent. The locations of the monitoring wells are depicted in Figure 3.

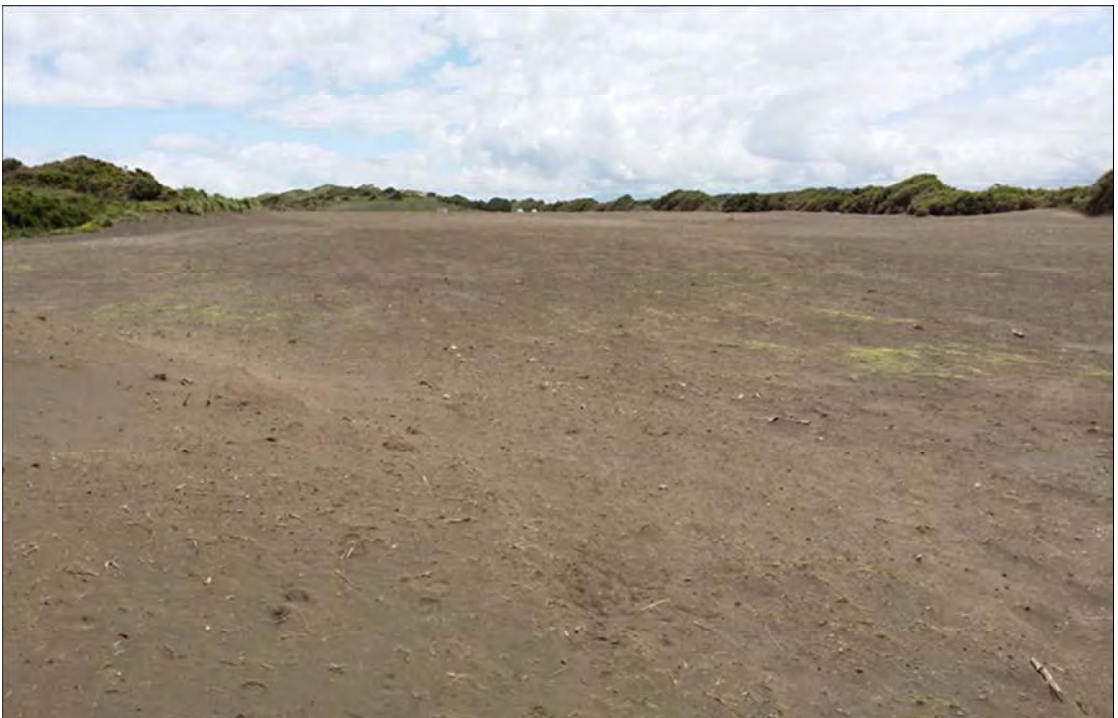
Photo 5 Vanner Landfarm final application areas- western projection F9 and F10 November 2015

Inspections undertaken by the Council this year noted that vegetation is establishing in area F9 and grass is sown in area F10, (Photos 5 and 6). The Council will continue to monitor the revegetation. The Company have described the process in more detail in the attached memorandum, Appendix II.

The Company has engaged Agriseed for advice moving forward (Appendix II). They have planted on three separate occasions, only to loose the majority of the crop on two occasions and 40% on the third occasion, however they intend to persevere. This underlines the Company's commitment to this site, which is pro-active.
