Waste Remediation Services Limited  
(WRS)  
Symes Manawapou Landfarm  
Monitoring Programme  
Annual Report  
2015-2016

Technical Report 2016-92

January 2017

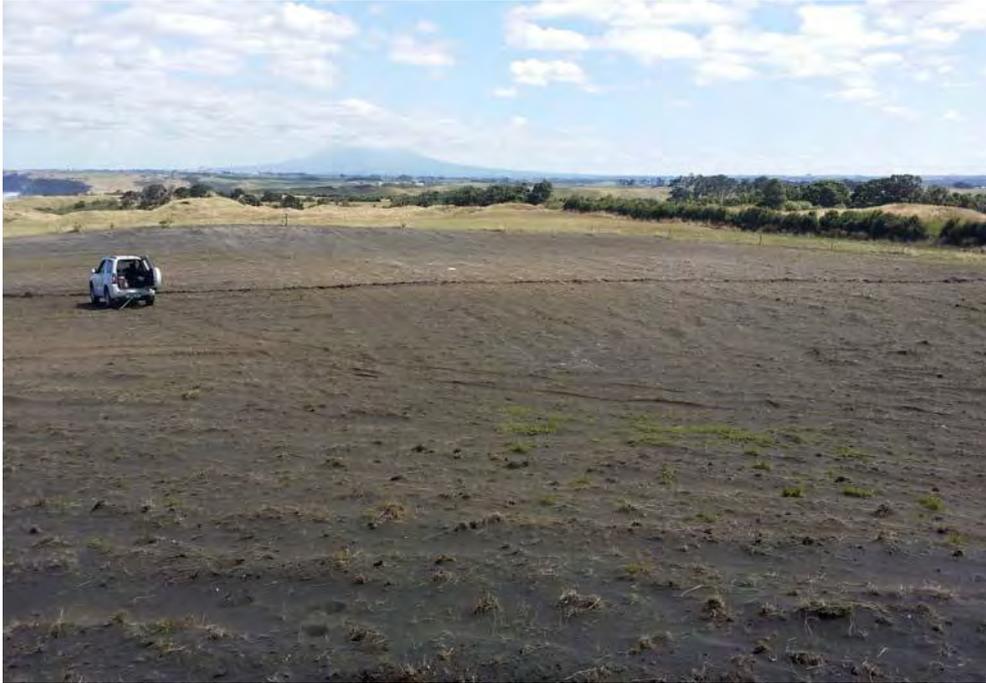
**Photo 1** Landfarm post application and reinstatement north west projection

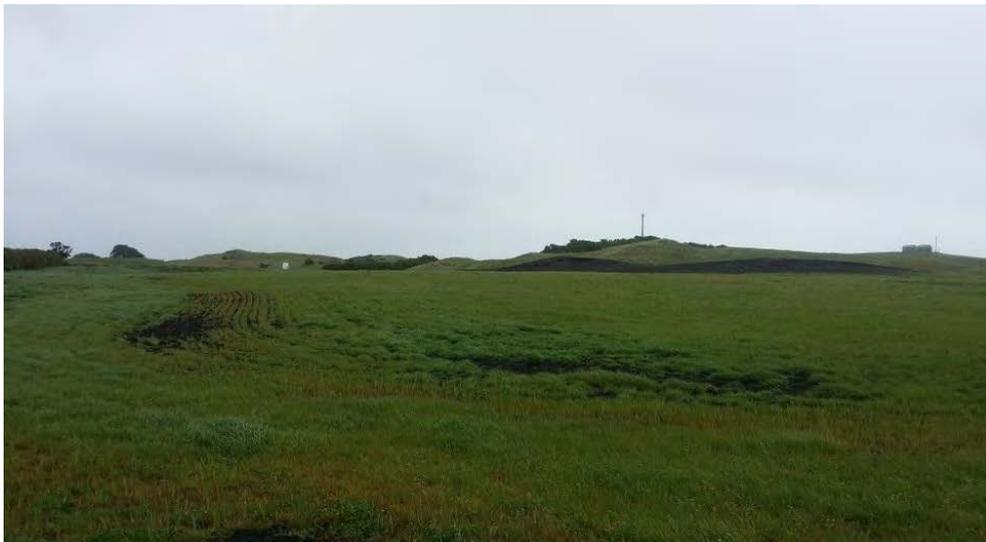
**Photo 2** Pasture cover establishment south east projection

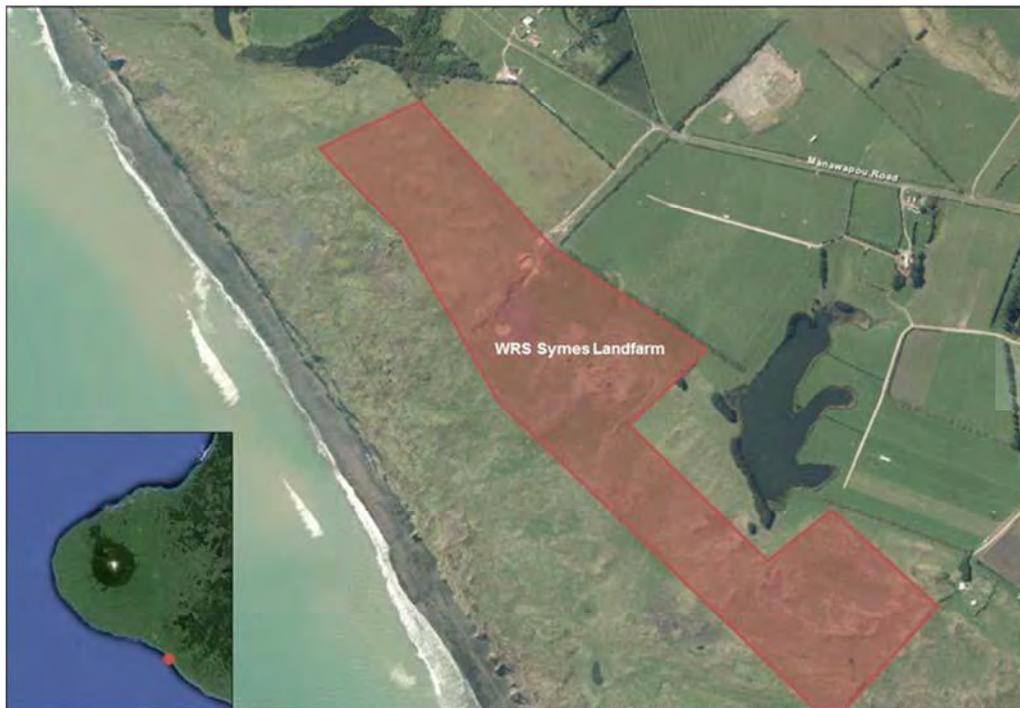
**Figure 1** Aerial image of the Symes Manawapou Landfarm with regional location

The site is located on Manawapou Road at Manutahi, South Taranaki. This site is positioned on marginal coastal farm land situated on reworked dune fields. An extensive (100-250 m) foredune is located seaward of the consented site, and will remain undisturbed by site activities. The foredune provides a considerable natural buffer from prevailing onshore winds. A natural gas pipeline runs adjacent to the length of the site on the seaward side, marking the seaward extent of the disposal site. In addition, a QE II covenant is located in the north western end of the site, and Lake Taumaha (which is a QE II covenant and a Key Native Ecosystem) is located east of the site. The proximity of the site to these recognised ecosystems has been taken into account in the setting of buffer distances and location of the stockpiling facilities.

The predominant soil type has been identified as black loamy sand and vegetation growth is primarily a mixture of pasture and dune grasses. Test pitting and the logging of boreholes on site indicated a relatively shallow water table. Test bores were augured to 10 m in the pit area, revealing extensive compacted, low permeable clays underlying coastal dune sands. Pit construction revealed mostly tightly packed sand at the pit bases (approximately 4-5 m below surface). Average annual rainfall for the site is 1,023 mm (taken from the nearby 'Duffy' monitoring station). As with the other South Taranaki coastal sites, this site is subject to strong winds.

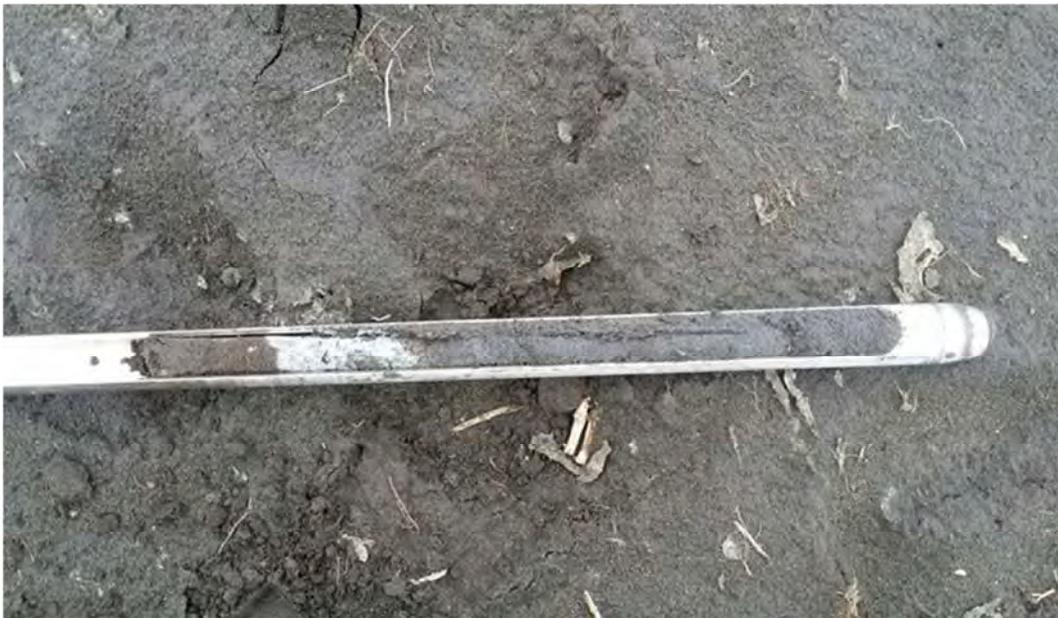
The methodology utilised by the Council for collecting soil samples across the land farmed area is adapted from the Guidelines for the Safe Application of Biosolids to land in New Zealand (2003). Whereby a soil corer is inserted to a depth of 400 mm +/- to encompass the zone of application, ten soil cores are collected, spaced 10 meters apart. These ten soil cores are then composited to gain one representative soil sample of an application area. An example of a soil core is provided in Photo 3.

**Photo 3** An example of a soil core collected from Symes Manawapou landfarm

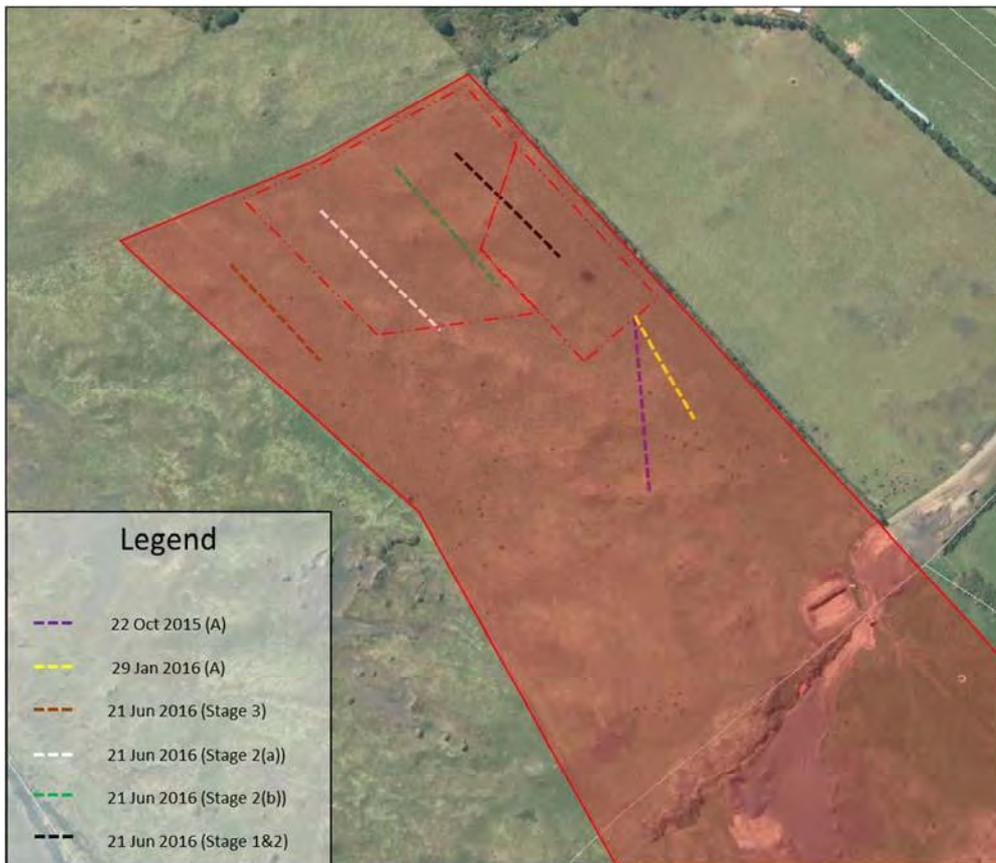
Thus if the results from this monitoring period are compared to the consent conditions (Table 2), the total metal analysis undertaken across the landfarmed areas returned low concentrations of heavy metals which are close to background Taranaki concentrations.

There was no exceedance in any of the other consented parameters which were analysed. There however exists a good deal of variation across the site as can be seen by the varied pH and varying level of soluble salts analysed.

TPH analysis ranged from 6-292 mg/kg which is a minimal concentration across the samples collected.

**Figure 2** Council soil transects Symes Manawapou Landfarm 2015-2016

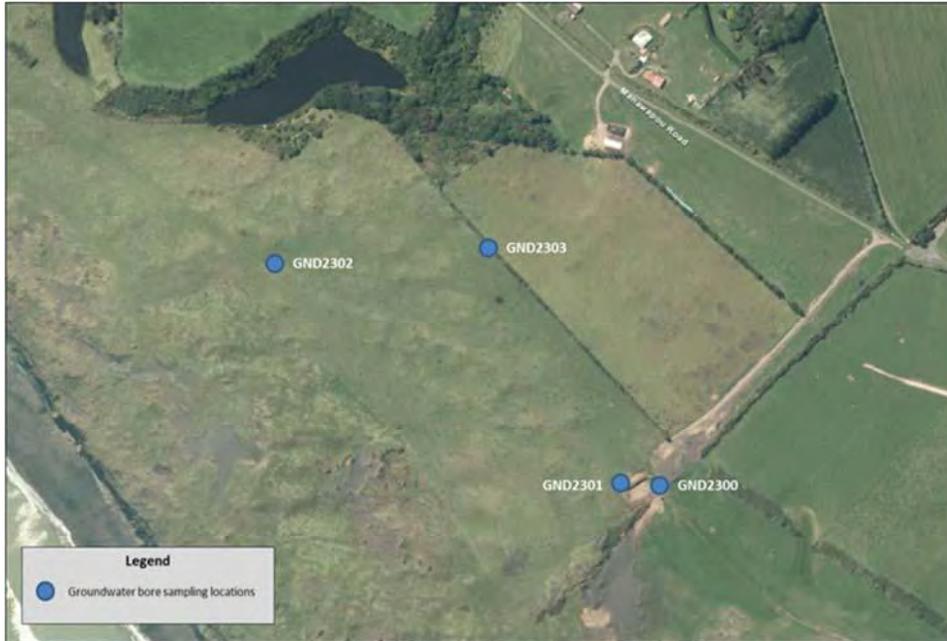
The site contains an active groundwater monitoring network of four groundwater monitoring wells. Two of these wells are located in close proximity to the storage cells to monitor for any potential leaching effects from the storage of material in the lined storage cells, of which the site contains three cells. The other two monitoring wells are located to the north west and north of the storage cells, on the site boundary to monitor for the potential for offsite migration of contaminants (Figure 3). The results of the analysis are provided in the following Tables 3-6.

**Figure 3** Locations of the active groundwater monitoring well network Symes Manawapou Landfarm

The elevation witnessed in well GND 2301 in terms of salt concentration was similarly echoed in two of the three existing wells on the site (Figure 3). GND 2303 which is located to the north of the site, close to the site boundary observed an increase in this period; 1,795g/m<sup>3</sup> to 2,769g/m<sup>3</sup>, as did GND 2300, which is located up gradient of the storage cells, from 673g/m<sup>3</sup> to 1,199 g/m<sup>3</sup>.

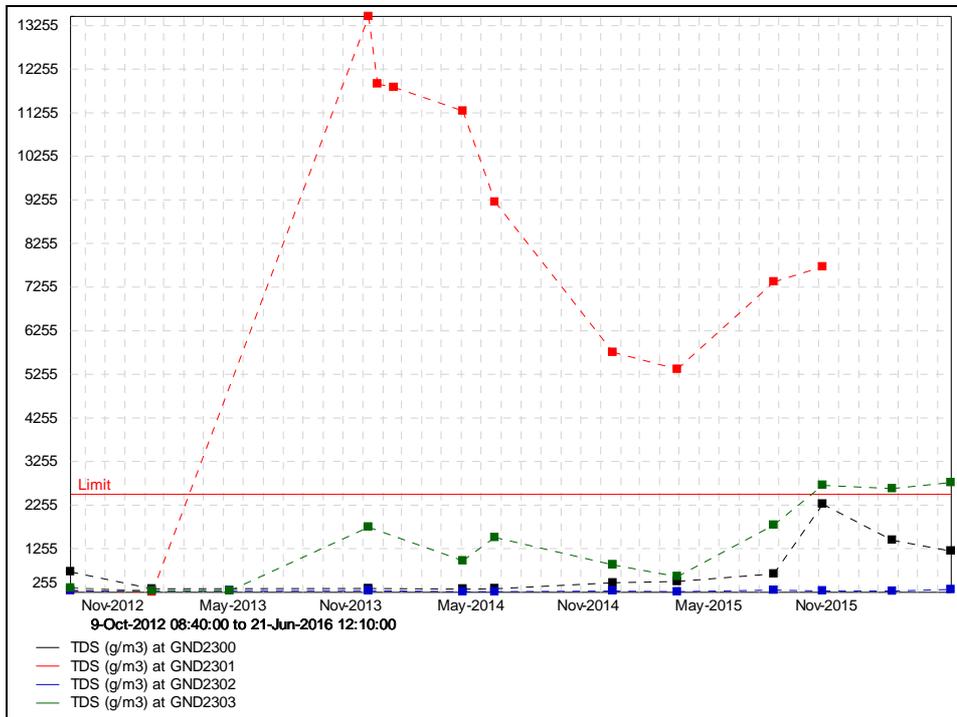
From reviewing the long term record of TDS analysis (Figure 4), GND 2301 has been affected by elevated TDS concentrations since November 2013. The other three

remaining wells have remained stable, below the concentration limit of the consent <math>2,500 \text{ g/m}^3</math>. There was a slight increase in December 2015, whether this was linked to a new delivery of material which was stored in the cells was unclear, the company did take delivery of material in November 2015.

**Figure 4** Total Dissolved Salt concentrations in groundwater Symes Manawapou long term record

To draw a conclusion as to the cause for this increase in TDS concentration in this period may be hard to accurately achieve. Reported in the previous monitoring period from the inspections, was that the liner of one of the cells had been repaired. Thus prior to this repair occurring, there existed a pathway for the fluid component of the storage cells to infiltrate into the local water table, in the locality of the storage cells.

Thus the likelihood is that a plume of elevated saline water exists in the vicinity of the storage cells, most likely caused by the historical intrusion of elevated saline water from the former tear within one of the storage cells. This coupled with the storage of recently delivered material on the side of the cells, rather than directly into the holding cell may serve as an explanation of the high TDS.

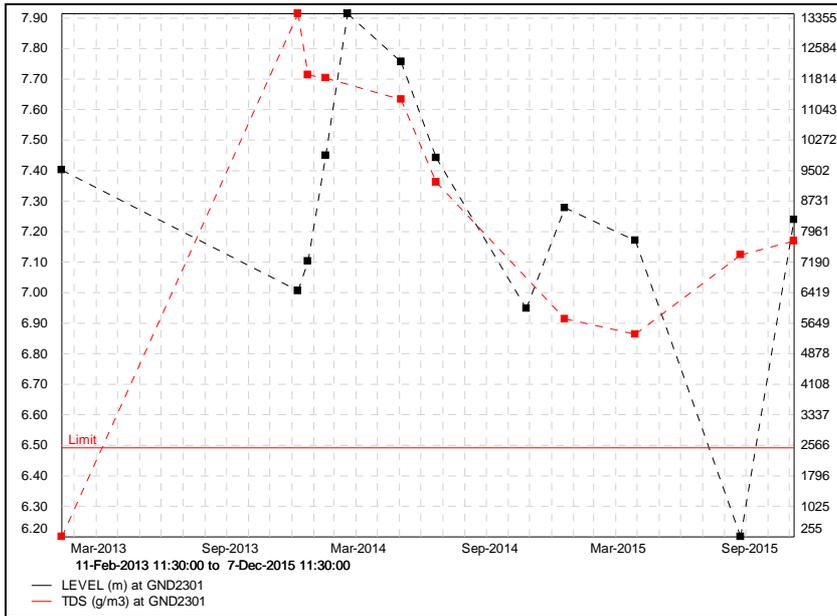
Linked to the high salt concentration in this well is also the detection of low chain hydrocarbons ( $1.8\text{-}1.2 \text{ g/m}^3 \text{ C}_7\text{-C}_9$  and  $0.6 \text{ g/m}^3 \text{ C}_{10}\text{-C}_{14}$ ). Should the level of these hydrocarbons increase in the following monitoring period there will be a requirement to ascertain the source of these hydrocarbons. At the moment as they are at low

concentrations and there are no likely receptors to be adversely effected by this low level of low chain hydrocarbons within a 100 m radius.

**Figure 5** Long term record Total Dissolved Salts (in red) (TDS) and water level (from top of casing) (in black) GND 2301

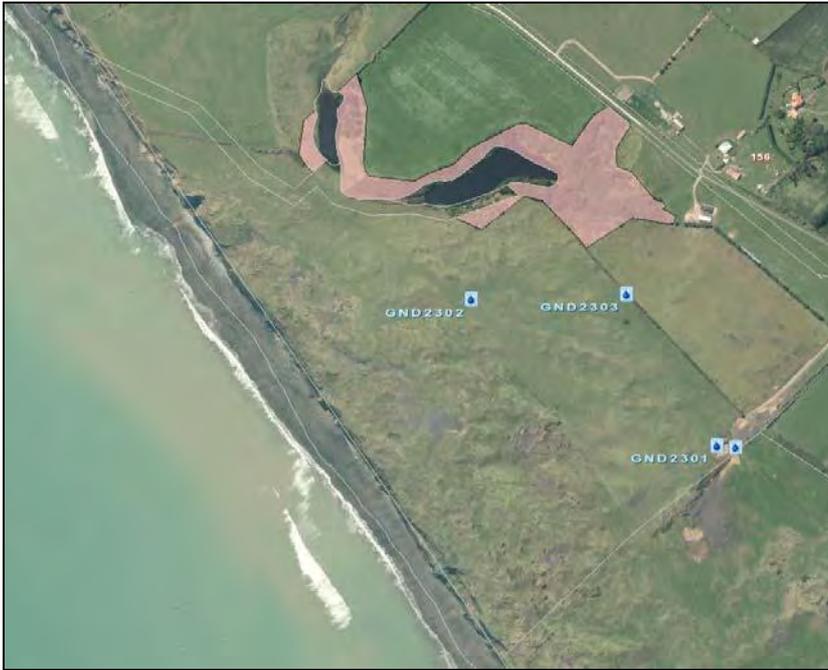
The other well which is of concern to the Council is GND 2303, which as already stated is located on the boundary of the site. The increase in the TDS observed in this well will be closely monitored moving forward. The rationale for the concern is due to the fact the well is located within two hundred meters of a QE II Covenant, which is situated to the north of the well (Figure 6 hatched area). Initial sampling in the up coming monitoring period has reported the salinity in this specific well location has reduced to below the consented limit of 2,500 g/m<sup>3</sup>.

**Figure 6** Groundwater monitoring locations in relation to QE II covenant in hatched area

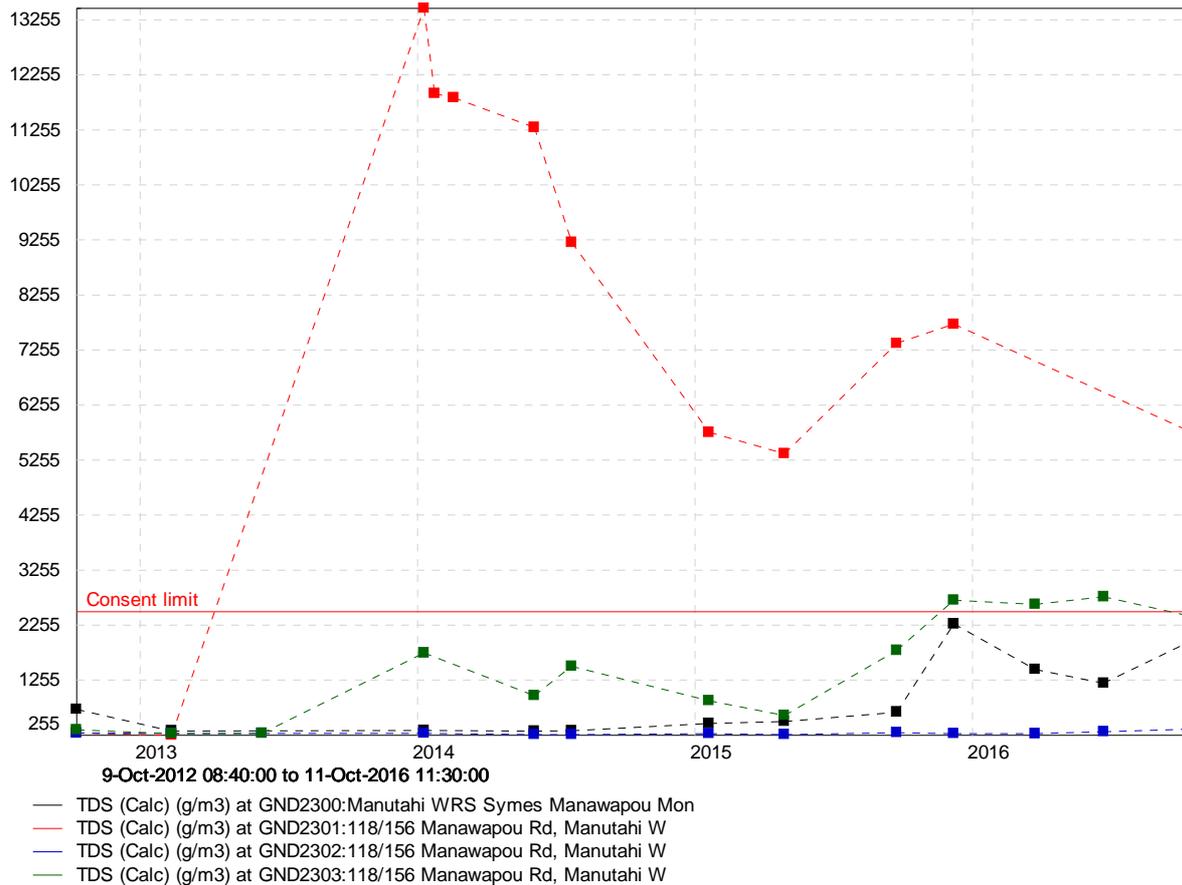
The main measurable environmental effect associated with the exercise of this consent in this monitoring period is centred on a legacy from the previous monitoring period in terms of elevated TDS concentrations. As in previous year, the concentration of TDS within GND 2301 has remained above the conditional value of 2,500 g/m<sup>3</sup>. In the previous monitoring period the high concentration was considered a result of storage cell liner failure, which was mitigated in mid 2014. This monitoring period has seen an elevation in concentration for two additional wells, GND 2300 and GND 2303 Figure 7.

**Figure 7** Long term TDS concentrations at Syms Manawapou Landfarm in the 2015-2016 monitoring period

When one compares the long term record (Figure 7), it may be discerned that the impact of elevated salts in wells GND2300 and GND2303 particularly, may well have been a function of this period. Prior to this monitoring period their concentrations had remained below the conditional value of 2,500 g/m<sup>3</sup>.

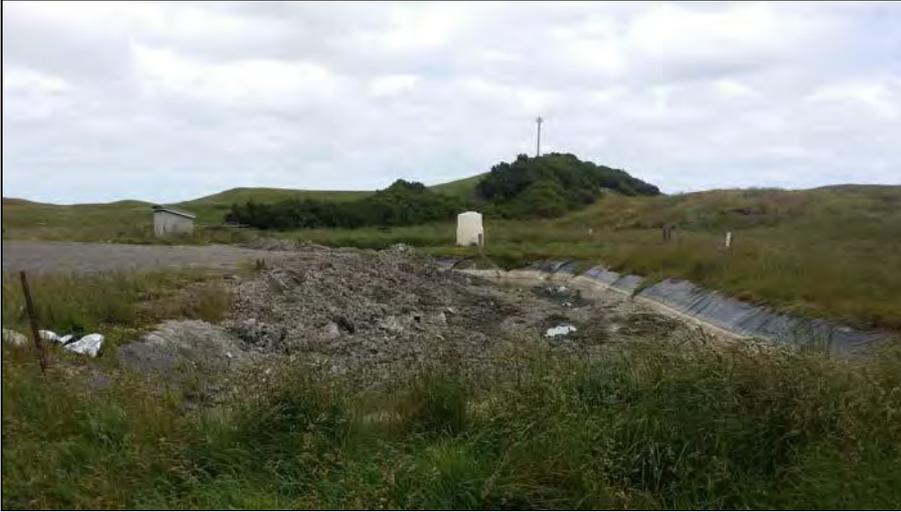
At times the level of drilling material contained within the storage cells was elevated above the height of the storage cells. A review of the recent photos will detail that at times there existed an overlap between the cell wall and the top loading area of cell and thus the potential existed for saline impacted fluids to infiltrate around the cell walls especially in times of high rainfall. Communication between the Council and the Company has led to these areas being addressed in terms of housekeeping and the overlap has been removed.

**Photo 4** Cell three Symes Manawapou December 2015

The sole purpose for lining of storage cells is to contain material which is discharged into the cell. If material is not fully discharged into the cells it has the potential to migrate/ leach into the soil strata as is possible at this location.

While the likelihood of a receptor being adversely affected by the high salinity in the direct locality of the storage cells is quite low, hence the rationale for positioning the majority of landfarms in close proximity to the coastal environment, it is good practice to make sure precautions are made to prevent this egress of salinity. This would include properly discharging material into the specific storage cell and the Company is now mindful of this potential pathway moving forward.

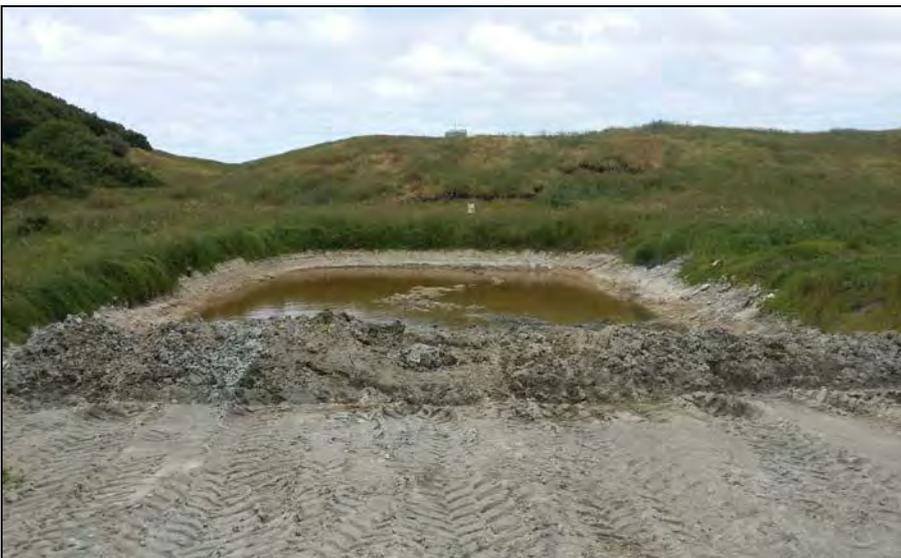
Linked to the delivery of material in November 2015 was the storage of drilling waste that was cited as a potential pathway (Photo 5) for elevated saline water to egress into the groundwater. This has now been addressed by the Company. At times the material which had been discharged was positioned on the lip of the cell rather than in it and at certain cells, mud was evident next to the cells, rather than in the cells (Photo 6), note that these picture were collected in December 2015.

**Photo 5** Cell one Symes Manawapou December 2015
