CD Boyd Drilling Waste Stockpiling
Landfarm/Landspreading
Monitoring Programme
Annual Report
2016-2017

Technical Report 2017-10

Taranaki Regional Council

March 2018

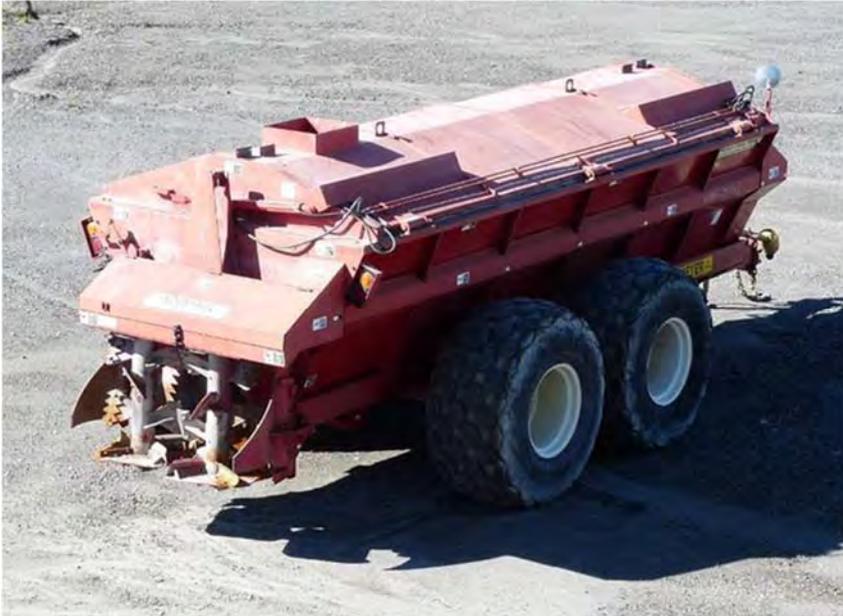
The preferred method for the treatment and disposal of drilling material at the consent holder's property is via landspreading (under consent 7591-1). A large muck spreader, detailed in Photo 1, is used for this purpose.

Photo 1 The landspreading unit utilised by the consent holder

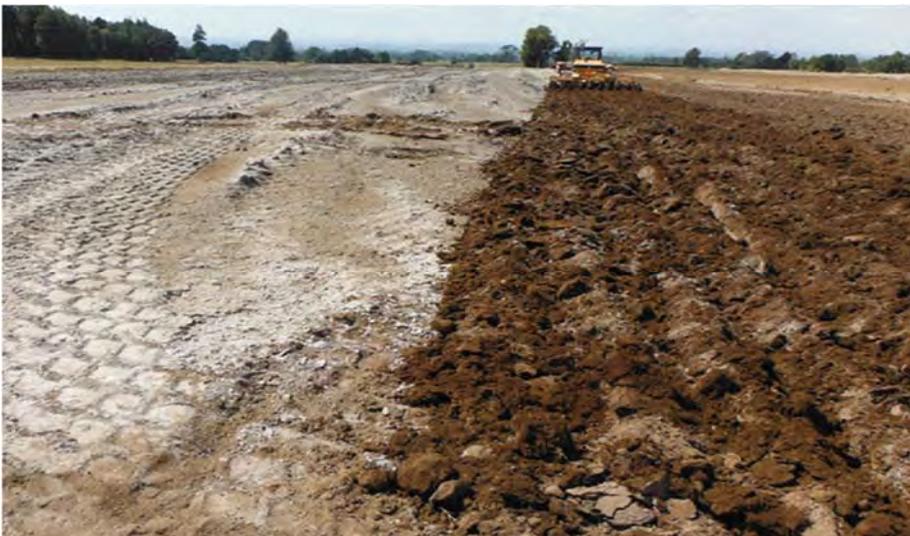
An auger in the base of the spreader conveys material back and through an opening (where the size is controlled by a sliding plate) where it contacts two rapidly rotating augers and is applied up to 10 m on either side. The deposition rate is controlled by the size of the opening at the rear of the unit and the speed of forward travel by the tractor. The waste is deposited onto existing pasture in small fragments, which are allowed some time to dry out before chain harrows and roman discs are used to till and break-up the waste which is dispersed back into the soil, as shown in Photo 2.

Photo 2 Tilling of the soil post landspreading

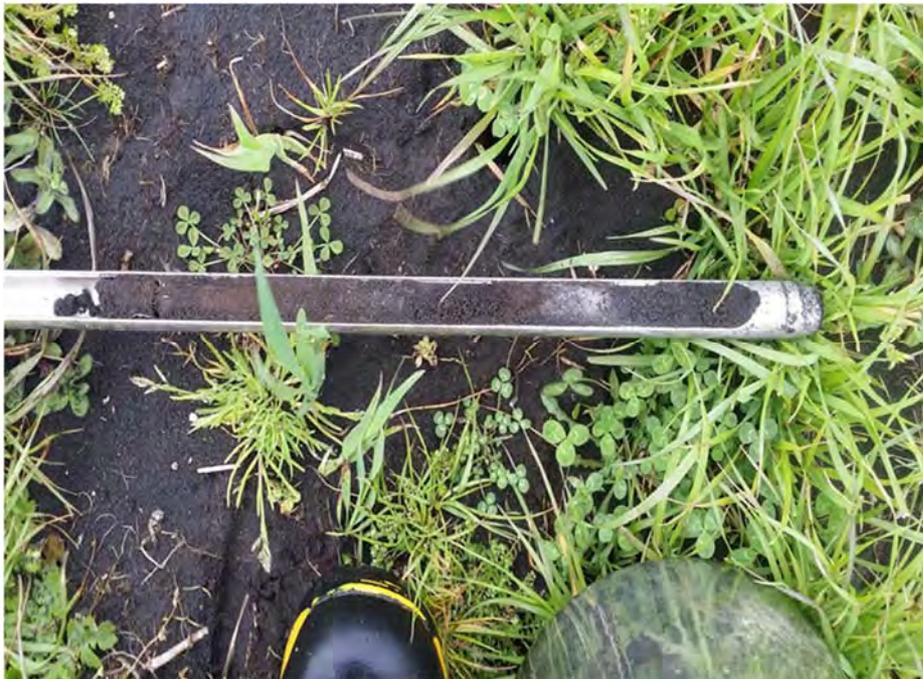
In total, six composite soil samples from specific disposal areas were collected by Council staff. The sampling methodology utilised is adapted from the Guidelines for the Safe Application of Biosolids to Land in New Zealand (2003). This is undertaken through the compositing of 10 soil cores (Photo 3) (400 mm +/- depth to encompass the zone of application) taken at 10 m intervals along transects through an application area.

Photo 3 An example of an extracted soil core

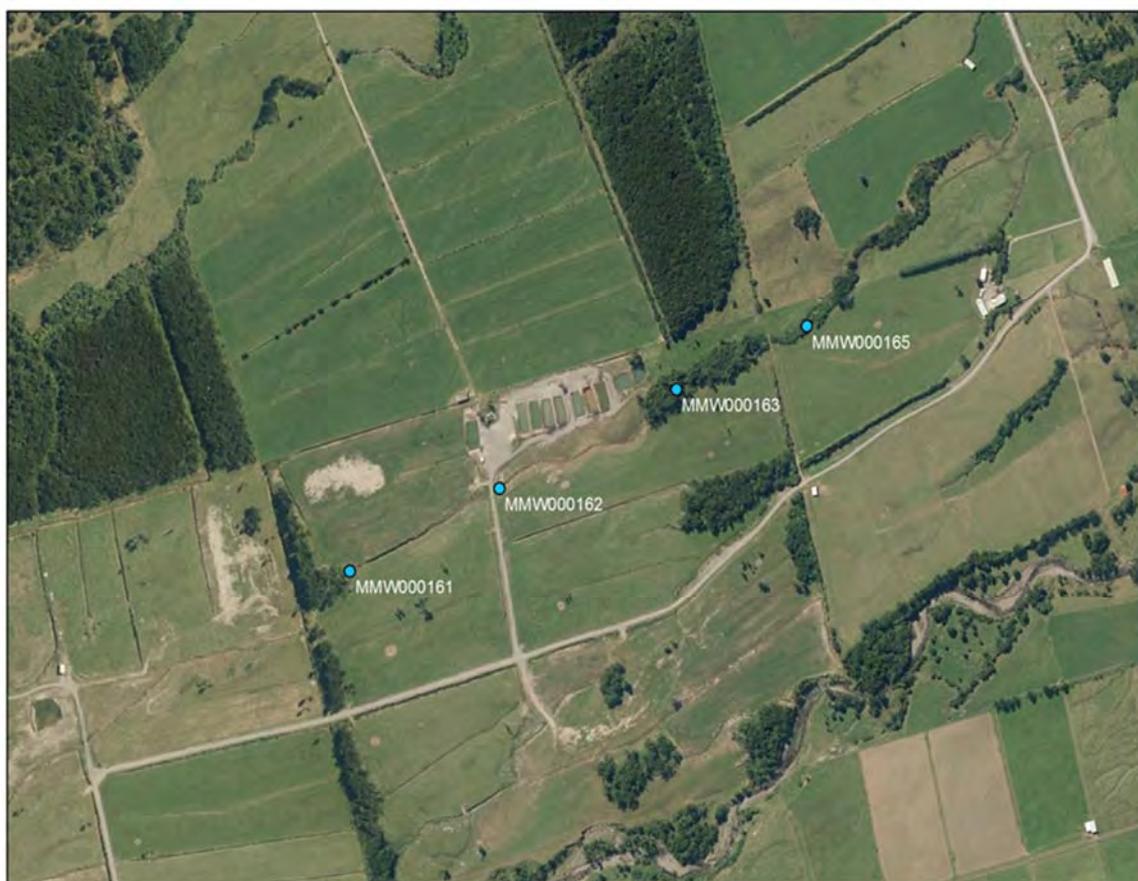
Figure 3 Biomonitoring sites in the unnamed tributary of the Mangamawhete Stream

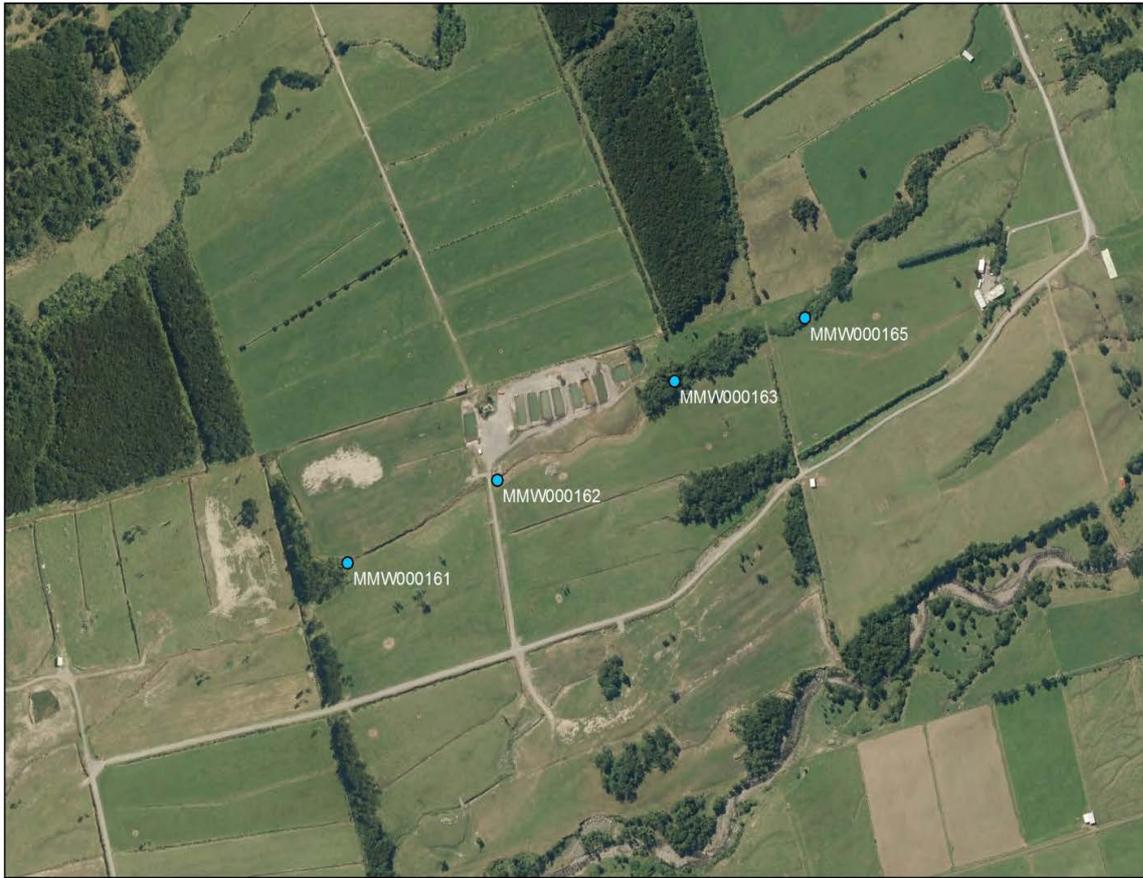
Figure 1 Biomonitoring sites in an unnamed tributary of the Mangamawhete Stream, sampled in relation to the Derby Rd drilling waste stockpiling site

This scheduled biomonitoring survey was undertaken at four sites on 22 December 2016 (Table 1 and Figure 1). At the time of the initial survey undertaken in April 2010, site 1 was established as a 'control site', upstream of the drilling stockpile area and sites 2 and 3 were established downstream of the skimmer pit discharge. During an inspection of the site in mid-2010, an unauthorised discharge of hydrocarbons was observed entering the stream. As a consequence of this inspection, changes were made to the on site

discharge. This fourth site provides comparative information, should deterioration be recorded at sites 2 or 3. The sampling site locations are presented in Table 1 and Figure 1.
