TAG Oil (NZ) Ltd  
Vanner Landfarm  
Monitoring Programme  
Annual Report  
2016-2017

Technical Report 2017-06

Taranaki Regional Council  
Private Bag 713  
STRATFORD  
November 2017

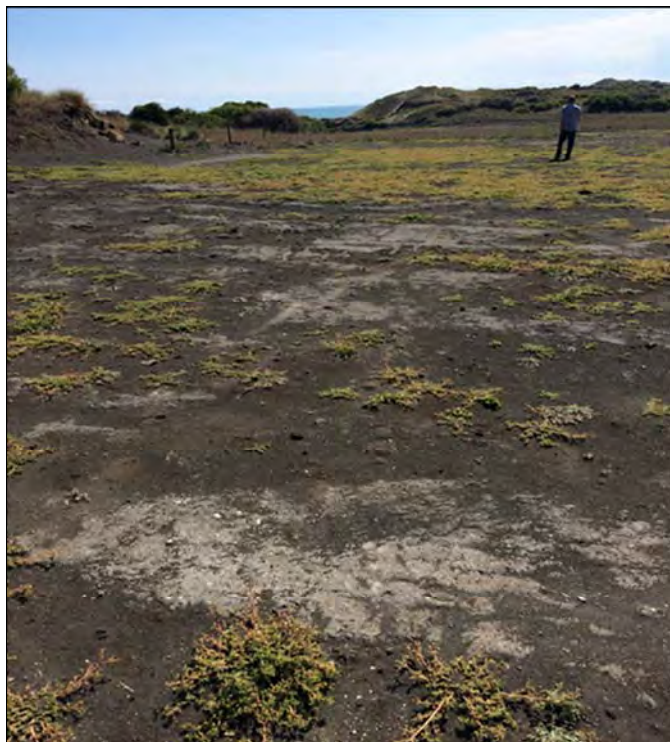
Figure 3 Area F8 March 2015 North West projection

Revegetation of the Vanner Landfarm has proved problematic. The initial landfarming exercise resulted in vegetation coverage of the lower areas, undertaken across areas F1- F7 inclusive (Figure 2), with little or no real revegetation issues. However, area F8 initially proved problematic in the establishment of the vegetation. Figure 3 (March 2015) indicated the scale of the revegetation required at the time. By November of 2015 (Figure 4) the establishment of vegetation had been undertaken. Note that this was two years after the application of material to land in this specific location.

Upon inspection in February 2017, it could be inferred that the scale of revegetation required was similar to area F8 in March 2015 (Figure 3), which had under gone similar issues during its revegetation.

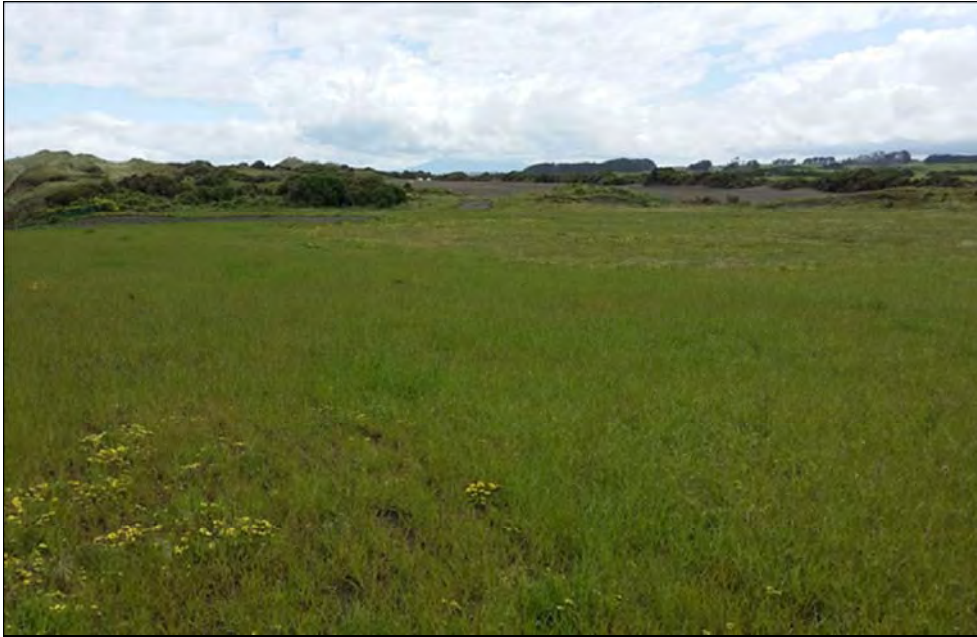
Figure 4 Area F8 November 2015 North West projection

Since this date, numerous attempts had been undertaken to re-establish the vegetation, however wind and rain erosion had hindered the progress.

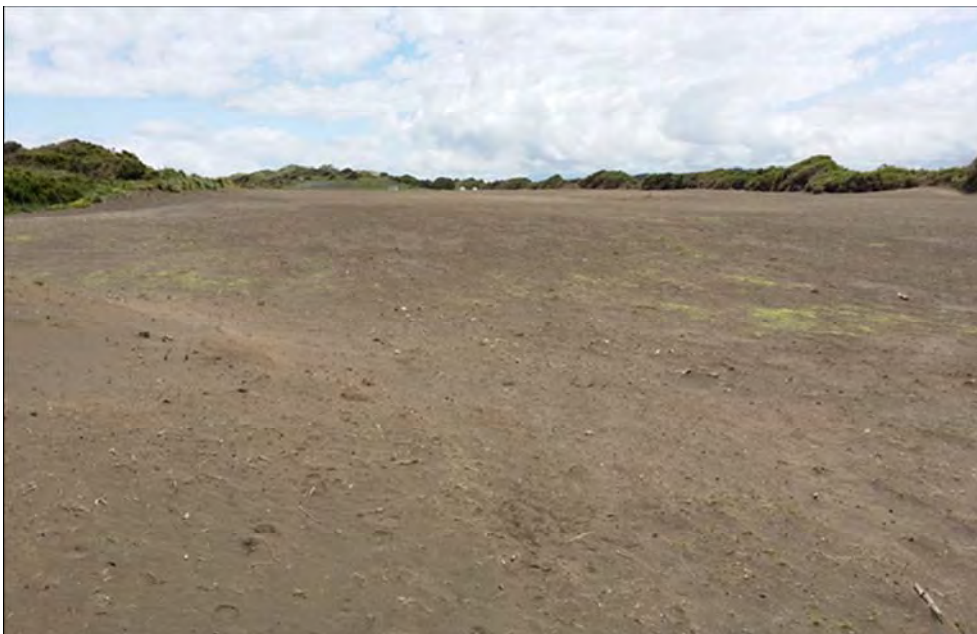
Figure 5 Areas F9 and F10 November 2015 North West projection

While the erosion is visible in certain parts, mainly area F9 and the southern portion of F10. The observation is that both areas, F9 and significantly F10, contain more vegetation (Figure 12 & 13) when compared to the same period last year (Figure 5).

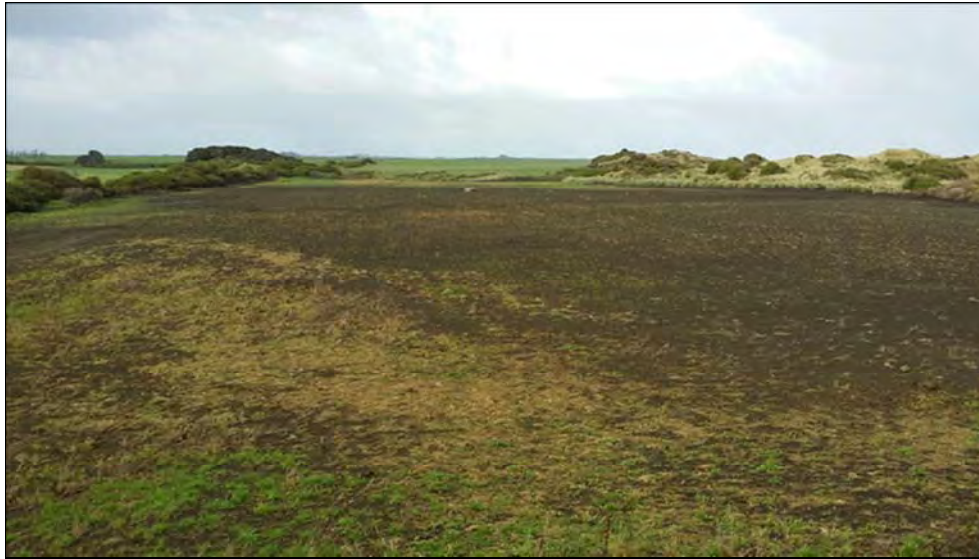
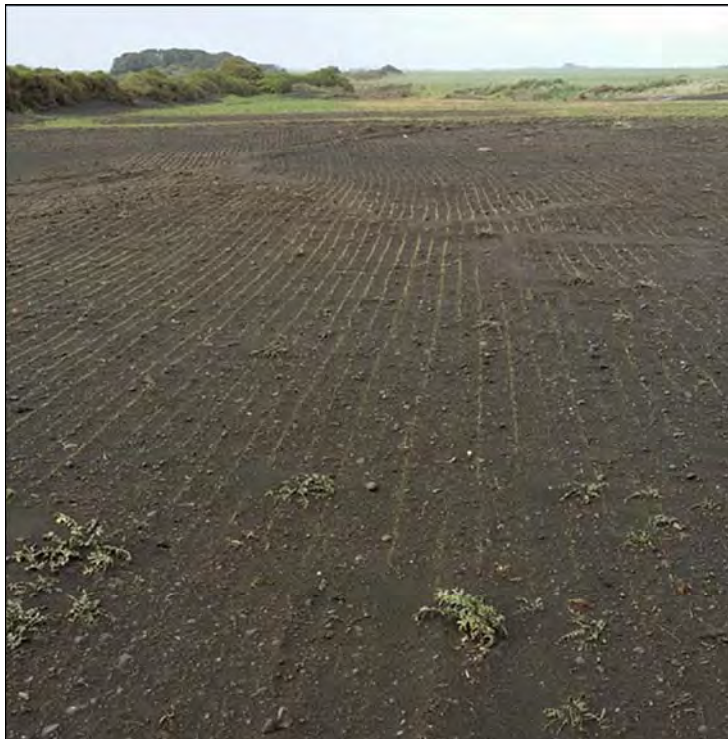
Figures 6 and 7 denote the follow up re-sown grass which was undertaken in May 2016. The re-sown grass was blown out through wind and rain erosion throughout the 2016 winter. In February of 2017, the site was revisited. The site management had undertaken additional works with a view of meeting condition 15 of consent 7942-1.1 The consent holder deployed and utilised tyres across the site with a view of mitigating the wind erosion (Figures 8 and 9).

Figure 6 Area F10 towards Area F9 May 2016 South East projection

Figure 7 Area F9 May 2016 South East projection

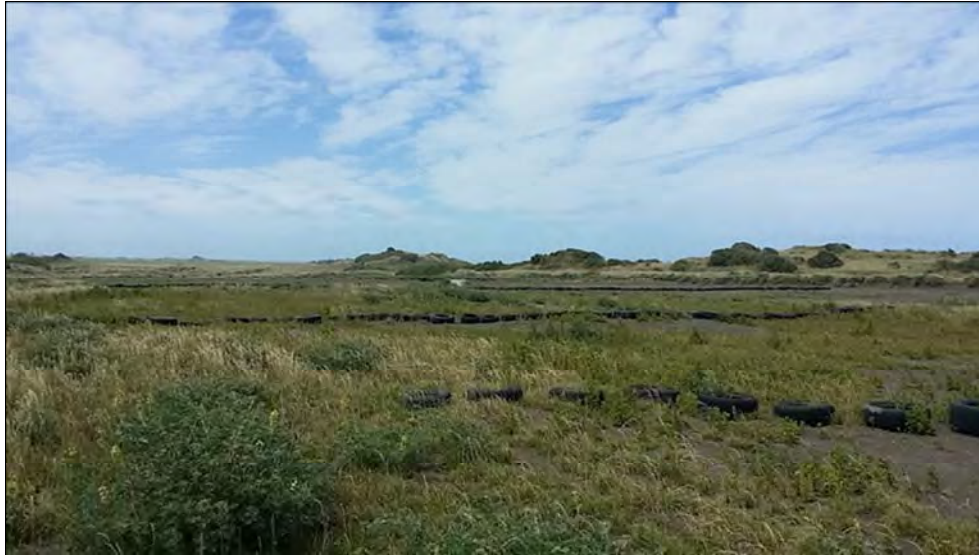
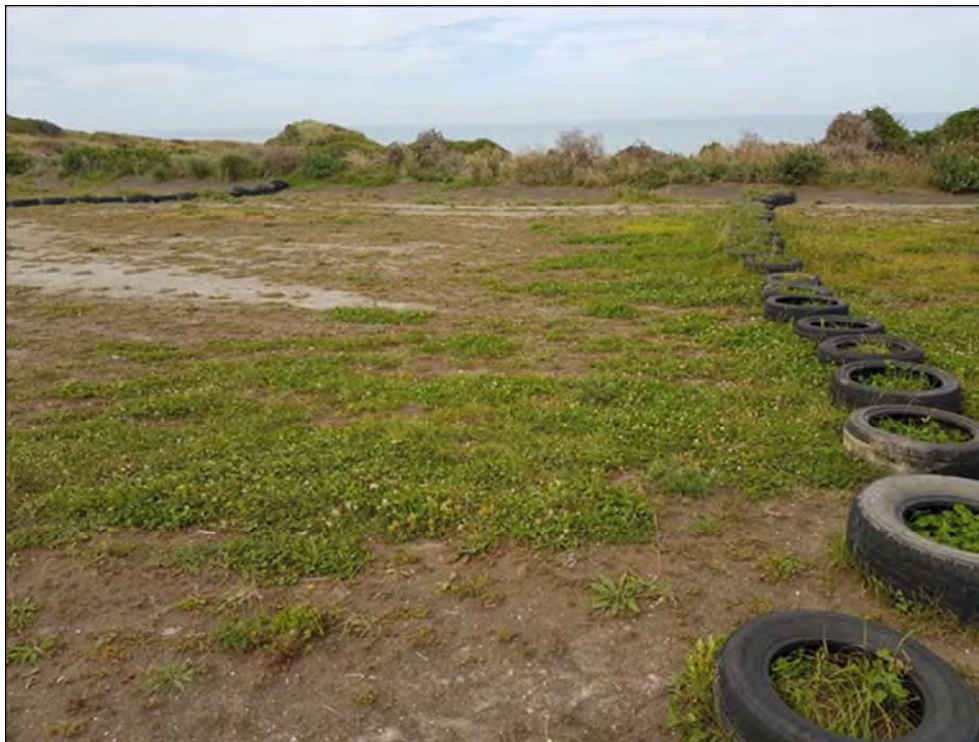
The initial findings of this monitoring year (2016-2017) indicated that the tyres appeared to be aiding with vegetation establishment in certain areas of the site. The Northern portion of F10 appeared to take well, while area F9 and the southern portion of F10, which are the more exposed of the remaining areas will require careful management (Inspection 23 February 2017). In some areas the effects of the wind erosion were clearly evident. The erosion had exposed the clay in places and these specific areas will require additional mitigation moving forward. As discussed in the final inspection, the landowner is monitoring these areas and adding straw when required, with a view of replanting in spring.

Figure 8 Area F10 looking towards F9 on South East Projection January 2017

Figure 9 Area F9 February 2017 South West projection

After a meeting with the Council officer in February 2017, the consent holder installed and managed a dairy shed effluent line with an associated irrigator to apply dairy shed effluent to the site with a view of providing additional sources of carbon and fertiliser.

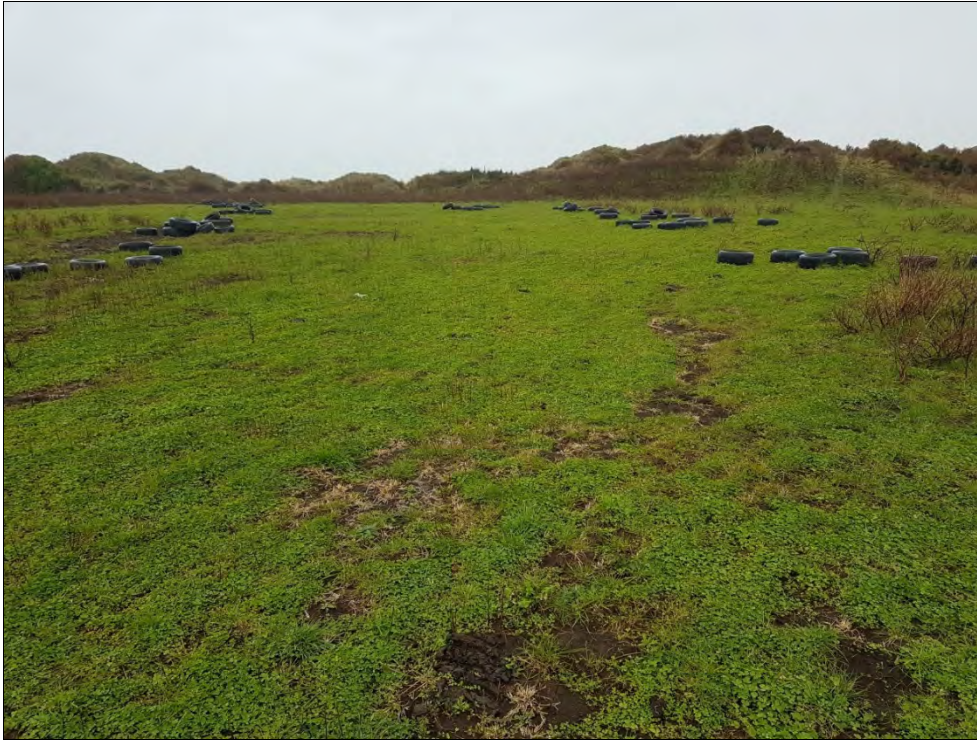
Figure 10 Area F9/F10 August 2017 South West projection

The site was visited again in August 2017, the observations by the Council's officer indicated that in certain parts of areas F9 and the northern F10 vegetation had taken hold (Figure 10). However, for portions of both these areas wind blown erosion was evident (Figure 11).

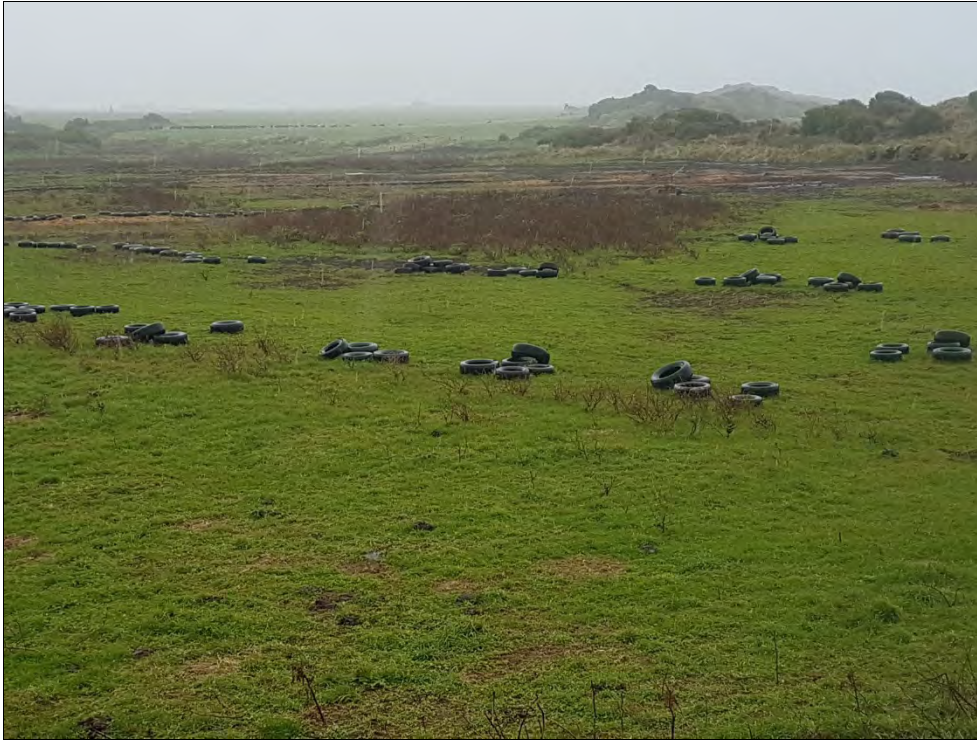
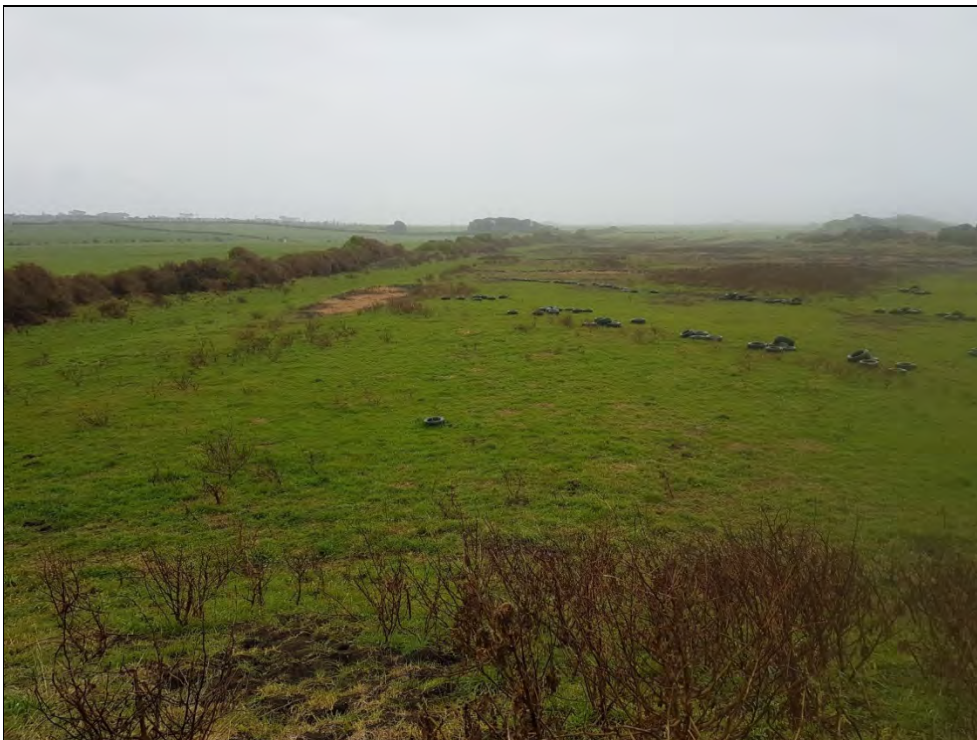
Figure 12 Area F10 towards F9 South West projection

Figure 13 Area F10 towards F9 South projection

Overall, the consent holder had been proactive with their response to the erosion of areas F9 and F10. The application of used car tyres coupled with the application of dairy shed effluent and associated irrigator appear to be mitigating the erosion issue.
