Freshwater contact recreational
water quality at Taranaki sites
State of the Environment Monitoring
Annual Report
2017-2018

Technical Report 2018-01

Taranaki Regional Council
Private Bag 713
STRATFORD
November 2018

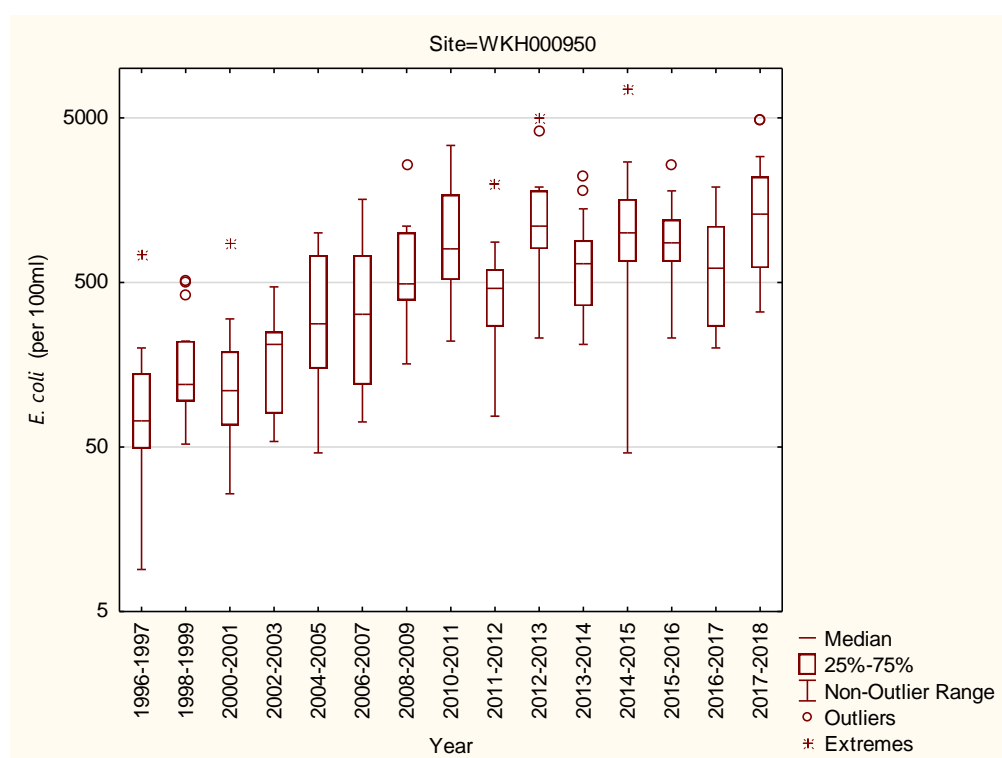
Figure 12 Box and whisker plots of *E. coli* for all summer SEM surveys in the Waiwhakaiho River adjacent to Lake Rotomanu

Summary statistics for the SEM *E. coli* data collected for Waiwhakaiho River opposite Lake Rotomanu over 22 summers are presented in Figure 12. [Note: These data had been collected prior to the current year from time to time for consent monitoring purposes].

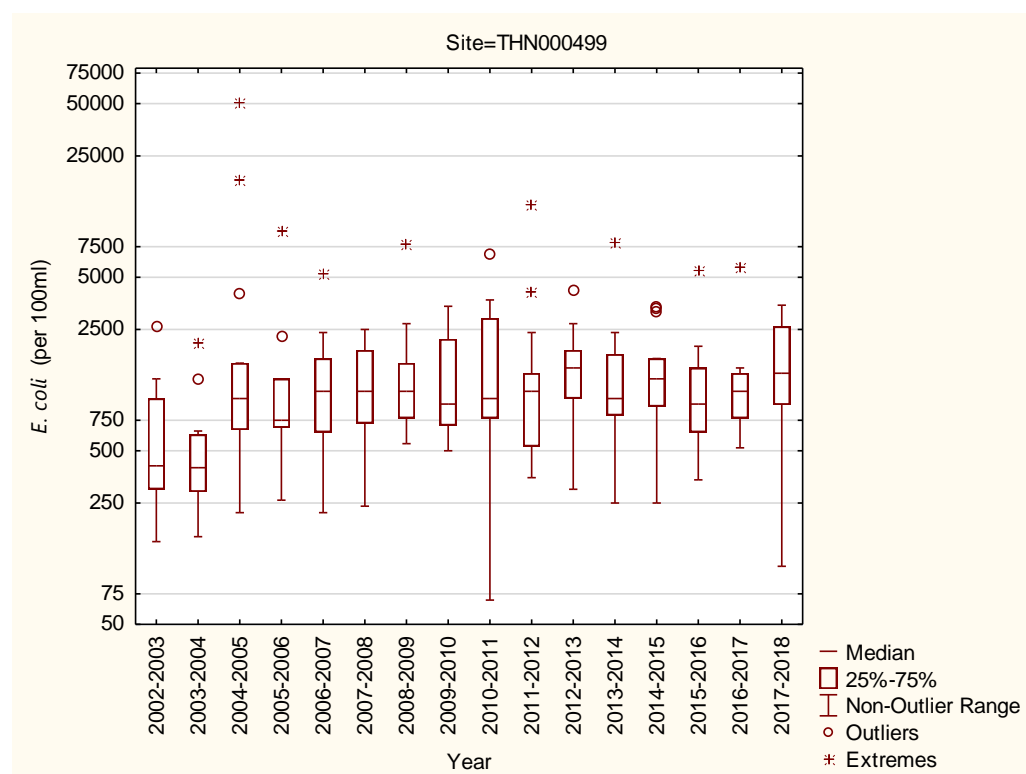
Figure 16 Box and whisker plots of *E. coli* for all summer SEM surveys of Te Henui Stream at mouth, East End

Summary statistics for the SEM *E. coli* data collected for Te Henui Stream at the mouth over 16 summers are presented in Figure 16.

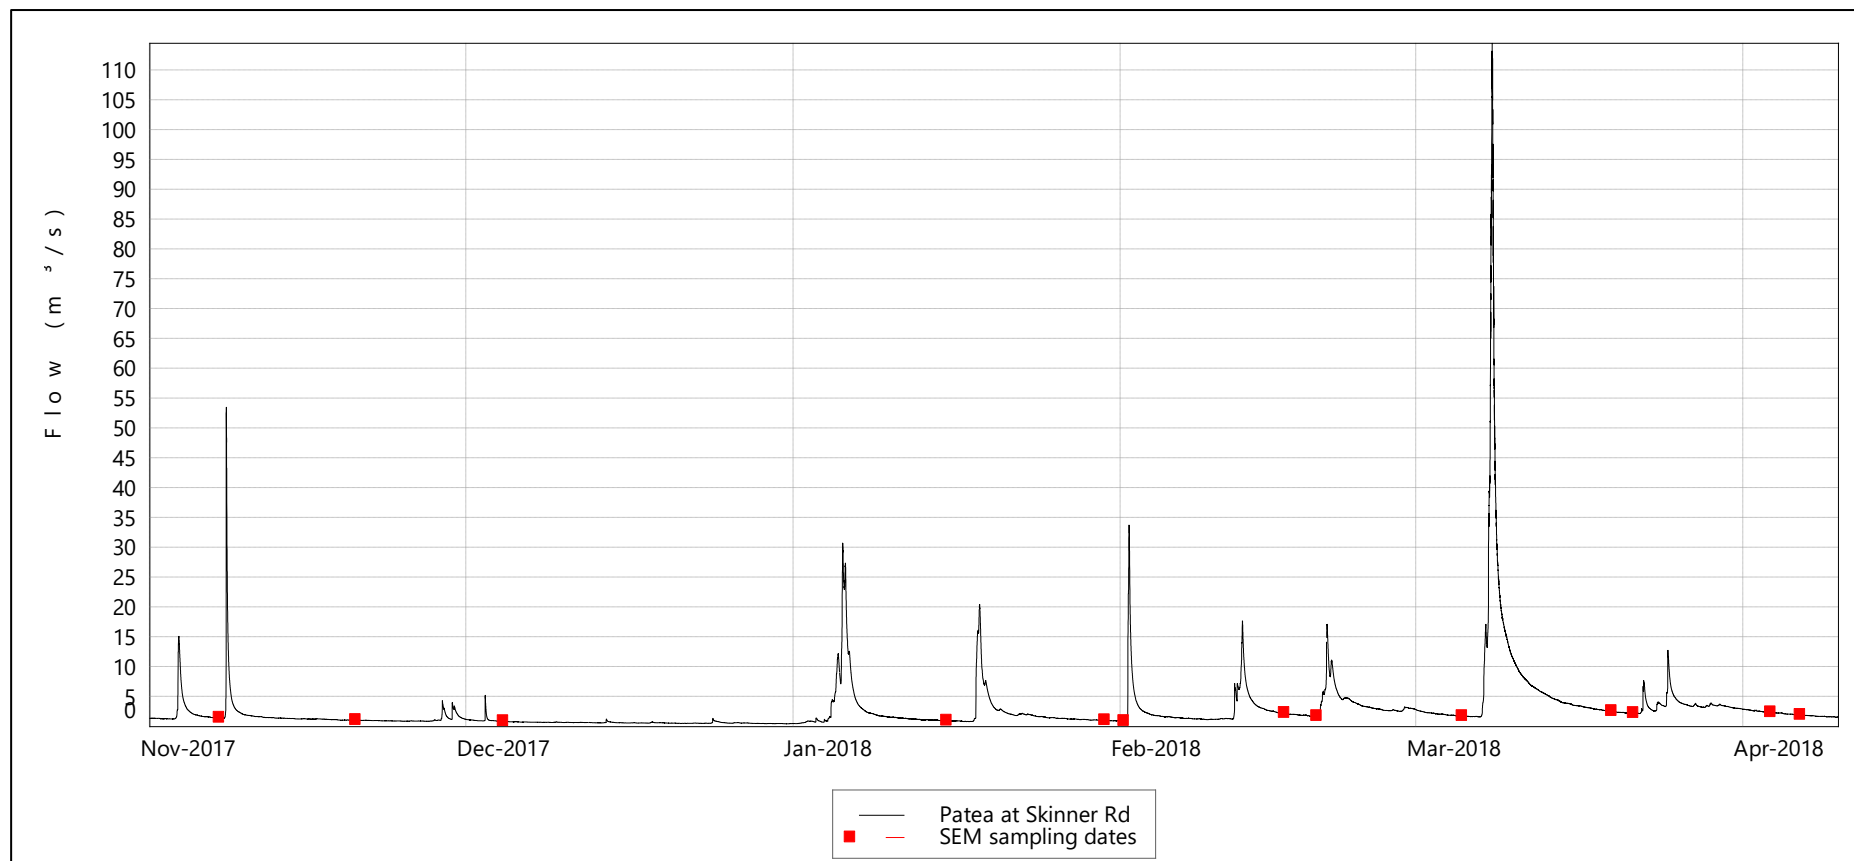
Figure 20 Flow in the Patea River at Skinner Rd during the survey period

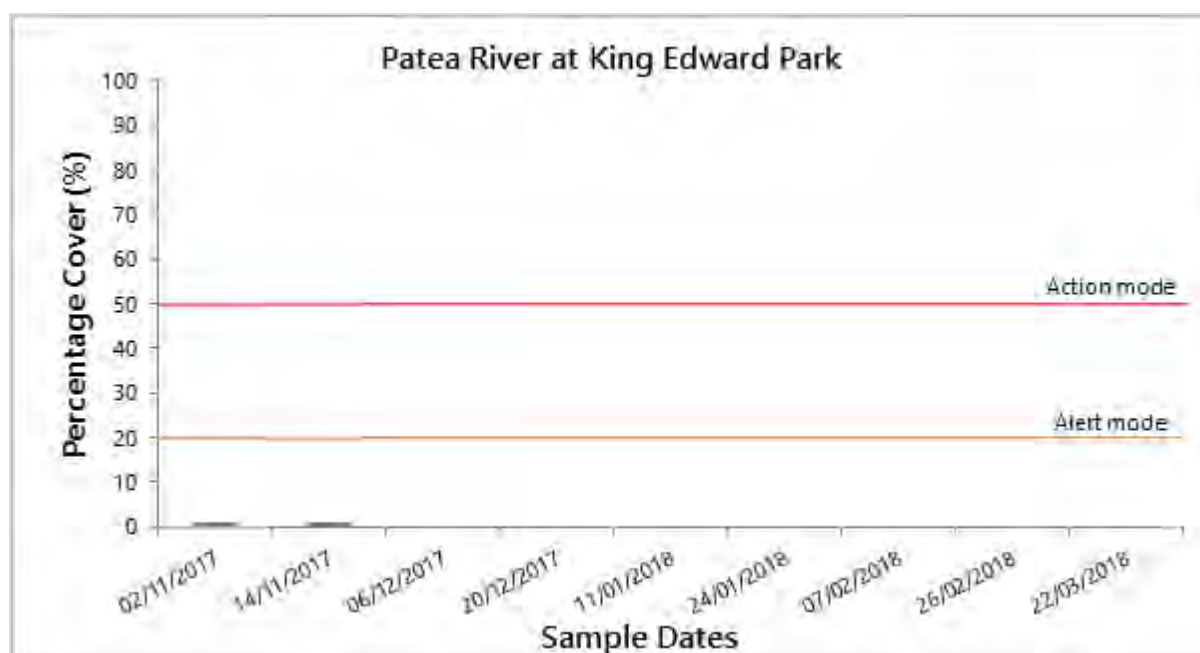
Figure 23 Percentage benthic cyanobacteria cover at the Patea River, Edward Park site.
