Inglewood Metal Limited  
Quarry Monitoring Programme  
Annual Report  
2014-2015

Technical Report 2015-08

September 2015

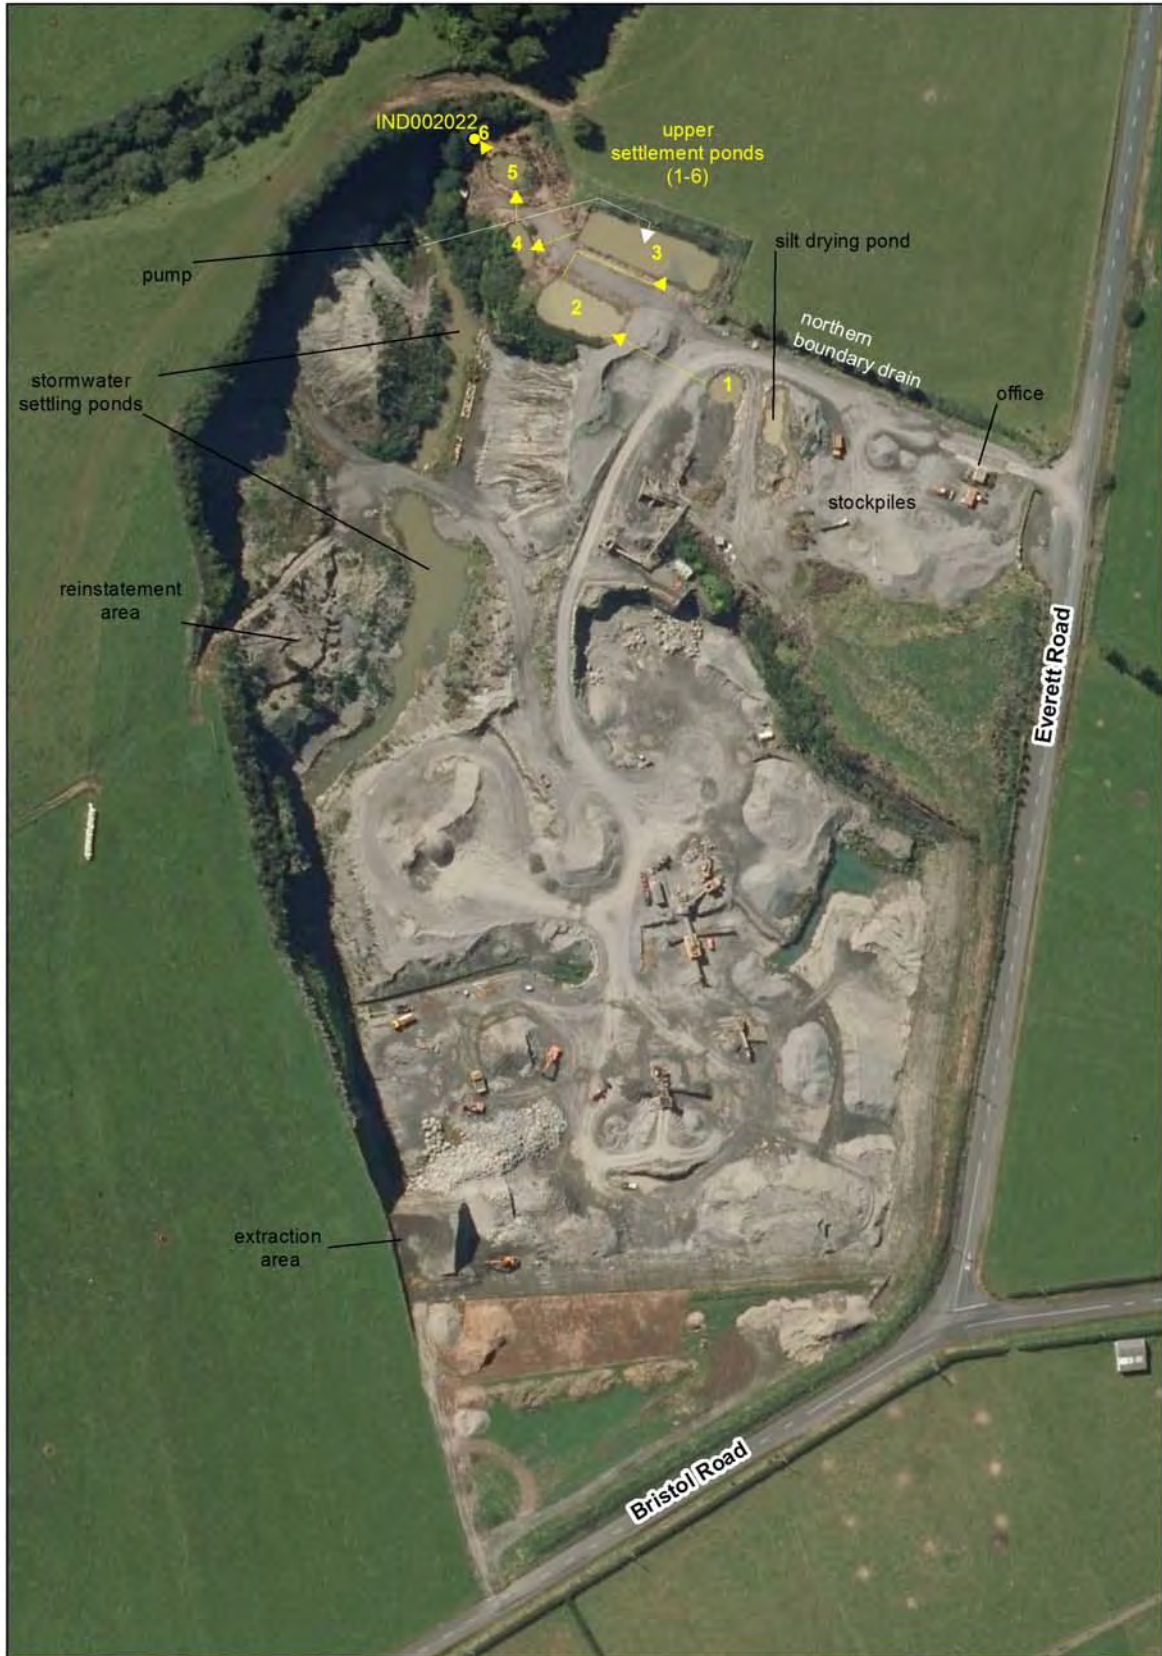
Figure 1 Quarry operations, wastewater treatment system

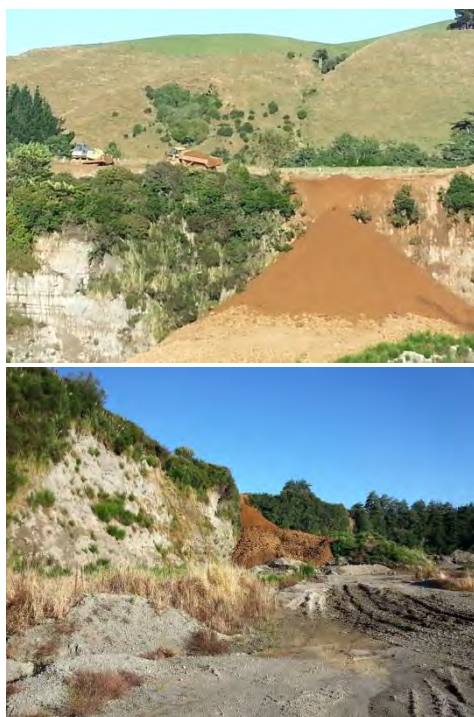
Photos 1 & 2 Recent progress with re-  
instatement, February, 2015

This inspection was performed during and following very dry weather conditions. The site was operative at the time of the inspection with processing of product in the quarry pit. The quarry pit area was tidy and no washing was taking place. The washing pond had recently been cleaned out and the second pond was due for de-silting. Re-  
instatement had begun in the quarry pit (Photos 1 and 2) and the final extraction area adjacent to Bristol Road had been opened up (see Figure 1). Pumping of stormwater and groundwater from the quarry pit to the third upper pond was occurring with a moderate rate of discharge from the final pond to the unnamed tributary. There was minimal discolouration from the tributary within the mixing zone of the Kurapete Stream which was in very low, clear flow upstream and at the Everett Road bridge. Sampling of wastewater and the receiving waters was performed. The sampling results are presented in Table 4.
