Inglewood Metal Limited
Quarry Monitoring Programme
Annual Report
2015-2016

Technical Report 2016-119

November 2016

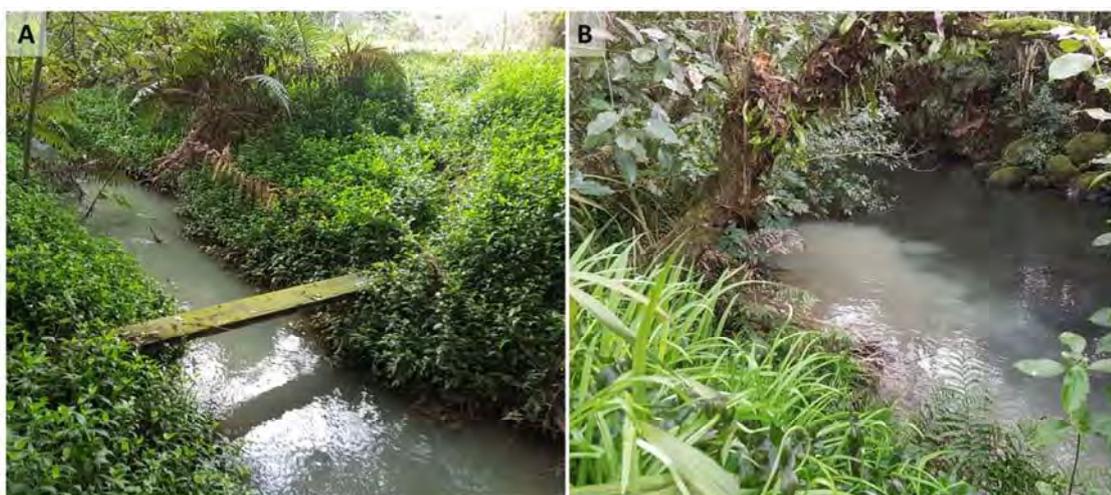
It has been previously noted that a combination of factors can increase the impact that the quarry discharge has on the receiving Kurapete Stream (Photo 1). The factors include a discharge that is laden with very fine sediment, limited dilution of the tributary in the receiving waters under low flow conditions, and the possible re-suspension of accumulated sediment previously deposited on the tributary stream bed. Of these factors, stream flow can be useful in interpreting monitoring results and estimating the likely severity of any incidents.

Photo 1 A: Unnamed tributary near the confluence with the Kurapete Stream. B: Turbid plume in Kurapete Stream at confluence with unnamed tributary.

As scheduled, the biomonitoring survey was undertaken during a period of low flow in the Kurapete Stream. This meant that around this time there would have been less potential for dilution and mixing where the tributary joined the Kurapete Stream. Additionally, the lower flow velocities would have allowed for sediment to settle out of suspension onto the streambed sooner. Therefore, the Kurapete Stream was particularly vulnerable to sedimentation during this period. As indicated by the survey, the quarry discharge had significantly impacted the streambed macroinvertebrate communities. This impacted was represented by a decrease in MCI values, sediment sensitive EPT taxa, and taxa abundances at the impact site relative to the control site. However, due to a fresh that occurred just seven days prior to the survey, the full extent of any deposited sediment was not likely recorded.

In the instance of the non-compliant discharge sample, this event followed a period of heavy rainfall with moderate flow in the Kurapete Stream. Relative to the period surrounding the biomonitoring survey, the stream was likely less vulnerable to impacts from the quarry at the time of this discharge. This is reflected in the results from the receiving water samples, which were compliant. Furthermore, observations of the Kurapete Stream noted that the water appeared clean and clear at both the upstream

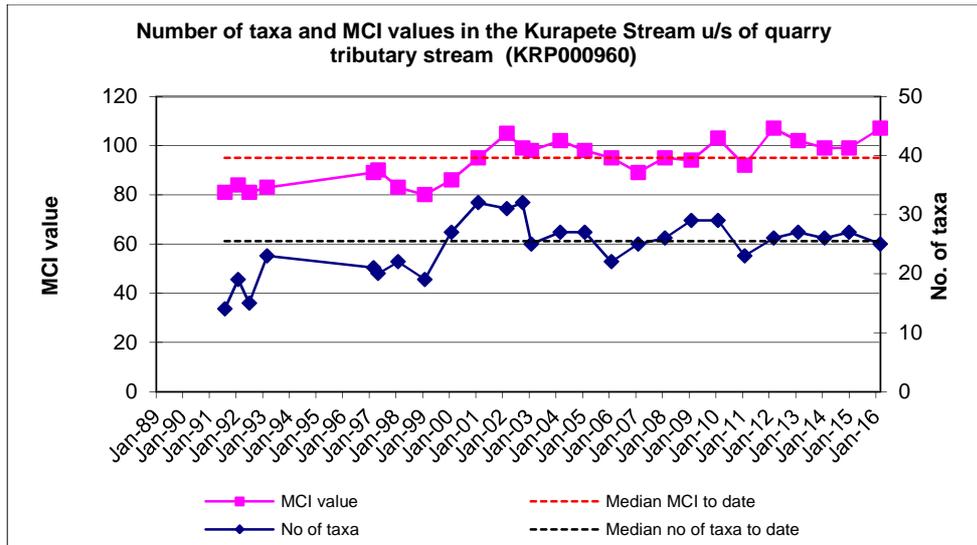
A moderately high macroinvertebrate community richness of 25 taxa was found at site I ('control' site) at the time of the summer survey. This was one less than the historical median for this site and two taxa lower than the previous survey on February 2015 (Table 3, Table 4).

The SQMCIs score of 5.1 units was significantly higher (Stark, 1998) than the median MCI score of 4.1 units (Stark, 1998) (Table 3, Table 4).

Figure 2 Taxa richness and MCI scores recorded to date at site I

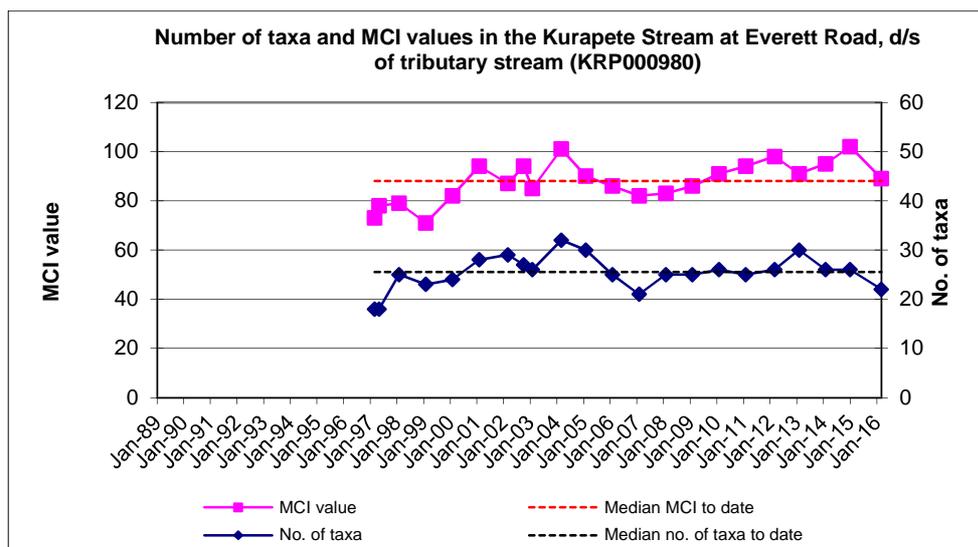
A moderately high macroinvertebrate community richness of 22 taxa was found at site I (‘impact’ site) at the time of the summer survey. This was four less than the historical median for this site and two taxa lower than the previous survey on February 2015 (Table 3, Table 4).

The SQMCIs score of 3.8 units was not significantly different (Stark, 1998) than the median MCI score of 3.6 units (Stark, 1998) (Table 3, Table 4).

Figure 3 Taxa richness and MCI scores recorded to date at site J
