New Plymouth District Council
New Plymouth Wastewater Treatment Plant
Marine Outfall and Sludge Lagoon
Monitoring Programme Annual Report
2014-2015

Technical Report 2015-112

May 2016

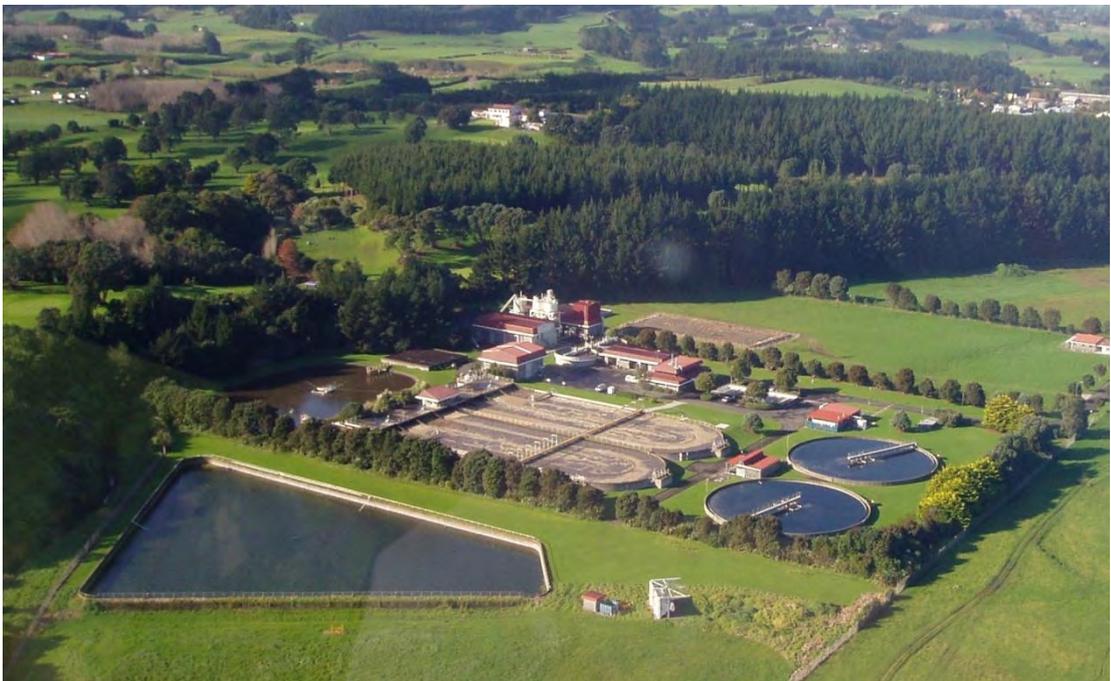
The NPWWTP (Photograph 1) treats the municipal wastewater from the New Plymouth urban area, Bell Block, Oakura and Inglewood, by a process of extended aeration activated sludge. There is also a substantial industrial load, equivalent to approximately 25% of the total biochemical oxygen demand (BOD) load, treated by the plant. The plant was commissioned in 1984, and has had its capacity expanded several times since.

Photograph 1 The New Plymouth Wastewater Treatment Plant

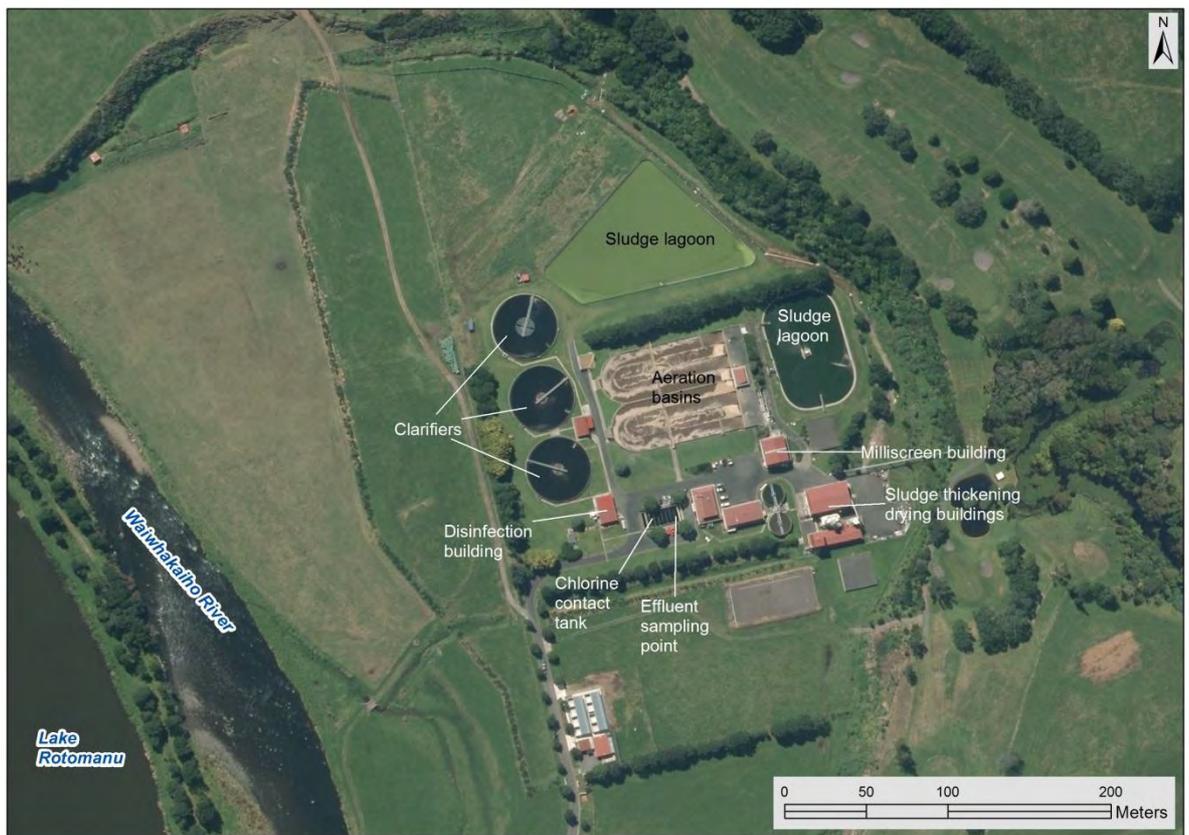
The activated sludge remaining in the clarifiers is returned to the aeration basins to maintain biological levels, while the surplus is diverted to the thermal drying facility (TDF) for sterilisation and disposal by alternative use (soil conditioner).

Figure 1 Layout of the New Plymouth Wastewater Treatment Plant

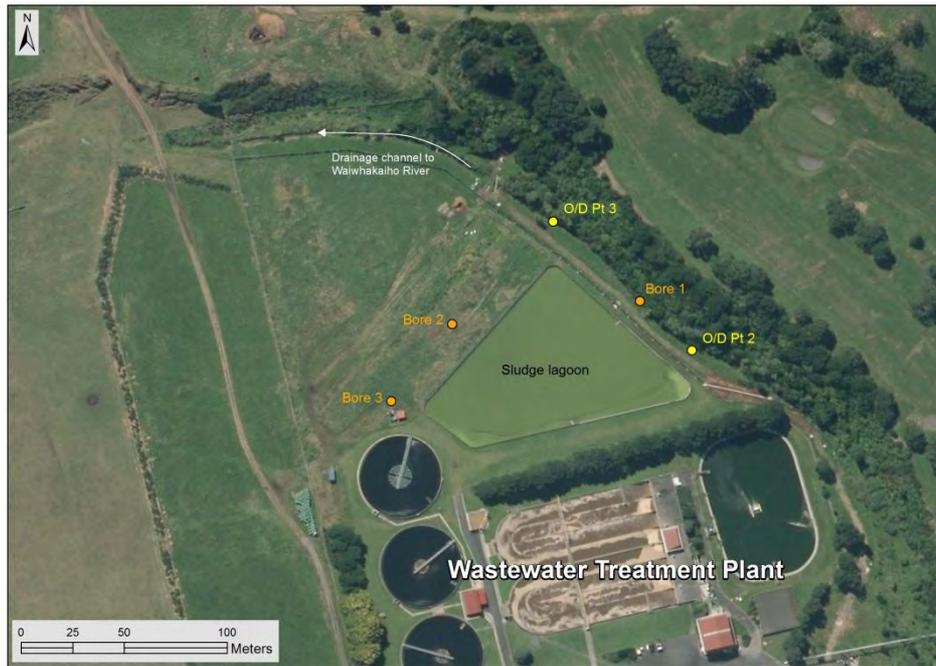
The results of sludge lagoon groundwater and surface water monitoring, undertaken monthly by NPDC, are summarised in Figures 7 to 12, along with a summary of previous results from 1990 to 2014. No data was able to be collected from Bore 3 during March and April 2015 as the bore was dry. All of the results from 2014-2015 are presented in Appendix V. The location of the sampling sites in relation to the lagoon are shown in Figure 6.

Figure 6 Sludge lagoon showing location of NPDC's groundwater bore and drain sampling sites

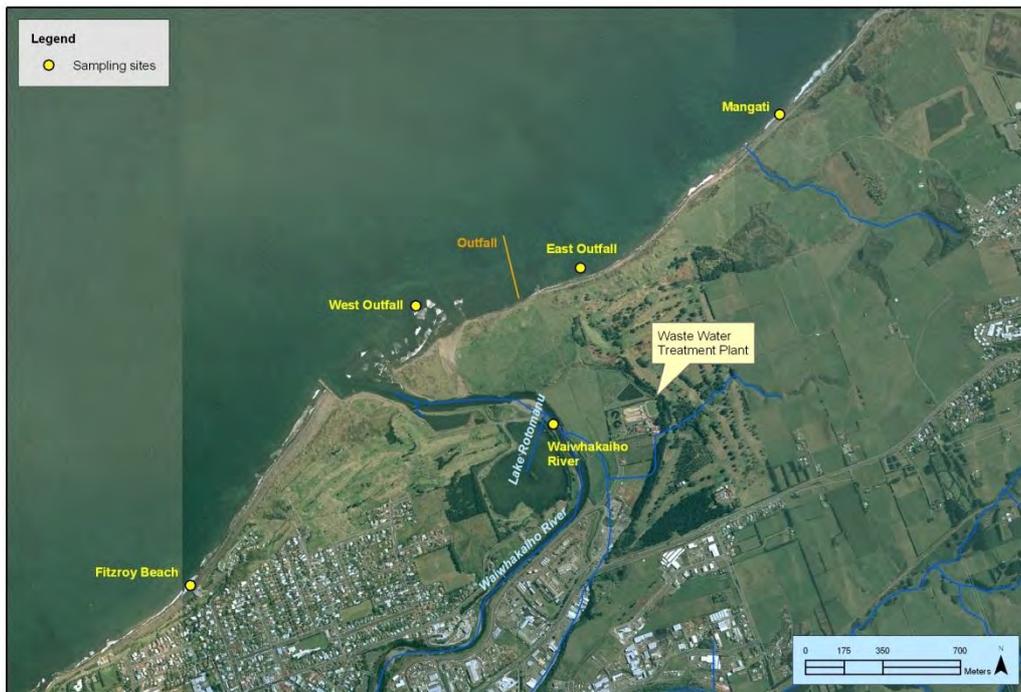
Figure 17 Location of monitoring sites in relation to the NPWWTP

Bacteriological water quality was monitored at four coastal sites in the vicinity of the marine outfall (Figure 17) during the summer months of 2014-2015 to assess whether the discharge from the marine outfall was having any adverse effects on coastal bathing water quality. A site on the Waiwhakaiho River was also monitored in order to determine any influence of the river on coastal water quality. Twelve to thirteen samples were collected at each site during dry weather conditions and analysed for enterococci, faecal coliforms, *E. coli* and conductivity.

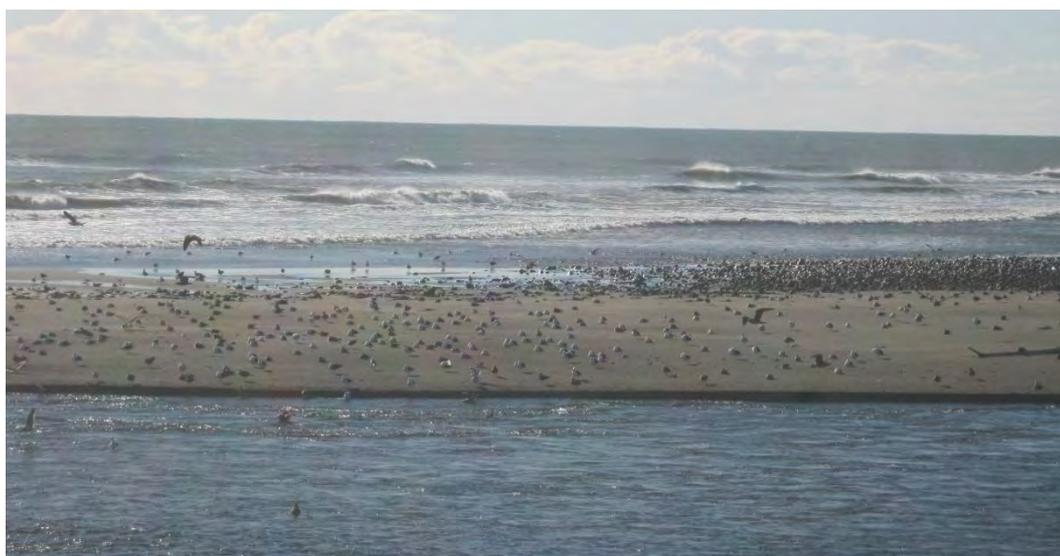
Photograph 2 Gulls at the mouth of the Waiwhakaiho River

Gulls are believed to be the main source of faecal contamination at the 500 m SW and Waiwhakaio River sites (Photograph 2). High numbers of gulls have been observed in close proximity to these sites and results from faecal source tracking support these observations.

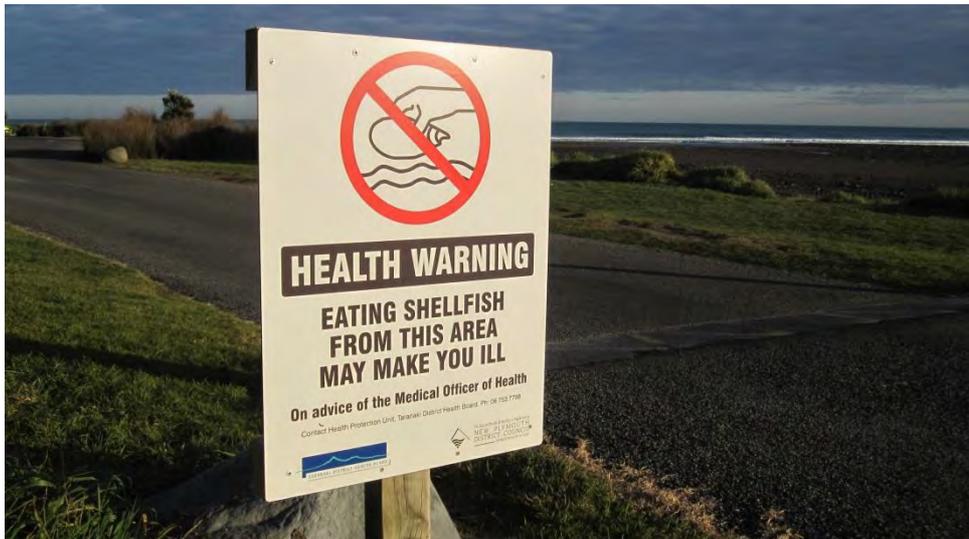
Photograph 3 Shellfish health warning sign at the Waiwhakaiho River mouth

Following the completion of the upgrade norovirus levels in mussel flesh dropped back to low or below detection levels (on 15 June 2014; Table 6). Results from this monitoring period (20 April 2015) indicate that the levels of norovirus in mussel flesh remain low or below detection levels. However, due to the highly infectious nature of norovirus, with only low concentrations posing a high risk of illness, shellfish warning signs remain in place at the Waiwhakaiho area and Bell Block (Photograph 3).

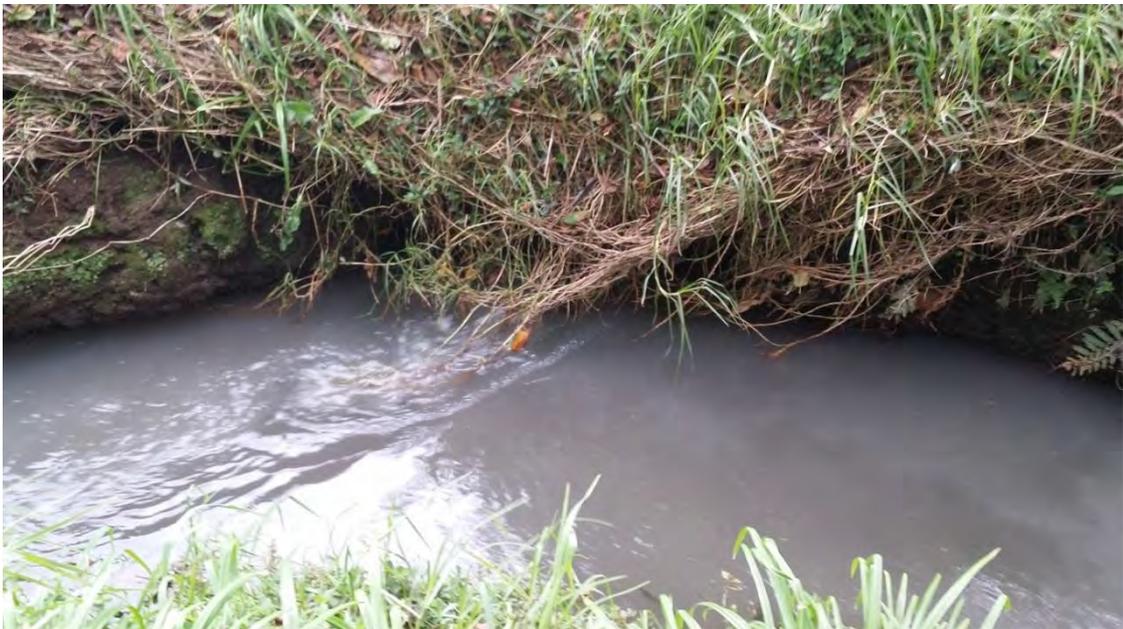
Photograph 5 Sewage discharging from a previously unidentified overflow discharge point into the Mangati Stream on 12 June 2015

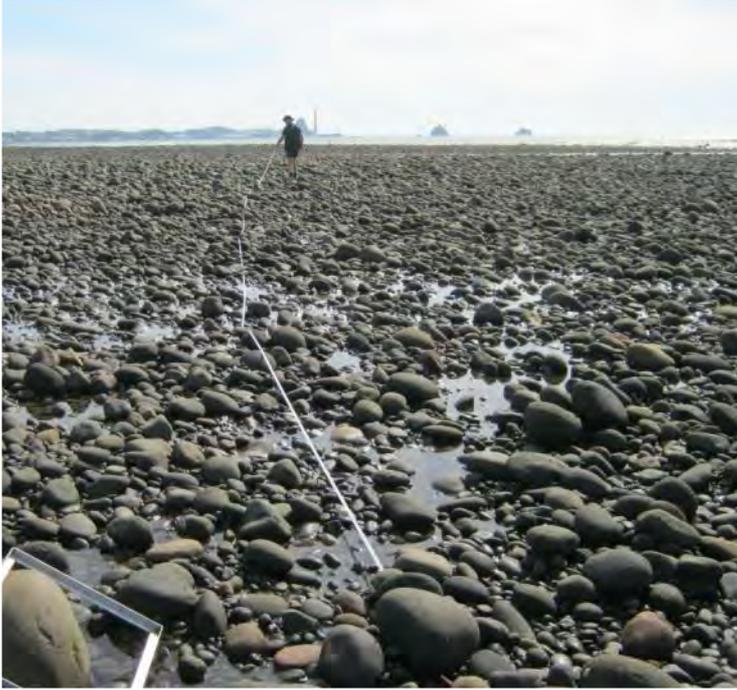
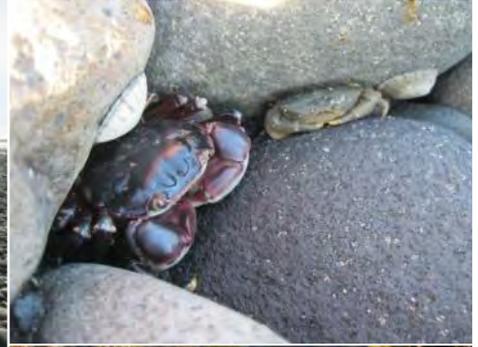
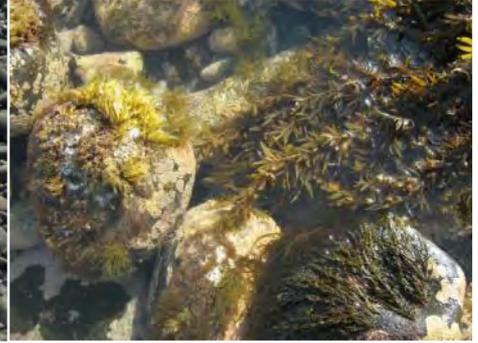
Photograph 1 Potential impact site at 500 m south west of the outfall (SEA902015)

The survey was conducted at five sites: 500 m south west of the outfall on the Waiwhakaiho Reef (SEA902015), 300 m north east of the outfall on the Waiwhakaiho Reef (SEA902010), the Mangati Reef (SEA902005) approximately 2.2 km north east of the outfall and the two control sites at Turangi Reef (SEA900095) approximately 16 km north east of the outfall, and Greenwood Road (SEA903070) approximately 22 km south west of the outfall (Photographs 1-5).

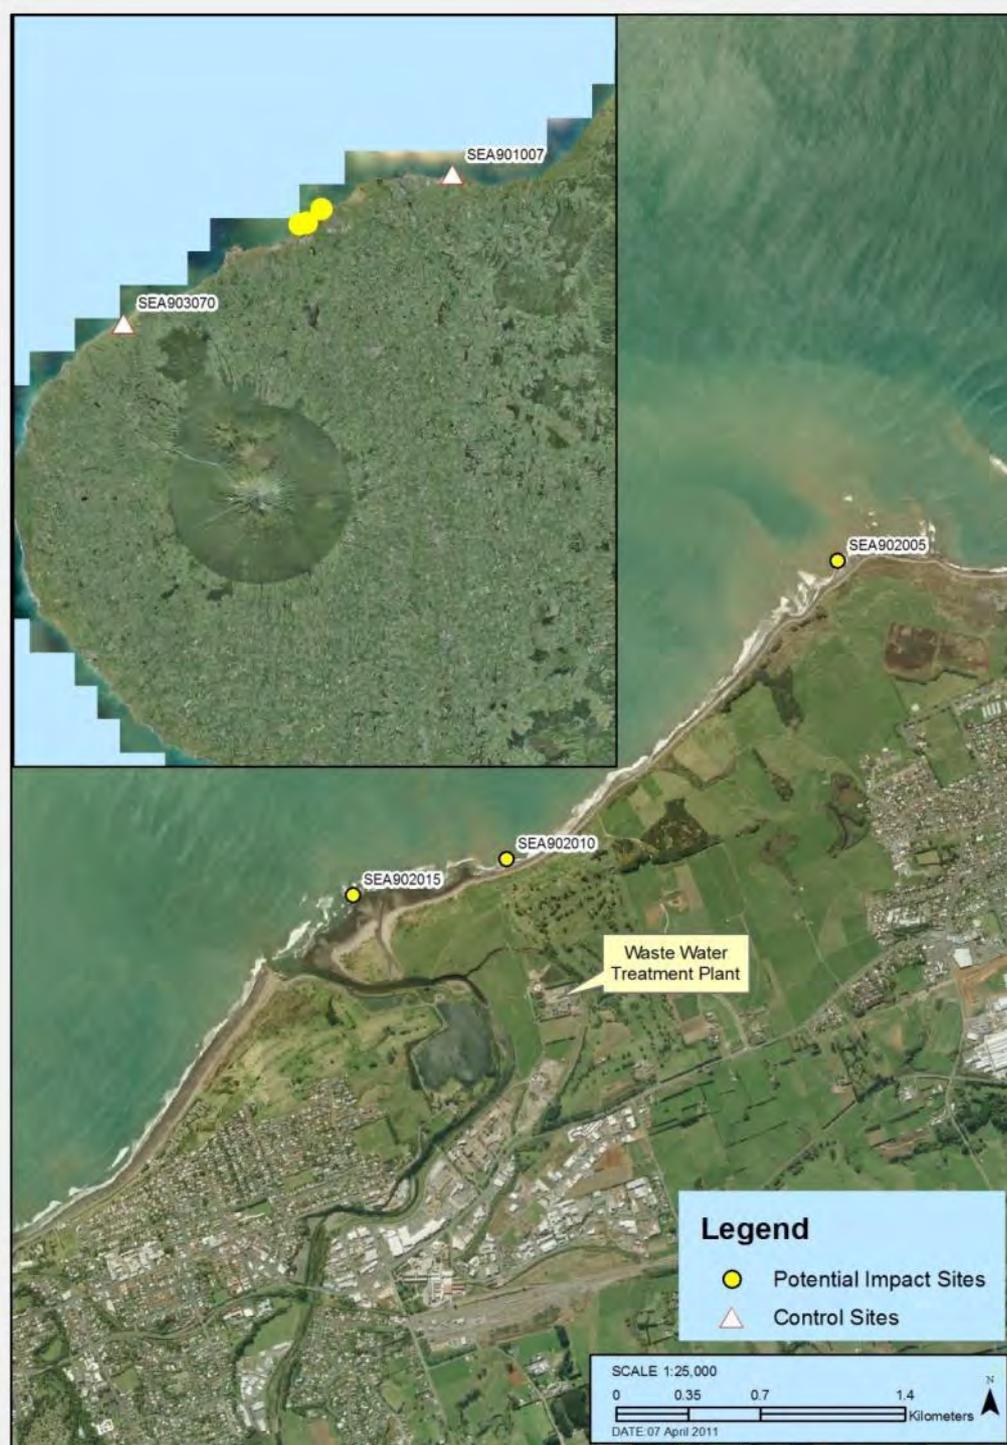
Figure 1 Location of the intertidal survey sites

At each site, a 50 m transect was laid parallel to the shore, approximately 0.6 m above chart datum. This transect was used to establish five 5 m x 3 m blocks. Within each block, 5 random 0.25 m² quadrats were laid giving a total of 25 random quadrats. For each quadrat the percentage cover of algae and encrusting animal species was estimated using a grid. For all other animal species, individuals larger than 3 mm were counted. Under boulder biota was counted where rocks and cobbles were easily overturned.

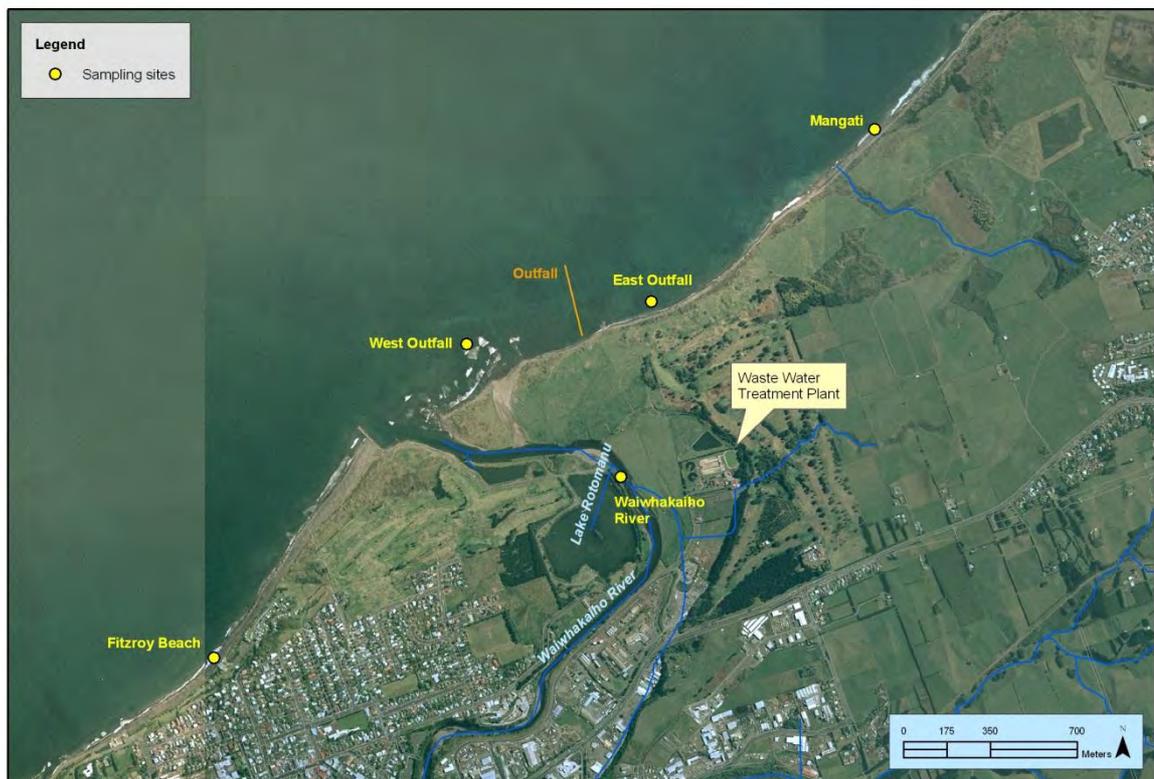
Figure 1 Location of monitoring sites in relation to the New Plymouth Wastewater Treatment Plant

The locations of the five sites sampled in the 2014-2015 monitoring programme are shown in Figure 1 and Table 2.

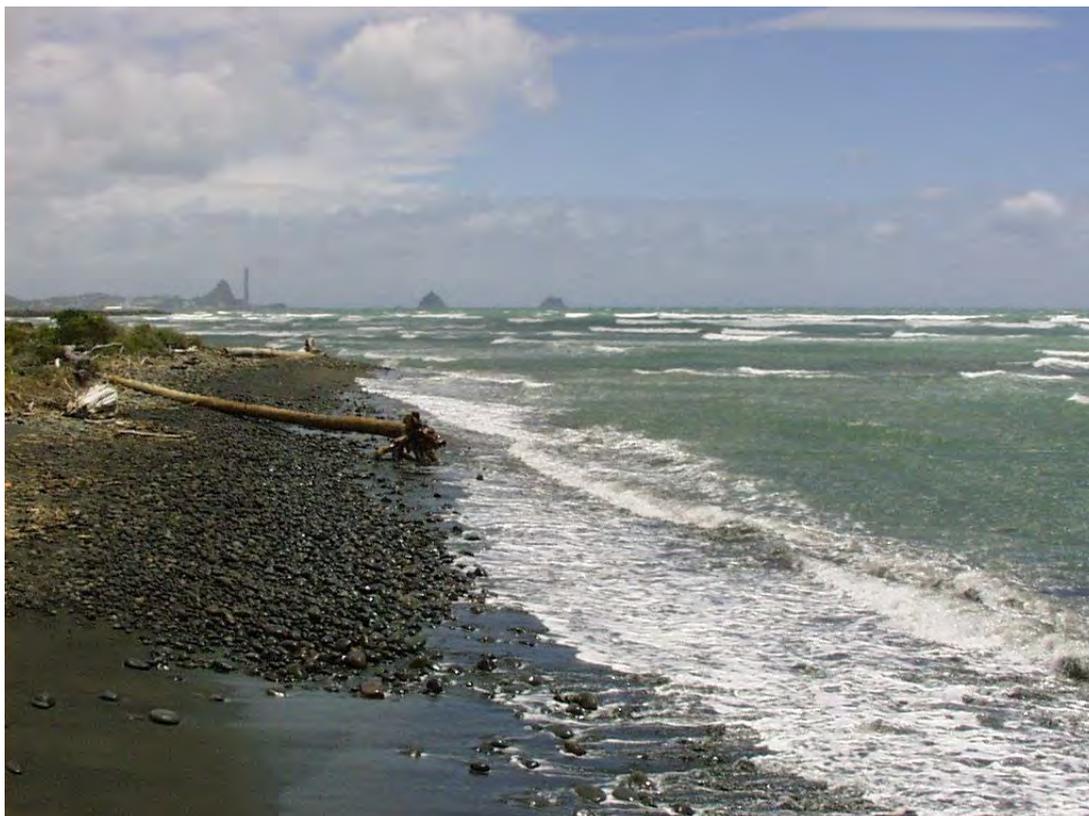
Photograph 2 The 500 m SW site

Faecal indicator bacteria medians and maxima were high, indicating poor water quality at this site. Faecal indicator bacteria counts from the 300 m NE site were lower than at the 500 m SW site. This would not be expected if discharge from the outfall was the main source of faecal contamination, taking into consideration the predominant north easterly flow.

As seen in previous surveys, high bacterial counts in the Waiwhakaiho River can influence the 500 m SW site. However, conductivity data indicates that only minor freshwater influence occurred at the 500 m SW site during the 2014-2015 summer season (Table 11). Gulls have been observed in high numbers on the cobbles and sand banks of the Waiwhakaiho Reef (Photograph 3), at the Waiwhakaiho River mouth and immediately upstream of the Waiwhakaiho River site (Photograph 4). Results from faecal source tracking indicate that gulls are likely to be the primary source of faecal contamination at these sites.

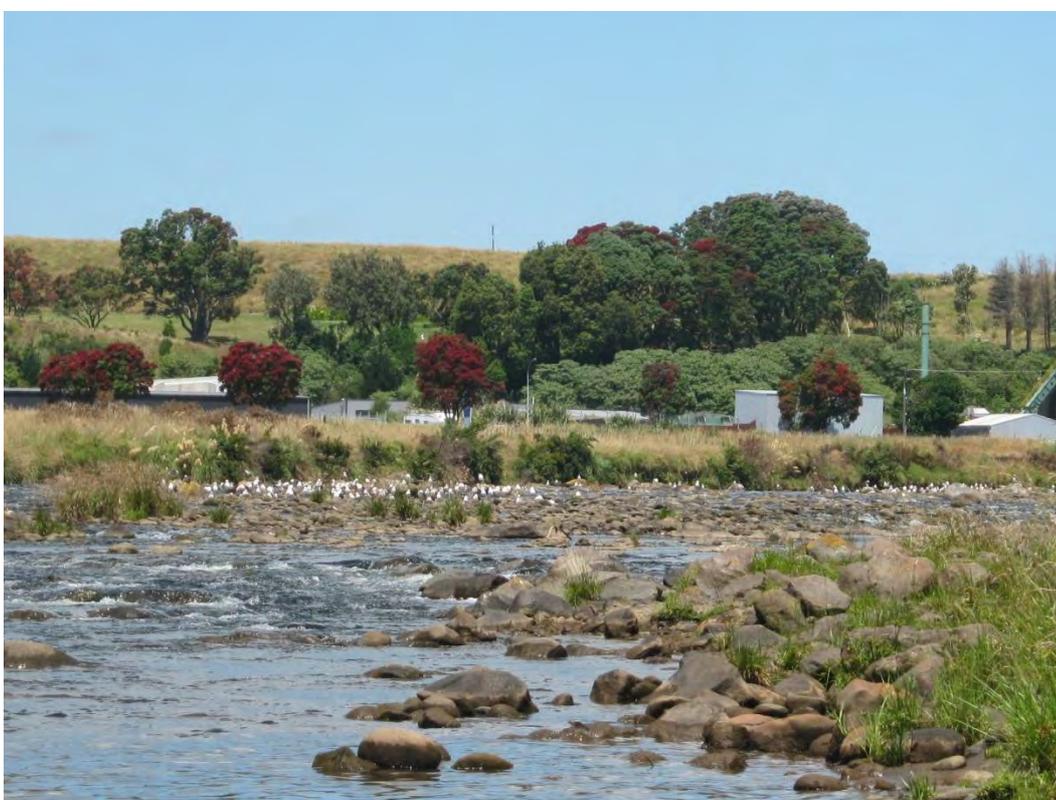
**Photograph 4** Gulls upstream of the Waiwhakaiho River site

Minima, maxima and medians for all faecal indicator bacteria were very high, indicating poor water quality at this site. Faecal source tracking results indicate that gulls are the main source of contamination (Photograph 4). Faecal contamination at this site can affect nearby coastal sites surrounding the river mouth- in particular the 500 m SW site.
