South Taranaki District Council
Eltham Wastewater Treatment Plant
Monitoring Programme
Annual Report
2015-2016

Technical Report 2016-29

January 2017

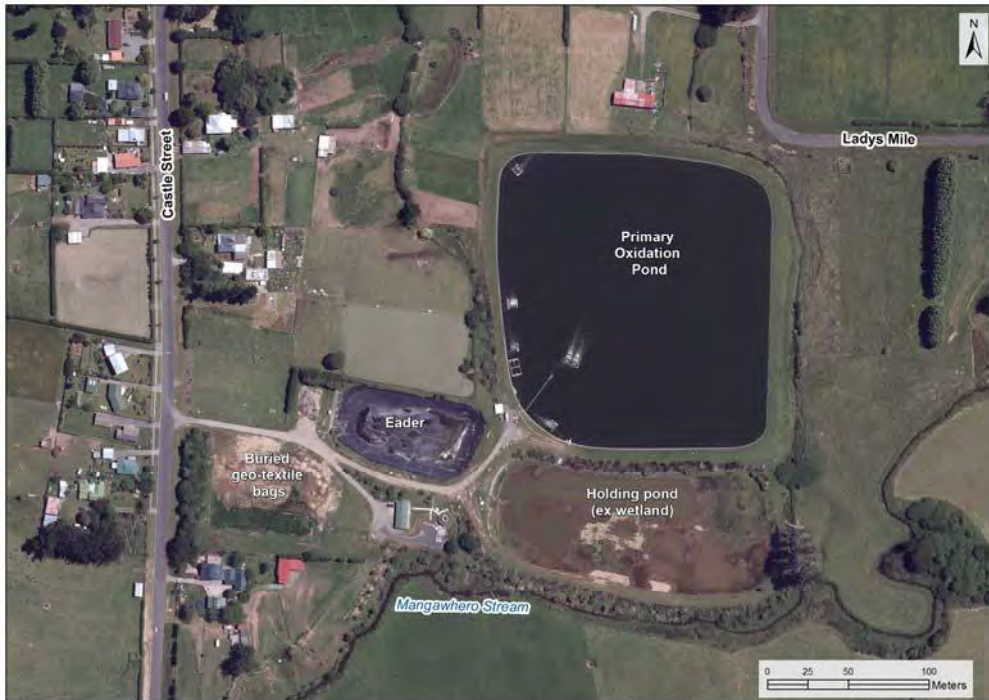
Figure 2 Aerial view of the Eltham WWTP showing the sludge geo-textile bags disposal area (lower LH corner) near the plant entrance [Note: the wetland (lower, centre) was converted to a holding pond in early 2011]

The primary pond was de-sludged during the 2006-2007 monitoring year with the de-watered sludge contained in geo-textile bags in an excavated, bunded area adjacent to the Earthen Anaerobic Digester (EADER) (Figure 2). A consent to discharge sludge from the WWTP and STDC water treatment plants to land at the Eltham WWTP site was granted in December, 2009 following concerns voiced by neighbours in relation to STDC's disposal of water treatment sludge at the site.

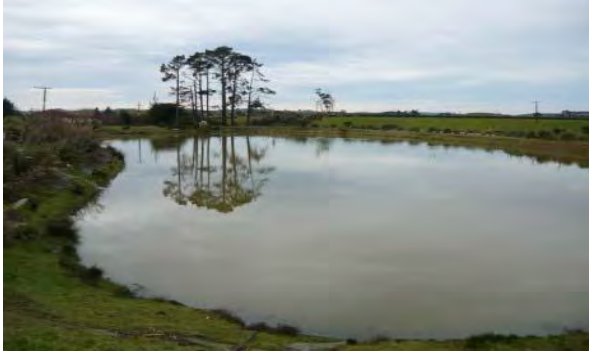
Photo 1 Overflow retention pond, 21 July 2011

Some use was made of the overflow retention pond in mid July 2011 due to surcharging of the Hawera town reticulation. This pond reached about 33% of its retention capacity (Photo 1) before increased pumping to the Hawera WWTP returned this holding facility to its normal, very low, level.

There was occasional usage of the overflow retention pond in the 2014-2016 period. No authorised overflows as per consent 7521-1 to the Mangawhero Stream were necessary at any time during the 2015-2016 monitoring period.

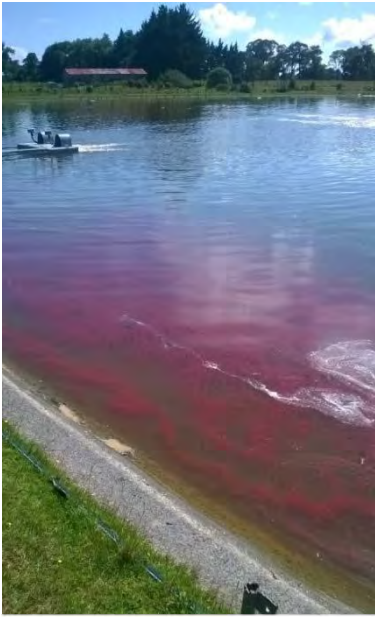
Photo 2 *Daphnia* spp. outbreak on primary pond, February 2016

In early February 2016, STDC notified the Council about an outbreak of *Daphnia* (water fleas) in the primary pond (Photo 2). To reduce the effect of the *Daphnia* feeding on and preserve the algal population of the pond, the dissolved oxygen levels in the pond were decreased by reducing the number of aerators operating. This was increased again following the disappearance of the outbreak.

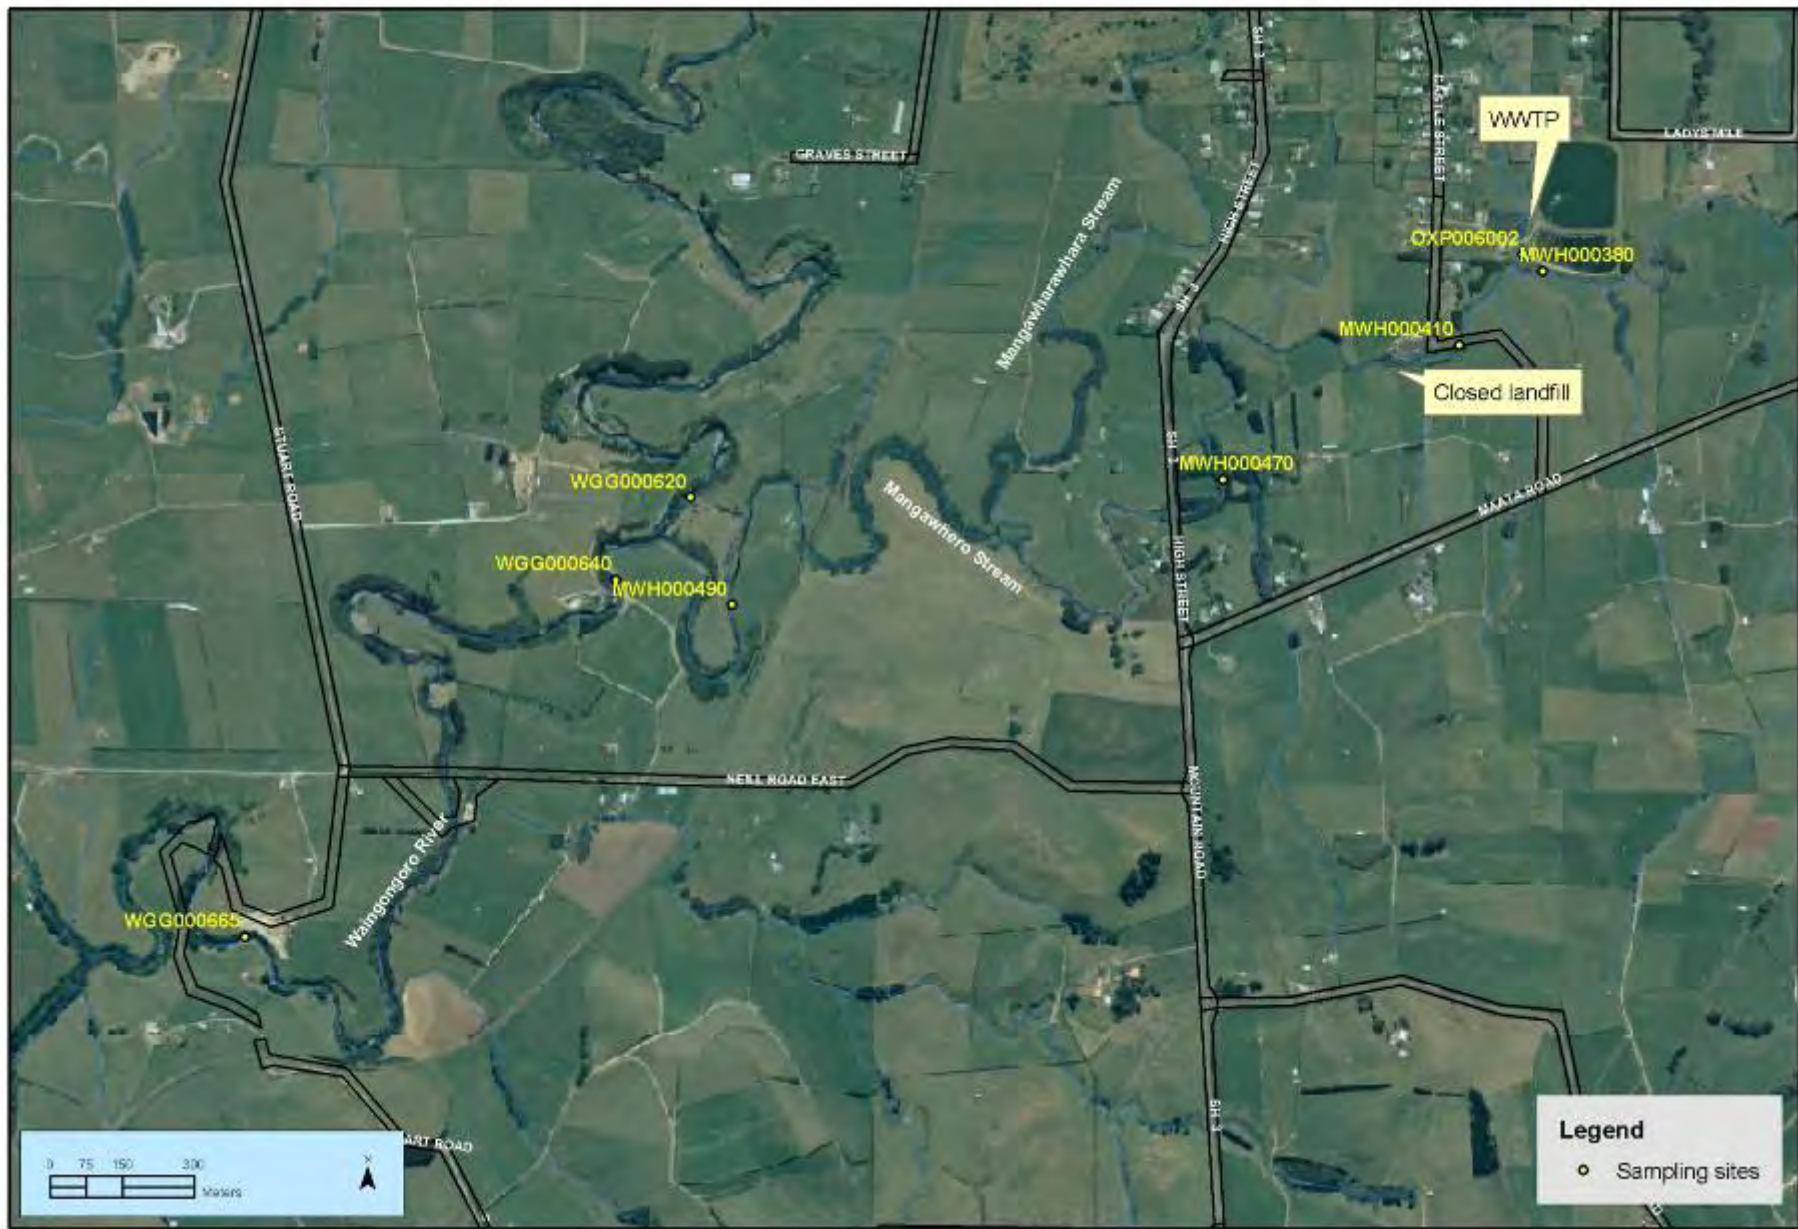
Figure 3 Location map of sampling sites in relation to the Eltham WWTP

The Council performed spring and summer reduced (three and five sites refer Figure 3) biomonitoring surveys in association with the consented overflow discharge from the Eltham wastewater treatment system and adjacent to the old rubbish tip site. In the absence of consented discharges, both surveys were performed to assess anticipated improvements in the biological 'health' of the receiving waters of both the Mangawhero Stream and Waingongoro River subsequent to the diversion of the Eltham WWTP discharge to the Hawera WWTP in mid-2010. Results of these surveys are summarised in Table 4 together with appropriate historical pre-diversion data (from the freshwater biology database). The full reports are included as Appendix II.
