The Council is taking steps towards improving ecosystem health, and identifying structures for removal and remediation. This section discusses three key aspects of our region's aquatic ecosystems: macroinvertebrates, periphyton (algae) and fish.

## What we know

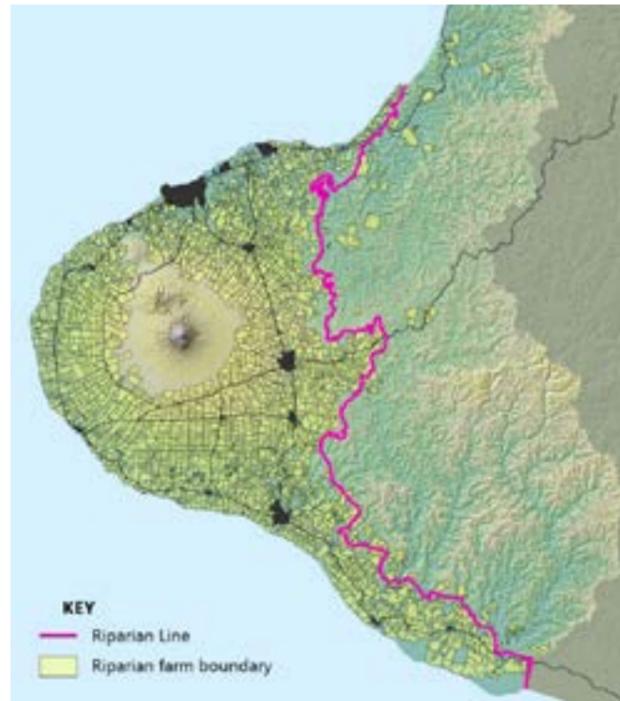
Area covered by the Council's riparian management programme.

Riparian margins are 89.5% fenced and 80.9% planted (or vegetated) as a result of 6,003km of new fencing and 4,575km of planting. More than 7.2 million native plants have been supplied to landowners at cost. This is significant under a voluntary approach and puts Taranaki ahead of the rest of the country with plan preparation and implementation.

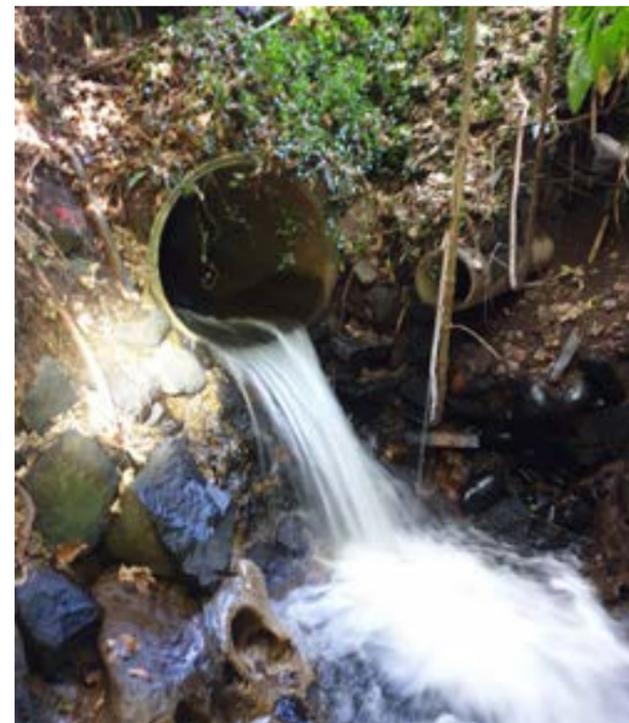
*Non-compliant stream culverts can prevent the upstream migration of fish due to the swift flows, shallow flows, steep approaches (waterfalls), overhangs (or perches) and by not providing rest areas.*

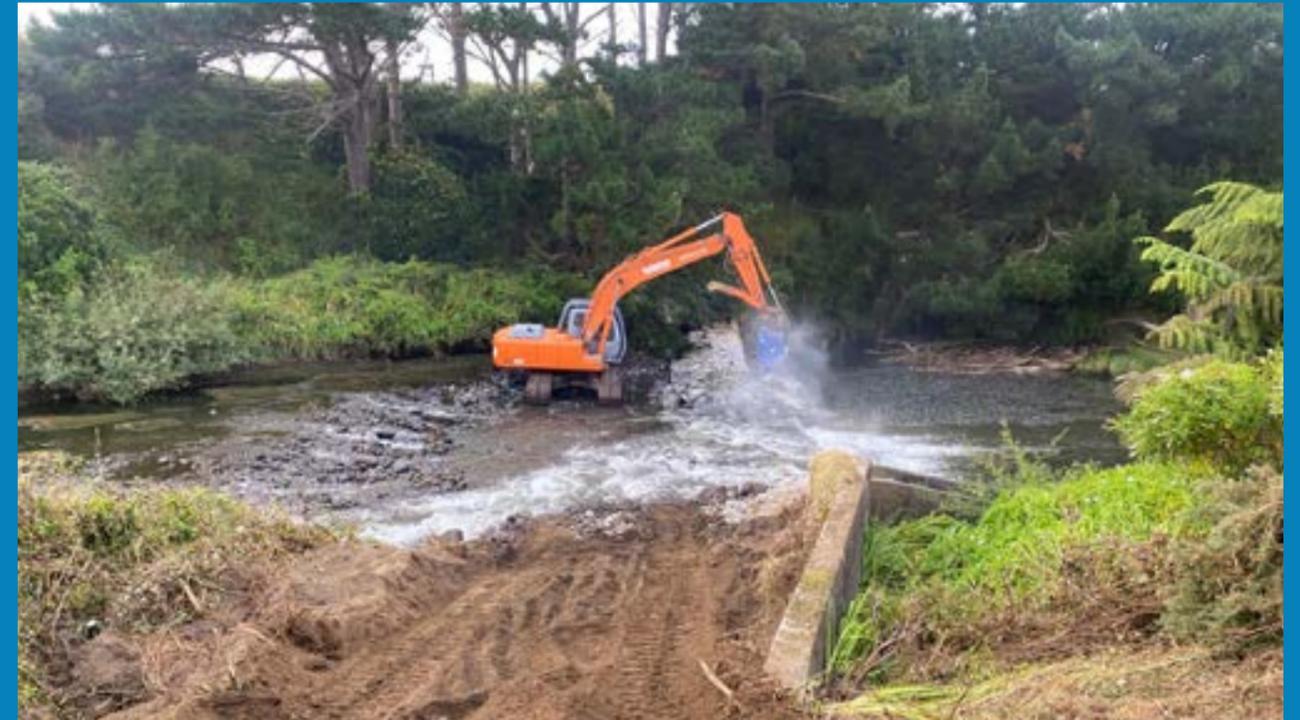
*The removal of the weir was a huge milestone.*

Thanks to a project led by Te Korowai o Ngāruahine Trust, with support from Fonterra Kāpuni, Taranaki Fish and Game, South Taranaki District Council and Taranaki Regional Council, a 3m high disused weir in South Taranaki has been removed.
