Lower Waitara River Flood Control Scheme

Asset Management Plan

28 August 2020

Document: 1939592

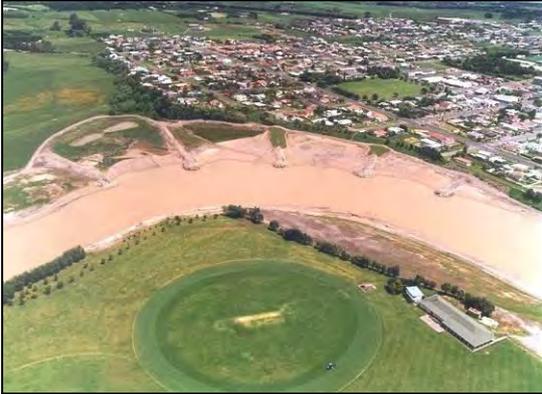
Figure 2: Waitara River – river control

The study identified that the river channel was relatively stable except for the section between the two bridges where the construction of the state highway bypass had caused changes to the river flood flow characteristics. The seawalls were found not to significantly affect the flood flows or flood levels upstream in the river. A revised 100 year flood return period flow of 3,000 cumecs was calculated.

Following the receipt of the report, the Council proceeded with the construction of an amended channel alignment fitting the natural meander curves for the length of the river between the two bridges. To establish and maintain this alignment a new channel was excavated and a series of seven groynes and other rock protection works were constructed. This construction work was carried out during 1993.

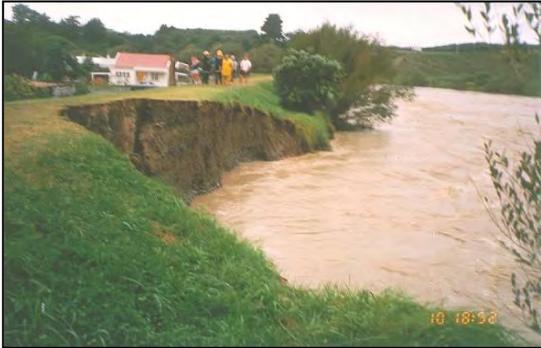
Figure 3: Waitara River bank collapse – 1990

During the March 1990 flood, major damage occurred in several locations in the scheme and further upstream in other locations on the river.

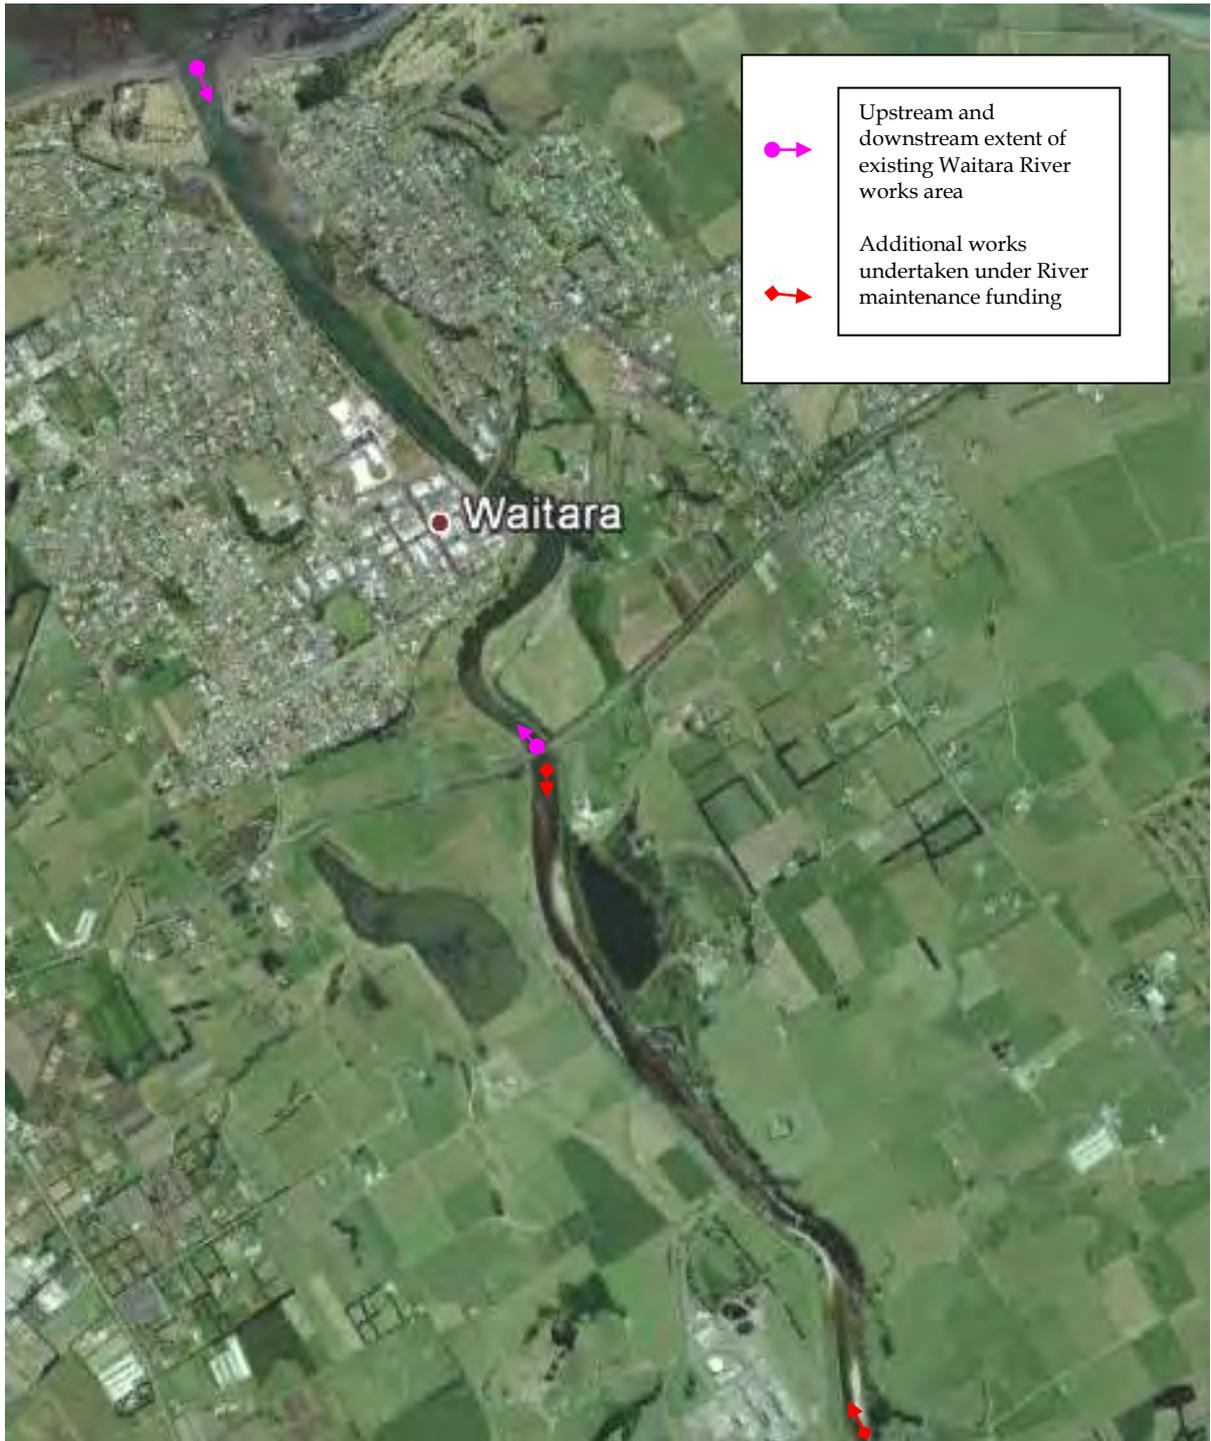
Figure 6: Scheme works area

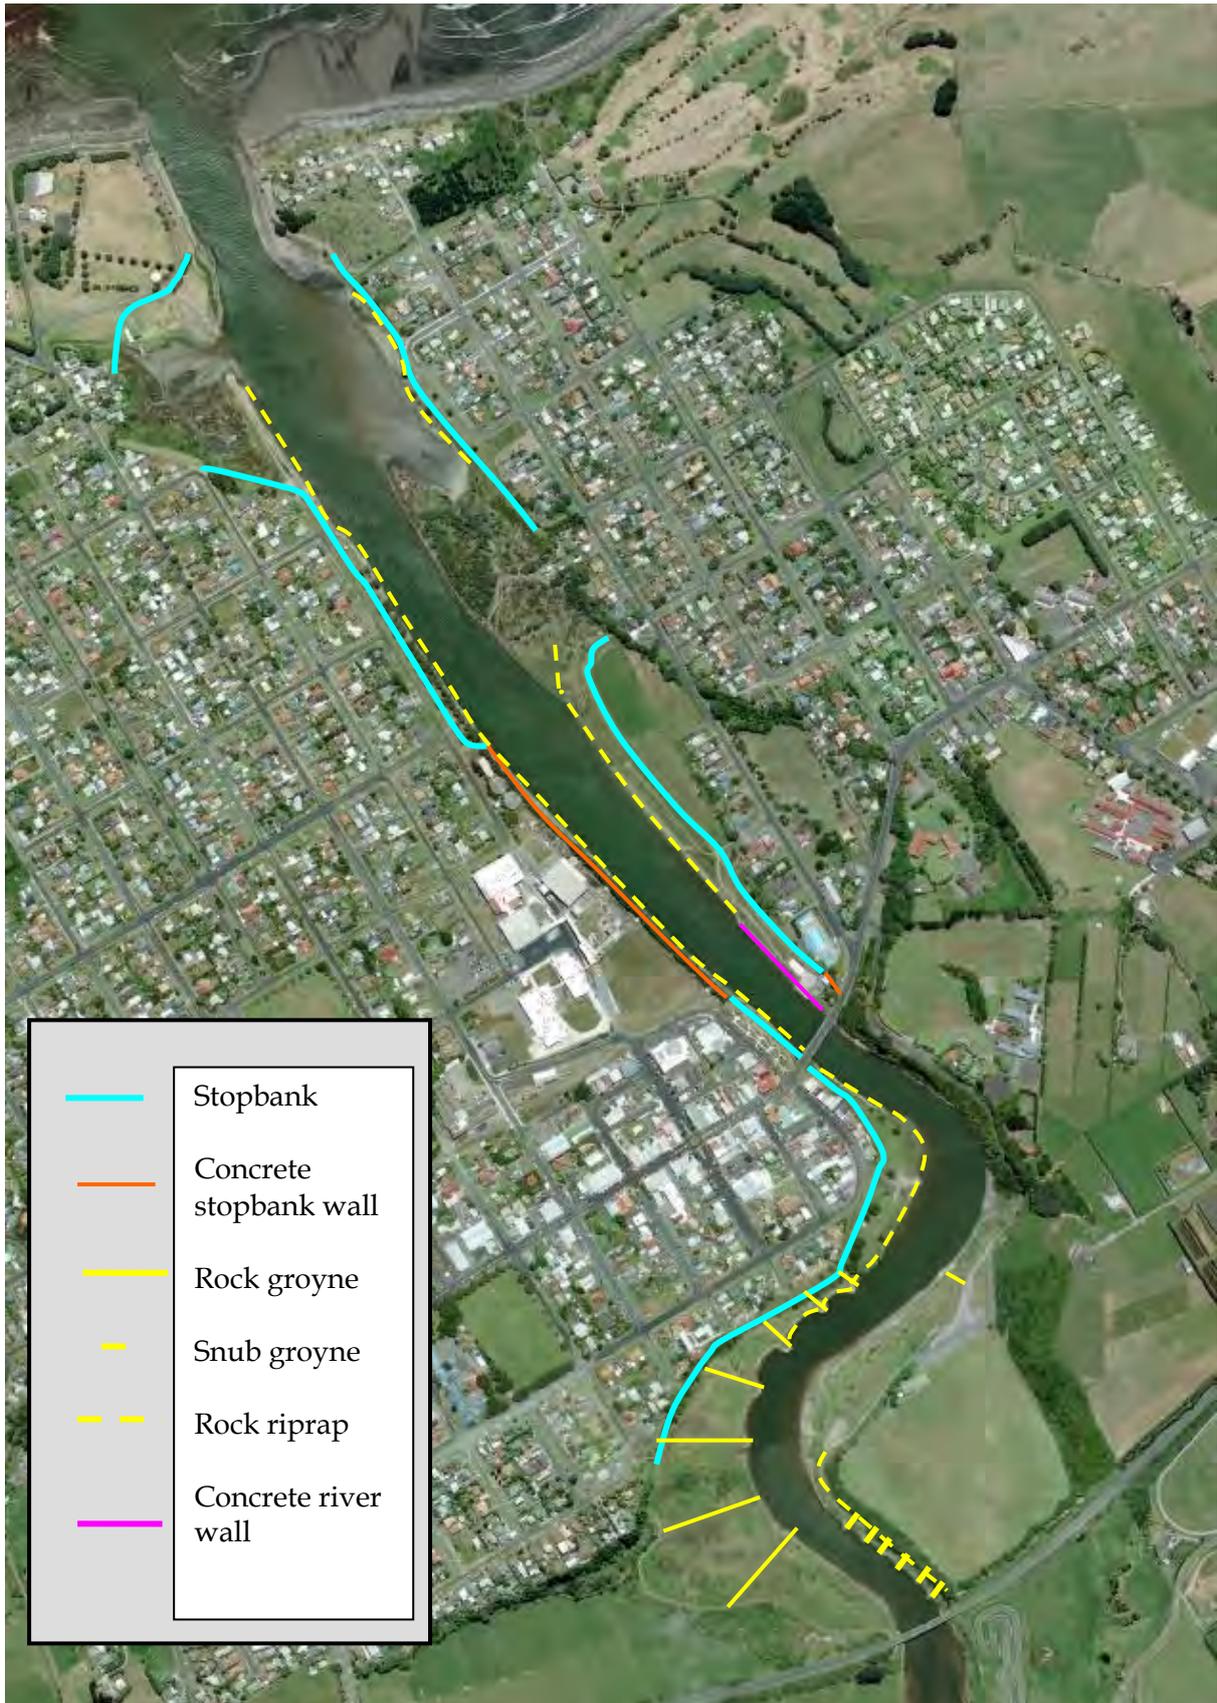
Figure 7: Location of Scheme Assets

Figure 7 details the general location of these assets. The access track and paths are not shown as their inclusion would clutter the drawing.

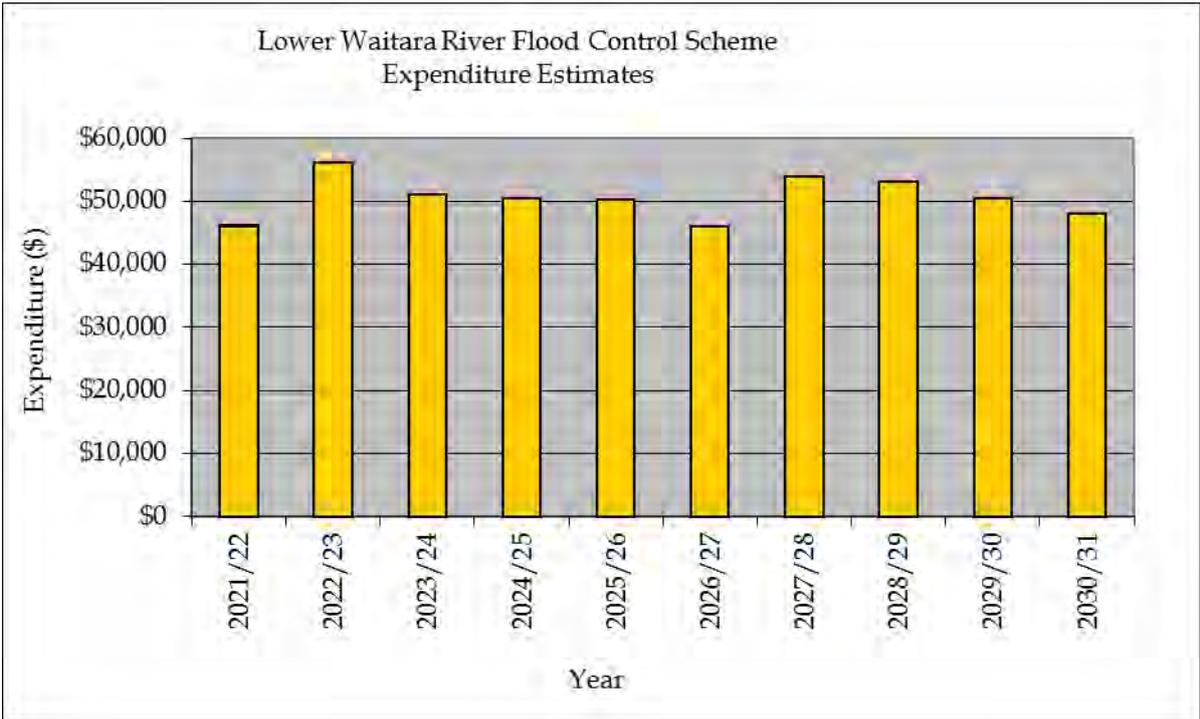
Figure 8: Cost estimates 2021 to 2031

Year	2021/22	2022/23	2023/24	2024/25	2025/26	2026/27	2027/28	2028/29	2029/30	2030/31
Contracting Costs	\$ 46,000	\$ 56,100	\$ 51,000	\$ 50,500	\$ 50,200	\$ 46,000	\$ 54,000	\$ 53,100	\$ 50,500	\$ 48,100
Total Annual Maintenance cost	\$ 46,000	\$ 56,100	\$ 51,000	\$ 50,500	\$ 50,200	\$ 46,000	\$ 54,000	\$ 53,100	\$ 50,500	\$ 48,100
