AGENDA

Operations and Regulatory Committee

07 February 2023 09:00 AM

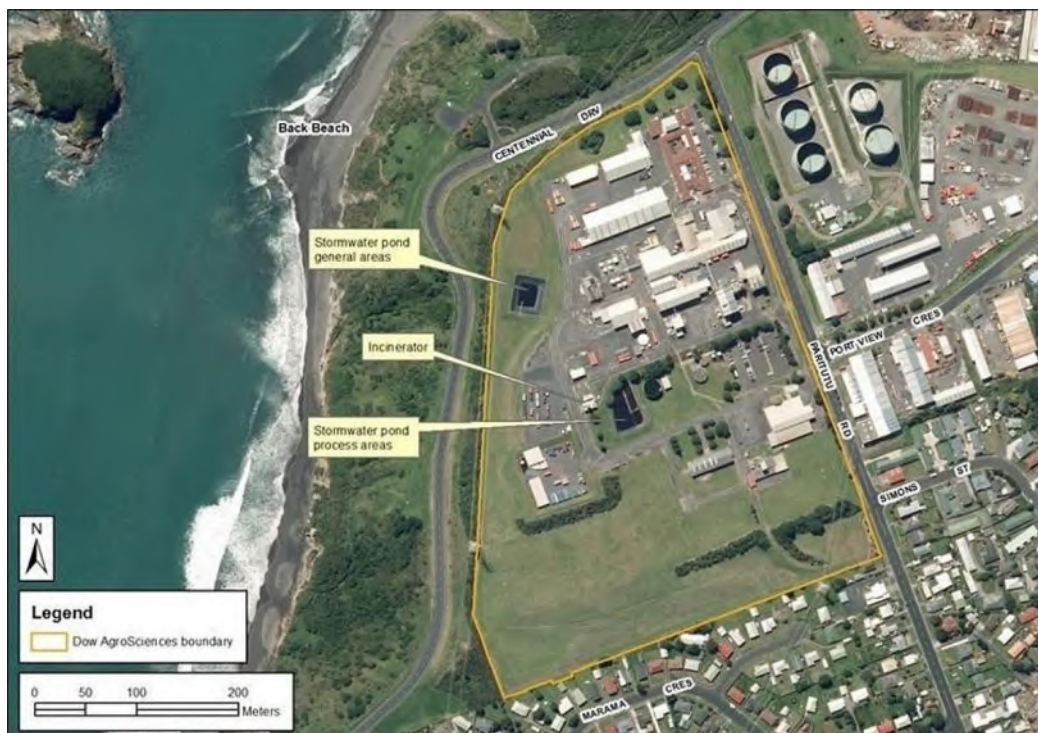
Figure 1: Dow Paritūtū site, New Plymouth. The site boundary is indicated by the yellow line.

17. The Dow Paritūtū agrichemical manufacturing site occupies a 16 hectare land parcel located between Paritūtū Road and Centennial Drive in north-western New Plymouth (Figure 1). Prior to the demolition works in 2022, the site comprised numerous process and storage buildings, an office and laboratory, a dedicated high temperature incinerator building, hazardous substances storage area, trade waste treatment plant, small tank farm, two stormwater retention ponds, and large grassed areas to the west and south.

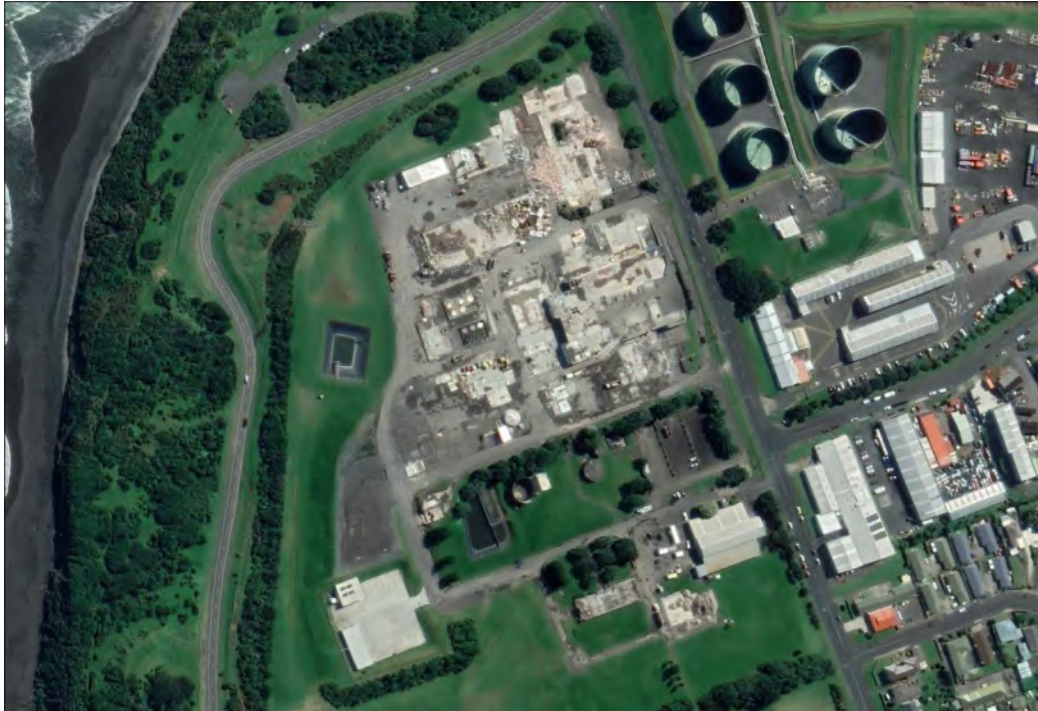
Figure 2: Aerial photograph of the Paritūtū site during demolition, around October 2022.

18. Demolition of the site in late 2022 involved the removal of all above ground structures, with the exception of the hazardous substance storage area and the stormwater retention systems. Concrete buildings that are integral to the retaining walls of the raised process area in the east of the site have also been left in place. Figure 2 below shows an aerial image of the site during demolition, taken around October 2022.

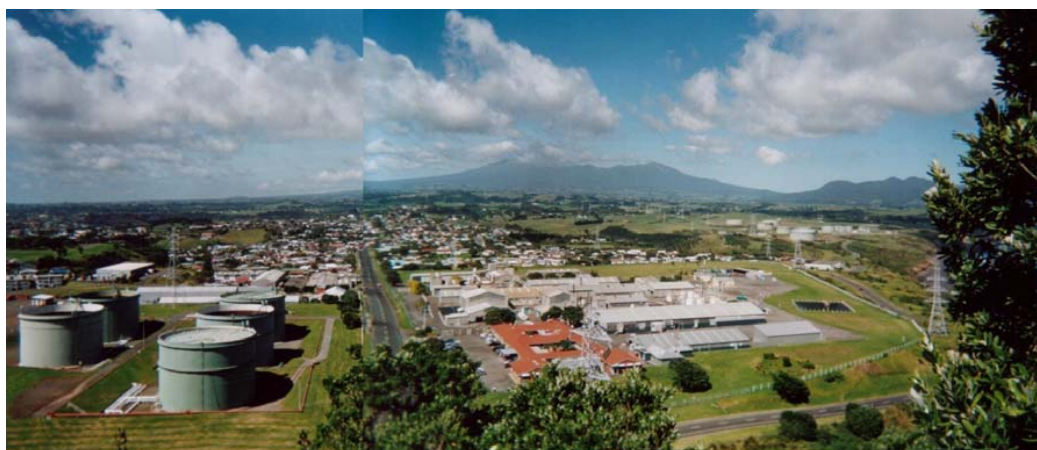
Photograph 1: Panoramic view of sample area from Paritutu, overlooking the Dow plant and residential areas beyond

At the time the plant was built on the Paritutu site (having moved from a site in Buller Street in central New Plymouth) the surrounding area was largely sand dunes and rural land. The area has subsequently been developed, with residential areas now to the south and south east of the site (Photograph 1, Figure 1).

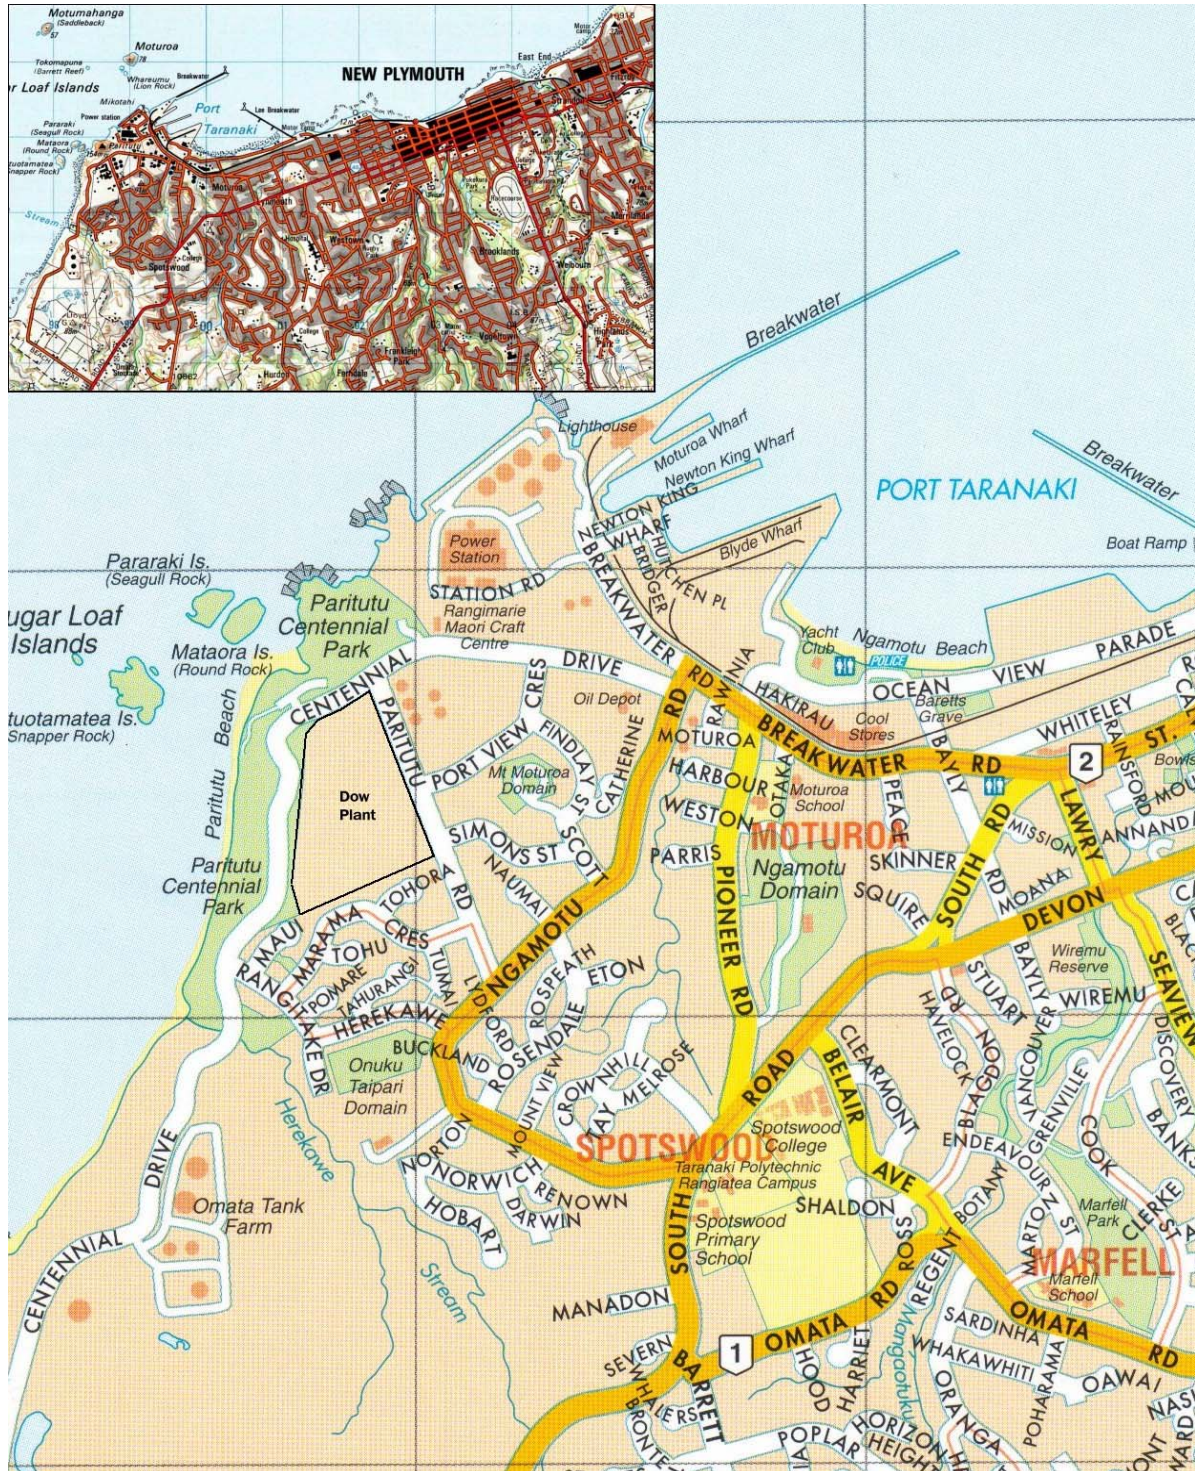
Figure 1: Location of study area
