AGENDA

Operations and Regulatory Committee

Operations and Regulatory Committee - Dow Paritutu Preliminary Site Investigation

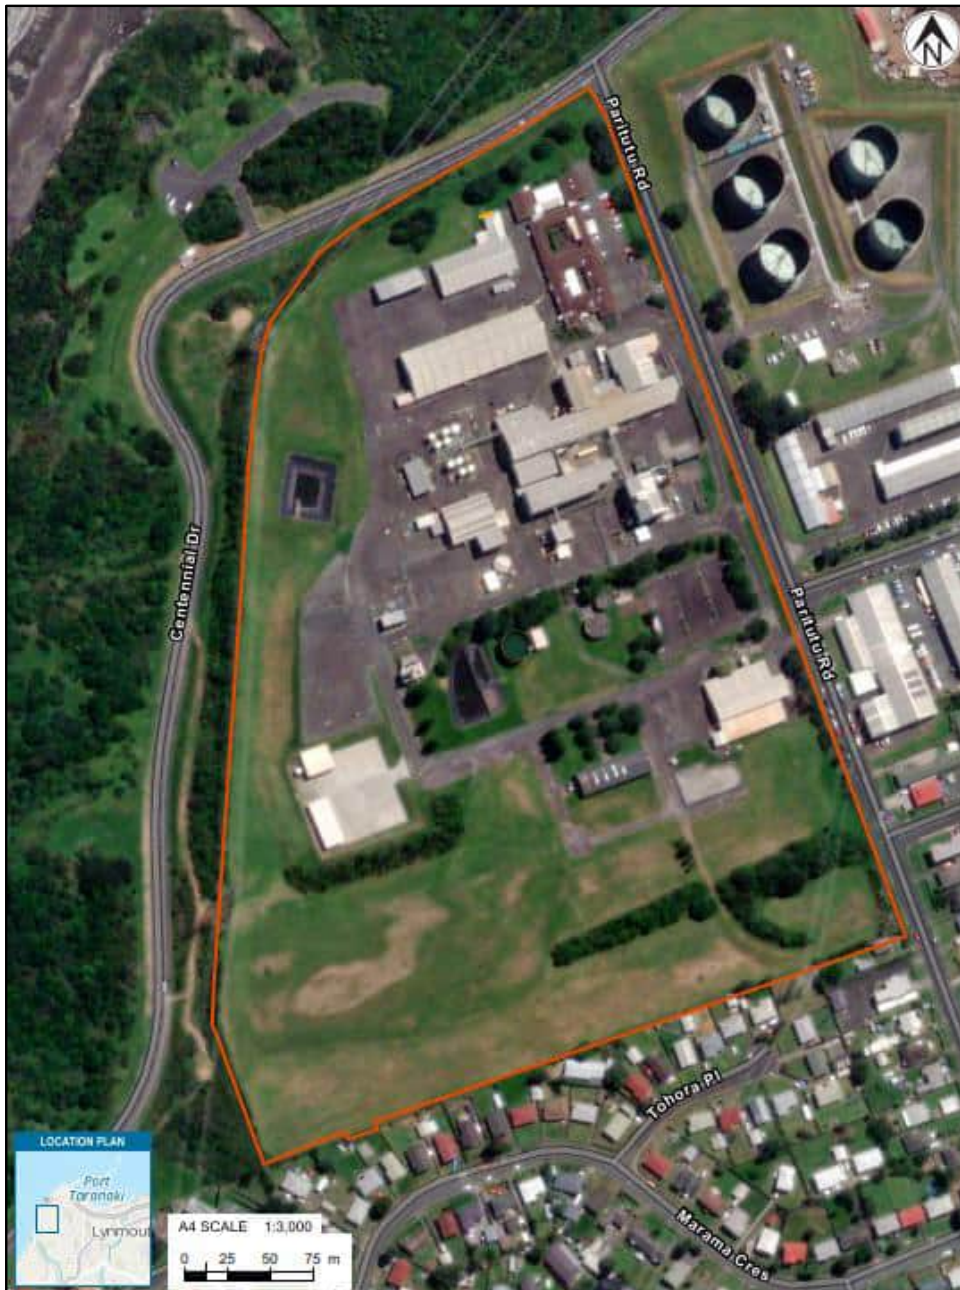
Figure 3.1: Site Location, with an approximate site boundary shown in orange.

The Paritūtū site has primarily been associated with agrichemical manufacturing operations since 1960, when the site was first established. The onsite facilities formerly included multiple facilities for chemical manufacture and storage as well as an administration building, pilot plant, solid and liquid incinerators, maintenance/engineering areas, and research and development facilities. [Table 3.1](#) provides an overview of the site description and [Figure 3.1, below](#), shows the site location.

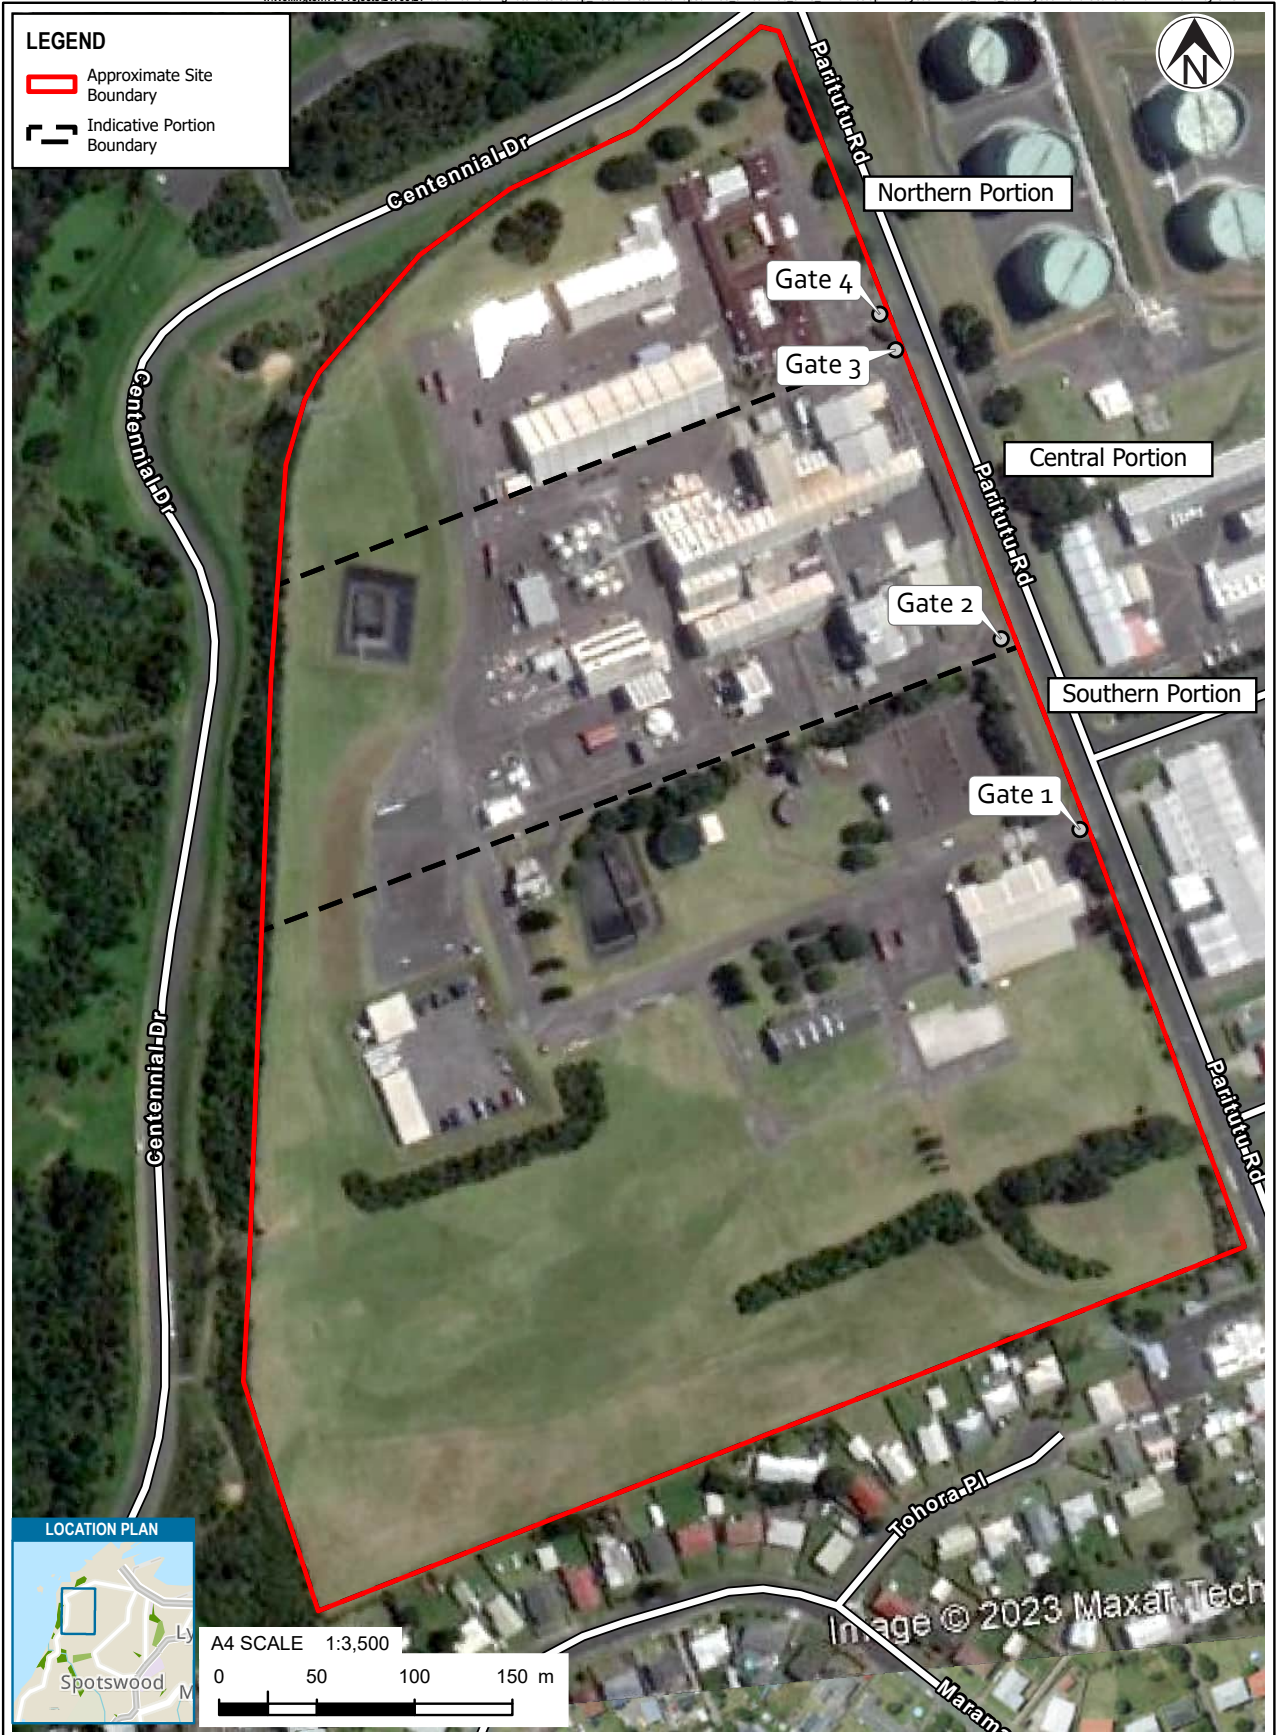
PROJECT No. 21795.0210			CLIENT	DOW CHEMICAL (NZ) LIMITED		
DESIGNED	CHUT	OCT.23	PROJECT	PARITUTU CONTAMINATED LAND ASSESSMENT		
DRAWN	CHUT	OCT.23	TITLE	PARITUTU SITE LAYOUT		
CHECKED	CHSA	OCT.23	SCALE (A4)	1:3,500	FIG No.	FIGURE 2.
APPROVED	DATE					REV 0

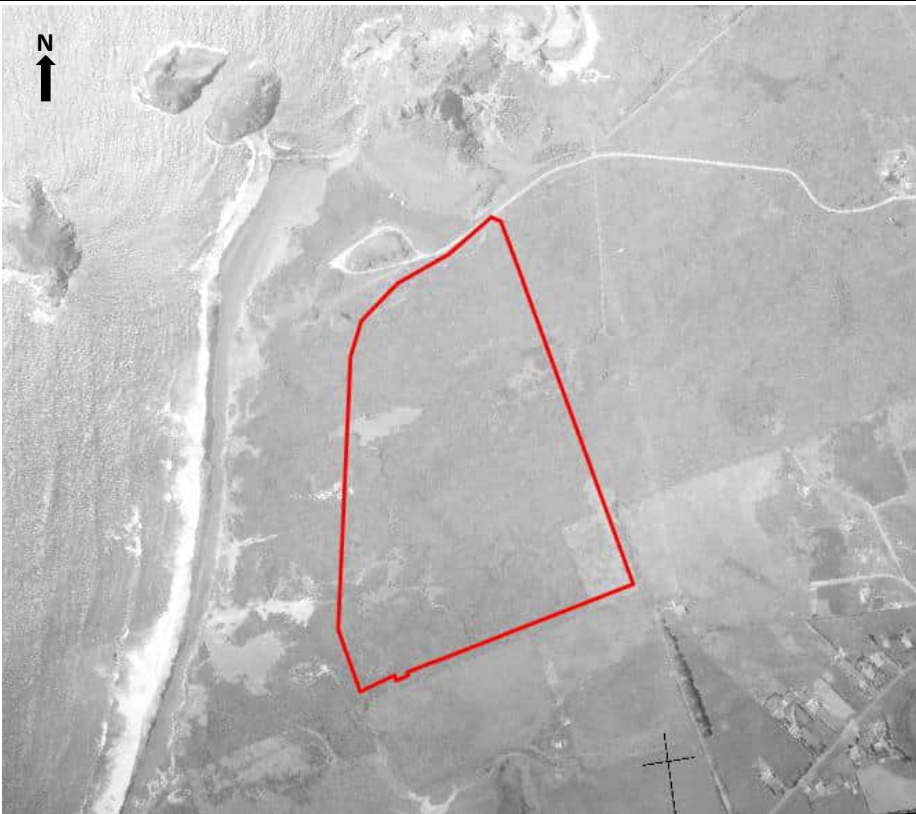
<p>This is a black and white aerial photograph from 1949. A red outline highlights a large, roughly rectangular area in the center of the image. To the left of this area is a wide, light-colored beach or shoreline. The terrain appears to be a mix of open fields and some structures. A north arrow is located in the upper left corner of the photograph. A small crosshair is visible in the lower right quadrant.</p>
1958 Alexander Turnbull Library

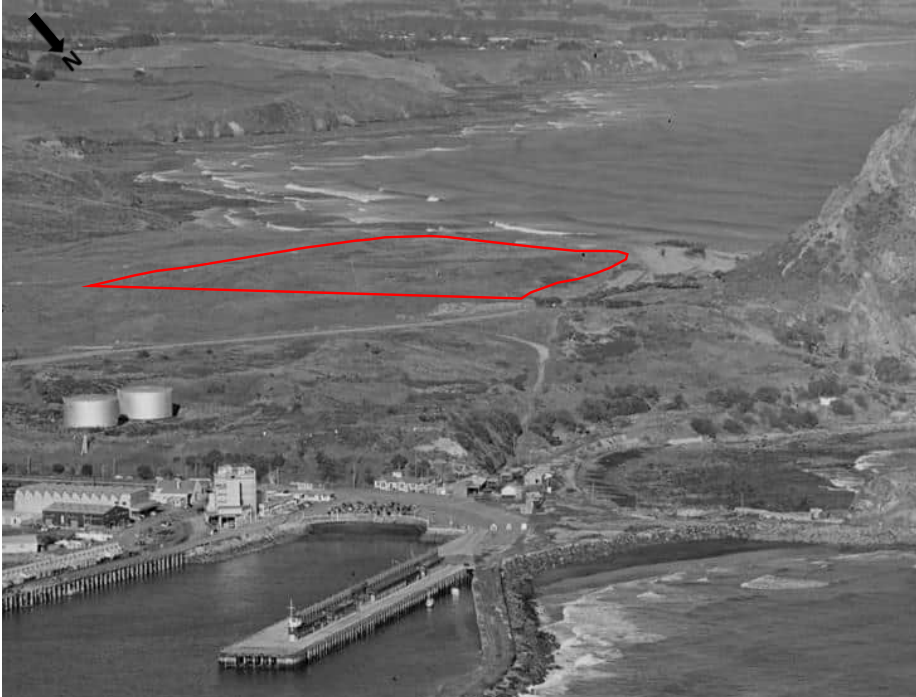
<p>This is a black and white aerial photograph from 1958, showing a different view of the same area. A red outline highlights a large, roughly rectangular area in the center. In the foreground, there is a large body of water with a long pier extending into it. Several large, cylindrical storage tanks are visible on the left side. The terrain is more developed than in the 1949 photo, with more buildings and infrastructure. A north arrow is located in the upper left corner of the photograph.</p>

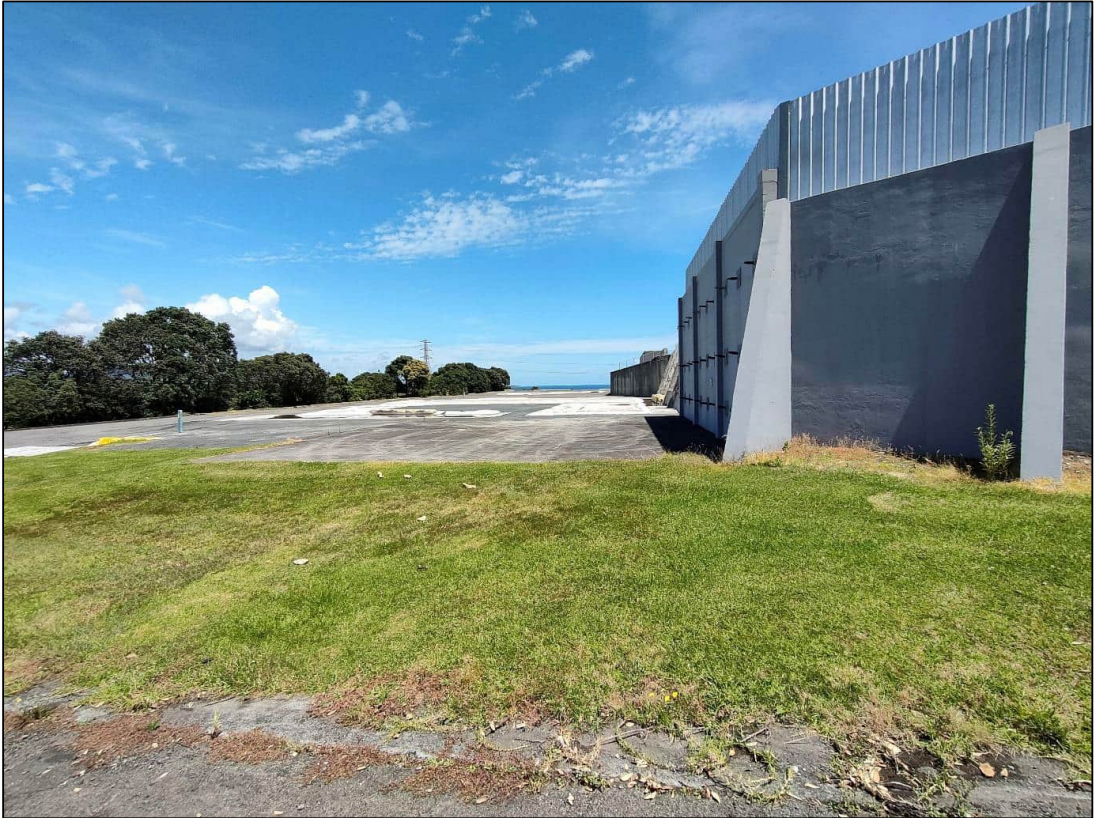
Photograph 7: View looking west showing the former footprint of Building 13, the retaining wall to the top yard behind Building 3.
