Todd Energy Aquatic Centre
Monitoring Programme
Annual Report
2016-2017

Technical Report 2017-33

August 2017

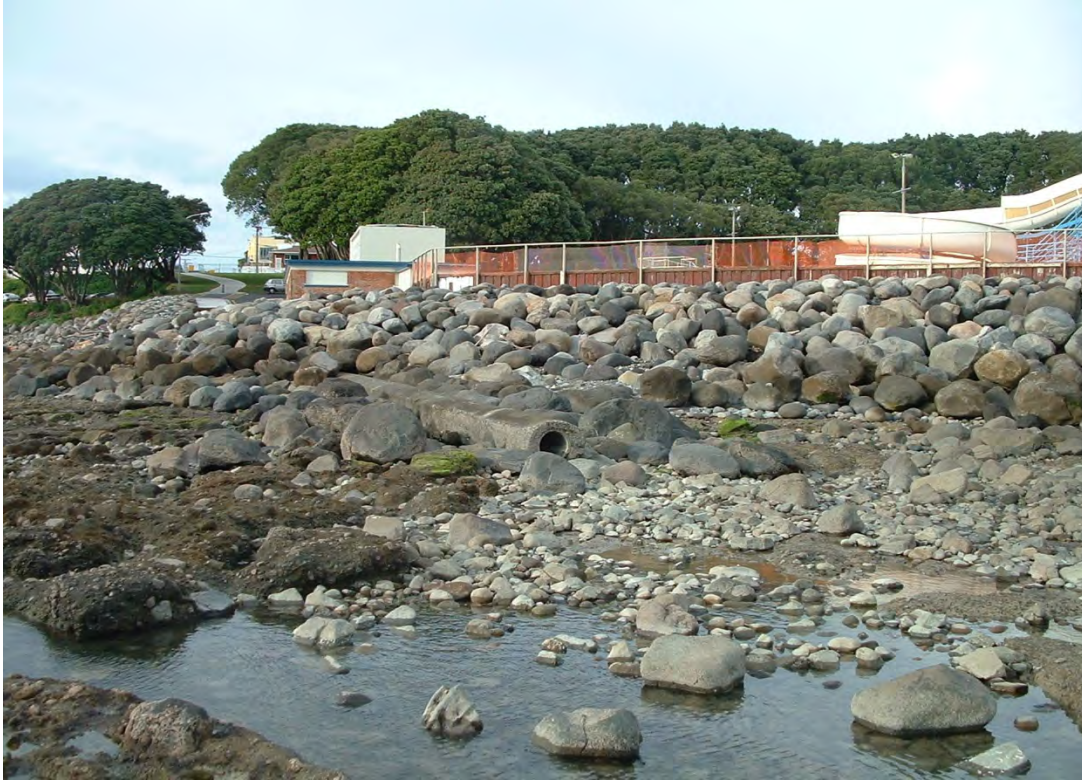
Discharge of wastewater from the outdoor pool complex filtration system takes place via the original discharge pipe which is situated on the foreshore to the east of the facility (Photo 1) and in the vicinity of an intake for water used in heat exchange by the swimming pool.

The discharge pipe consists of a 300 mm diameter encased concrete pipe and discharges at approximately mid-tide level. This structure was constructed in 1962 and has been in use ever since for the purpose of backwashing the outdoor pool filters.

Photo 1 Aquatic Centre marine outfall
