Stratford District Council
Municipal oxidation ponds system
Monitoring Programme
Annual Report
2014-2015

Technical Report 2015-07

September 2015

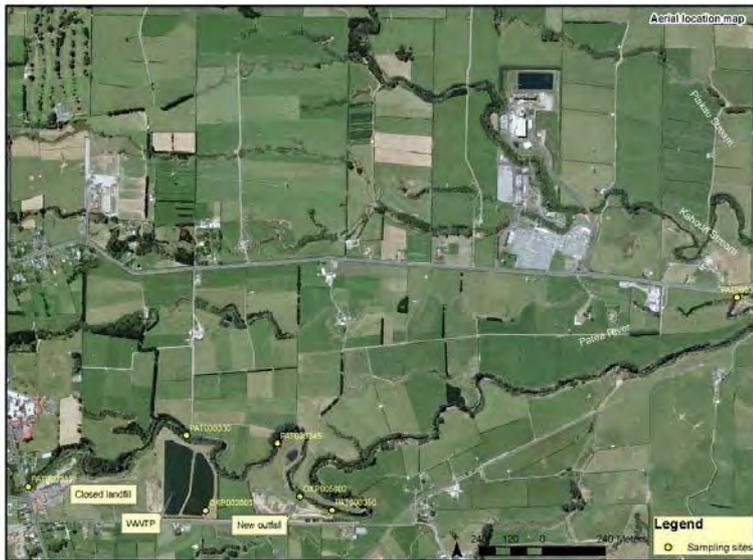
**Figure 1** Aerial photo of site and location of sampling sites since the upgrade of the WWTP

A late summer assessment of the impact of the upgraded oxidation ponds' system effluent discharge on the receiving waters of the Patea River was performed on 16 February 2015 when flow in the river (at the Skinner Road recorder) was 0.78 m³/s, during a very low recession flow period (although not as extreme as the very low, lengthy recession flow surveyed in the summer of 2008). Sites were located (Figure 2) as summarised in Table 4.

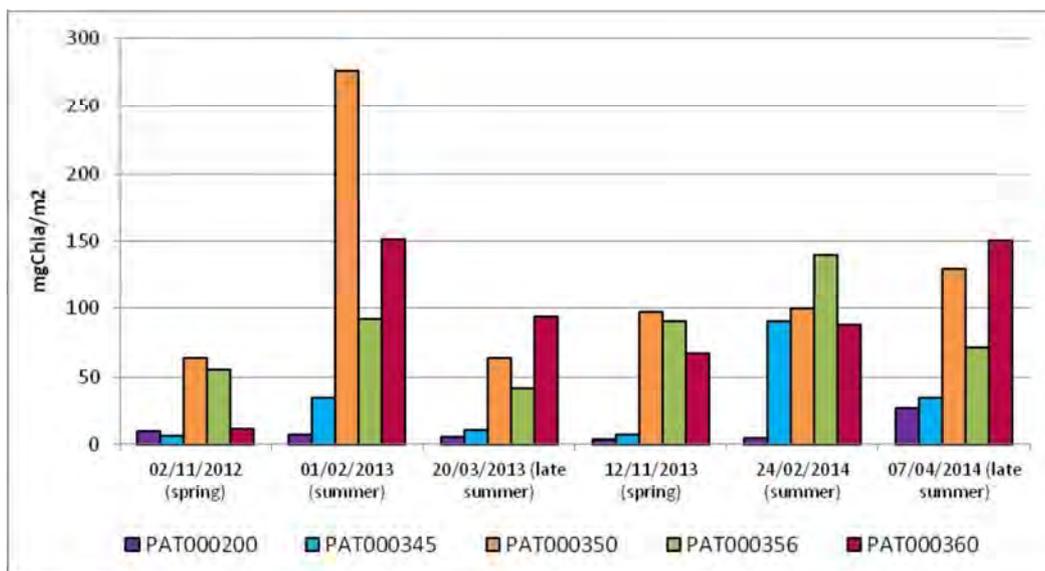
Figure 2 Chlorophyll-a concentrations in the Patea River for the spring 2012 to late summer 2013 and spring 2013 to autumn 2014 periods

This illustrates (Figure 3) the impact of the WWTP discharge (between sites PAT000345 and PAT000350) upon the streambed periphyton cover in the mid reaches of the Patea River in each of the two periods.

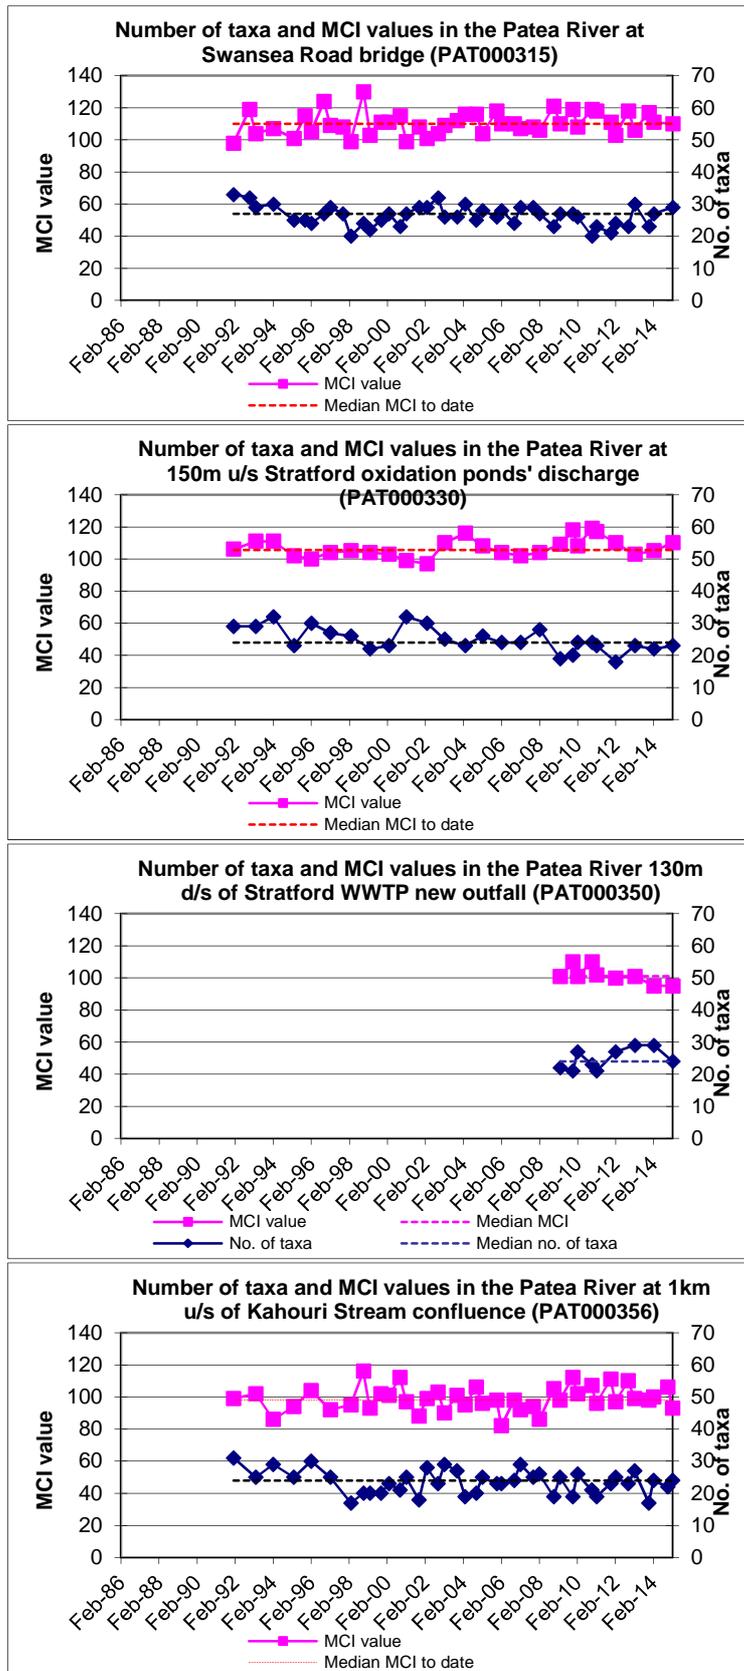
Figure 3 Taxa richness and MCI scores recorded to date at the Patea River sites

The results from the current survey (Table 2) indicated faunal richnesses ranging from one taxon below (site 2) to two taxa above (site 1) median richnesses (ranging from 23 to 29 taxa) present at the four river sites. These taxa numbers were well within ranges previously recorded (Table 1) at the three longer established sites (1, 2 and 4).

The range of taxa richnesses was generally typical of richnesses recorded by previous surveys which have been recorded under summer, more widespread periphyton cover and tending toward low flow conditions.
