Patea Freezing Works Detailed Site Investigation Report

Document No: 451931

Taranaki Regional Council
Private Bag 713
STRATFORD 4352

May 2008

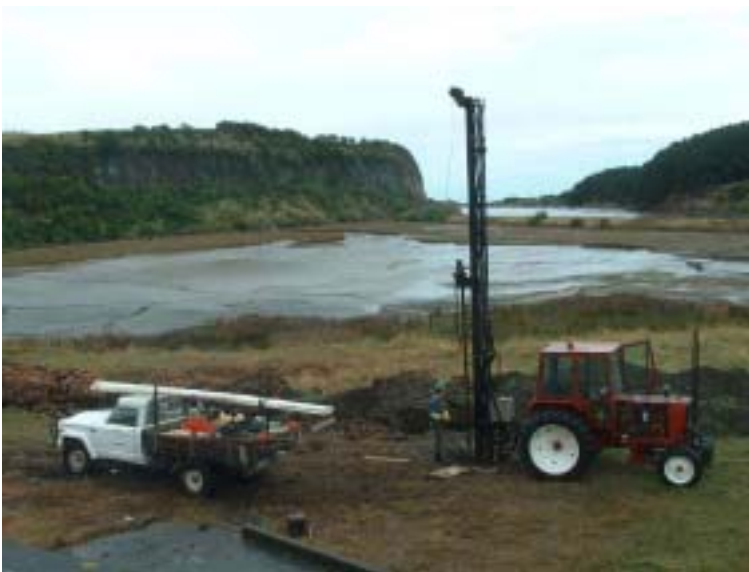
Photograph 12 Drilling MW1

Interdrill Limited was contracted to install five piezometers, four monitoring and one background (photograph 12). The location of the wells was determined after levelling of existing bores on the site by the Council's hydrologist gave an indication of the groundwater flow direction. Full details of this process can be found in section 5 of this report discussing geology and hydrology. The original scope of work had included the analysis of drill cuttings, however this was not completed. It was decided that the fill composition had already been adequately characterised, through investigation of the trench and test pits.

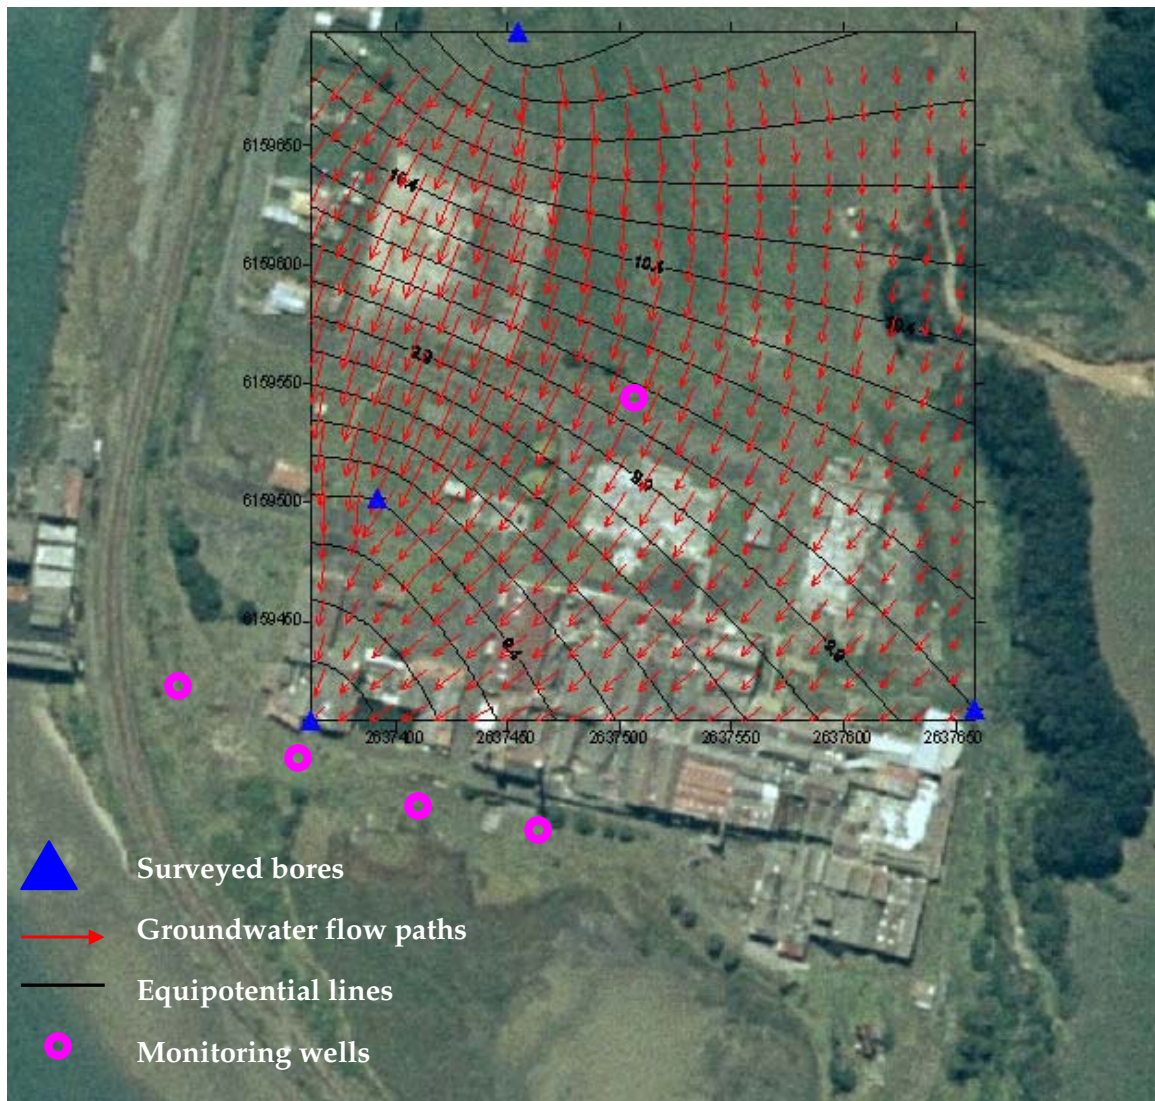
Figure 7 Surveyed bores, flow paths and monitoring wells

Figure 7 depicts the groundwater flow system at Patea Freezing Works site. Groundwater travels along flow paths (red vector lines) which extend from areas of groundwater recharge to areas of groundwater discharge, in this case travelling S-SW towards the Patea River and the Tasman Sea farther downgradient. Equipotential lines are indicated as black lines.

Five monitoring wells were installed at the locations shown in Figure 7 above. The well characteristics are: well diameter 150mm, filter sock wrapped around a slotted PVC pipe, the filter pack used was gravel, bentonite was used for the plug and each was grouted-below Ground Toby Boxes.
