Page, M.J.; Rosser, B.J.; Townsend, D.B.; Carey, J.M.; Ries, W.F. 2015. Reconnaissance report on landsliding caused by the 19-20 June 2015 rainstorm in the Taranaki-Wanganui-Manawatu region, *GNS Science Consultancy Report 2015/172*. 50 p. + Appendices

## ABSTRACT

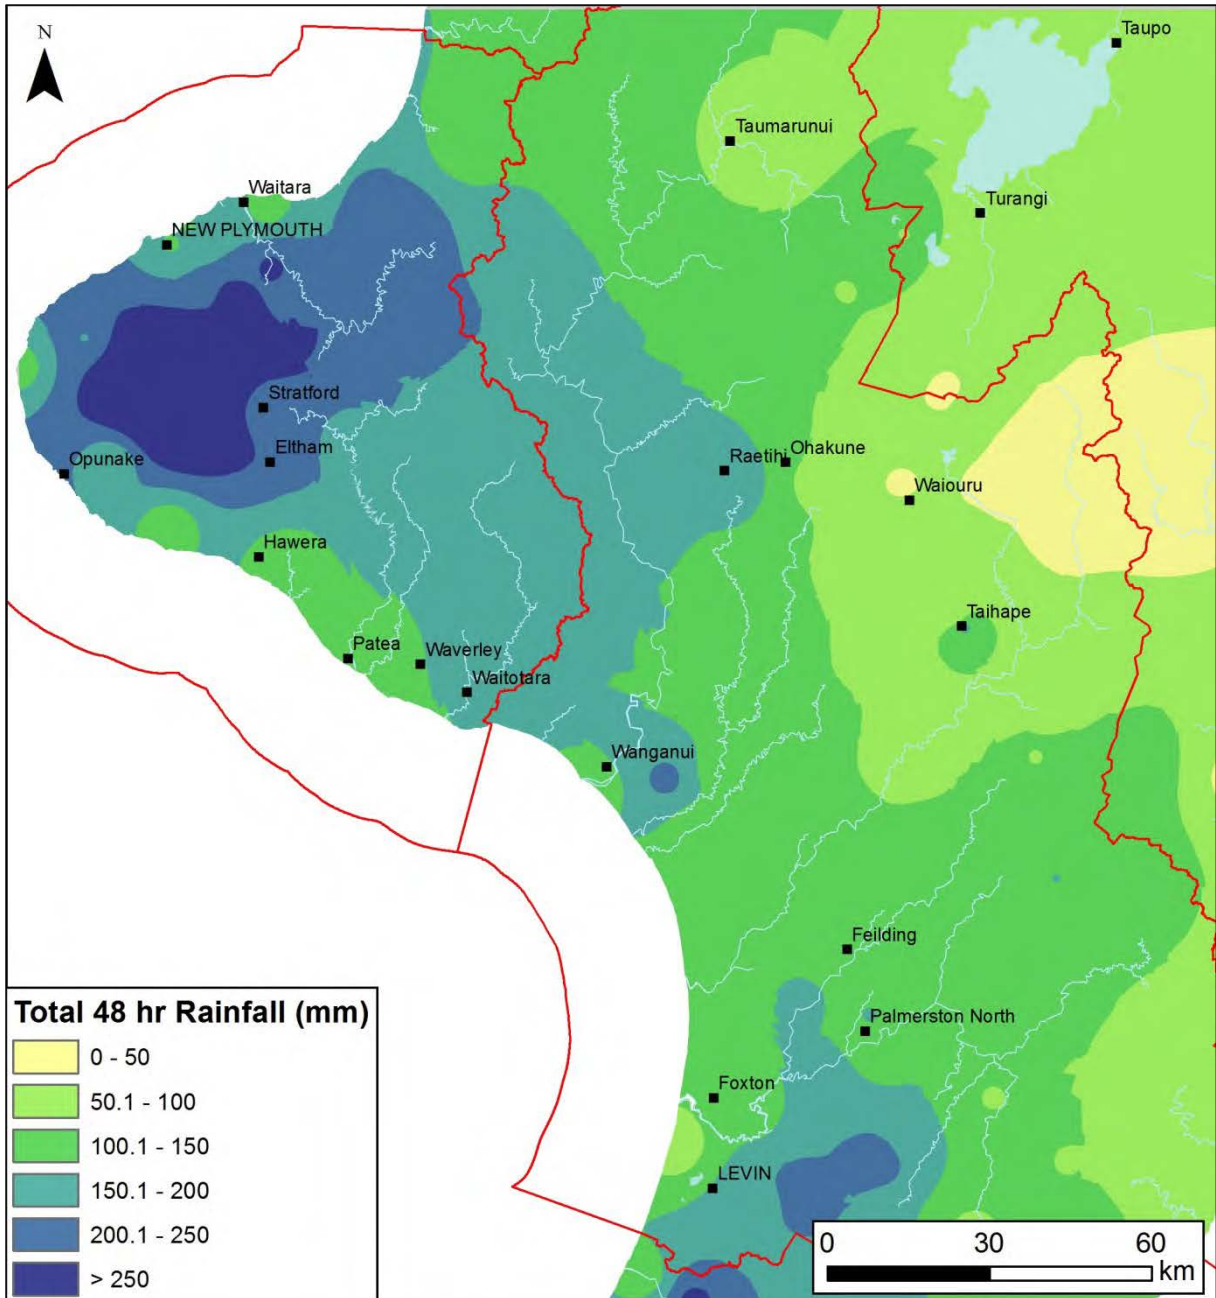
Rainfall for the event for the 19–20th June was between 150 and 250 mm in hill country of north Taranaki, and between 100 and 200 mm in the hill country of south Taranaki. In the Wanganui-Manawatu regions, rainfall was highest in the mid to lower reaches of all the main catchments and the upper reaches of the Whanganui catchment. Totals were between 100 and 200 mm, with highest totals in the Whanganui catchment. Totals in the upper reaches of the other main catchments were generally between 50 and 100 mm (Figure 1).

**Figure 1** 48-hour rainfall totals for the 19–20 June 2015 storm. Data from Taranaki Regional Council and Horizons Regional Council (Red lines show council boundaries).

1. Landsliding was generally confined to areas where 48-hour rainfall totals were >100 mm (Figure 1). This approximated an Average Recurrence Interval of between 20–100 years (from HIRDS).
2. Landsliding was largely confined to areas in pasture (Figure 15 and Figure 16), or recently planted or logged forest (Figure 17). Landsliding was less common in scrub (Figure 18, Figure 19, Figure 20), and infrequent in areas of indigenous forest and closed-canopy exotic plantation forest (Figure 21 and Figure 22).

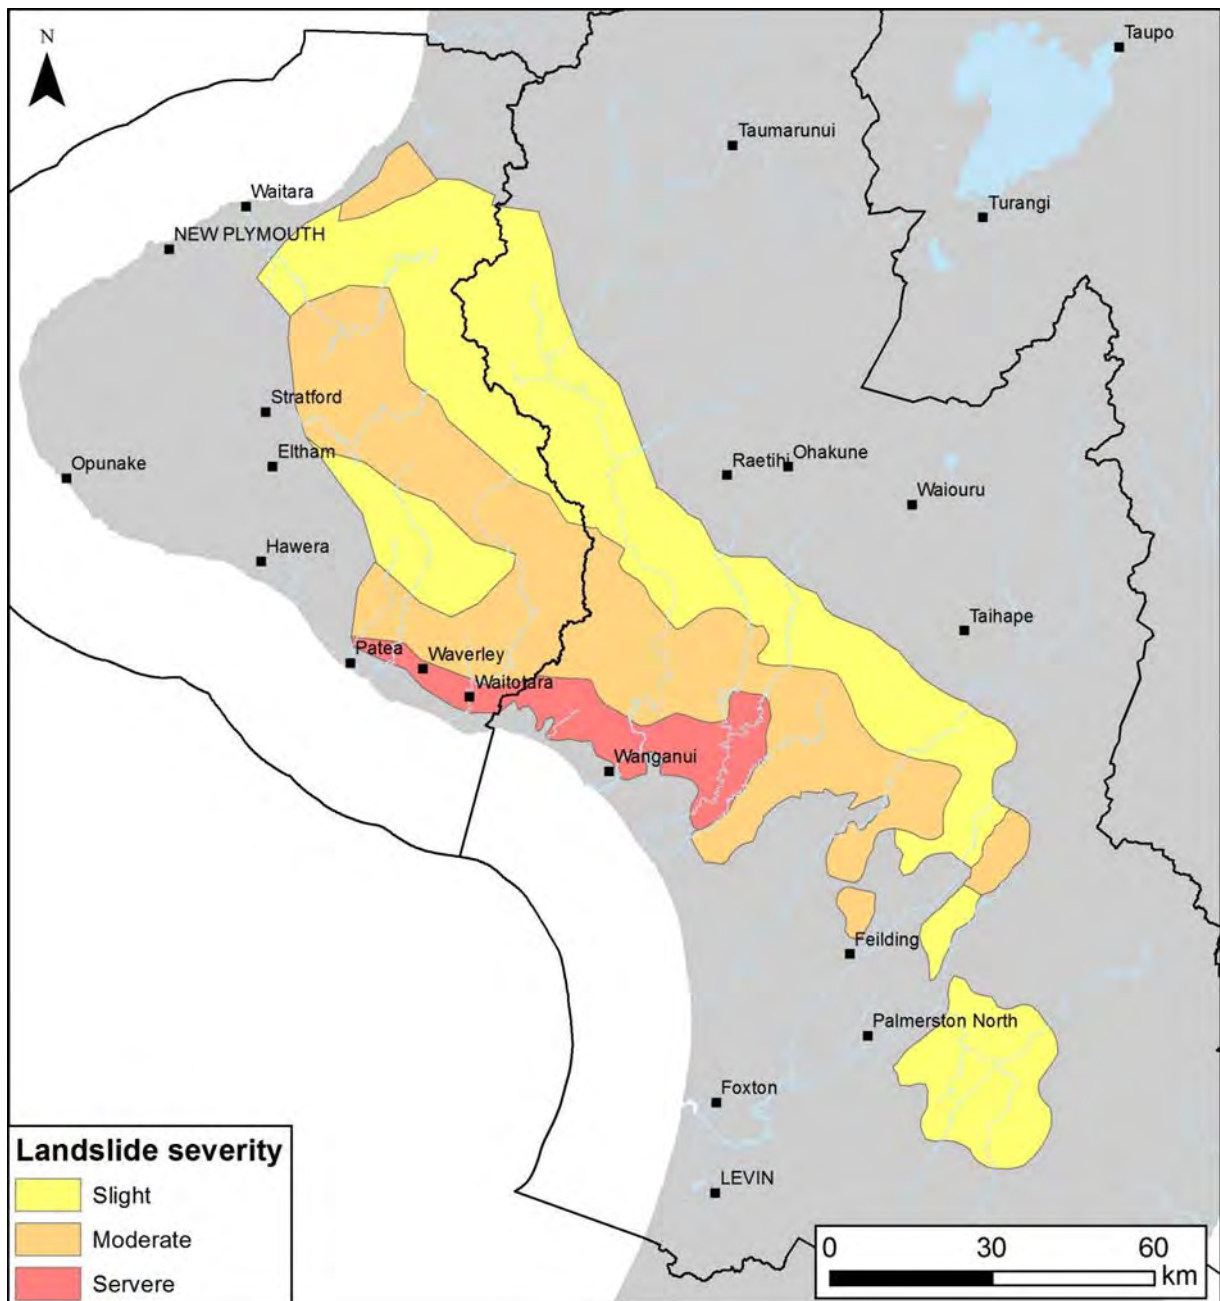
Landslide severity was classified into three classes: slight (<1% of hill slopes affected) (Figure 3 and Figure 4), moderate (1–10%) (Figure 5–Figure 8), or severe (>10%) (Figure 9 and Figure 10). Because of the limited value of the satellite imagery, the map showing approximate landslide extent and severity (Figure 11) was largely based on the reconnaissance flights, with spatial extrapolation using storm rainfall and terrain characteristics. Landsliding classified as slight occurred across ~4600 km<sup>2</sup> of hill country, moderate landsliding across 3600 km<sup>2</sup>, and severe across 700 km<sup>2</sup>. Figure 12 shows the landslide extent and severity in the February 2004 storm, which was the most severe storm on record in the region (Hancox and Wright 2005a). A comparison of the extent of landsliding in the 2015 and 2004 storms is presented in Section 4.0. The severity scales for the 2015 and the 2004 maps are different. The 2004 assessment has four severity classes with narrow % landsliding ranges (<5%), while the 2015 assessment has only three severity classes with broader landslide % ranges (10%). The 2004 severity assessment was based on a combination of oblique and vertical aerial photos, satellite imagery and ground checking, The 2015 severity assessment was only based on the oblique aerial photos, with very limited information added from the satellite imagery, and this only provided sufficient information for the broader classification.

**Figure 11** Map showing distribution of landslide severity in the June 2015 storm. Slight - <1% of hill slopes affected, Moderate - 1-10% of hill slopes affected, Severe - >10% of hill slopes affected.

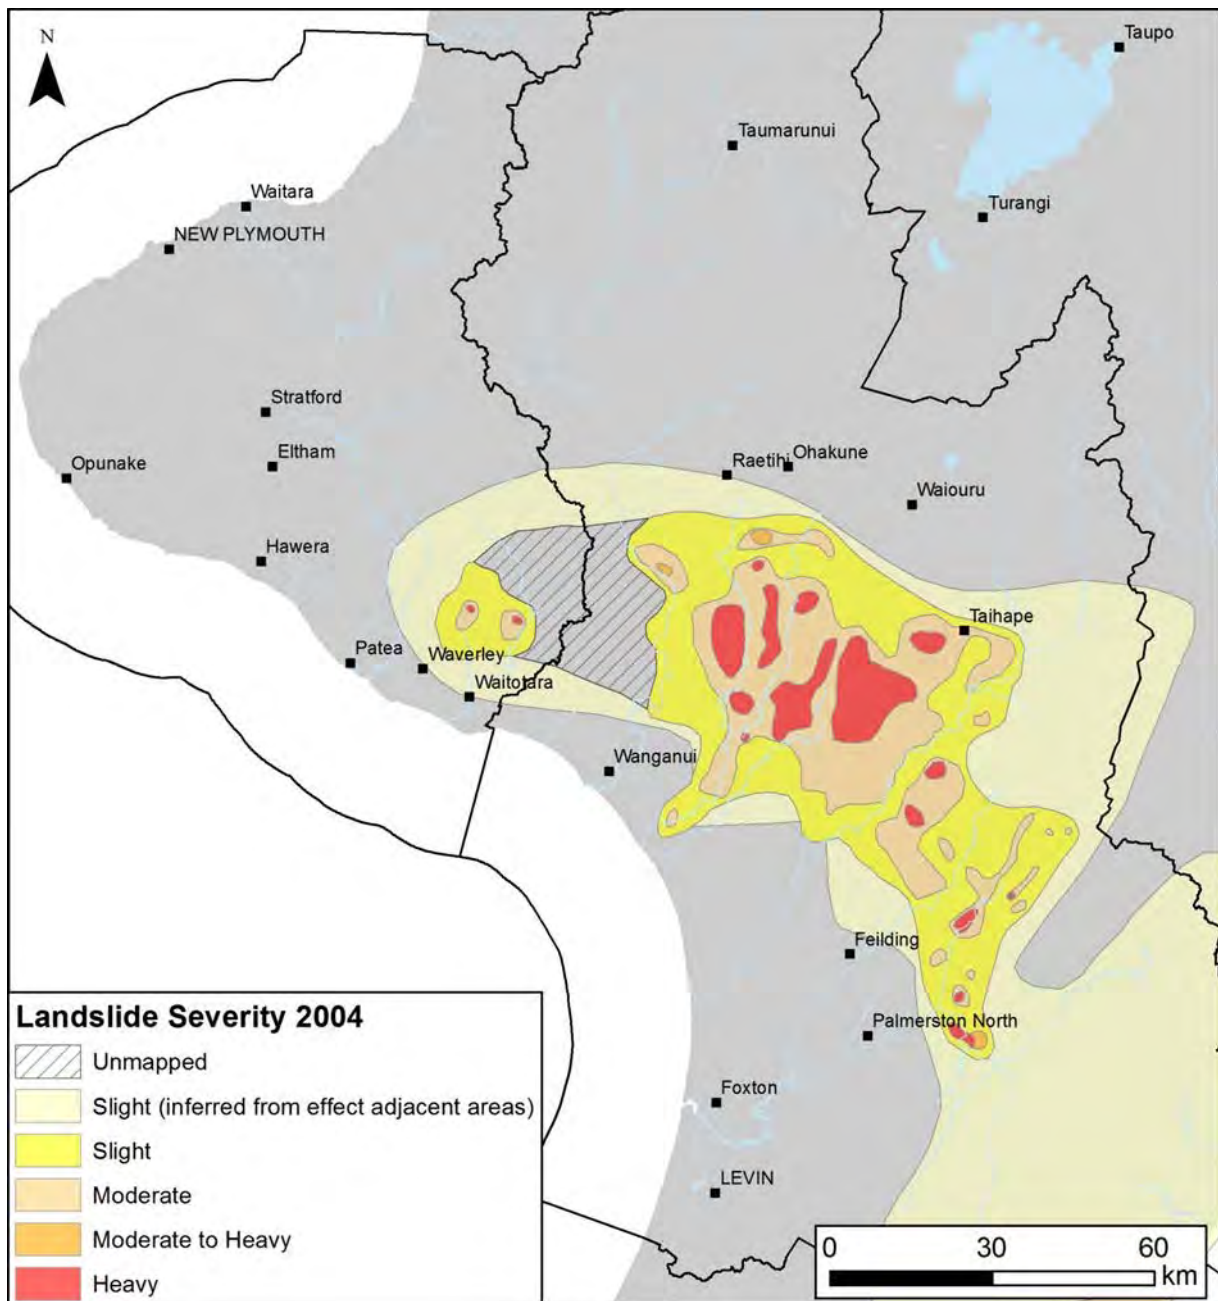
**Figure 12** Map showing distribution of landslide severity in the February 2004 storm (from Hancox and Wright 2005a). Slight - <1% landsliding per km<sup>2</sup>, Moderate - 1-2.5% landsliding per km<sup>2</sup>, Moderate to heavy - 2.5-5% landsliding per km<sup>2</sup>, Heavy - 5-10% (some areas 10-35%) landsliding per km<sup>2</sup>.

The 19–20 June 2015 storm was the largest to occur in the region since the February 2004 storm and floods. While on a regional scale the landsliding and flooding in 2015 was not as severe as in 2004, in some areas farmers have reported that the 2015 event was worse. This is to be expected as cells of high-intensity rain commonly occur within the broader rainfall pattern of such storms. Following the 2004 storm, two GNS Science Reports were published. The first report provides an initial assessment of the overall extent and location of landsliding, and illustrates the nature and types of landslides (Hancox and Wright 2005a). The second report contains a detailed analysis of factors that controlled the distribution of landslides, sediment delivery to streams, and landslide damage (Hancox and Wright 2005b). There are some broad similarities in the distribution of landsliding in 2015 and 2004 (Figure 11 and Figure 12). The main differences are that the 2015 event extended north from the Waitotara catchment to affect the eastern Taranaki hill country as far north as Waitara/Urenui, and in the south extended only as far as Woodville and Levin. In 2004 slight to moderate landsliding also occurred in the Wairarapa and Wellington regions. In the 2015 storm the most severe landsliding in the Horizons Regional Council area was nearer the coast, and occurred on the dissected terrace-lands and extended up to 40-45 km inland on Tertiary hill country between Waitotara and Feilding. In 2004 the same catchments were affected, but the most severe landsliding was further inland, in an area between 30 and 70 km from the coast. Overall landsliding occurred over an area of 8,900 km<sup>2</sup> in 2015, compared with 16,000 km<sup>2</sup> in 2004.

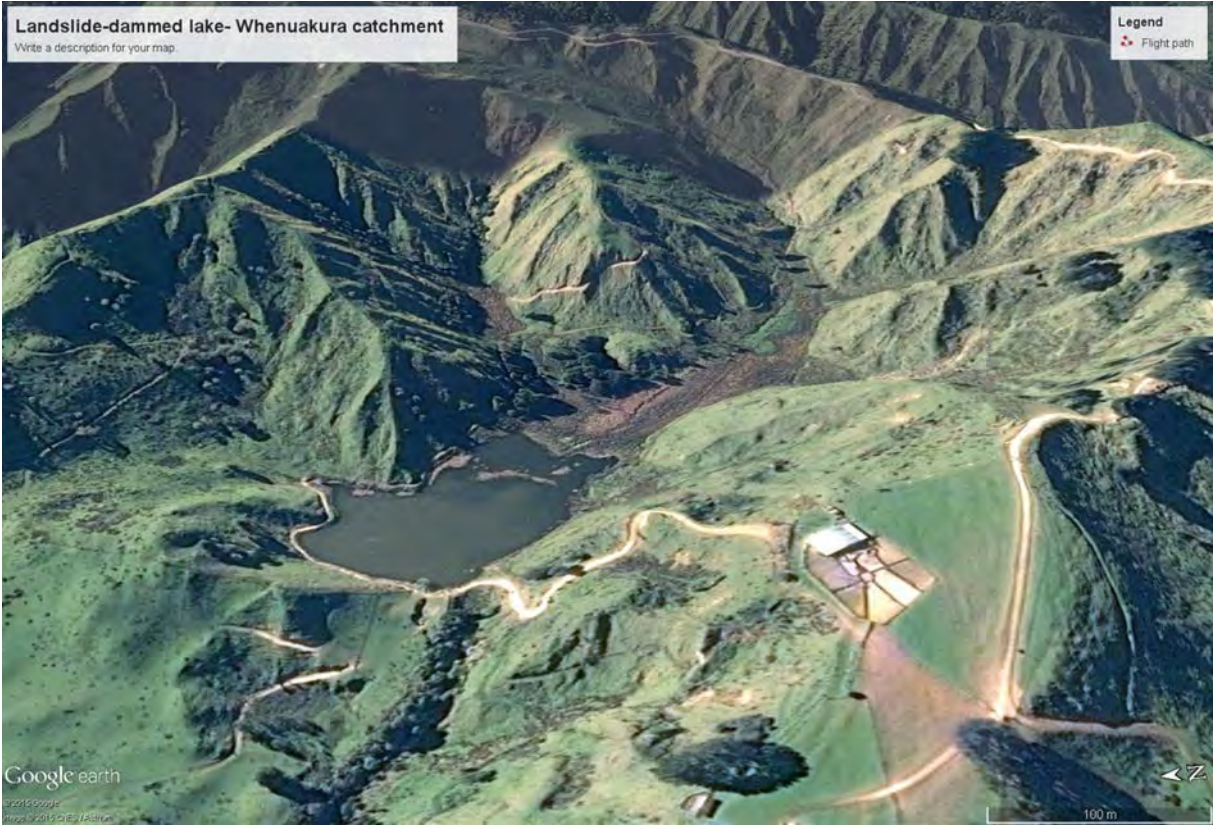
The outlet of a 2.1 ha lake in a small catchment between the Kaikanui and Hetore Streams on the Whenuakura River also eroded during the storm, leading to complete drainage of the lake (Figure 58). In this case Google Earth images show an access track existed across the outlet since at least April 2001 (Figure 59). The small size of the catchment together with the relatively wide valley floor at the head of the lake indicate an abundant supply of sediment, and suggest that the sediments exposed in the lake bed may contain a storm history record.

**Figure 59** Google Earth image (September 2013) showing lake, outlet and access track prior to failure.

These are the only observed instances of pre-existing landslide-dammed lakes being affected by erosion of the landslide debris that led to their formation, and there are numerous such lakes in the south-eastern Taranaki hill country. Further, none were affected by the 2004 storm. In the case of Lake Mangawhio, it may be that the upgrade of the road and establishment of the culvert were instrumental in the erosion of the outlet channel and drop in lake level during the June 2015 storm. Similarly, for the small lake in the Whenuakura catchment, it would appear that culverting of the outlet under the access track around the lake may have been instrumental in the erosion of the outlet channel and subsequent draining of the lake.
