Origin Energy NZ Ltd

Rimu Pipeline Leak, October 2010: Cause, Remediation and Learning Points

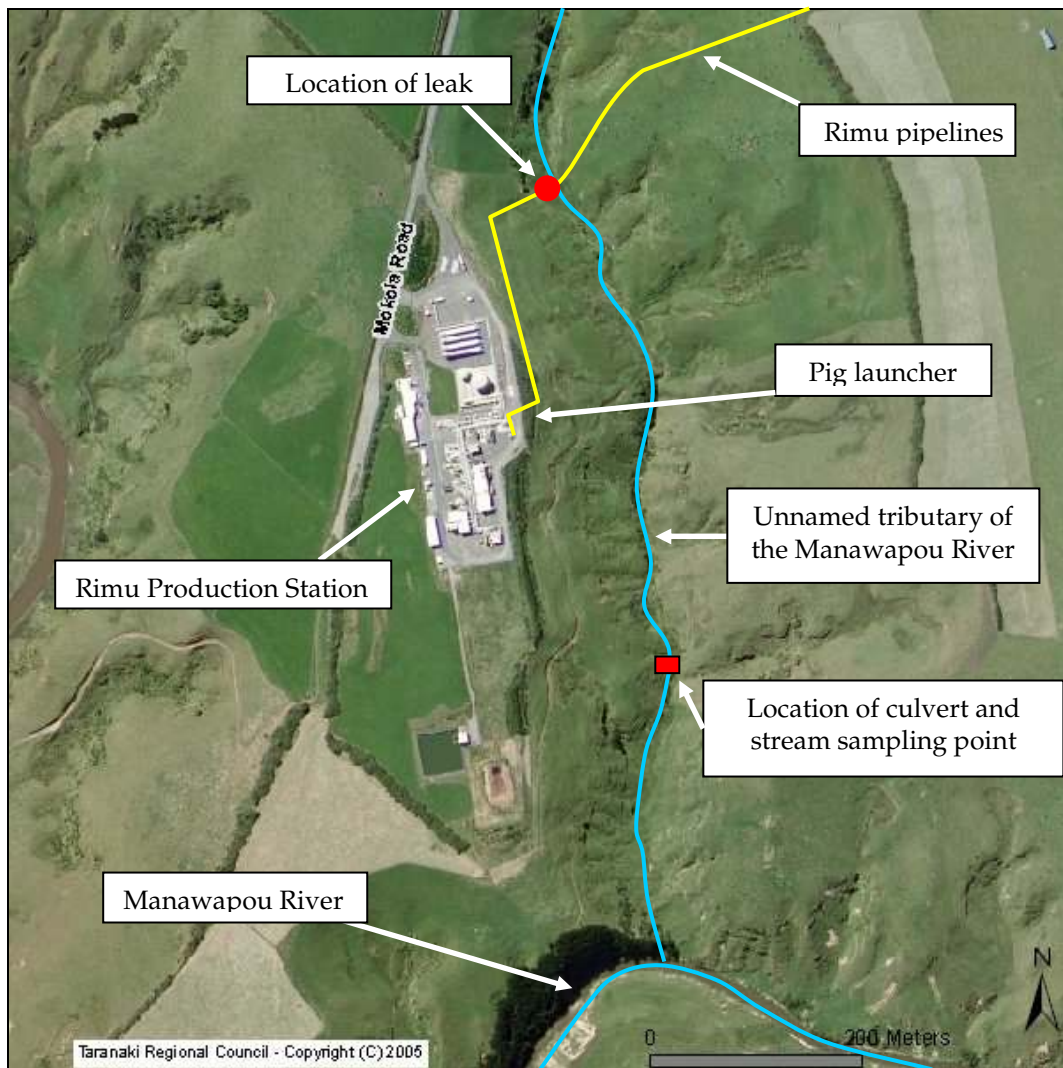
Figure 1 Rimu A pipeline and leak location

- 1.1 In October 2010 an estimated 200-500 litres of well stream fluid, namely produced oil and water, was found to have leaked into an unnamed tributary of the Manawapou River, with a visibly affected area reaching 80 m downstream from the discharge point. The spill was noticed by a local farmer.
- 1.2 The unauthorised discharge was sourced to a 100 mm (4 inch diameter) NB pipeline operated by Origin Energy Resources New Zealand (OENZ) connecting the Rimu A wellsite to the Rimu Production Station (RPS).

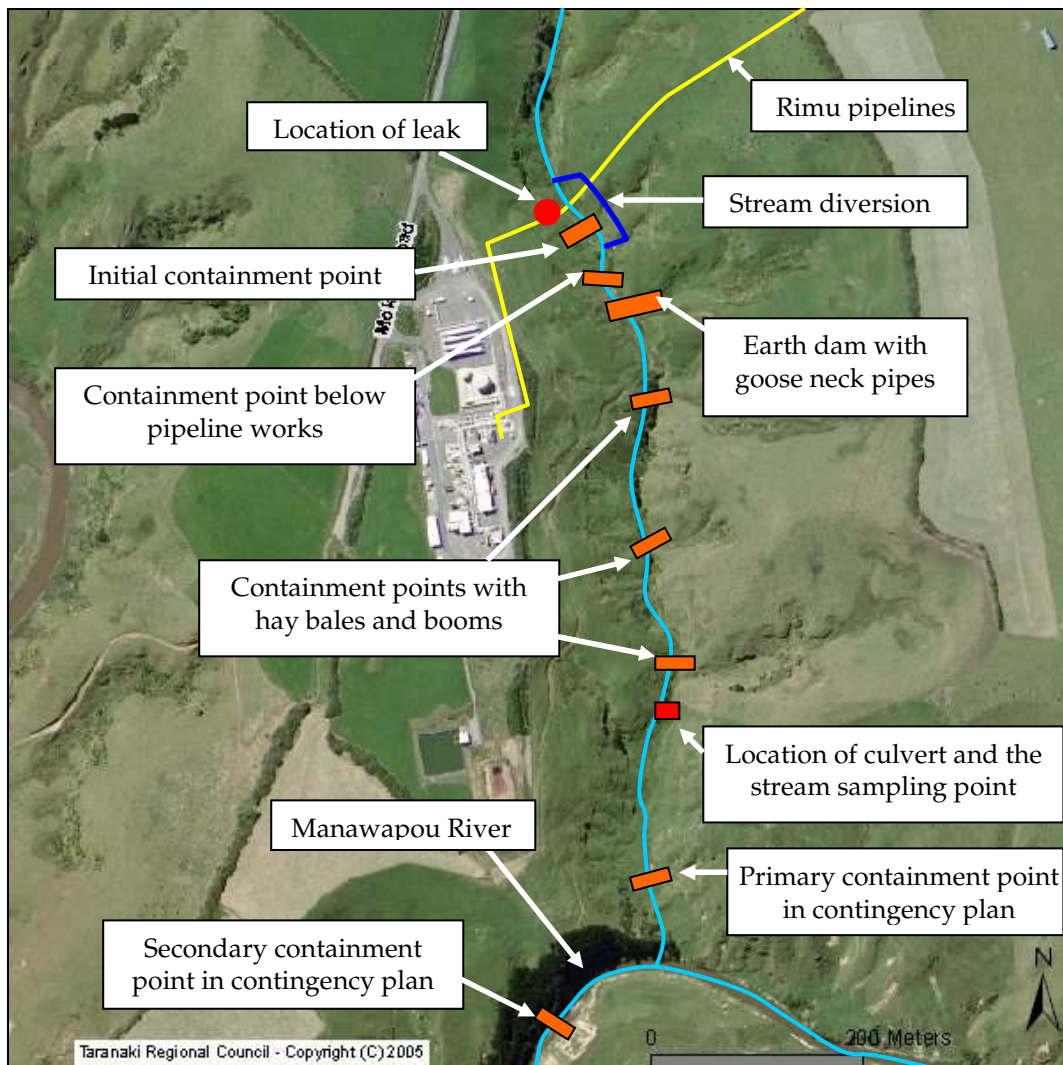
Figure 2 Rimu A pipeline leak response and contingency plan details

3.38 A number of containment points were established below the discharge point with the primary containment point being at the culvert about 400 m below the discharge point (Figure 2). Photographs were taken.

3.39 Observations and photographs show that floating hydrocarbons, caused by the disturbance of the streambed during recovery of the crude oil, were being contained in the absorbent booms placed in front of the hay bales. This provides evidence that this method of containment was effective.

3.97 small amount of silt had gone from the ring drain to the tributary, only as far down as the earth dam (Figure 2).

- 4.1. Following primary containment on 8th October 2010, which involved placing hay bales and absorbent booms at various places in the stream, OENZ set about cleaning up the stream (Figure 2). Through crews armed with shovels and rakes cleaning all obvious deposits of waxy oil from the stream environment occurred for about two weeks. The oil was contained in bags and stored in a containment facilities onsite (Photographs 7 and 8).
