STDC Coastal Structures

Monitoring Programme

Biennial Report

Technical Report 2023-37

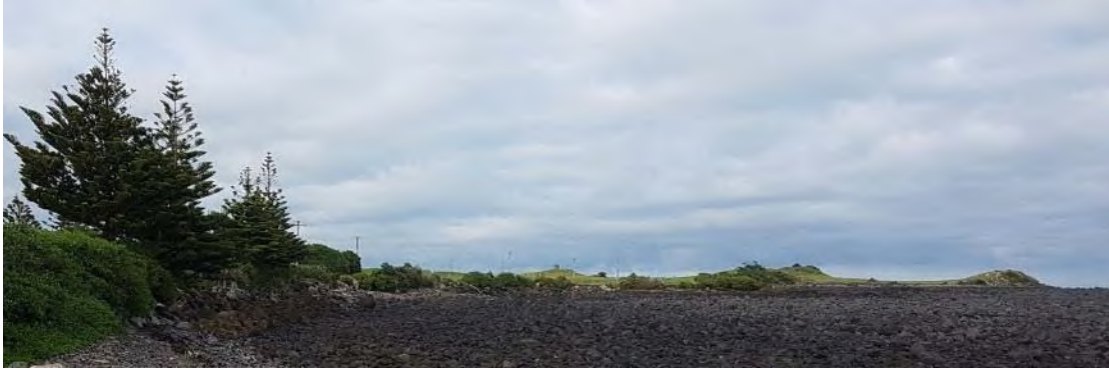
As a result of the works, the boulder protection now extends from the boat ramp in the north to the pre-existing 40 m of boulder protection south of Bayly Road, with a total length of approximately 290 m (Photo 1).

Photo 1 Bayly Road seawall (April 2017)

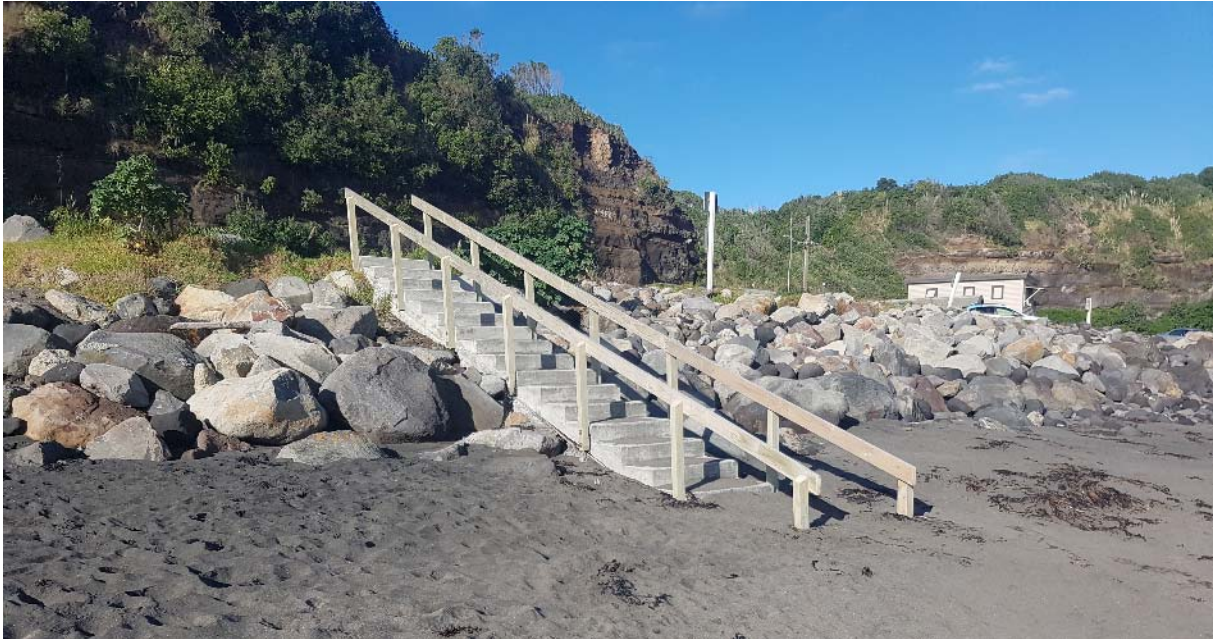
Photo 2 Middleton Bay seawall and staircase (9 June 2021)

Coastal permit 5504 was renewed in August 2019. The renewal process authorised additional rock to be placed at the northern end of the structure as well as the installation of a new concrete staircase for beach access (Photo 2).

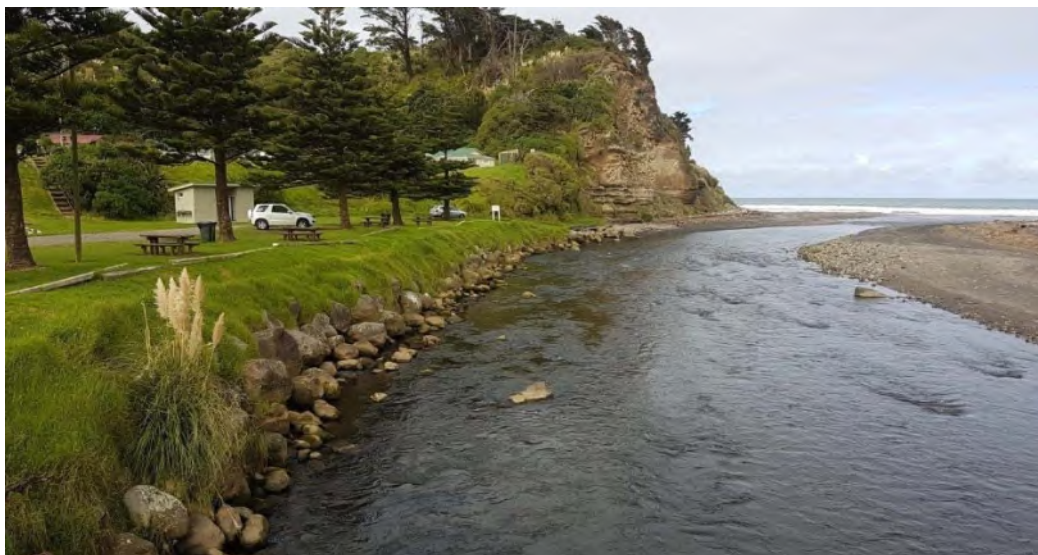
Following receipt of a complaint regarding works in the Kaupokonui Stream in 2002, investigation by Council officers discovered that substantial boulder rock rip rap had been placed on the true left bank of the Kaupokonui Stream (Photo 3).

Photo 3 Looking downstream along rock protection works in the Kaupokonui Stream (April 2017)

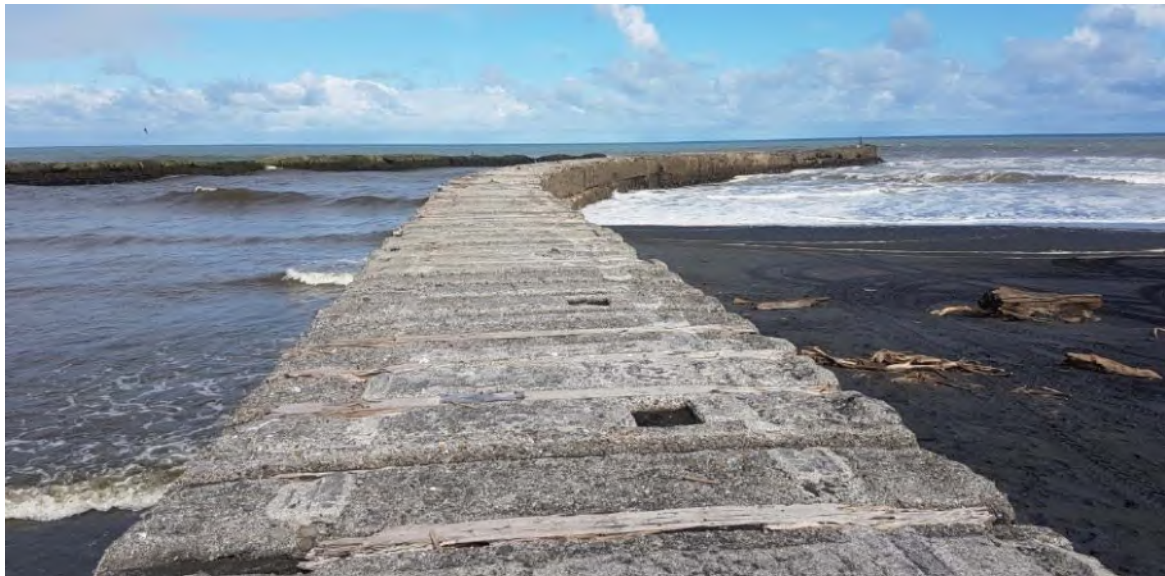
Photo 4 Pātea groynes (April 2017)

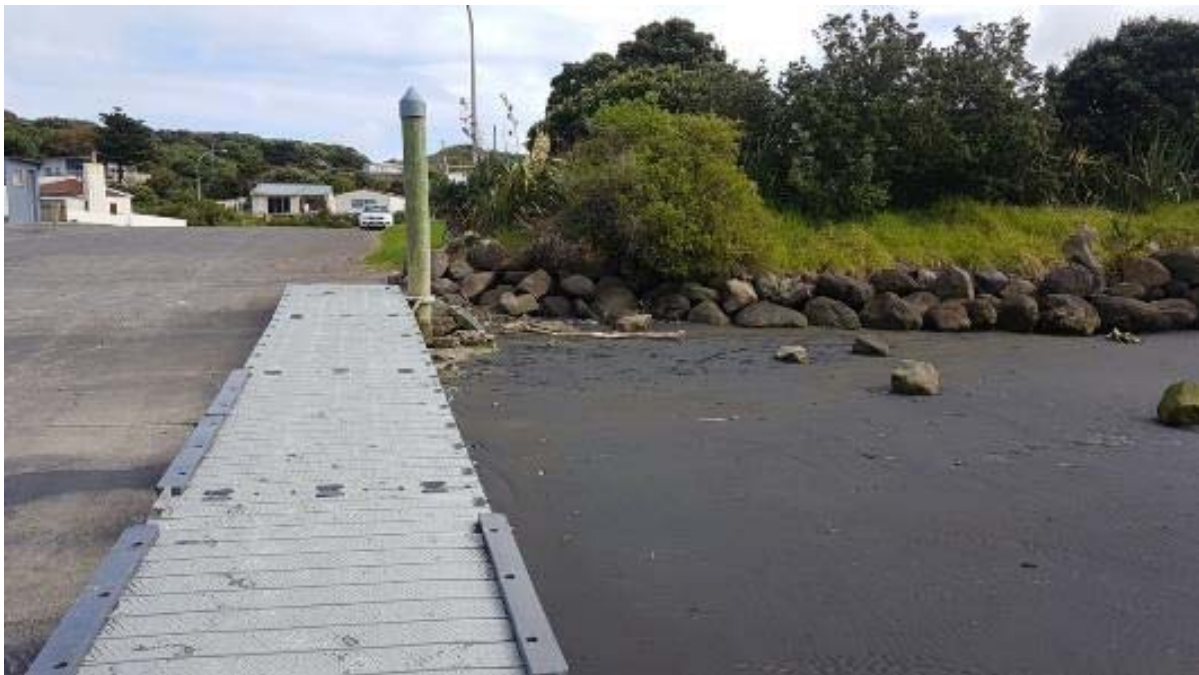
Photo 5 Pātea boat ramp (April 2017)

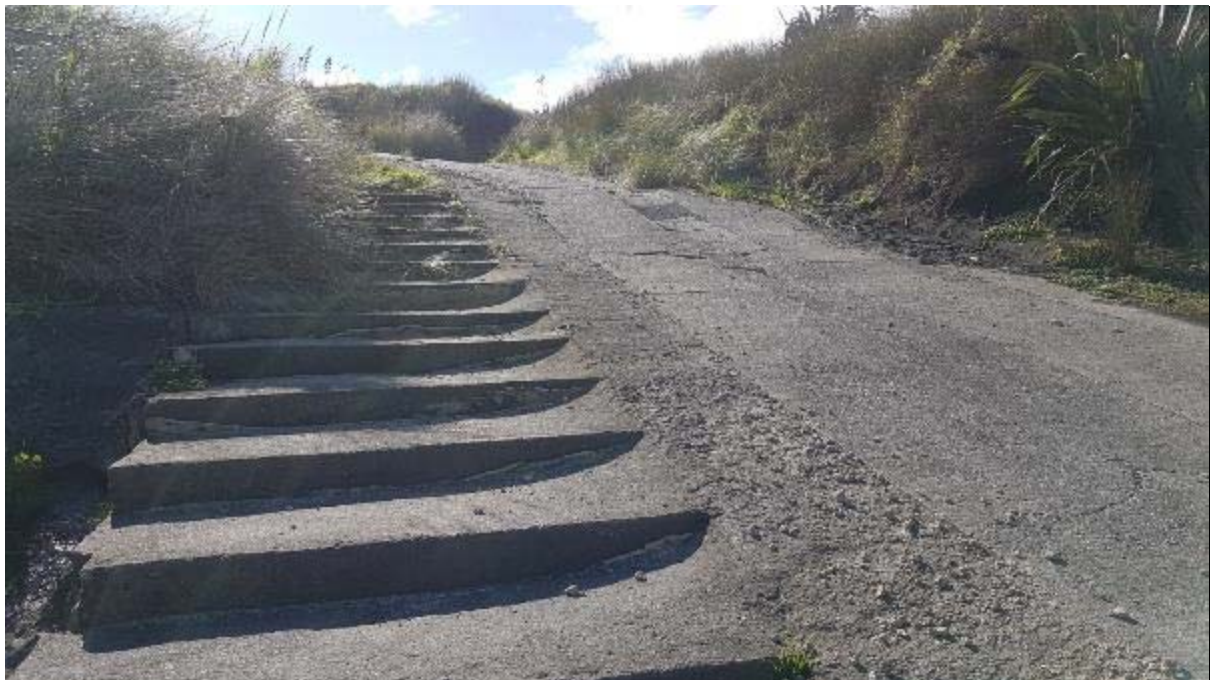
Photo 6 Access to Caves Beach (April 2017)
