Remediation New Zealand Ltd

Uruti composting facility

Monitoring Programme

2021-2022

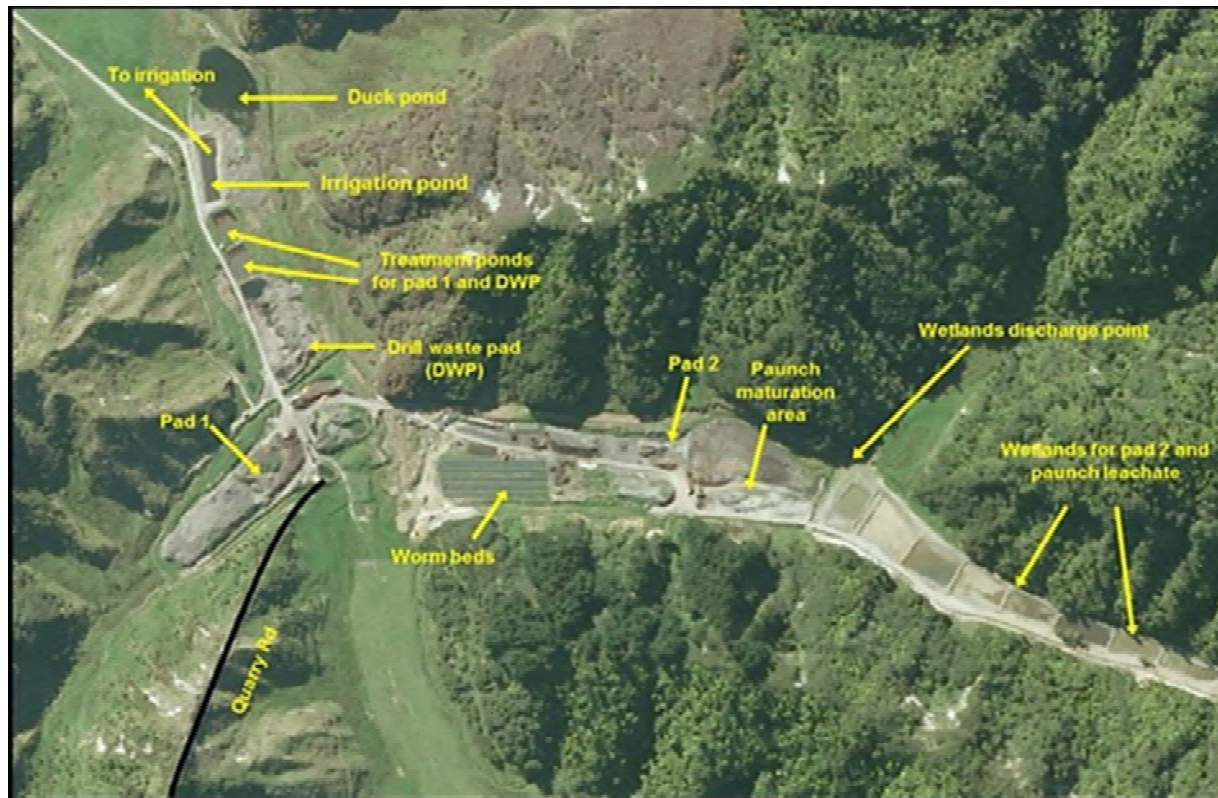
Figure 2 Site map of operational areas RNZ Uruti

The composting operation at the Uruti site generates a significant amount of leachate and contaminated stormwater from three main processing areas. These are the greenwaste composting pad (Pad 1), the paunch pad (pad 2) and the drilling wastes pad (pad 3).

Pad 3 holds drilling muds, fluids and cuttings which have been mixed with sawdust and/or other organic material such as poultry waste. This very large pile was turned initially to stimulate the composting process in the initial phase. The Company noted that it had been unable to find a market for the drilling wastes, due to perception, but in any case Council and RNZ monitoring during the year under review has found it to contain toxic contaminants at concentrations that make it unsuitable for uncontrolled distribution. Some of this material has been moved elsewhere on the site.

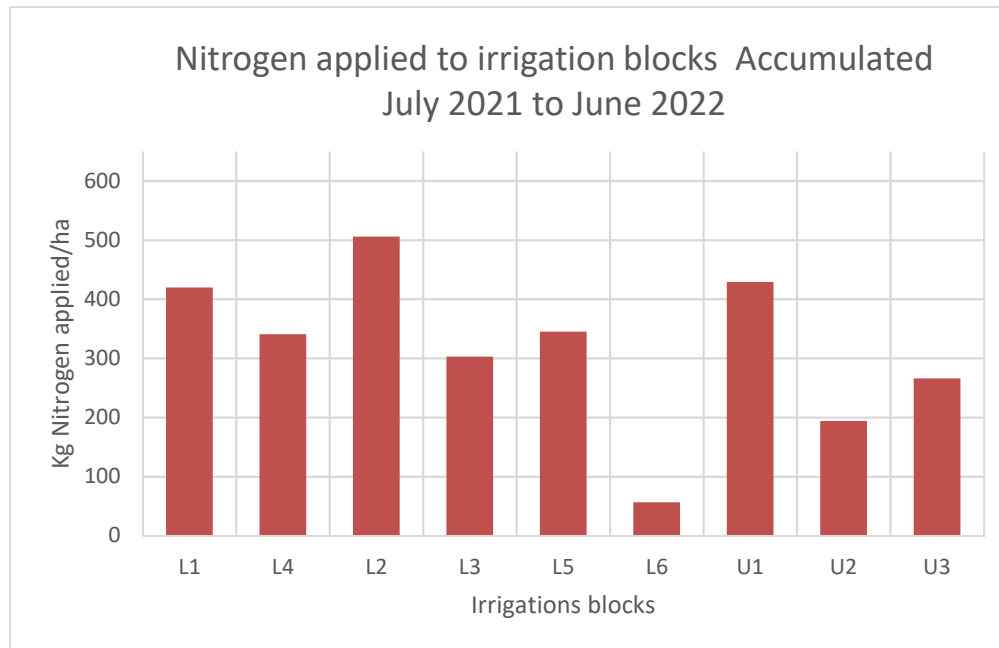
Figure 17 Annual nitrogen loadings to irrigation areas (as supplied by RNZ. See text). Prospective consent limit 400 kg/ha/yr

Table 32 below sets out a summary of monthly pumping and loading data provided by RNZ. Of significance, pumping was highest (as measured by hours of pumping and volume pumped) in winter 2021 and autumn 2022. This is at variance to accepted farm irrigation management, which promotes wastewater storage over winter and targets spring and summer for maximum irrigation discharge volumes and nitrogen loadings, which is when pasture is most able to take up nitrogen as new growth. This suggest that RNZ is using irrigation as a means to avoid the irrigation wastewater pond from overflowing, rather than as a means of providing effective nitrogen capture and utilisation.

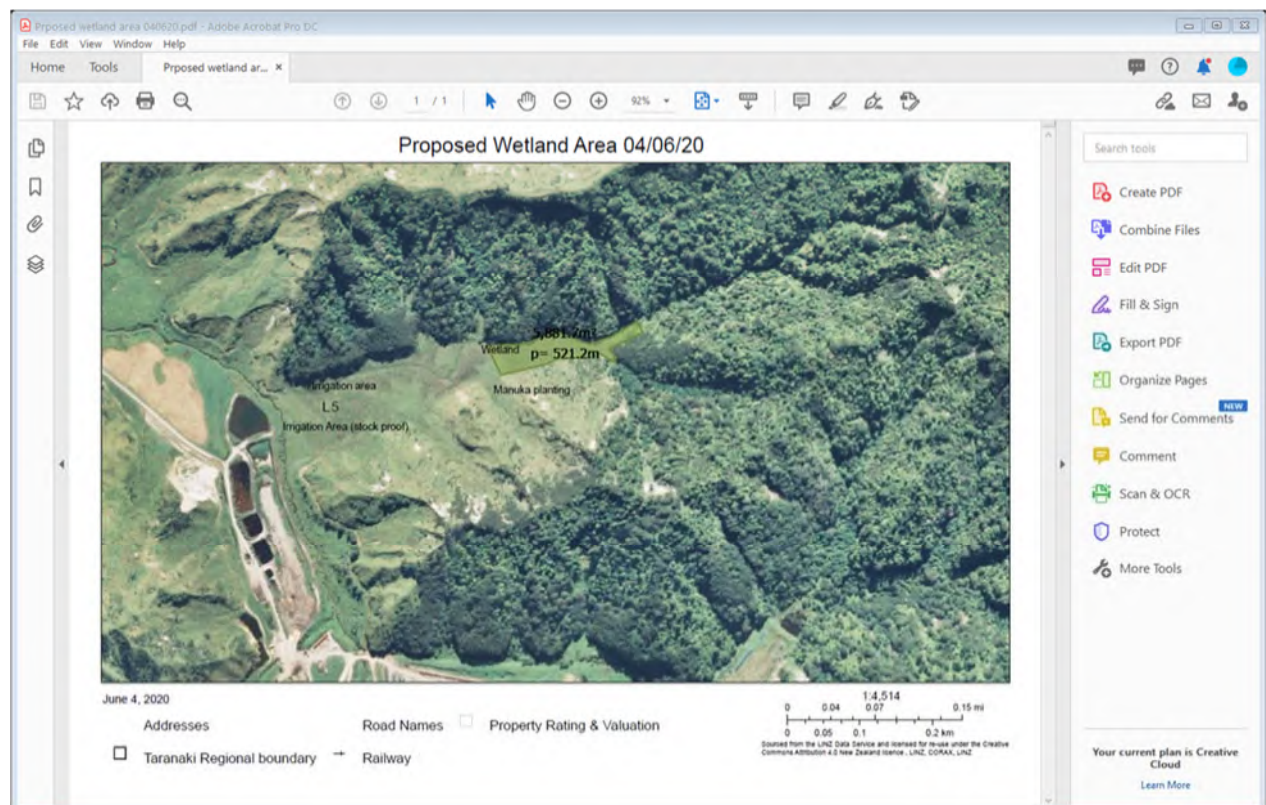
Diagram 1-Site of proposed wetland

The location of the proposed wetland is upstream of the L5 irrigation area. The wetland will have an approximate area of 0.588ha.

Regenerative native bush is to the north and east of the proposed wetland. It is proposed to plant manuka on the southern hillside. To the western side of the proposed wetland is irrigation area L5.

The proposed wetland area has been grazed in the past and has little or no swamp vegetation. There is *Juncus* sp. growing in the wetland area.
