**Dow Final Preliminary Site Investigation Review**

- Preliminary Site Investigation, Paritūtū, New Plymouth prepared for Dow Chemical (NZ) Limited by Tonkin & Taylor Limited (T+T); Final Version 007 dated 11 July 2024 (the final PSI report).

0021795.0200 v007

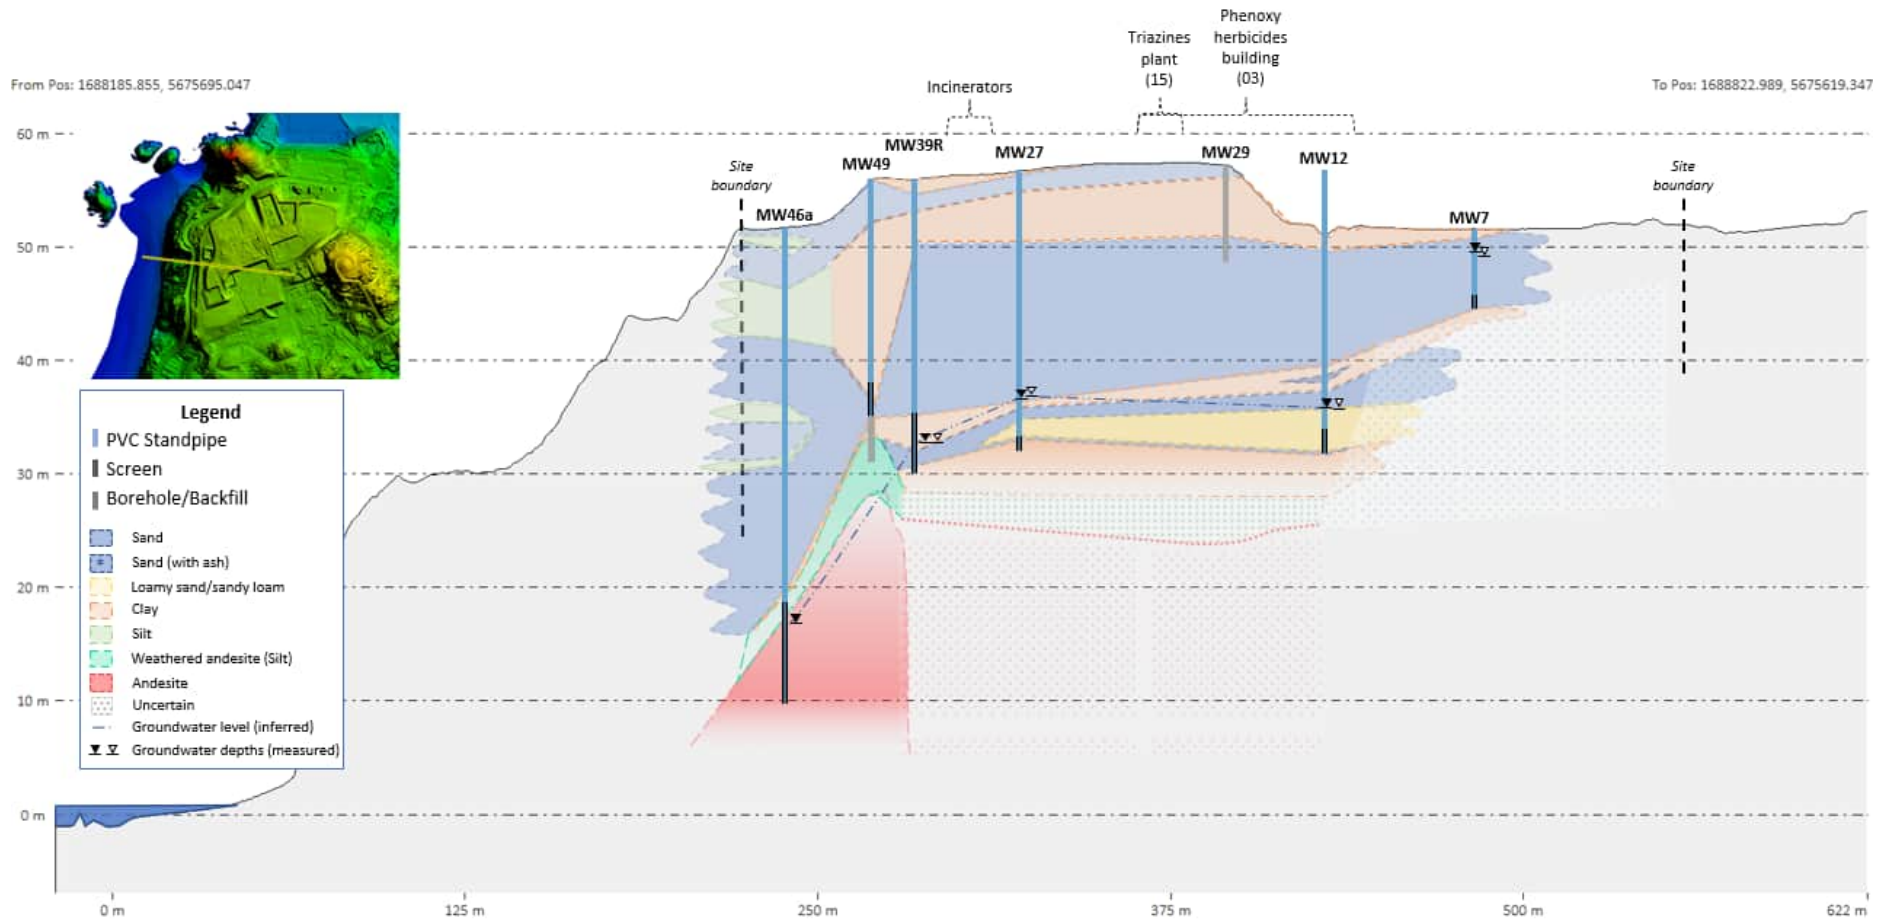
Figure 6.1: West to east hydrogeological cross-section of the Dow Paritutu site. Where groundwater depths are not displayed on the figure, groundwater was not encountered within the monitoring wells during the 2022 monitoring round. Note: open triangles indicate where water was noted during drilling and solid triangles are stabilised water levels.

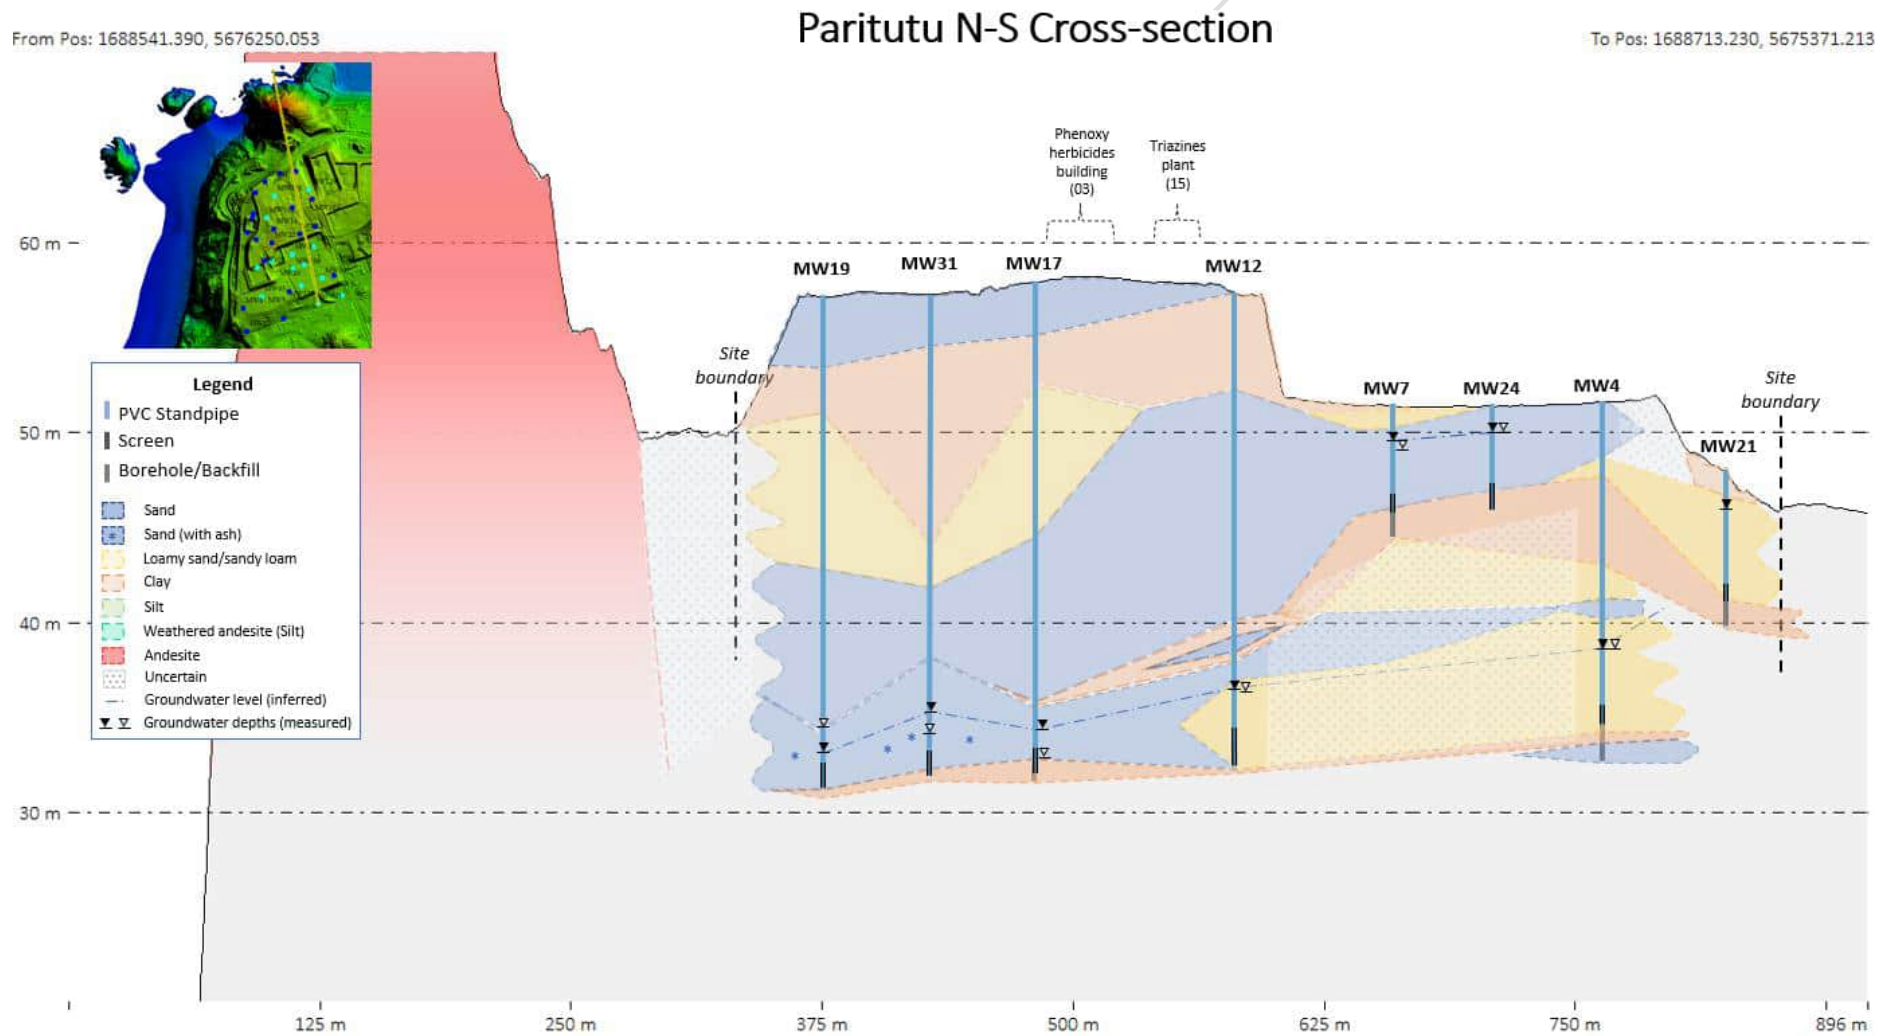
Figure 6.2: North to south hydrogeological cross-section of the Dow Paritutu site. Where groundwater depths are not displayed on the figure, groundwater was not encountered within the monitoring wells during the 2022 monitoring round. Note: open triangles indicate where water was noted during drilling and solid triangles are stabilised water levels.

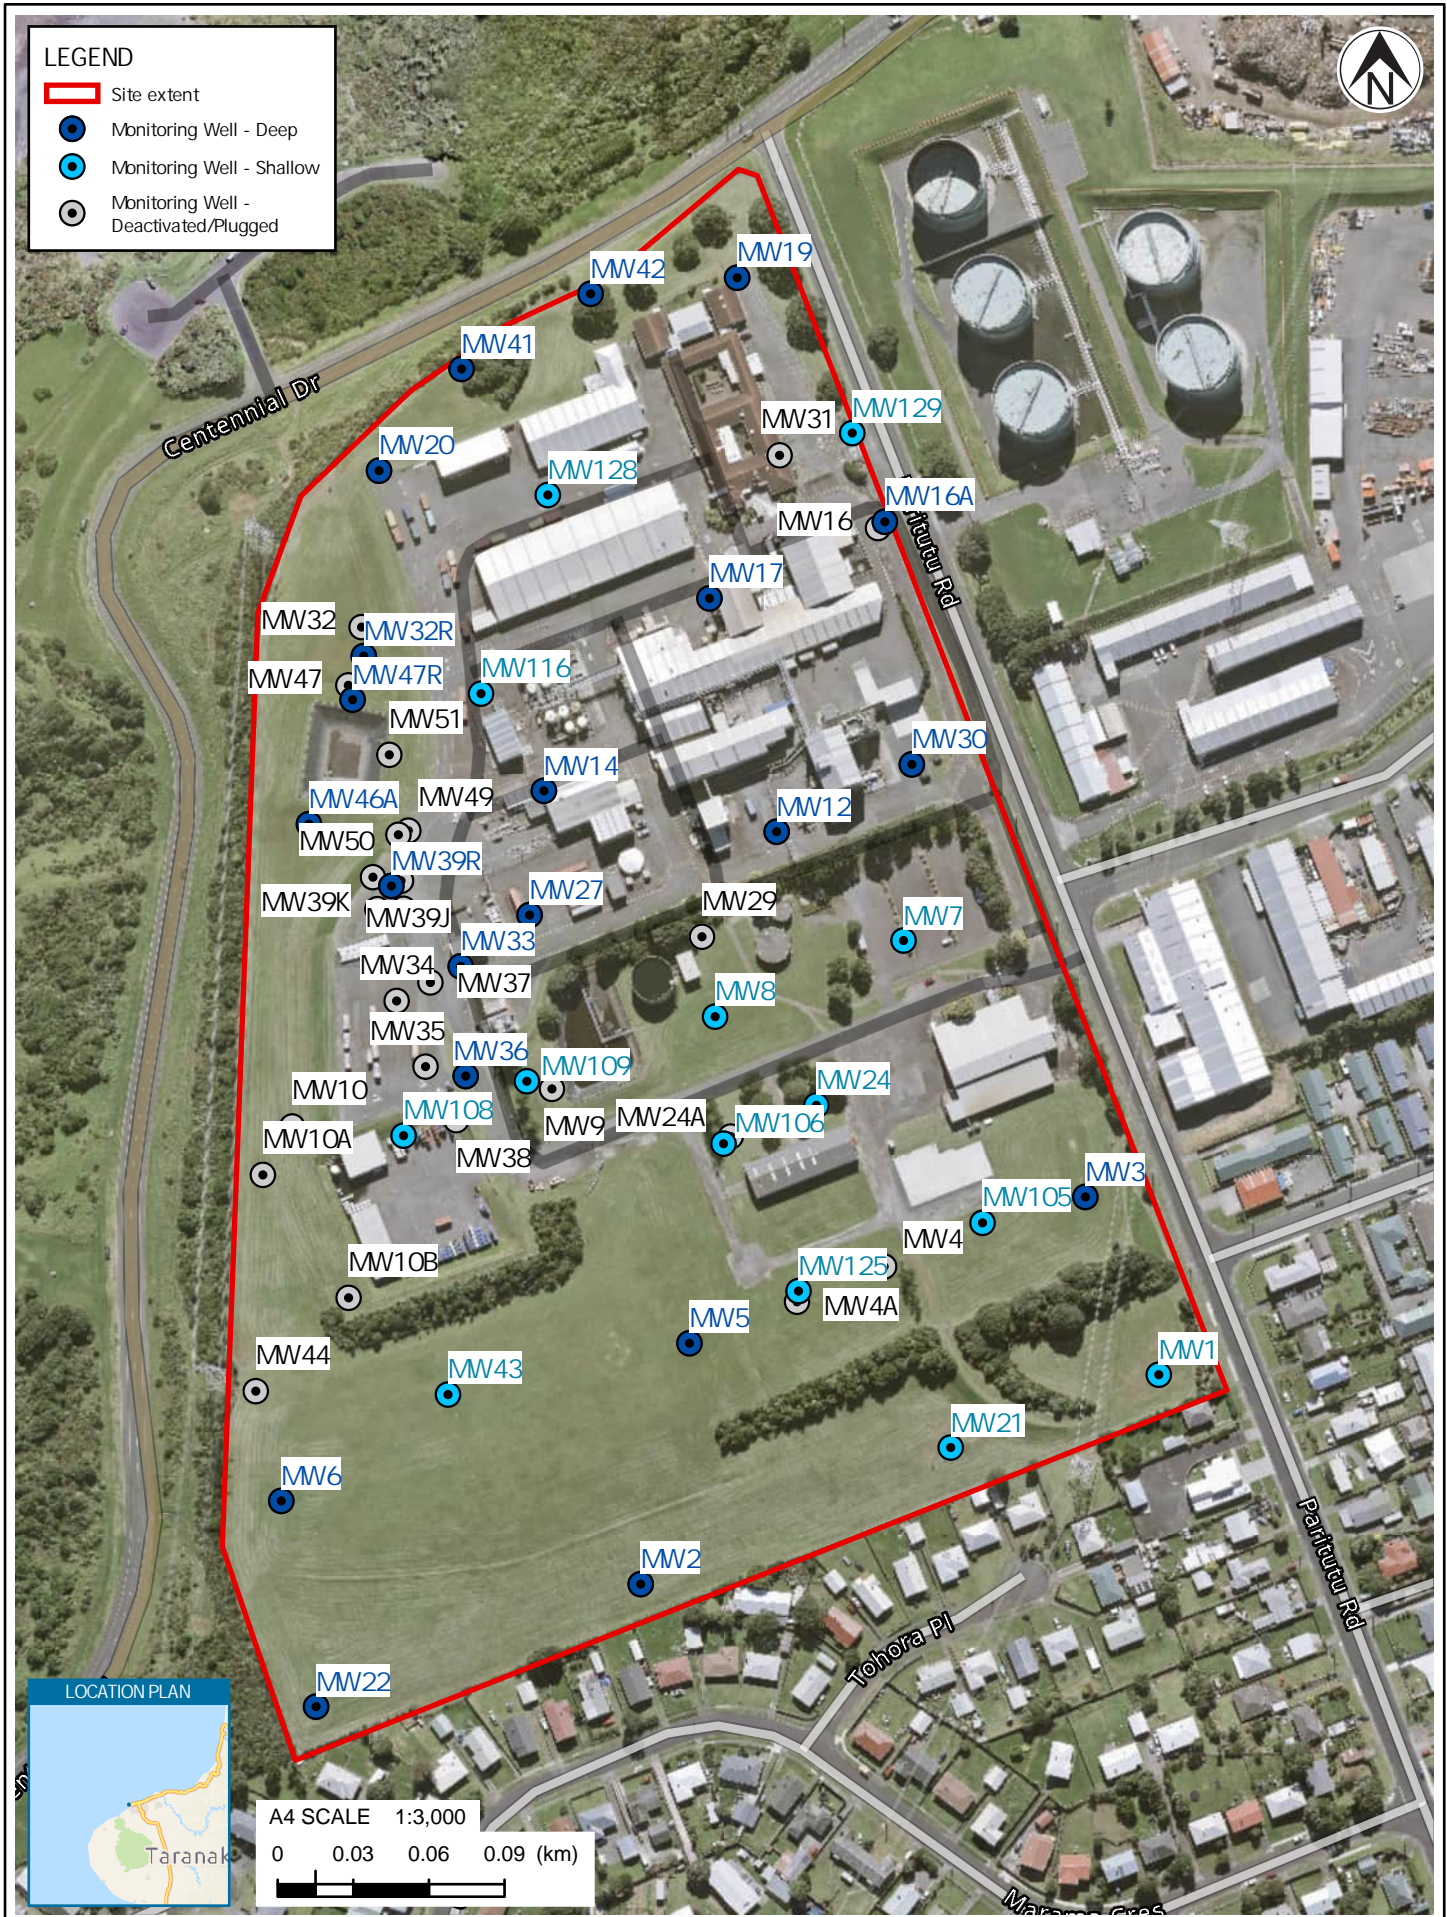
CLIENT	<b>DOW CHEMICAL (NEW ZEALAND) LTD</b>	
PROJECT	<b>PARITUTU ROAD, NEW PLYMOUTH</b>	
TITLE	<b>SITE AND MONITORING WELL LOCATION PLAN</b>	
SCALE (A4)	1:3,000	FIG No. FIGURE 8.
		REV 0

<b>Record 4 (2014)</b>	Possible waste disposal and/or historic infilling impacting groundwater.	Phenoxies, chlorophenols.	Contaminant concentrations recorded within select monitoring wells (including MW36, MW37, MW39J, MW46, MW46a) between 2002 and 2007 (see <b>Figure 8, Appendix A</b> ).
<b>Record 6 (2015)</b>	Possible waste disposal and/or historic infilling impacting soil.	Phenoxies, Chlorophenols.	Contaminants identified within soil at MW109 and MW39R, including at depths up to 6.9 m bgl (see <b>Figure 8, Appendix A</b> ). Surficial contamination not recorded at MW39R; however, surficial contamination was recorded in the 1995 investigation (Record 4). MW39R (2015) is located less the two meters from MW39J (1995). Additionally, odours and elevated PID readings were noted during borehole excavation of MW39R.
<b>Record 6 (2015)</b>	Waste disposal and/or historic infilling impacting groundwater (deep).	Phenoxies and chlorophenols (including 2,4-DB; 2,4,5-TP; PCOC).	Contaminant concentrations recorded at MW39R. Concentrations of select analytes exceeded applicable guidelines (see <b>Figure 8, Appendix A</b> ).
