NPDC Colson Road Landfill  
Monitoring Programme  
Annual Report  
2018-2019

Technical Report 2019-45

Taranaki Regional Council  
Private Bag 713  
STRATFORD  
February 2020

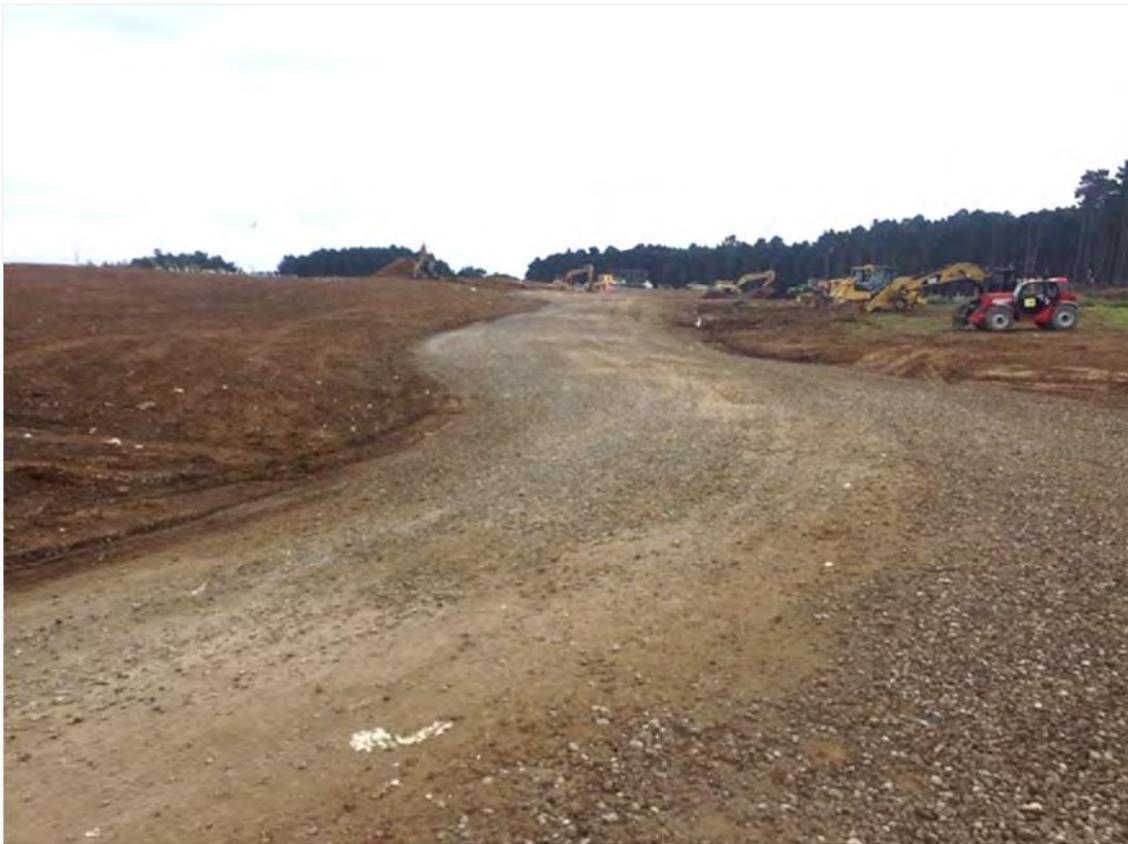
Photo 7 Temporary access road to tipping area and intermediate cover, May 2019

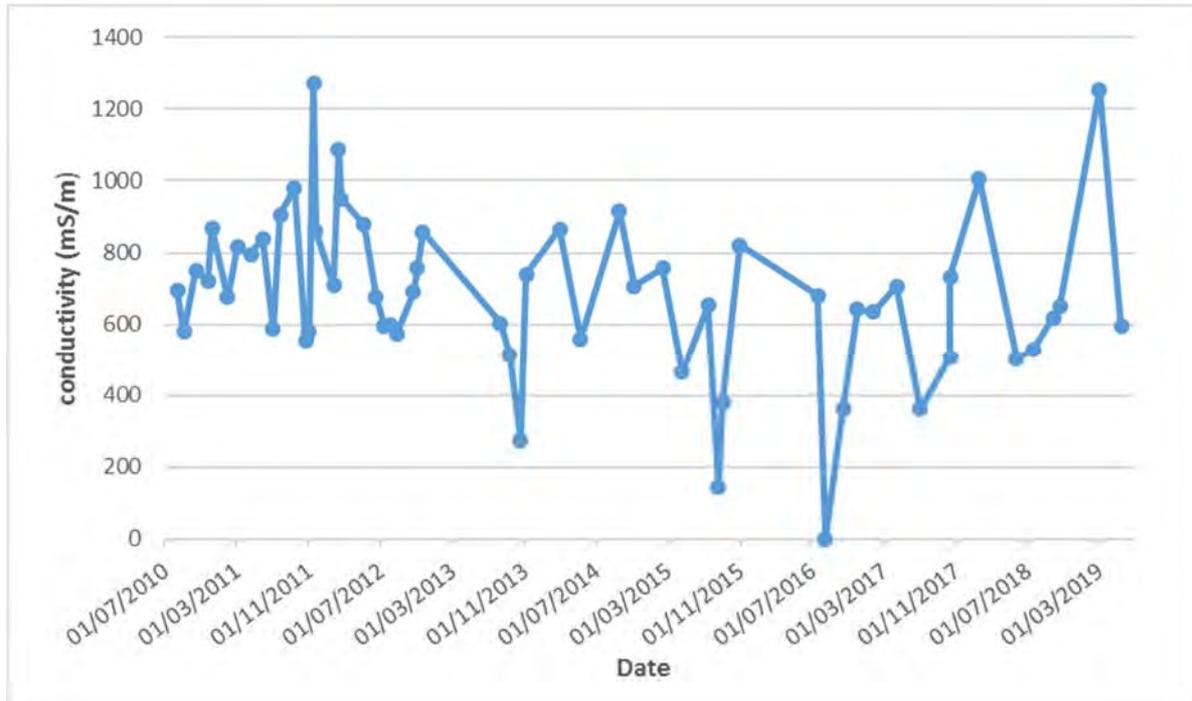
The results gathered by NPDC during the year under review reflect typical leachate quality. There are no obvious trends in the indicator leachate constituents measured emerging at this stage (for example, the

concentration variations within each parameter are likely to reflect seasonal variations in leachate quality and the dilution afforded by the contaminated stormwater that is diverted through this system.

Figure 6 Leachate conductivity July 2010 to date

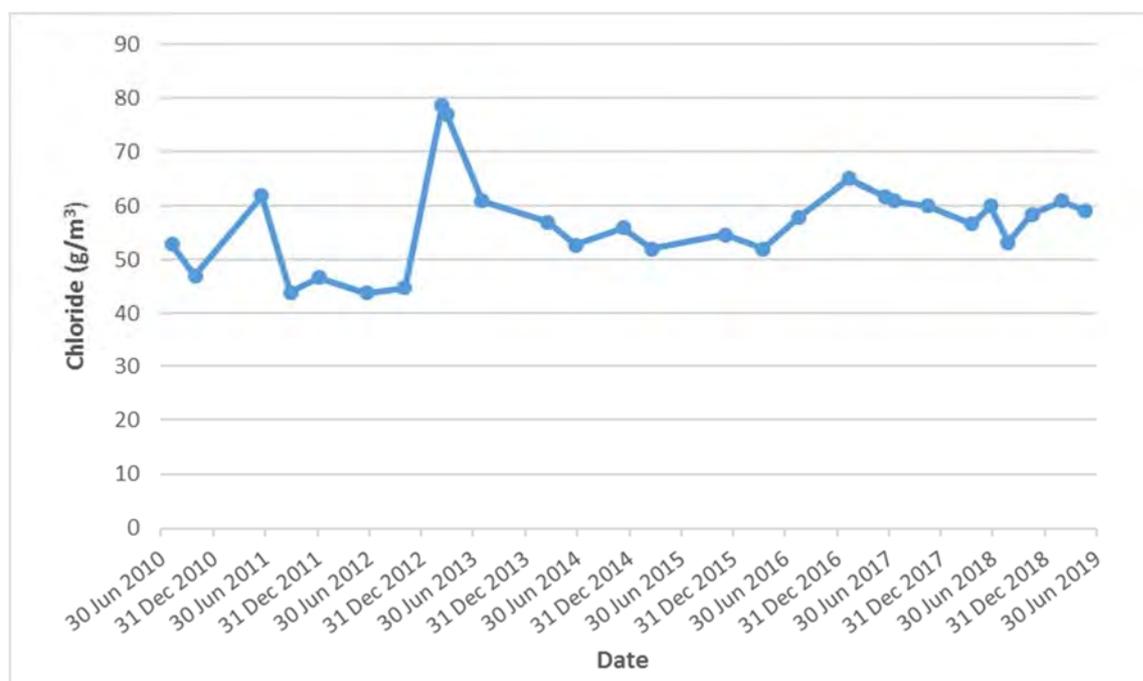
Historically, drainage analysis has shown that little, if any, contamination has been occurring in the groundwater immediately below the liner. Although the level of key indicator species such as zinc and chloride (Figure 7) are relatively stable over the last several years there may be an emerging trend of very slight increasing contaminants. In particular, the results for the 2017-2019 years indicate that some contaminant concentrations such as ammoniacal nitrogen have increased more noticeably (Figure 8).

Figure 7 Chloride concentration in the under liner drainage

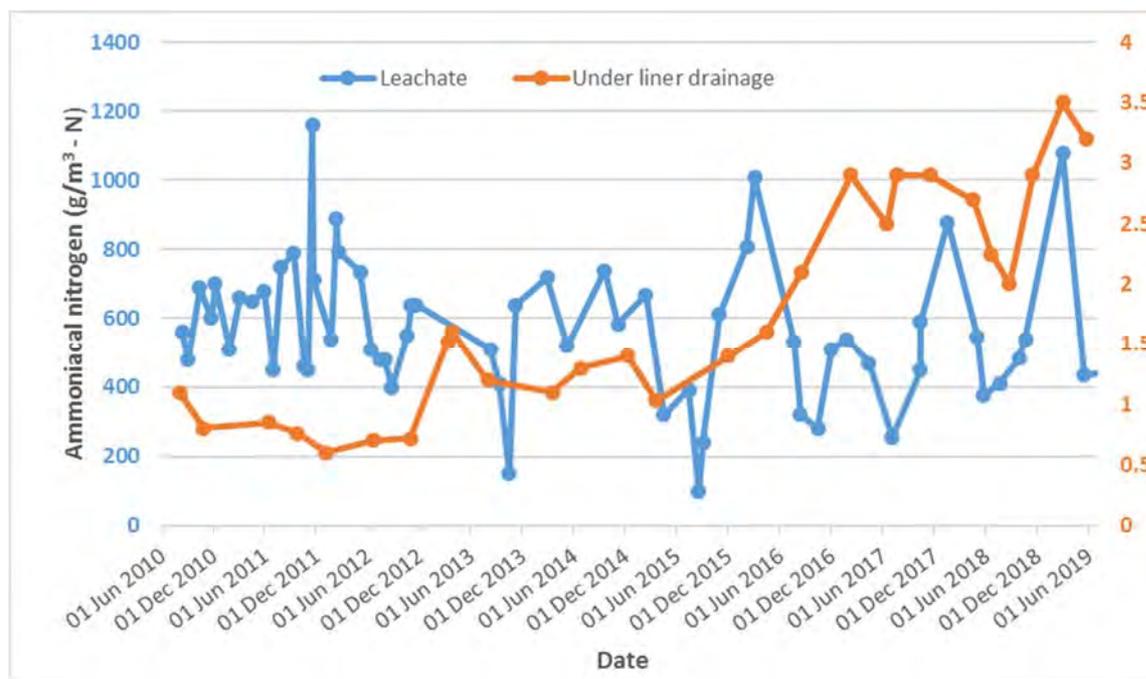
Although these indicator constituents show very slight contamination of the groundwater and or springs under the landfill, the levels are not currently of immediate environmental concern as they remain within normal ranges for Taranaki groundwater. They are however comparatively higher than any of the monitoring bores surrounding the landfill. At this stage it is difficult to assess whether the increase in the ammoniacal nitrogen concentration in the under liner drainage is as a result of changes in the leachate strength or an increasing amount of leachate getting through the liner. It is noted that during the 2017-2019 years, the ammoniacal concentration of the under liner drainage has followed a similar pattern to the

leachate. Monitoring of the contaminant concentrations in the under liner drainage will continue. Given the changes in this indicator, a recommendation will be included in this report that NPDC widen the range of parameters be increased to those given in Table 8-1 of the Technical Guidelines for Disposal to Land (WasteMINZ, 2018) on at least one occasion annually. An additional recommendation is that the NPDC review the Landfill Management plan to ensure that the criteria for determining whether any contamination is occurring that is greater than the natural variation be included along with measure to be taken remedy, mitigate or if practicable prevent continuation of any effect on the groundwater quality as per conditions 5, 6 and 7 of consent 4621-1.

Figure 8 Ammoniacal nitrogen concentration in the under liner drainage

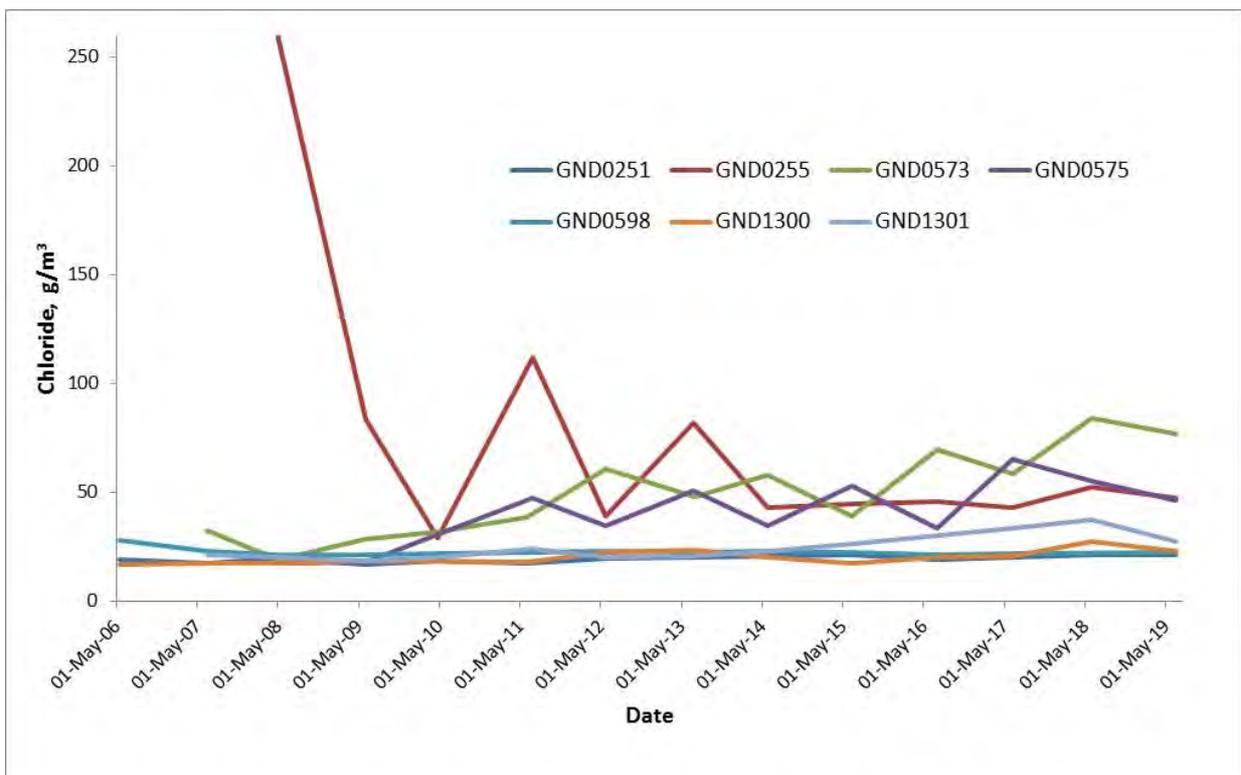
Figure 11 Chloride concentrations in the Colson Road groundwater bores, June 2006 to date

It can be seen that the chloride concentration in bore GND0255 (up gradient of the landfill) have been stabilising at a decreased level since the spike found in April 2008. Conversely, in bores GND0573, GND0575 (and to a lesser extent GND1301), although the changes are relatively small, it does appear that there may be an emerging trend of increasing chloride concentrations. These bores are down gradient of landfill Stages 2 and 3, and may be indicative of some minor leachate contamination.

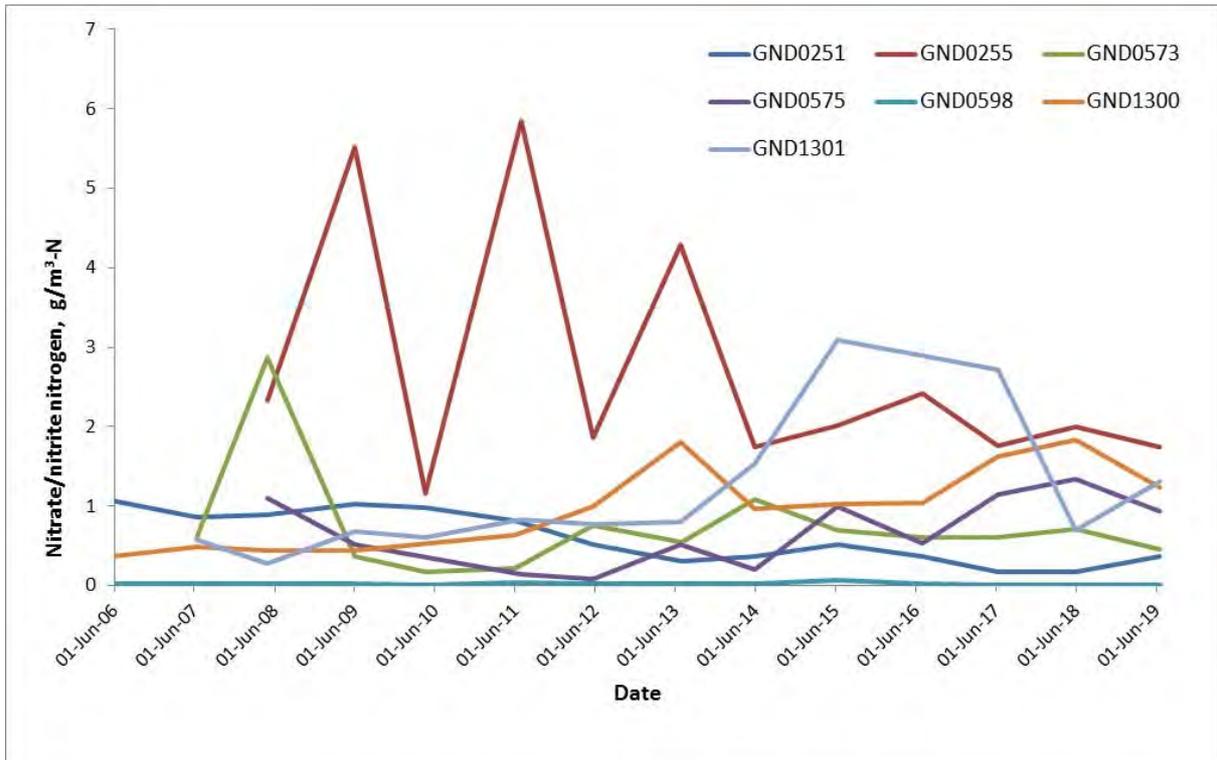
Figure 12 shows that there may also be an emerging trend of increasing nitrate/nitrite nitrogen concentrations in some of these bores, that is, GND0575 (north east of the landfill) and GND1300 (north east of the composting area and east of the southern end of the landfill). This finding is consistent with the potential emerging trend of increasing nitrate/nitrite nitrogen in the under liner drainage results provided by NPDC (2.2.1.2, Figure 8). In contrast, it is noted that the nitrate/nitrite nitrogen results obtained at GND1301 (further east of the landfill than GND0575) during the year under review was still relatively low, following the higher results obtained in the 2014-2015, 2015-2016 and 2016-2017 years.

Figure 12 Nitrate/nitrite nitrogen concentrations in the Colson Road groundwater bores, June 2006 to date

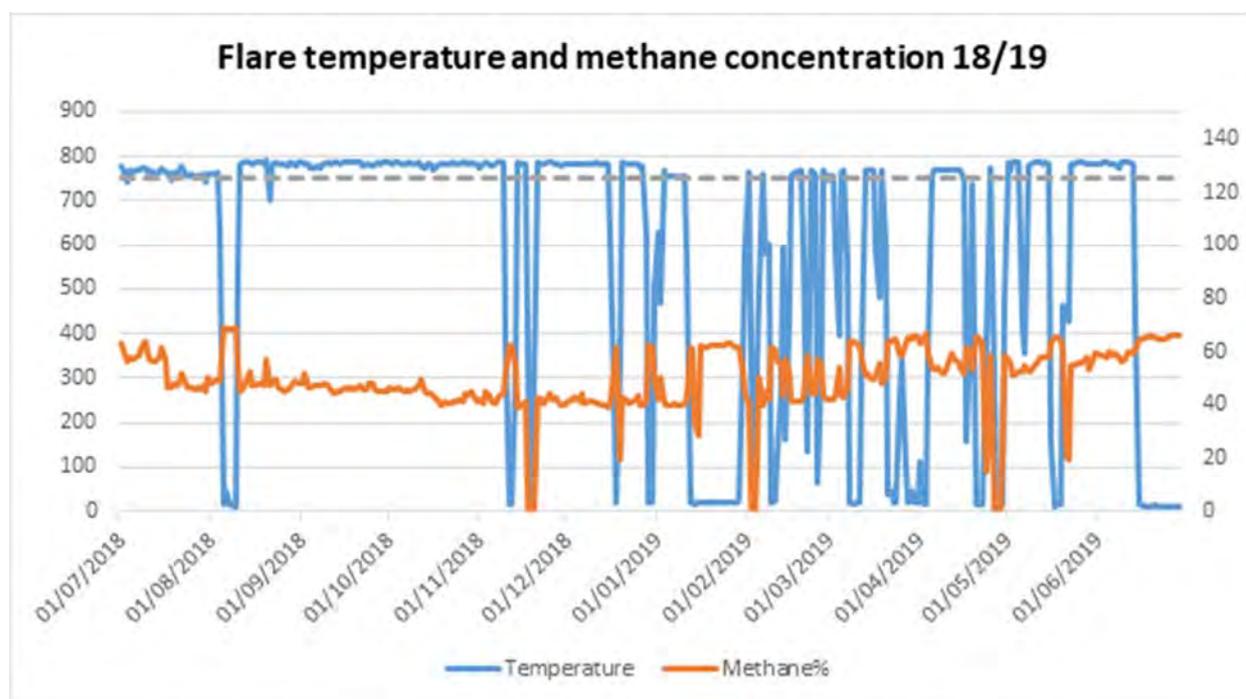
Updated annual information on the feed gas and temperature was provided upon request in the form of graphed methane and temperature data from the continuous (1 minute) data collected by the monitoring system integrated into the flare system (Figure 13).

Figure 13 Methane and temperature recorded by the landfill gas flare for the year under review

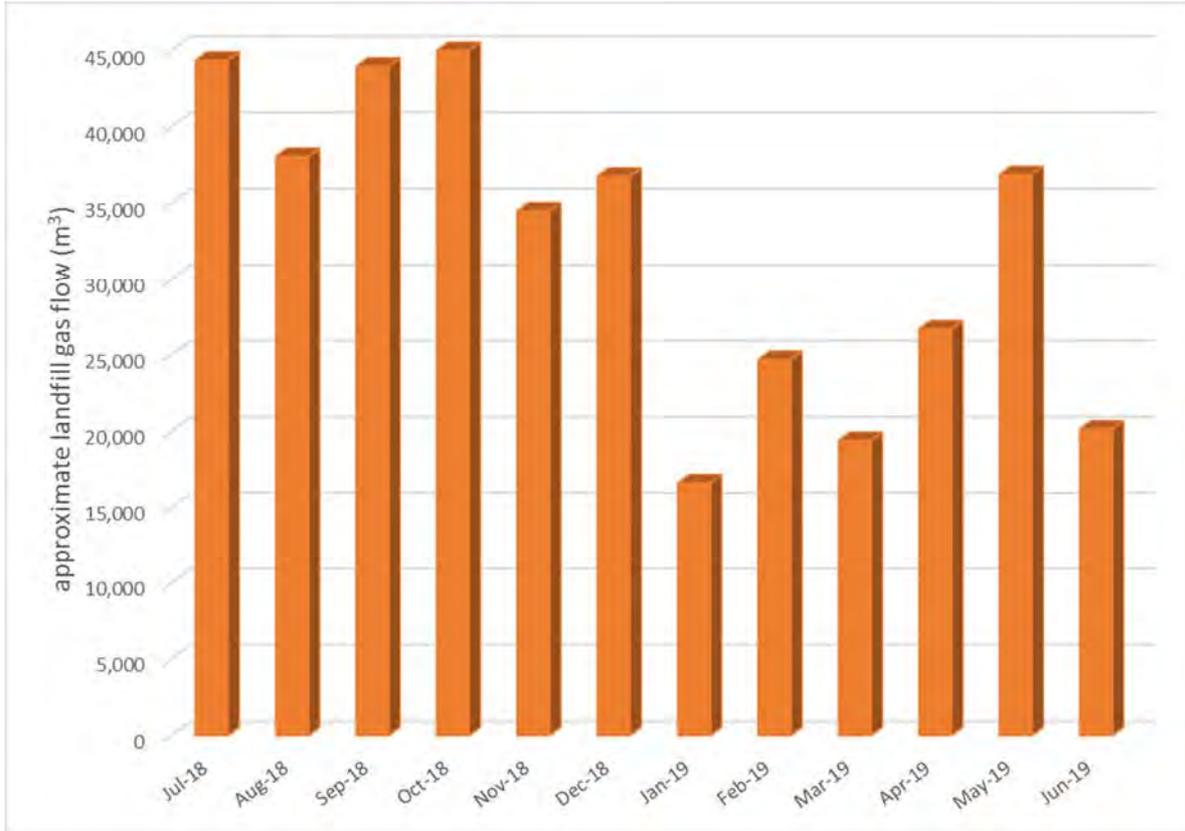
The total landfill gas volume treated by the flare during the year under review was 386,959 m<sup>3</sup> calculated from daily average landfill gas flow in m<sup>3</sup>/h. The monthly averaged landfill gas flows are shown in Figure 14.

Figure 14 Monthly landfill gas flow volumes flared

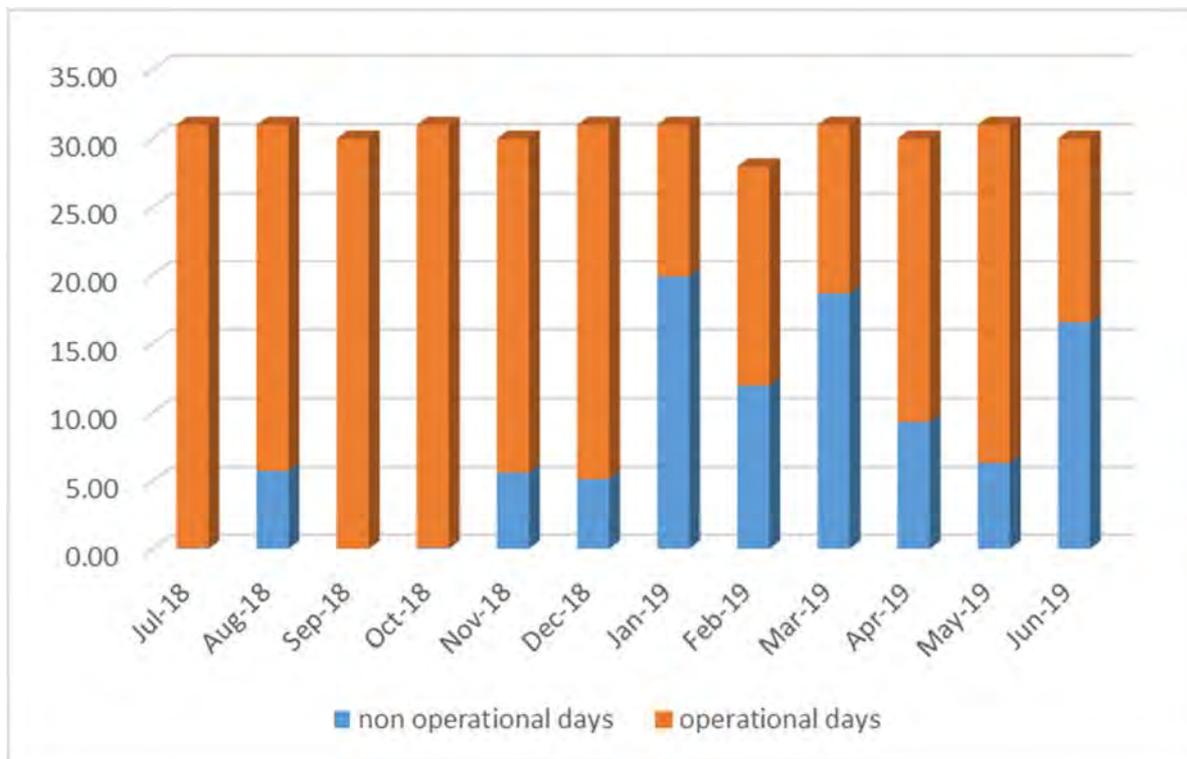
A flare fault log was provided for the year under review. This showed that there was a total of 99.5 non-operational days due to faults, which is 27 % of the year. The longest non-operational period was just under 19 days from 11 to 30 January 2019. The reason given for the shutdown was a fault on the extraction fan control system. This is a fault that was logged as the cause of 41.5 of the total 99.5 non-operational days. At the time of writing the report Council was informed that this fault has occurred only once to date in the 2019-2020 year. The other common causes of shutdown was the burner being over temperature. The shutdowns due to the burner temperature appeared to have been resolved by the replacement of temperature control probe. A summary of the monthly non-operational hours is given in Table 15 and Figure 15. It is noted that there were no odour complaints received by the Council during any of the non-operational periods.

Figure 15 Monthly operational/non-operational hours for the Colson Road landfill gas flare for the year under review

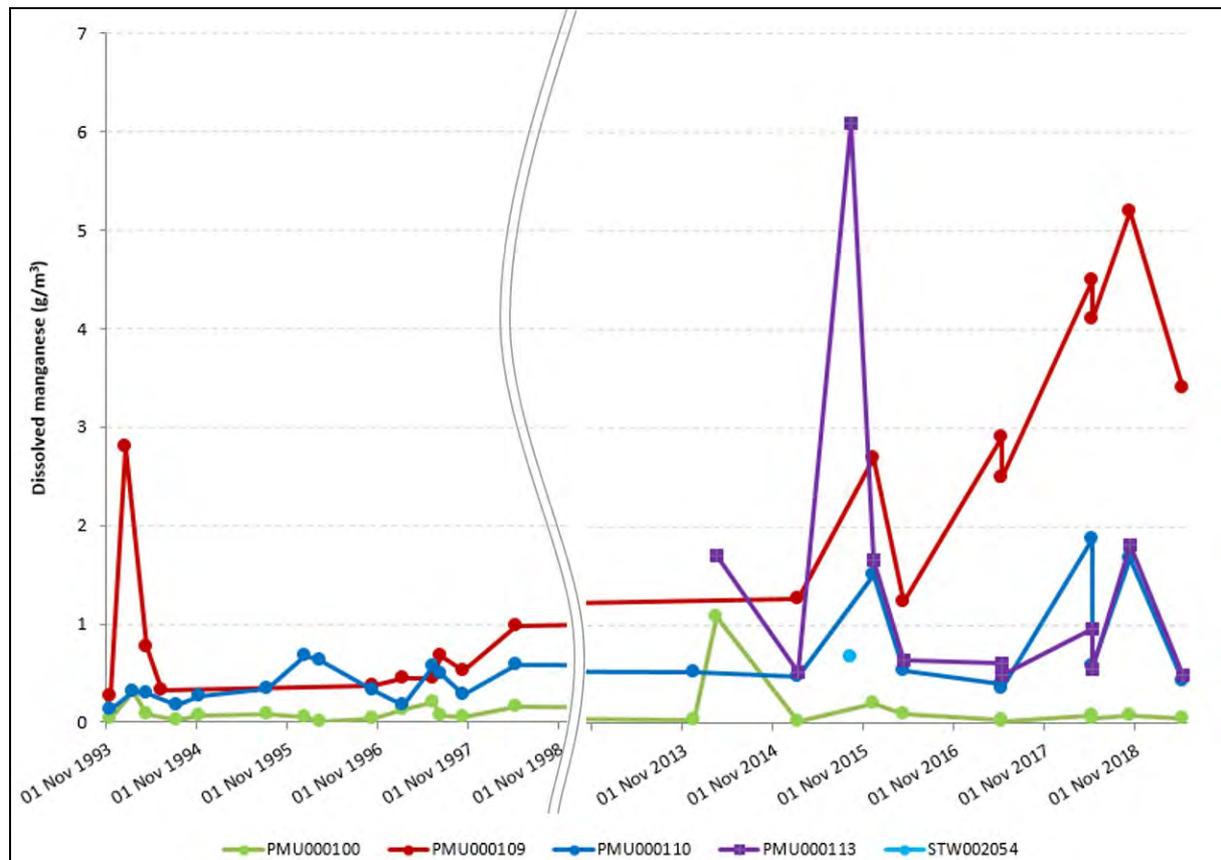
Chemical sampling found that there were no significant adverse effects found in the Puremu Stream during the period under review. There were a total of four non-compliant results found in relation to discharges authorised by consent 4619, two were exceedances of the faecal coliform count and two were exceedances of the ammoniacal nitrogen concentration. On one occasion the ammoniacal nitrogen concentration was within the uncertainty of measurement of the test method, and in the case of the other three exceedances there were likely unsourced contributions from outside the landfill. There was also one exceedance of the total manganese limit at the compliance point for discharges authorised by consent 2370 (PMU000110). However, the result obtained was less than the ANZECC guideline for the protection of 95% of species. This is the second time in the last two years that the consent limit has been exceeded however, manganese has been monitored at this point only since the 2013-2014 year, and in both cases the following sampling result was compliant (Figure 16). It is therefore too early to confidently comment on whether this is part of an emerging trend of increasing concentrations at this site. There does appear to be a trend of increasing manganese concentration at site PMU000109, which is inside the mixing zone and therefore not a compliance issue. It may however suggest that NPDC may want to investigate this further to ensure continued consent compliance at site PMU000113.

Figure 16 Dissolved manganese concentrations in the wetland polishing area and Puremu Stream
