Stratford District Council  
Municipal oxidation ponds system  
Monitoring Programme  
Annual Report  
2013-2014

Technical Report 2014-14

July 2014

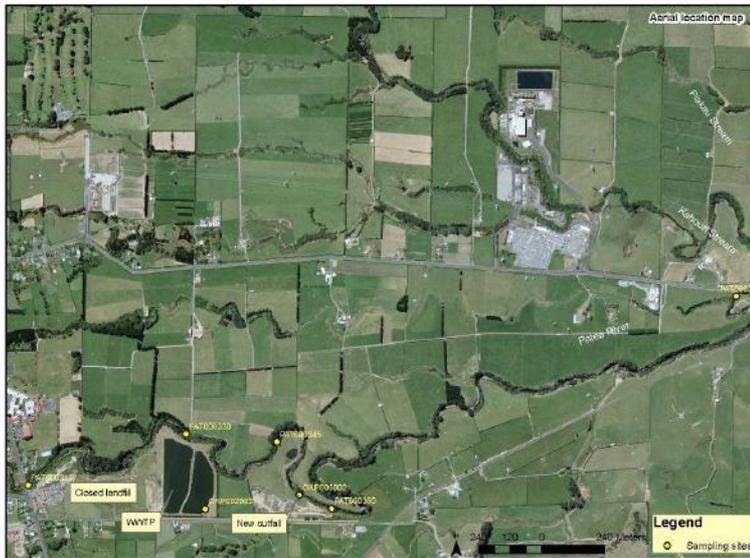
**Figure 1** Aerial photo of site and location of sampling sites since the upgrade of the WWTP

A late summer assessment of the impact of the upgraded oxidation ponds' system effluent discharge on the receiving waters of the Patea River was performed on 19 February 2014 when flow in the river (at the Skinner Road recorder) was 0.87 m<sup>3</sup>/sec, during a low recession flow period (but not as extreme as the very low, lengthy recession flow surveyed in the summer of 2008). Sites were located (Figure 2) as summarised in Table 4.

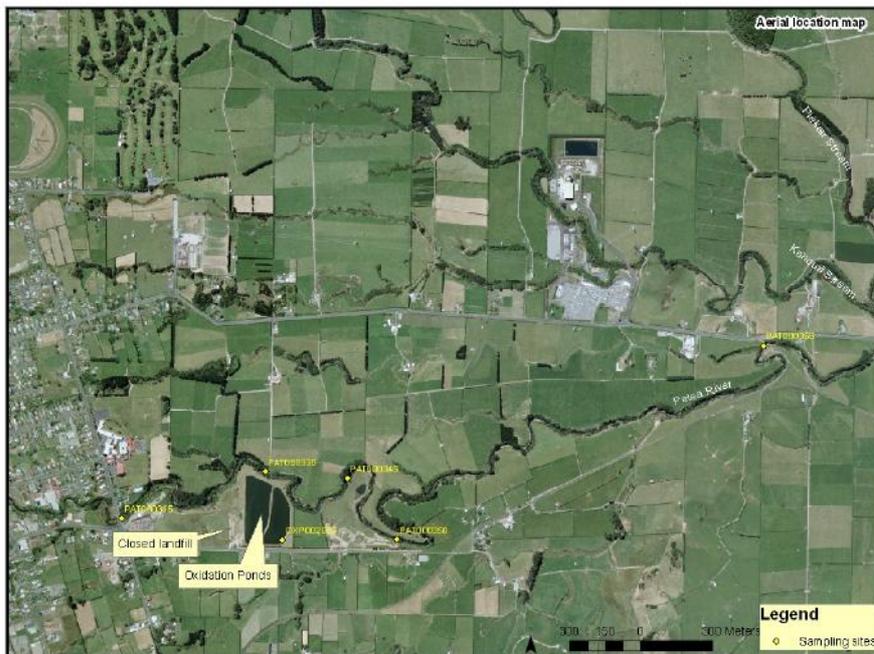
**Figure 2** Aerial photo of site and location of sampling sites

The standard '400 ml kick sampling' technique was used to collect streambed (benthic) macroinvertebrates from three established sites and one more recently established site in the Patea River (illustrated in Figures 1 and 2), on 18 February 2014.

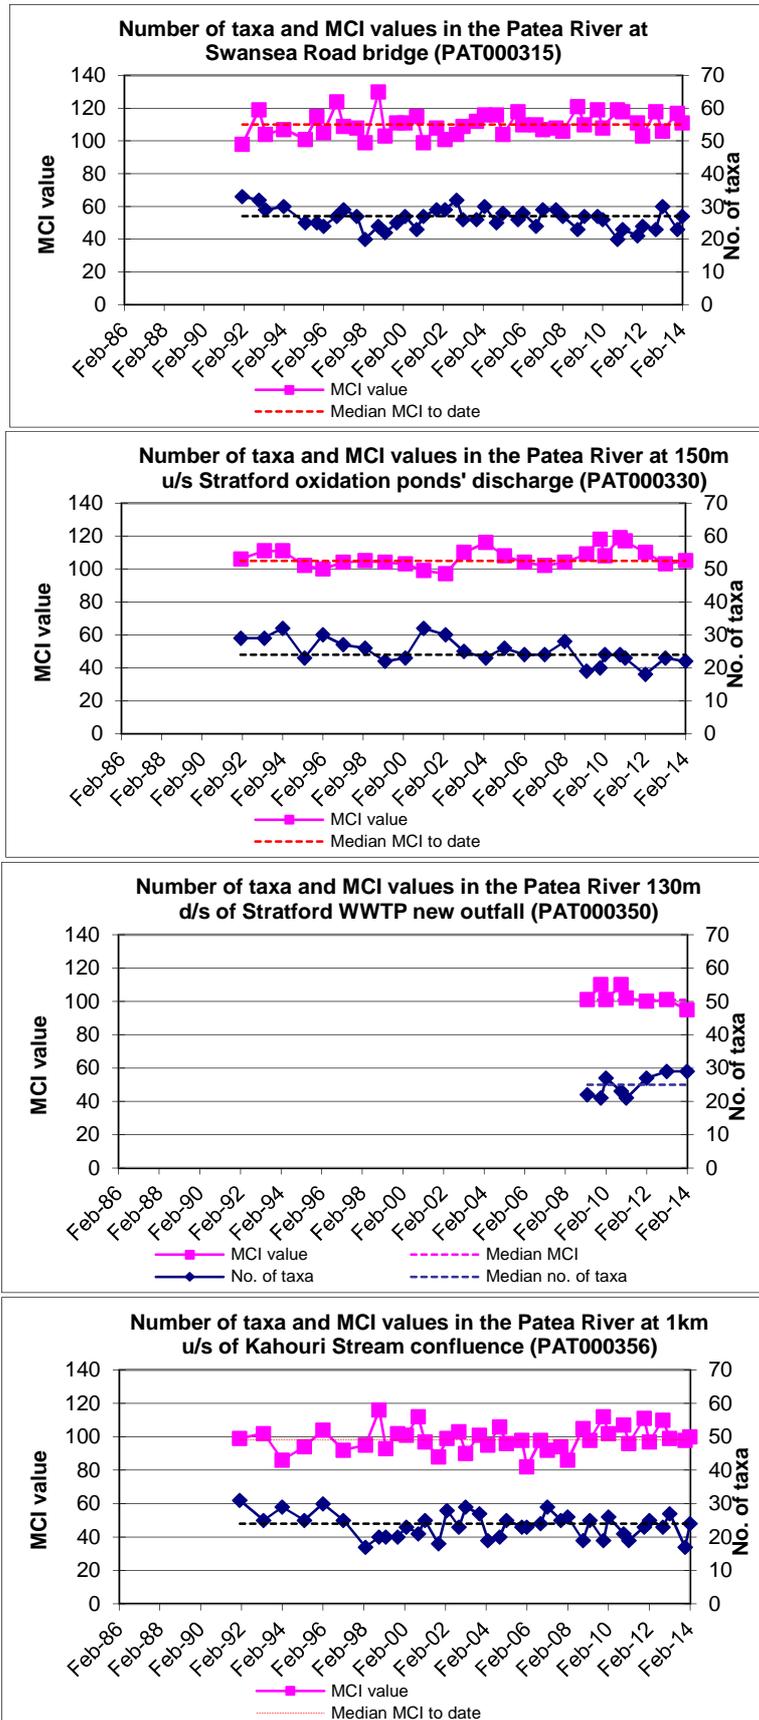
Figure 3 Taxa richness and MCI scores recorded to date at the Patea River sites

The results from the current survey (Table 2) indicated faunal richnesses ranging from two taxa below (site 2) to 6 taxa above (site 3a) median richnesses (ranging from 22 to 29 taxa) present at the four river sites. These taxa numbers were well within ranges previously recorded (Table 1) at the three longer established sites (1, 2 and 4). The richness at the most recently established site (site 3a) was equal with the maximum richness recorded by the few surveys at this site to date.

The range of taxa richnesses was generally typical of richnesses recorded by previous surveys which have been recorded under summer, more widespread periphyton cover and tending toward low flow conditions.
