Todd Energy Aquatic Centre Monitoring Programme Annual Report 2015-2016

Technical Report 2016-104

August 2016

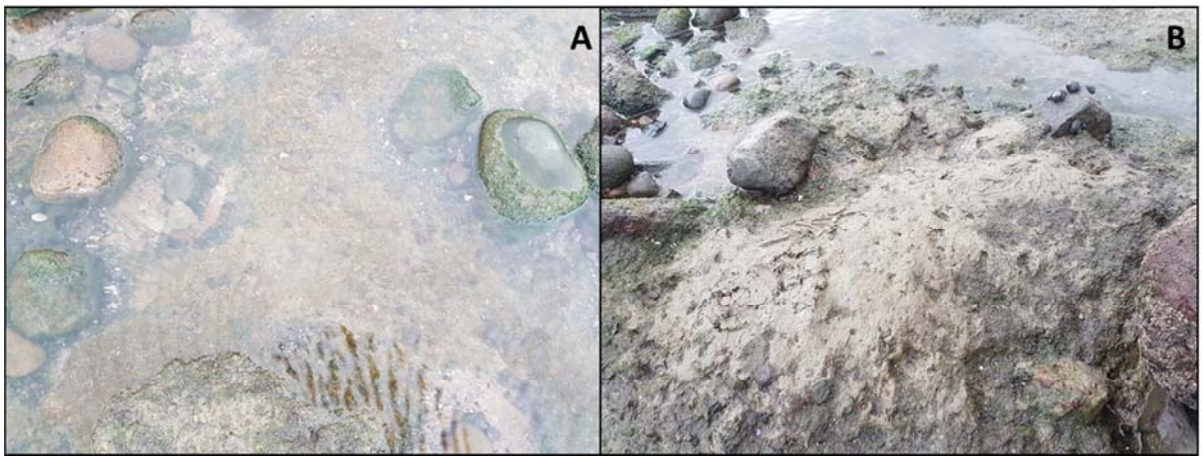
TEAC staff, the origin of this discharge may have been the site stormwater system, which also drains to the outfall structure. The outdoor pool had only been partly emptied since the previous day; indicating compliance with the consent condition of only discharging in batches within two hours either side of high tide (Photo 3). The reef inspection found no detectable chlorine odour or any visual issues outside of the designated discharge mixing zone. A thin brown microbial growth was found on the base of the shallow pools in front of the outfall, within the mixing zone (Photo 4). However, this growth was less prevalent as what was observed in the previous reef inspection (on 12 March 2016). Unidentified grey mats (likely to be either a colonial ascidian or sponge) were also observed in the vicinity of the outfall.

Photo 4 (A) Brown microbial growths and (B) unidentified grey mats in vicinity of outfall
