Stratford District Council
Municipal oxidation ponds system
Monitoring Programme
Annual Report
2012-2013

Technical Report 2013-32

November 2013

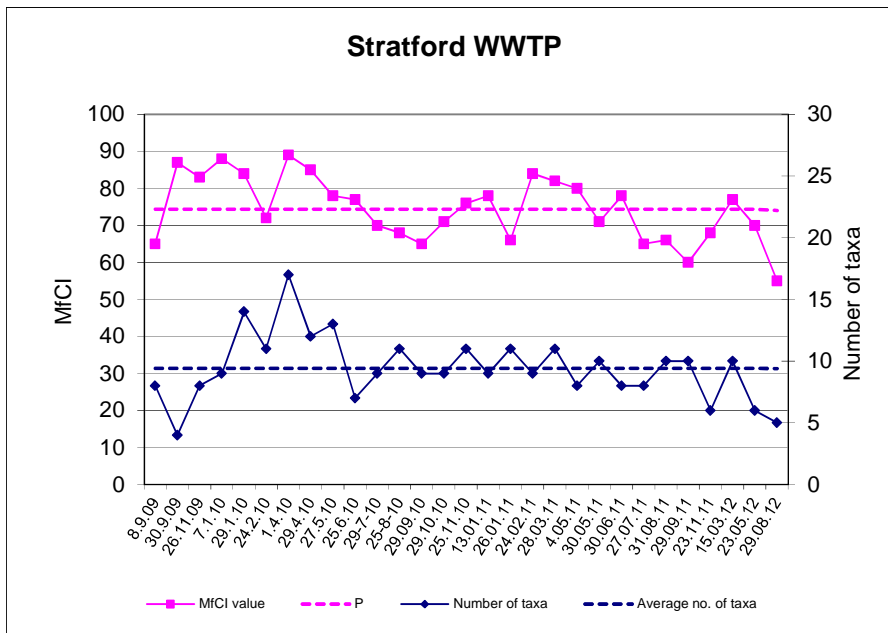
Figure 1 Numbers of taxa and MfCI values for phytoplankton monitoring of the final cell of the Stratford secondary oxidation pond during the 2009-2013 (four year) period

The average microfloral community index (MfCI) value for the Stratford secondary pond had been 67 units prior to the upgrade. This average score has been 74 units in the tertiary cell since the upgrade. In August 2012 the MfCI score (55 units) was below the pre-upgrade average and the post-upgrade average but the very wet (flushing) conditions continued the trend toward lower scores.

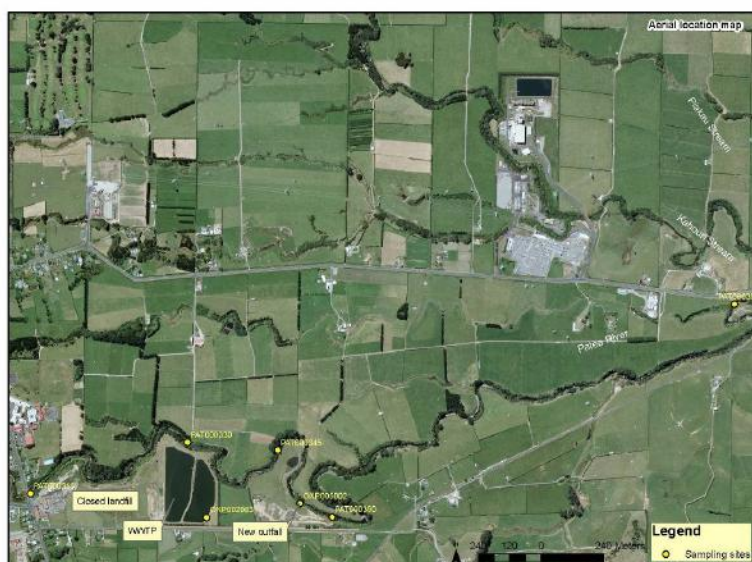
**Figure 2** Aerial photo of site and location of sampling sites since the upgrade of the WWTP

A late summer assessment of the impact of the upgraded oxidation ponds' system effluent discharge on the receiving waters of the Patea River was performed on 20 February 2013 when flow in the river (at the Skinner Road recorder) was 1.11 m³/sec, during a very low recession flow period (but not as extreme as the very low, lengthy recession flow surveyed in the summer of 2008). Sites were located (Figure 2) as summarised in Table 4.

Site	Location	GPS location	Site code
Patea River	at Swansea Road bridge (upstream of landfill and WWTP discharges)	E1711801 N5644382	PAT000315
Patea River	approximately 250 m downstream of the WWTP original discharge (and 350m upstream of the new outfall)	E1712748 N5644549	PAT000345
Secondary oxidation pond tertiary cell effluent	at manhole upstream of rock riprap outfall	E1712834 N5644344	EXP005002
Patea River	approximately 130 m downstream of the WWTP new outfall	E1713033 N5644266	PAT000350
Patea River	approximately 1 km upstream of the Kahouri Stream confluence	E1714497 N5645112	PAT000356

One late-summer biomonitoring survey was performed under very low flow conditions at the four sites listed in Table 9 and illustrated in Figure 2 with the resultant report attached as Appendix II.

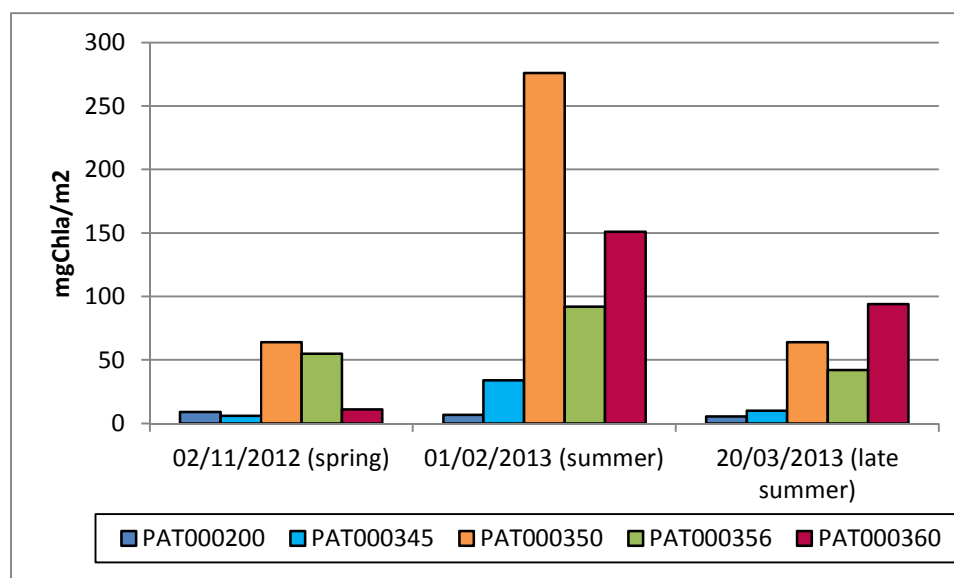
Figure 3 Chlorophyll-a concentrations in the Patea River for the spring 2012 to late summer 2013 period

An example of interim chlorophyll-a (indicator of algal biomass) results is presented in Figure 3 and summarised in Table 11 for the five sites from near the National Park boundary (PAT000200) to Skinner Road, about 4.5km downstream of the WWTP outfall (PAT000360). This illustrates the impact of the WWTP discharge (between sites PAT000345 and PAT000350) upon the streambed periphyton cover in the mid reaches of the Patea River on three survey occasions.

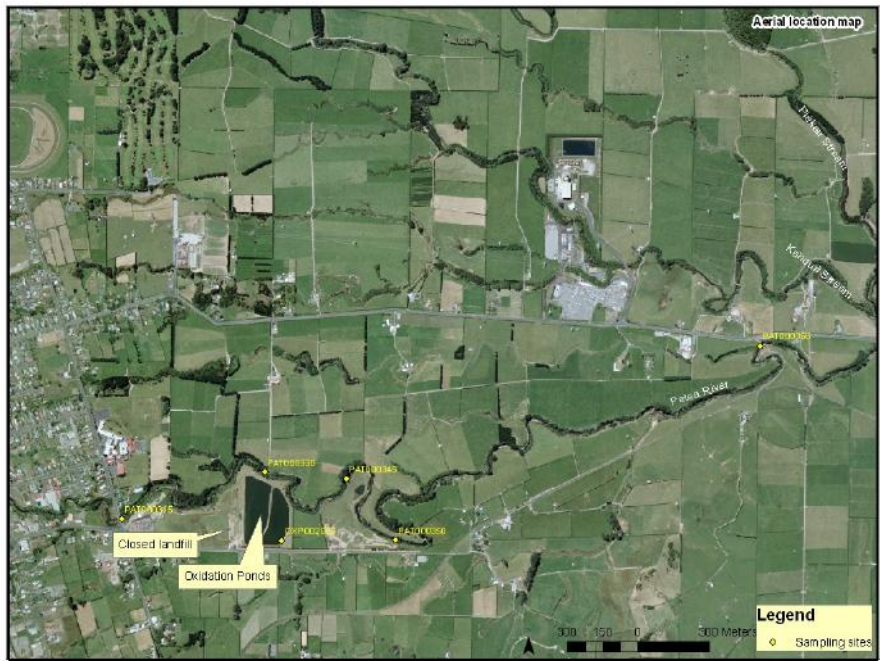
Figure 2 Aerial photo of site and location of sampling sites

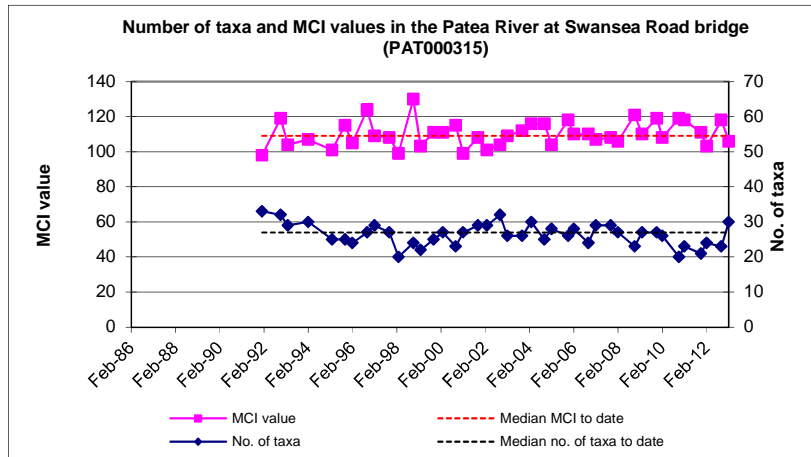
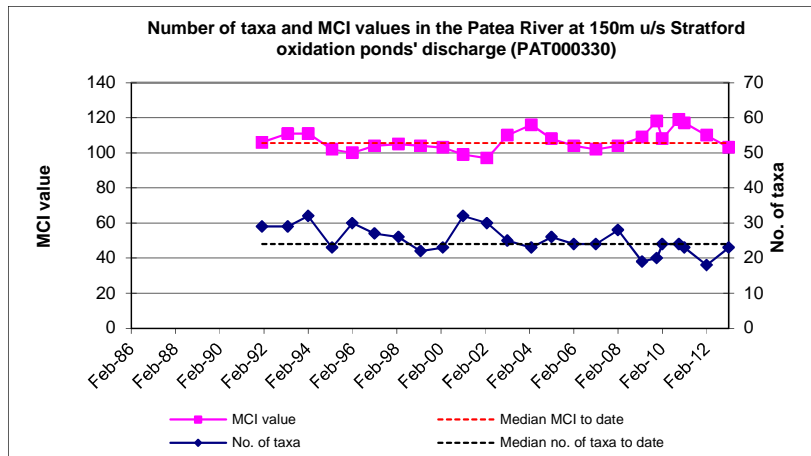
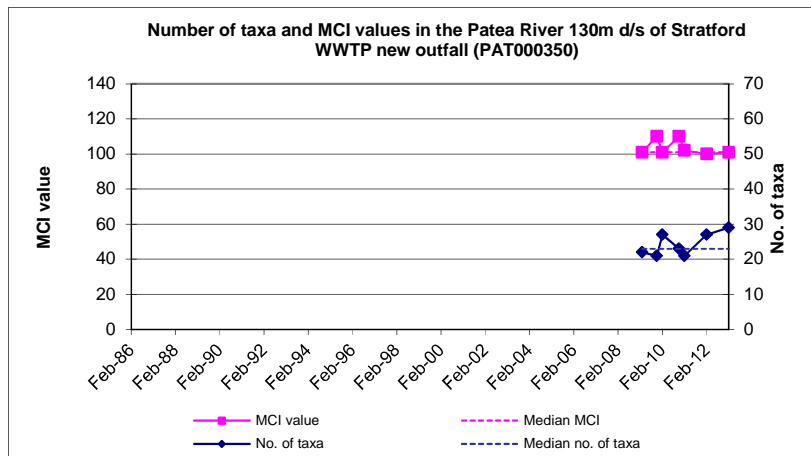
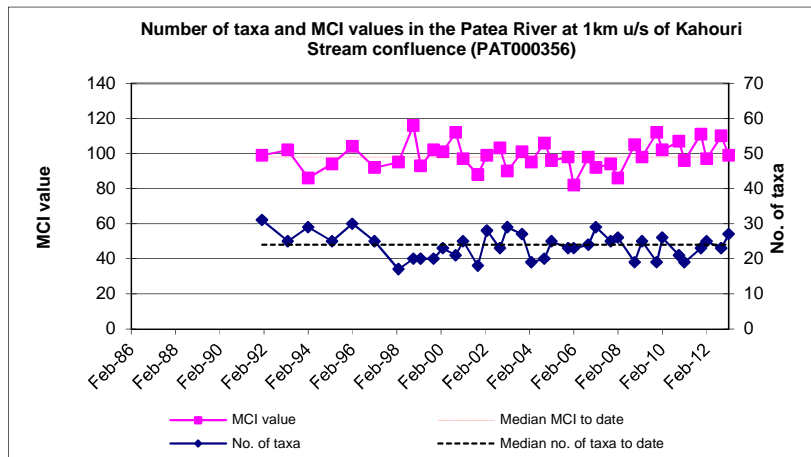
Figure 3 Taxa richness and MCI scores recorded to date at the Patea River sites

The range of taxa richnesses was generally typical of richnesses recorded by previous surveys which have been recorded under summer, more widespread periphyton cover and tending toward low flow conditions.
