Port Area Industrial Catchments Monitoring Programme Annual Report 2017-2018

Technical Report 2018-86

April 2019

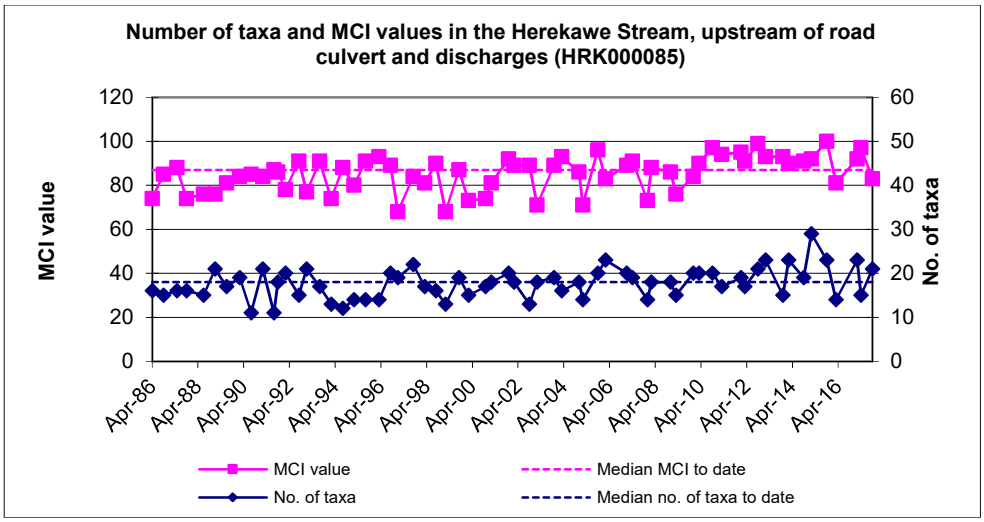
Figure 2 Number of taxa and MCI values in the Herekawe Stream upstream of the Centennial Road culvert since monitoring began in 1986

The $SQMCI_S$ score of 3.7 units was not significantly different (Stark, 1998) to the median MCI score of 4.0 units, but was significantly lower than the preceding survey (4.8 units) (Stark, 1998) (Table 4).

The community was characterised by two 'tolerant' taxa [snails (*Potamopyrgus*) and orthoclad midges] (Table 5).

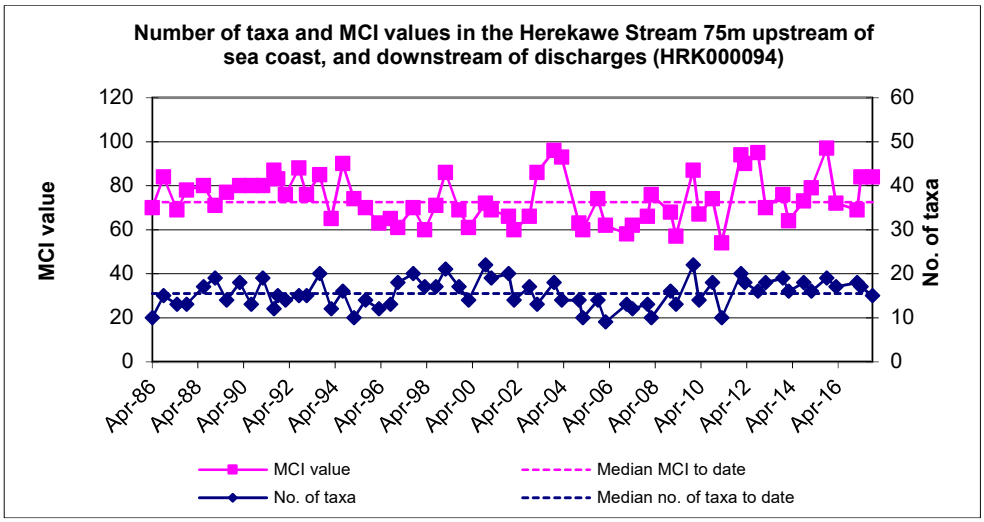
Figure 3 Number of taxa and MCI values in the Herekawe Stream downstream of industrial stormwater discharges since monitoring began in 1986

The $SQMCI_S$ score of 4.0 units was not significantly different to median MCI score of 3.7 units or the preceding survey (3.7 units) (Stark, 1998) (Table 4).

The community was characterised by two 'tolerant' taxa [snails (*Potamopyrgus*) and orthoclad midges] and one 'moderately sensitive' taxon [amphipod (*Paracalliope*)] (Table 5).

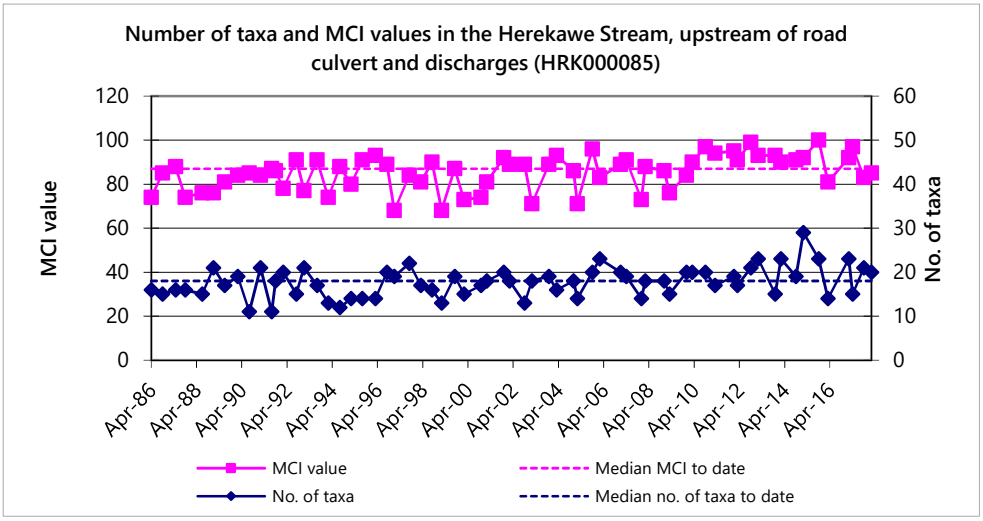
Figure 2 Number of taxa and MCI values in the Herekawe Stream upstream of the Centennial Road culvert since monitoring began in 1986

The $SQMCI_S$ score of 3.9 units was not significantly different (Stark, 1998) to the median MCI score of 4.0 units and to the preceding survey (3.7 units) (Stark, 1998) (Table 4).

The community was characterised by two 'tolerant' taxa [snails (*Potamopyrgus*) and sandflies (*Austrosimulium*)] and one 'moderately sensitive' taxon [amphipod (*Paracalliope*)] (Table 5).

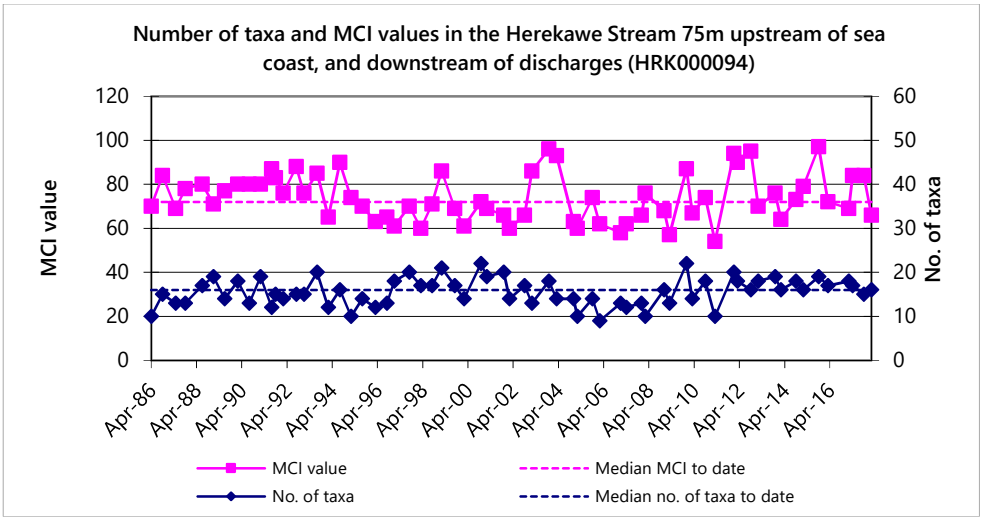
Figure 3 Number of taxa and MCI values in the Herekawe Stream downstream of industrial stormwater discharges since monitoring began in 1986

The $SQMCI_S$ score of 3.8 units was not significantly different to median MCI score of 3.7 units or the preceding survey (4.0 units) (Stark, 1998) (Table 4).

The community was characterised by two 'tolerant' taxa [snails (*Potamopyrgus*) and water boatman (*Sigara*) (Table 5).
