Stratford District Council Landfills Monitoring Programme Annual Report 2014-2015

Technical Report 2015-59

February2016

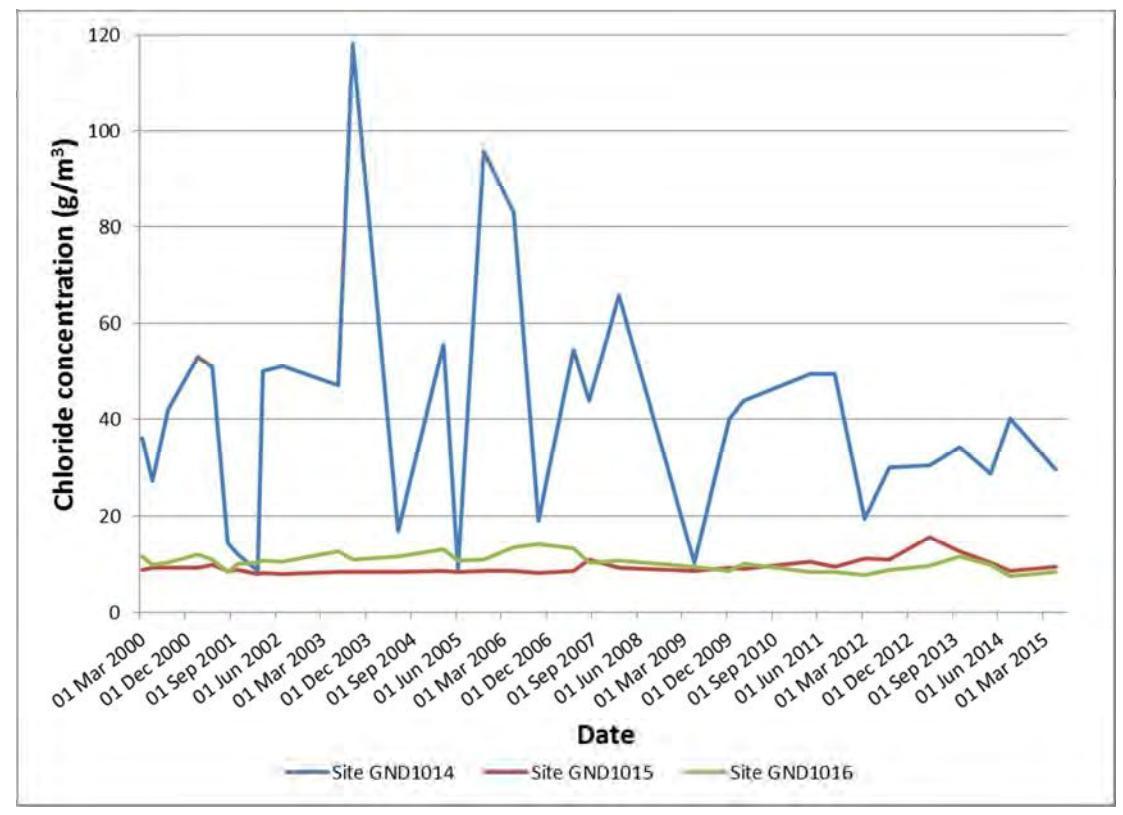
Figure 3 Graph showing chloride levels in groundwater at the Stratford landfill

As with the results from previous samples taken from these monitoring bores, the groundwater down gradient of the landfill (as represented by bore GND1014), shows some evidence of contamination from the landfill. The graphs of historical data given in Figures 3, 4 and 5 show how bore GND1014 is affected by landfill indicator species; ammoniacal nitrogen, chloride, and zinc. The graphs also show how the levels of chloride and ammonia are apt to fluctuate against the more stable background levels found in the two bores mid and up gradient from the filled area (more so in the case of chloride and ammoniacal nitrogen). Zinc is found to be higher in the down gradient bore but is also seen to fluctuate in the up gradient bores as well, which may indicate other local effects in the groundwater.

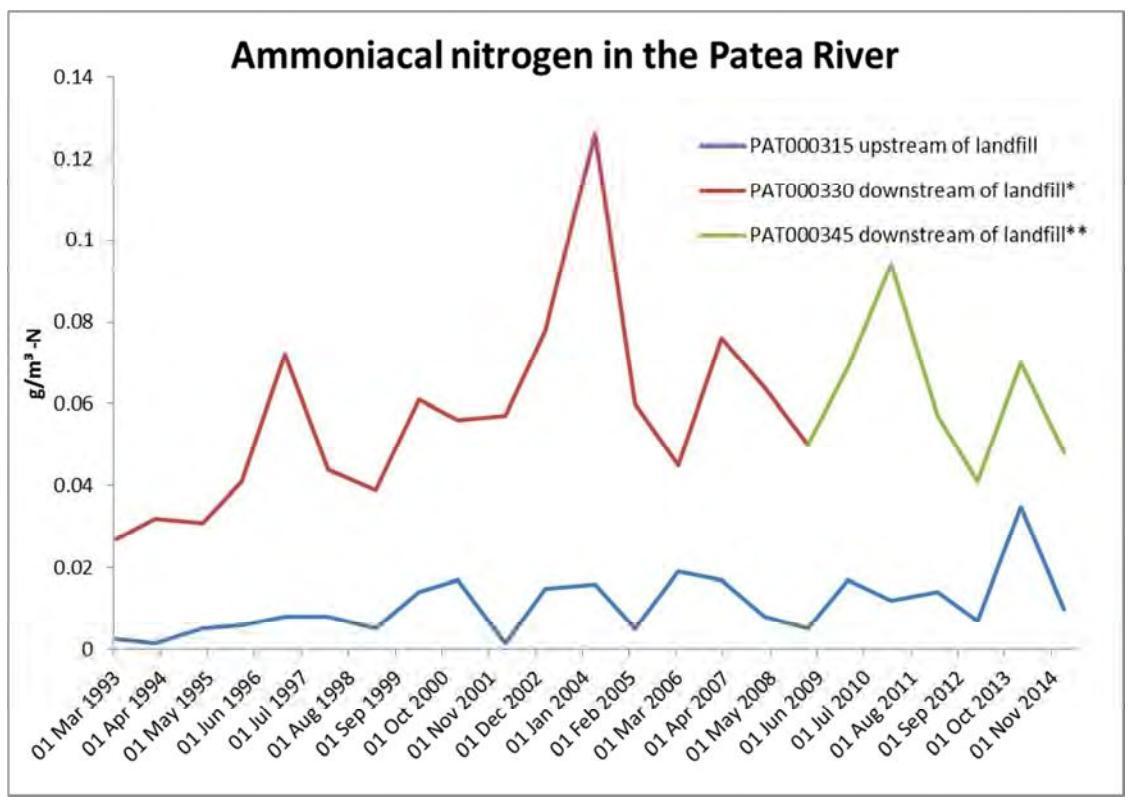
Figure 6 Graph showing ammoniacal nitrogen levels in the Patea Stream up and downstream of the landfill (where comparative data is available).

Figure 6 shows the ammoniacal nitrogen data gathered over the past 25 years. It is noted that, as the Stratford WWTP had an upgrade in 2009, the discharge point of the WWTP was moved and the sites used to monitor the downstream effects of the landfill also changed. Monitoring at site PAT000330 ceased in March 2009, with monitoring continuing at site PAT000345, further downstream.

Whilst there is some separation between the sites locations, the graph indicates that a similar, stable, and modest rise in ammoniacal nitrogen has occurred in the Patea River as result of the landfill's presence. The highest level of ammoniacal nitrogen found downstream of the landfill since monitoring began was  $0.87 \text{ g/m}^3$ , on 16 March 2005. Under the pH and temperature conditions prevailing at the time of sampling, this ammoniacal nitrogen concentration would have resulted in an unionised ammonia concentration of  $0.014 \text{ g/m}^3$ , well below the  $0.025 \text{ g/m}^3$  unionised ammonia guideline used for the long term protection of aquatic ecosystems.

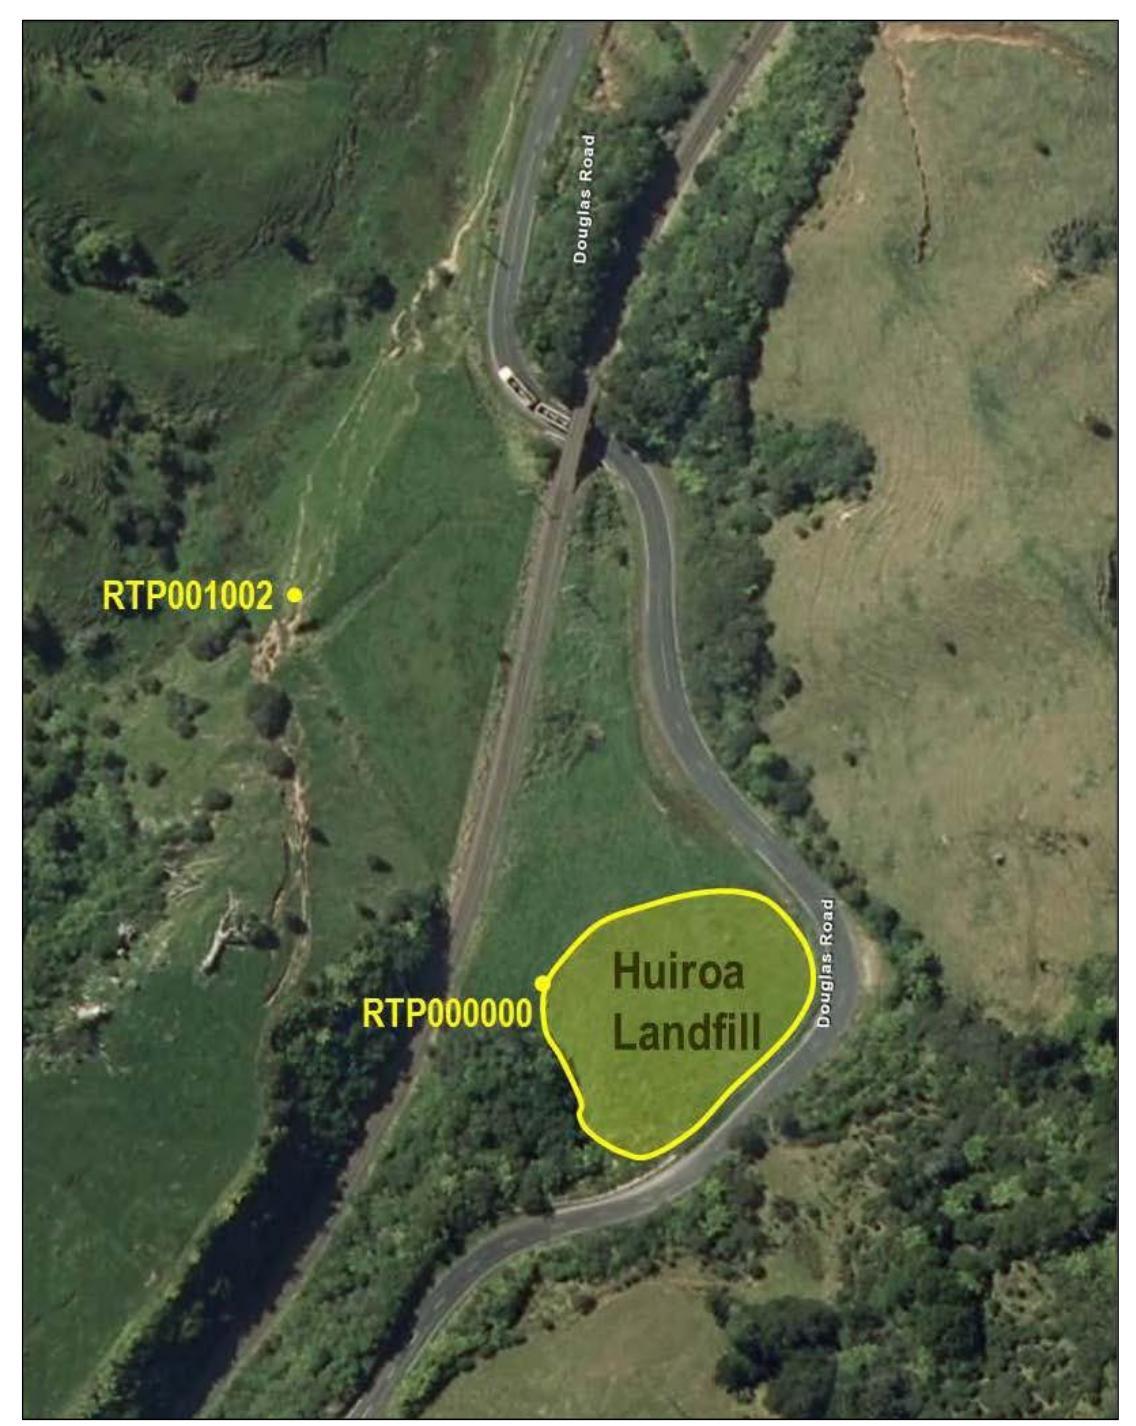
Figure 7 Huiroa landfill and approximate sampling locations

This closed landfill is monitored on a triennial basis, with inspections and sampling undertaken during the period under review. The location of the landfill and monitoring sites are shown in Figure 7.

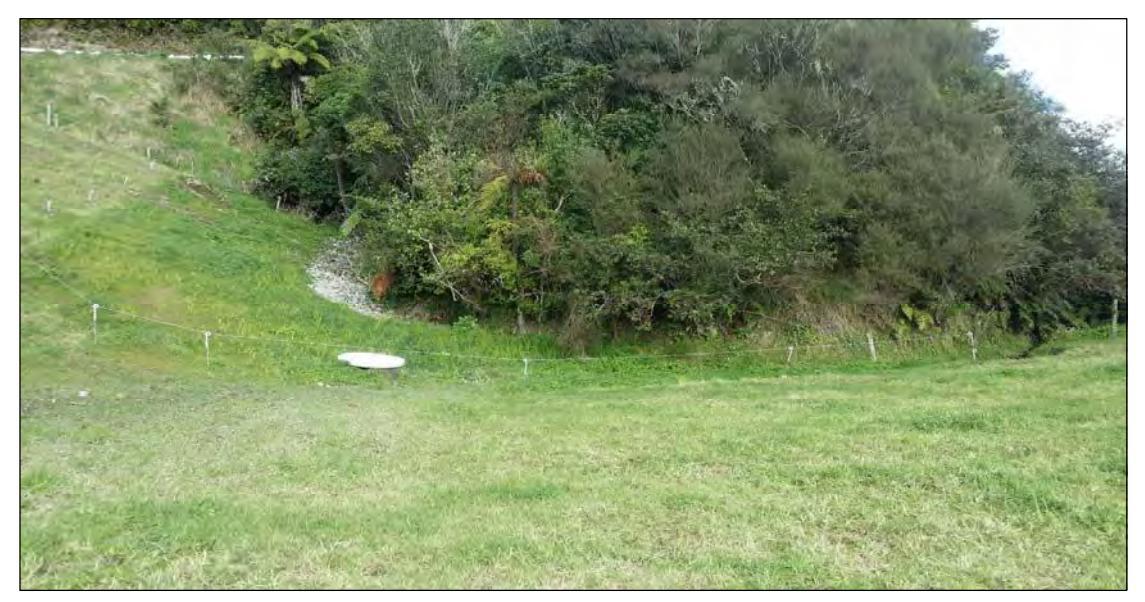
Photo 1 Remediated stormwater drain at Huiroa closed landfill

The south western batter had been remediated and no exposed refuse was observed. There was a minor amount of rilling in the top corner of the drain, attributed to the extremely high rainfall of the previous few days. This area, including the stormwater drainage system, was fenced off with a single-wire fence and had re-grassed well. The stormwater drain along the south western side of the cap had been filled in with rocks to create a rip rap. The material was well-consolidated and permeable (stormwater was heard draining through at the time of inspection). The pipe at the bottom of the drain was clear of debris. A small hole in the ground surface was observed at the edge of the concrete sump. No odour or dust issues were noted. Photographs were taken.

SDC was instructed to address the exposed refuse, and ensure that this area of the cap and drain were protected from stock damage.

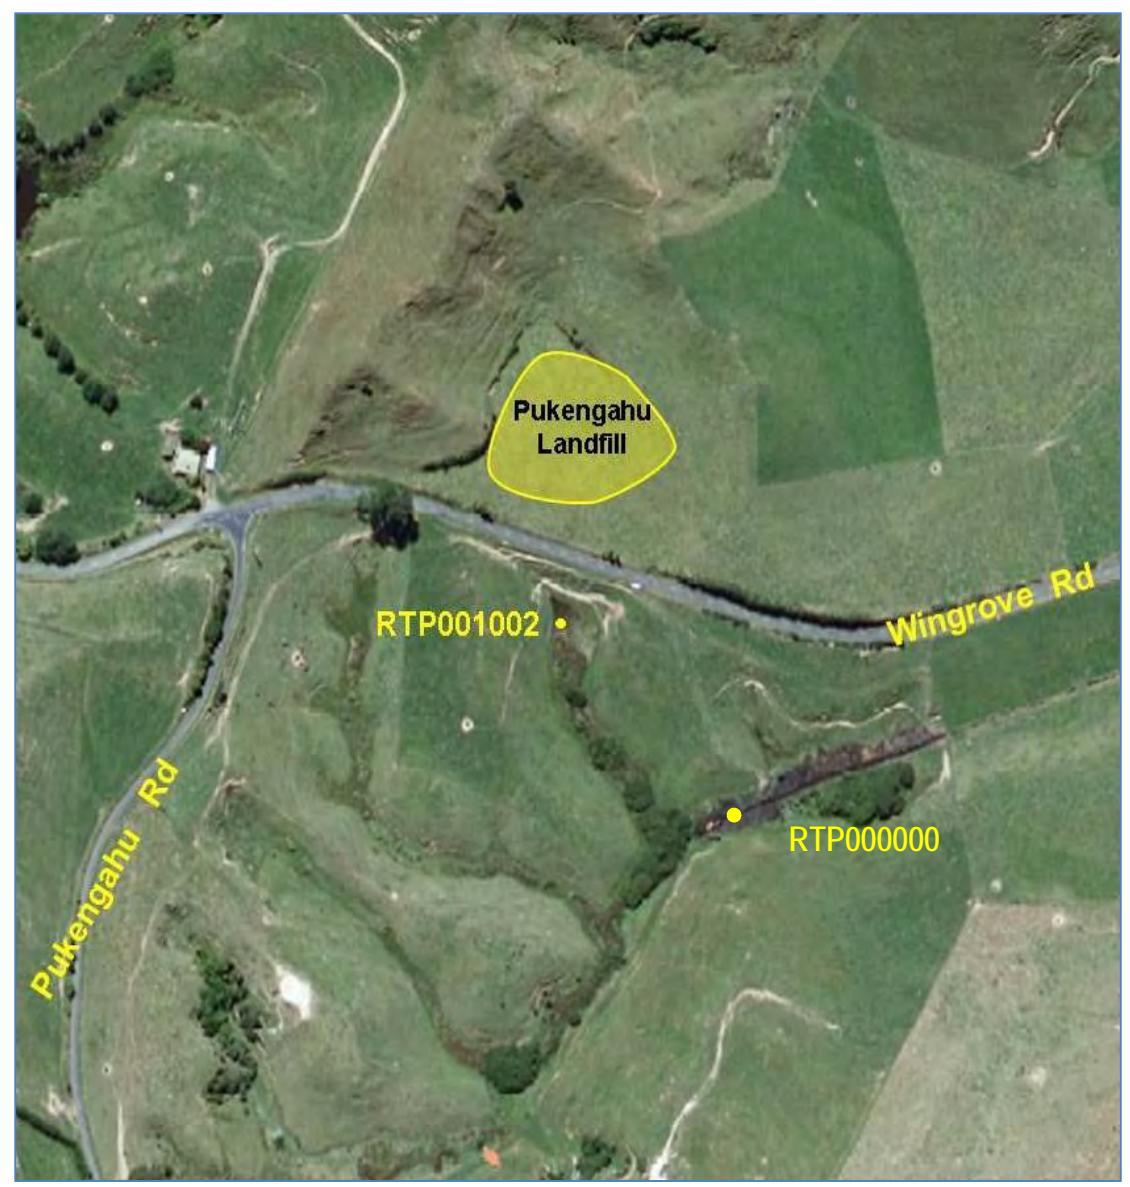
Figure 8 Pukengahu landfill and approximate sampling locations

The site is situated in a small gully off Wingrove Road (Figure 8). At the base of the gully is a small wetland area, which is fed by a spring that is culverted beneath the road and feeds into a small unnamed stream. The dump was unmanaged but was mostly used for the discharge of domestic waste by local residents. The landfill closed in 1991 and the site was reinstated by SDC. It is monitored on a triennial basis, with inspections and sampling undertaken during the period under review.

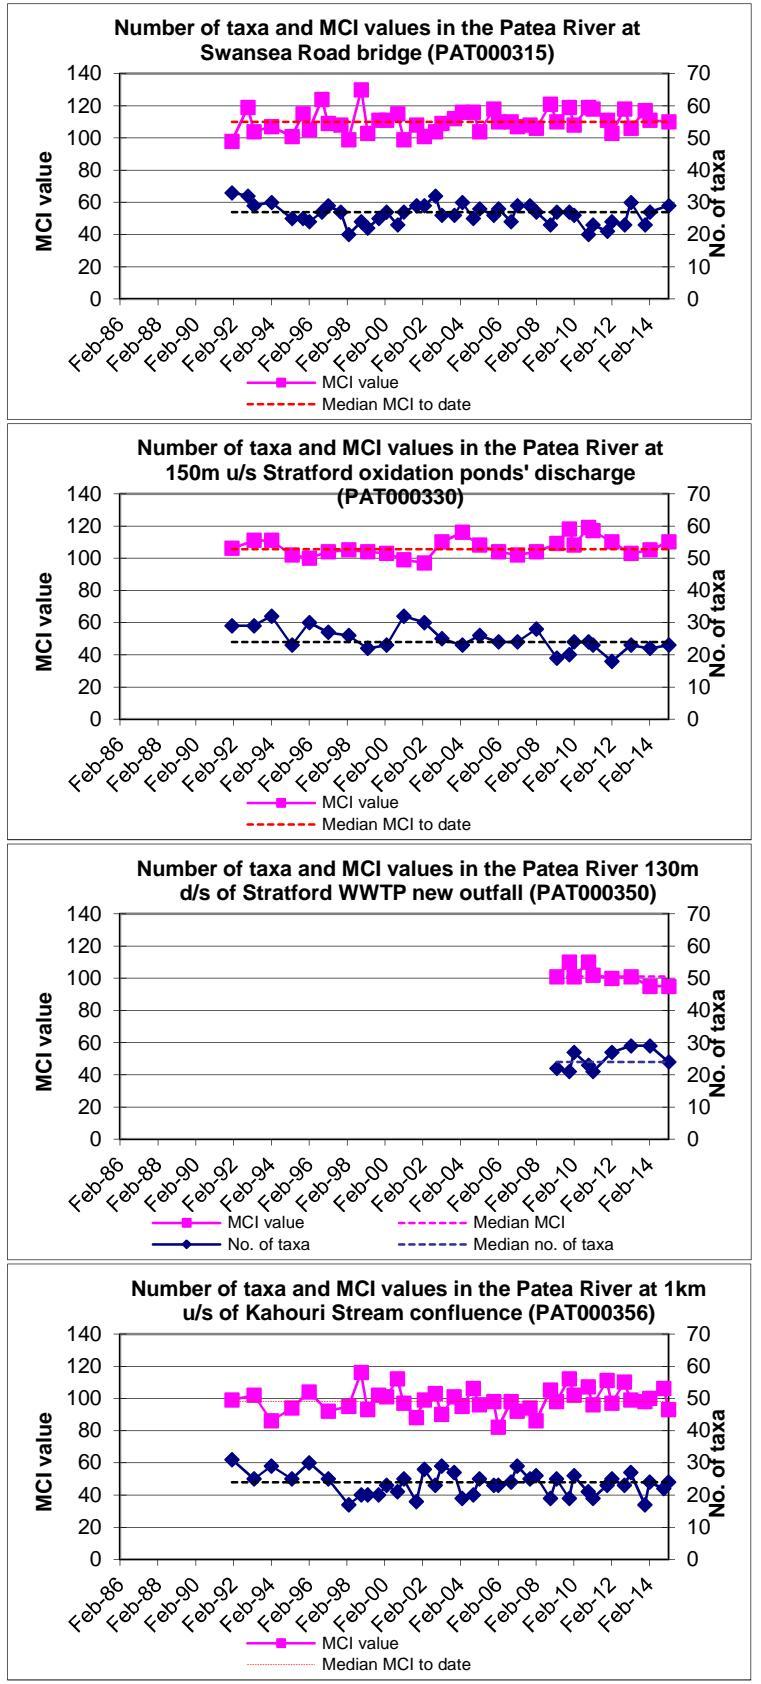
Figure 3 Taxa richness and MCI scores recorded to date at the Patea River sites

The results from the current survey (Table 2) indicated faunal richnesses ranging from one taxon below (site 2) to two taxa above (site 1) median richnesses (ranging from 23 to 29 taxa) present at the four river sites. These taxa numbers were well within ranges previously recorded (Table 1) at the three longer established sites (1, 2 and 4).

The range of taxa richnesses was generally typical of richnesses recorded by previous surveys which have been recorded under summer, more widespread periphyton cover and tending toward low flow conditions.
