REPORT

Haehanga Catchment Preliminary Groundwater Investigation

Remediation New Zealand

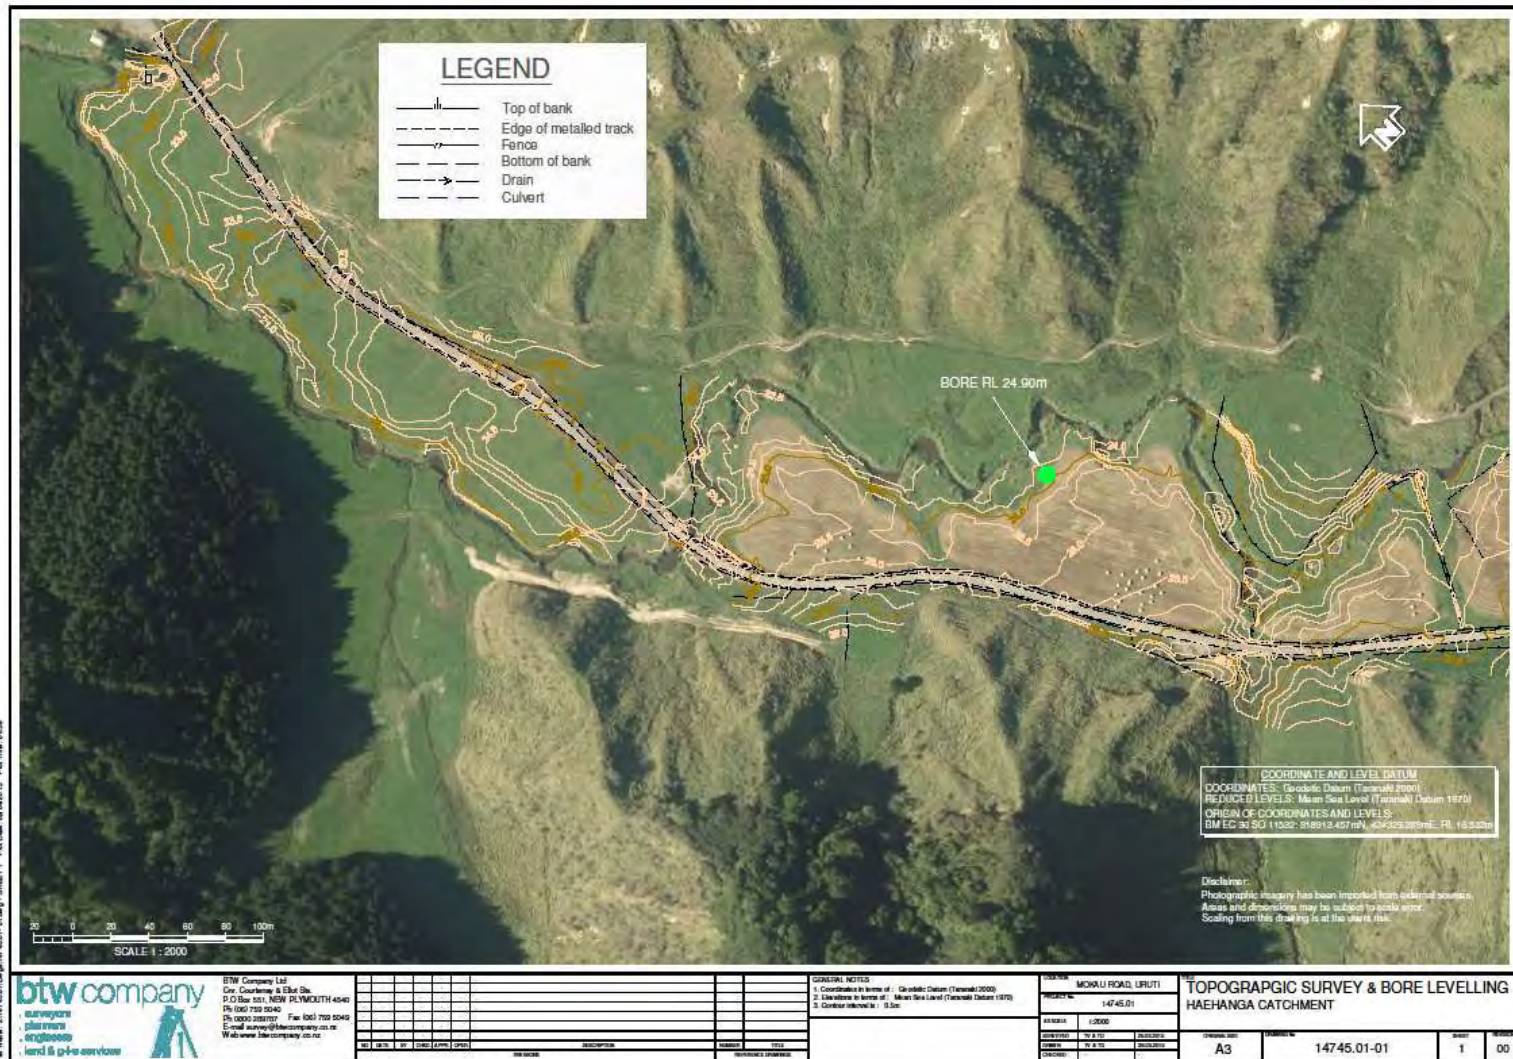
Figure 2.1:Uruti Composting Topography Survey-lower part of site. Green dot denotes GND 2190 and reduced level

Monitoring bore locations are shown on the site plan in Figure 2.1-2.3. Monitoring bore construction details are in Appendix A. Photographs of the well construction are presented in Appendix B.

Based on these parameters above, average hydraulic gradients and linear groundwater velocities have been estimated. Hydraulic gradients have been determined from the groundwater reduced levels in the monitoring bores GND 2188 to GND 2190 and distances between bores taken from the Topographic Survey (Figure 2.1-2.3).

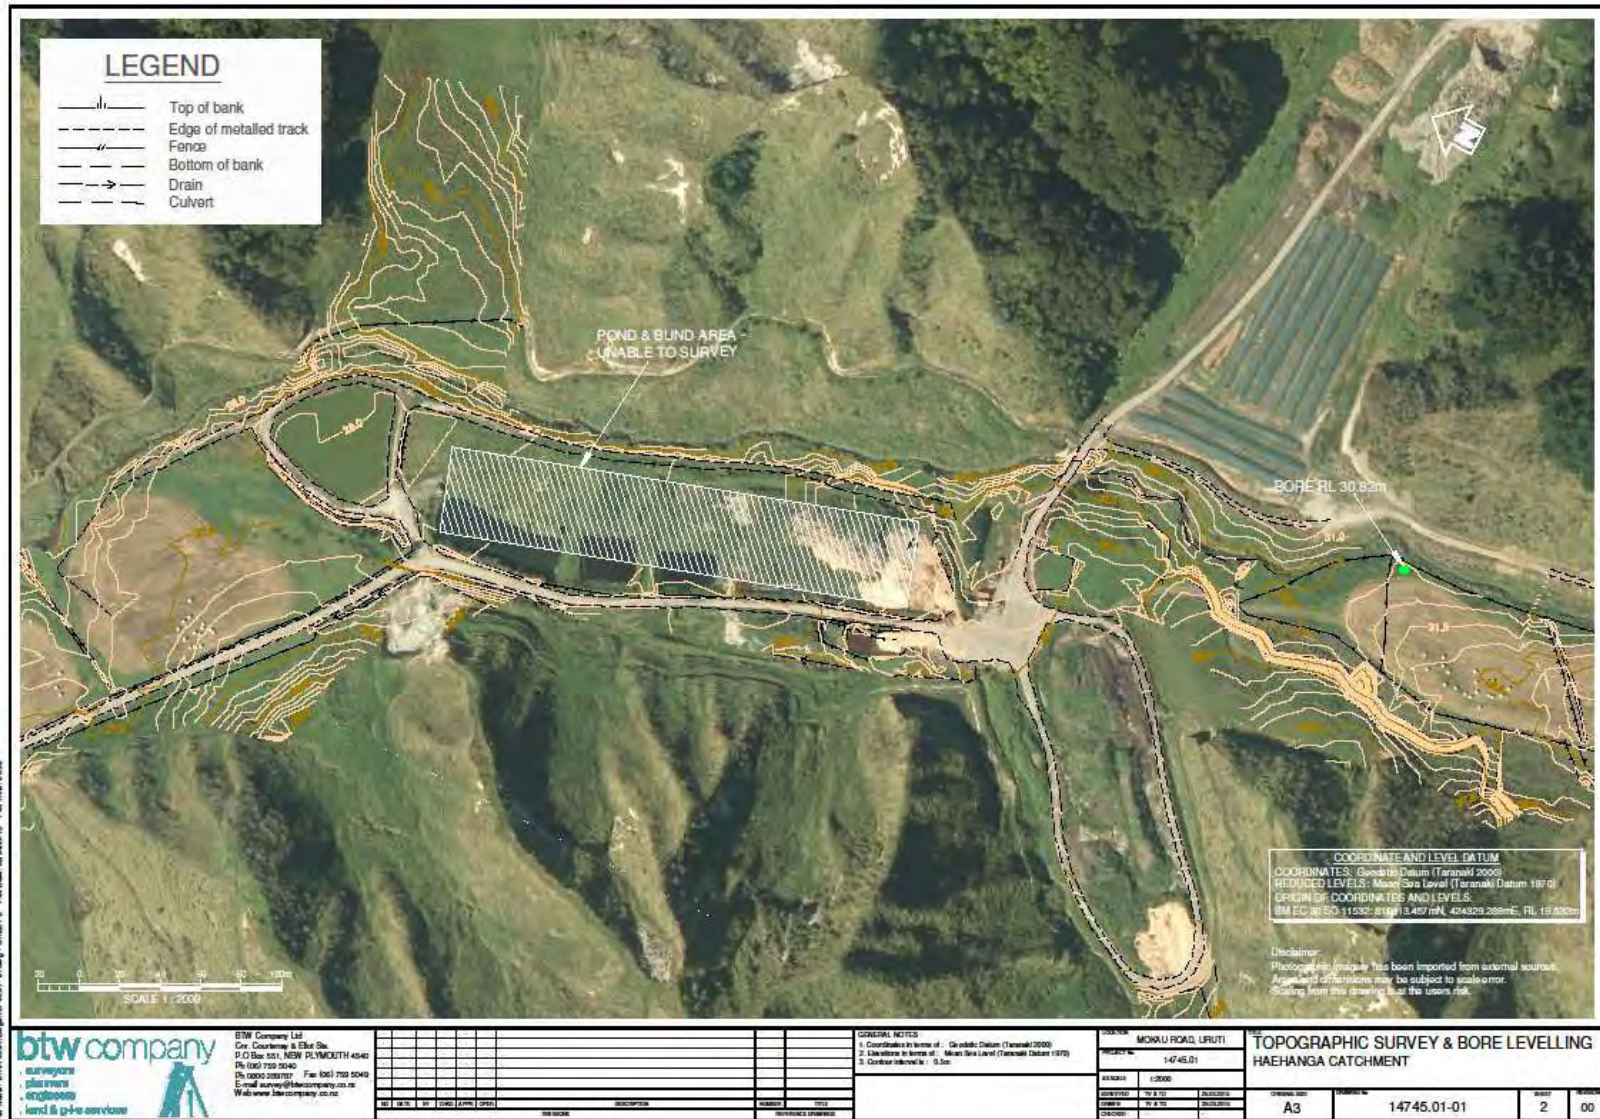
Figure 2.2:Uruti Composting Topography Survey-middle part of site. Green dot denotes GND 2189 and reduced level

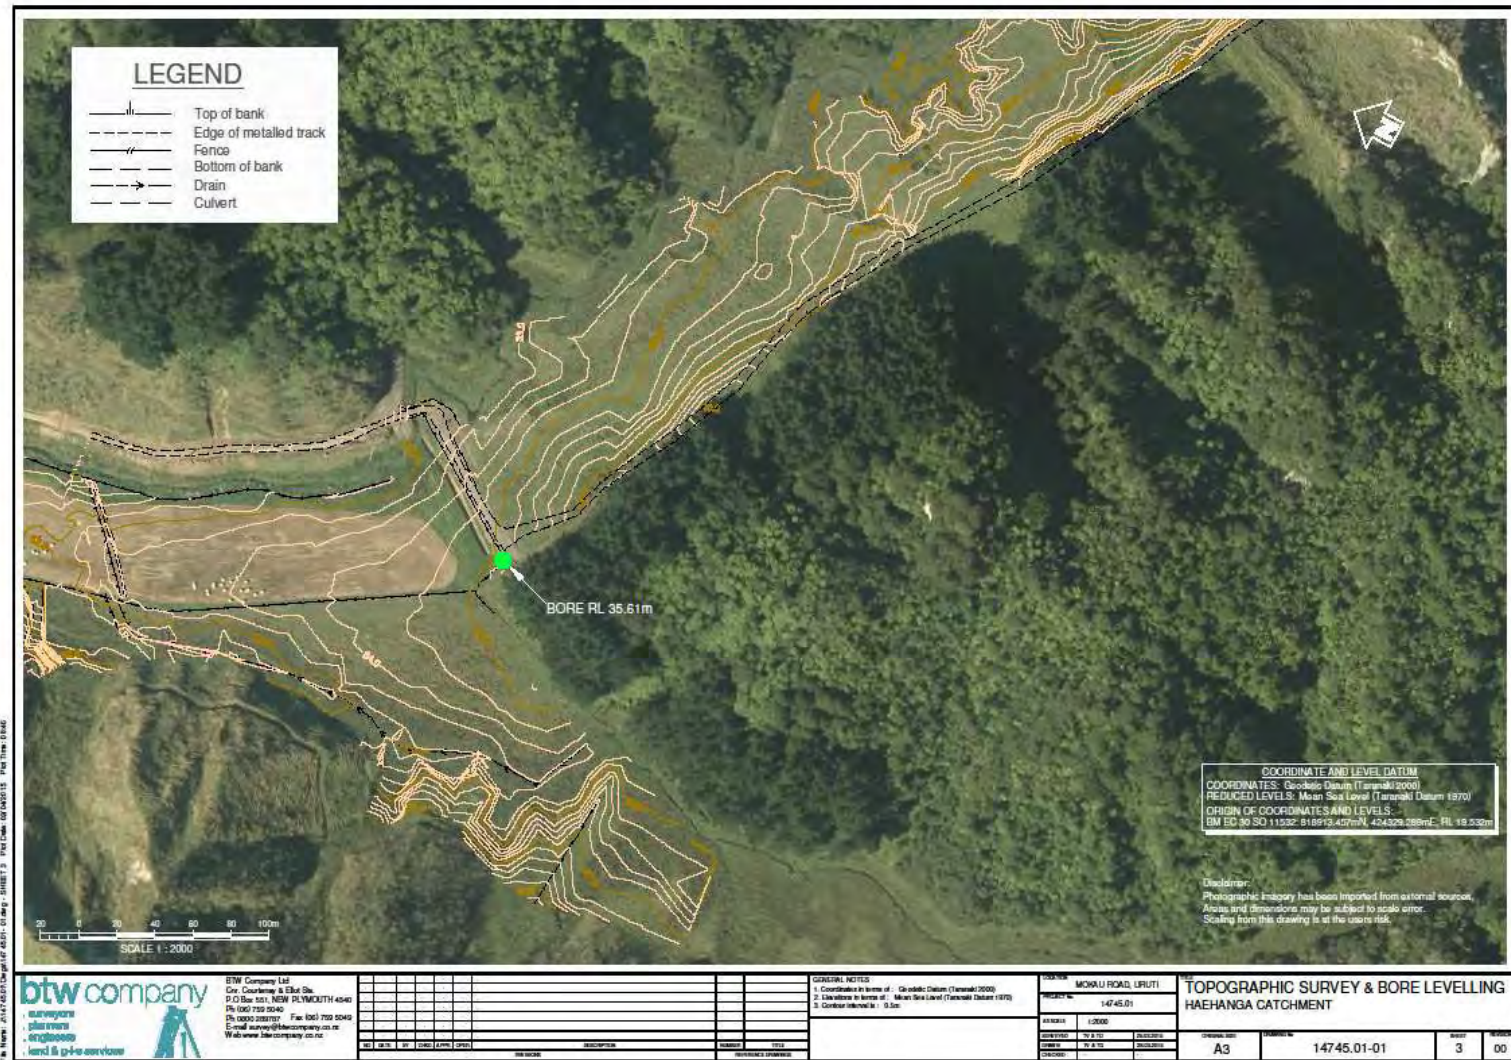
Figure 2.3:Uruti Composting Topography Survey-upper part of site. Green dot denotes GND 2188 and reduced level

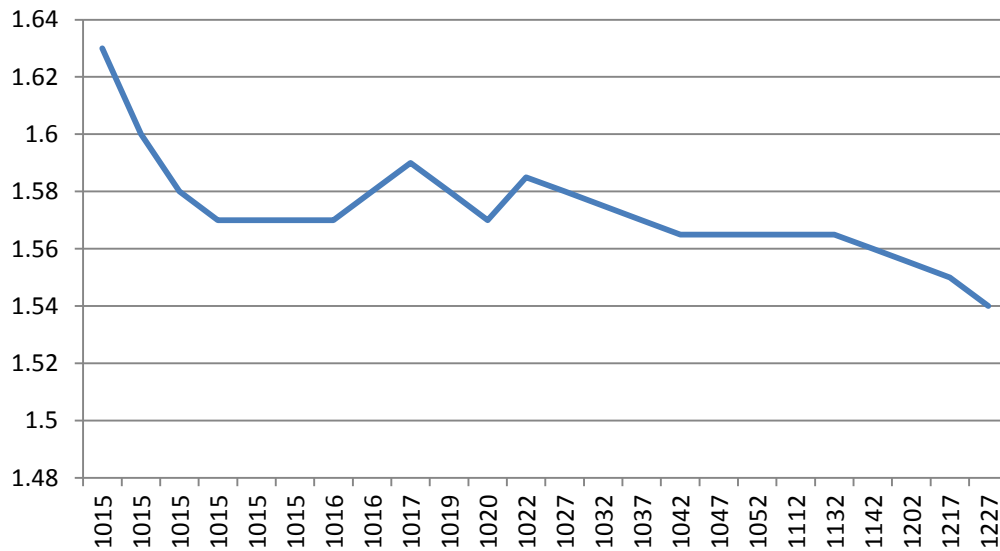
The erratic water levels in GND 2188 during recovery phase of the 'slug test' are represented in Figure 2.4.

Figure 2.4: Fluctuating water levels in GND 2188

The 'slug test' method requires removal of a set amount of water, where after recovery of water levels is timed with a stopwatch. The four litre 'slug' was removed by a high rate vacuum pump, and the recovering water level was determined with a calibrated electronic dip tape. Both monitoring bores did not fully recover to their initial water levels after 100 minutes. GND 2188 recorded sudden surges in water levels after several minutes, with erratic variability in water levels during the timed recovery phase. User error and dip failure were ruled out as both BTW Company technicians corroborated the water level measurements and operation of the electronic dip tape in a bucket of water. Groundwater levels in GND 2190 fluctuated in the initial three minutes after 'slug' removal but in the next one hour and 14 minutes water levels stabilised but never fully recovered to initial water level. However, final water levels only measured 10mm below the initial water level.

Due to the inconsistencies recorded in GND 2188, only permeability calculations were undertaken for GND 2190. These calculations were undertaken using the Bouwer and Rice method (1976) available from free software from the USGS website (<http://pubs.usgs.gov/of/2002/ofr02197/index.html>) and the online Bouwer and Rice calculator (http://www.groundwatersoftware.com/calculator_11_slugtest.htm).

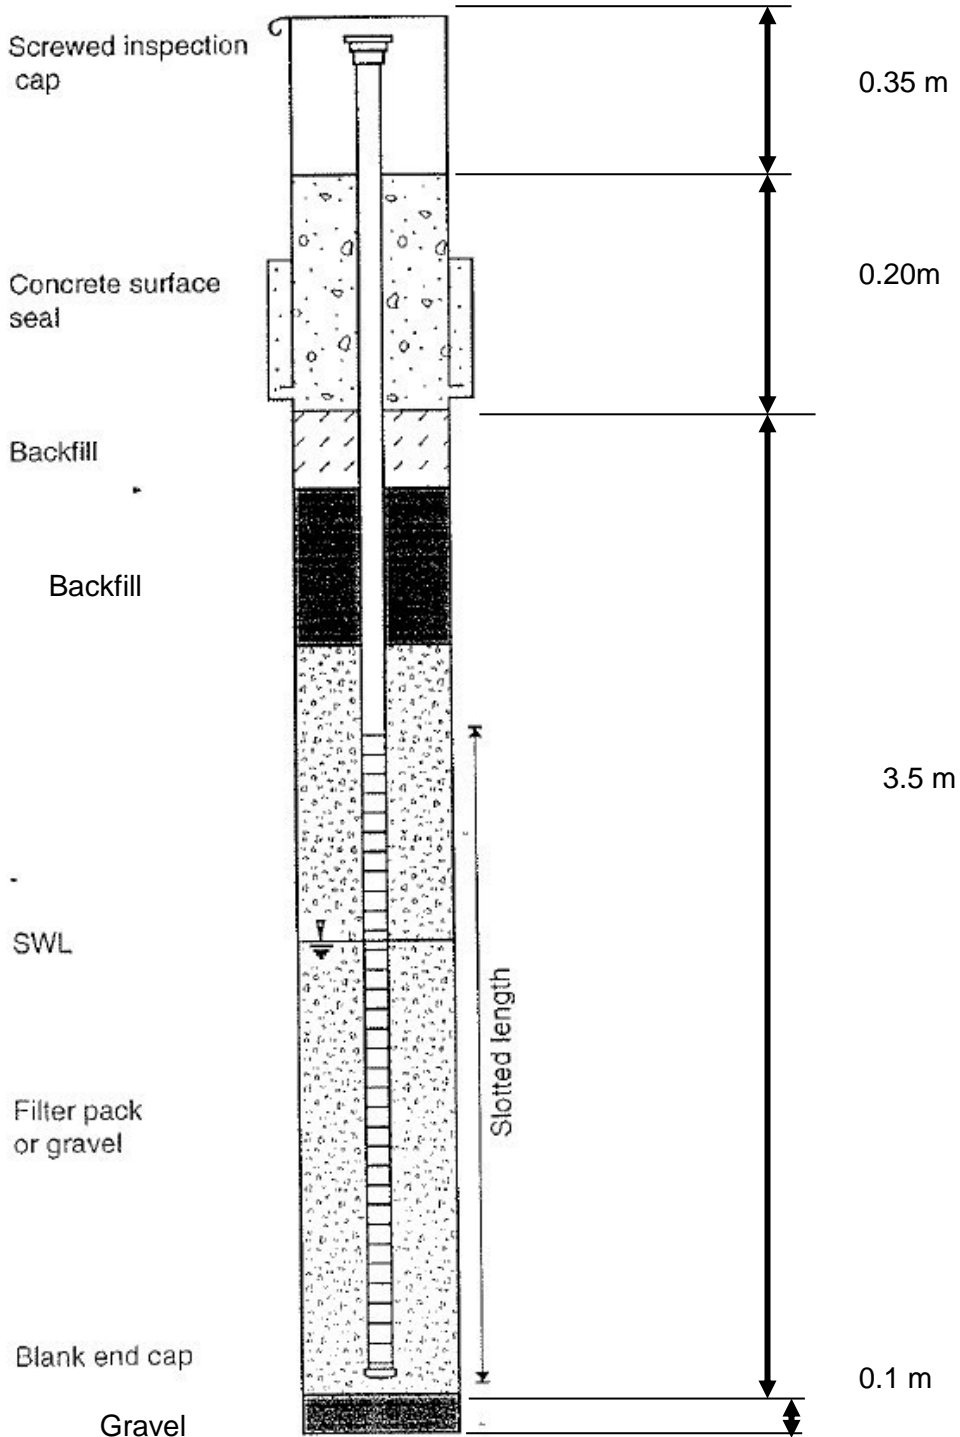
Monitoring wells – Remediation New Zealand - Uruti

CASING and SCREENS:

PVC: 51.8mm (2-in) satisfactory,
slotted screen.

- Final depths should be measured and recorded
- The slotted portion of the pipe should start 0.2m below the ground level as per the schematic. This is not the case in all the bores.
- The top of the monitoring well should be capped to prevent contaminants entering the bore
- The top of the casing should be 300 mm above the ground and sealed so that potential contaminants or small animals cannot get in.
- A 2 meters perimeter fence should be erected around the monitoring well (i.e, 0.5 x 0.5 x0.5 x 0.5)

Well construction information is also limited but deemed critical to the analysis of slug test data, and as such several of the parameters required for the Bouwer and Rice Method (1970) were estimated from the monitoring well schematic (Appendix A). These parameters were screen length, base of aquifer and the annular fill above the screen. It is therefore highly recommended that all future monitoring bores installed onsite, accurate bore logs and lithology below 2 m be described, along with accurate bore construction information as to allow recalculation of groundwater velocities.

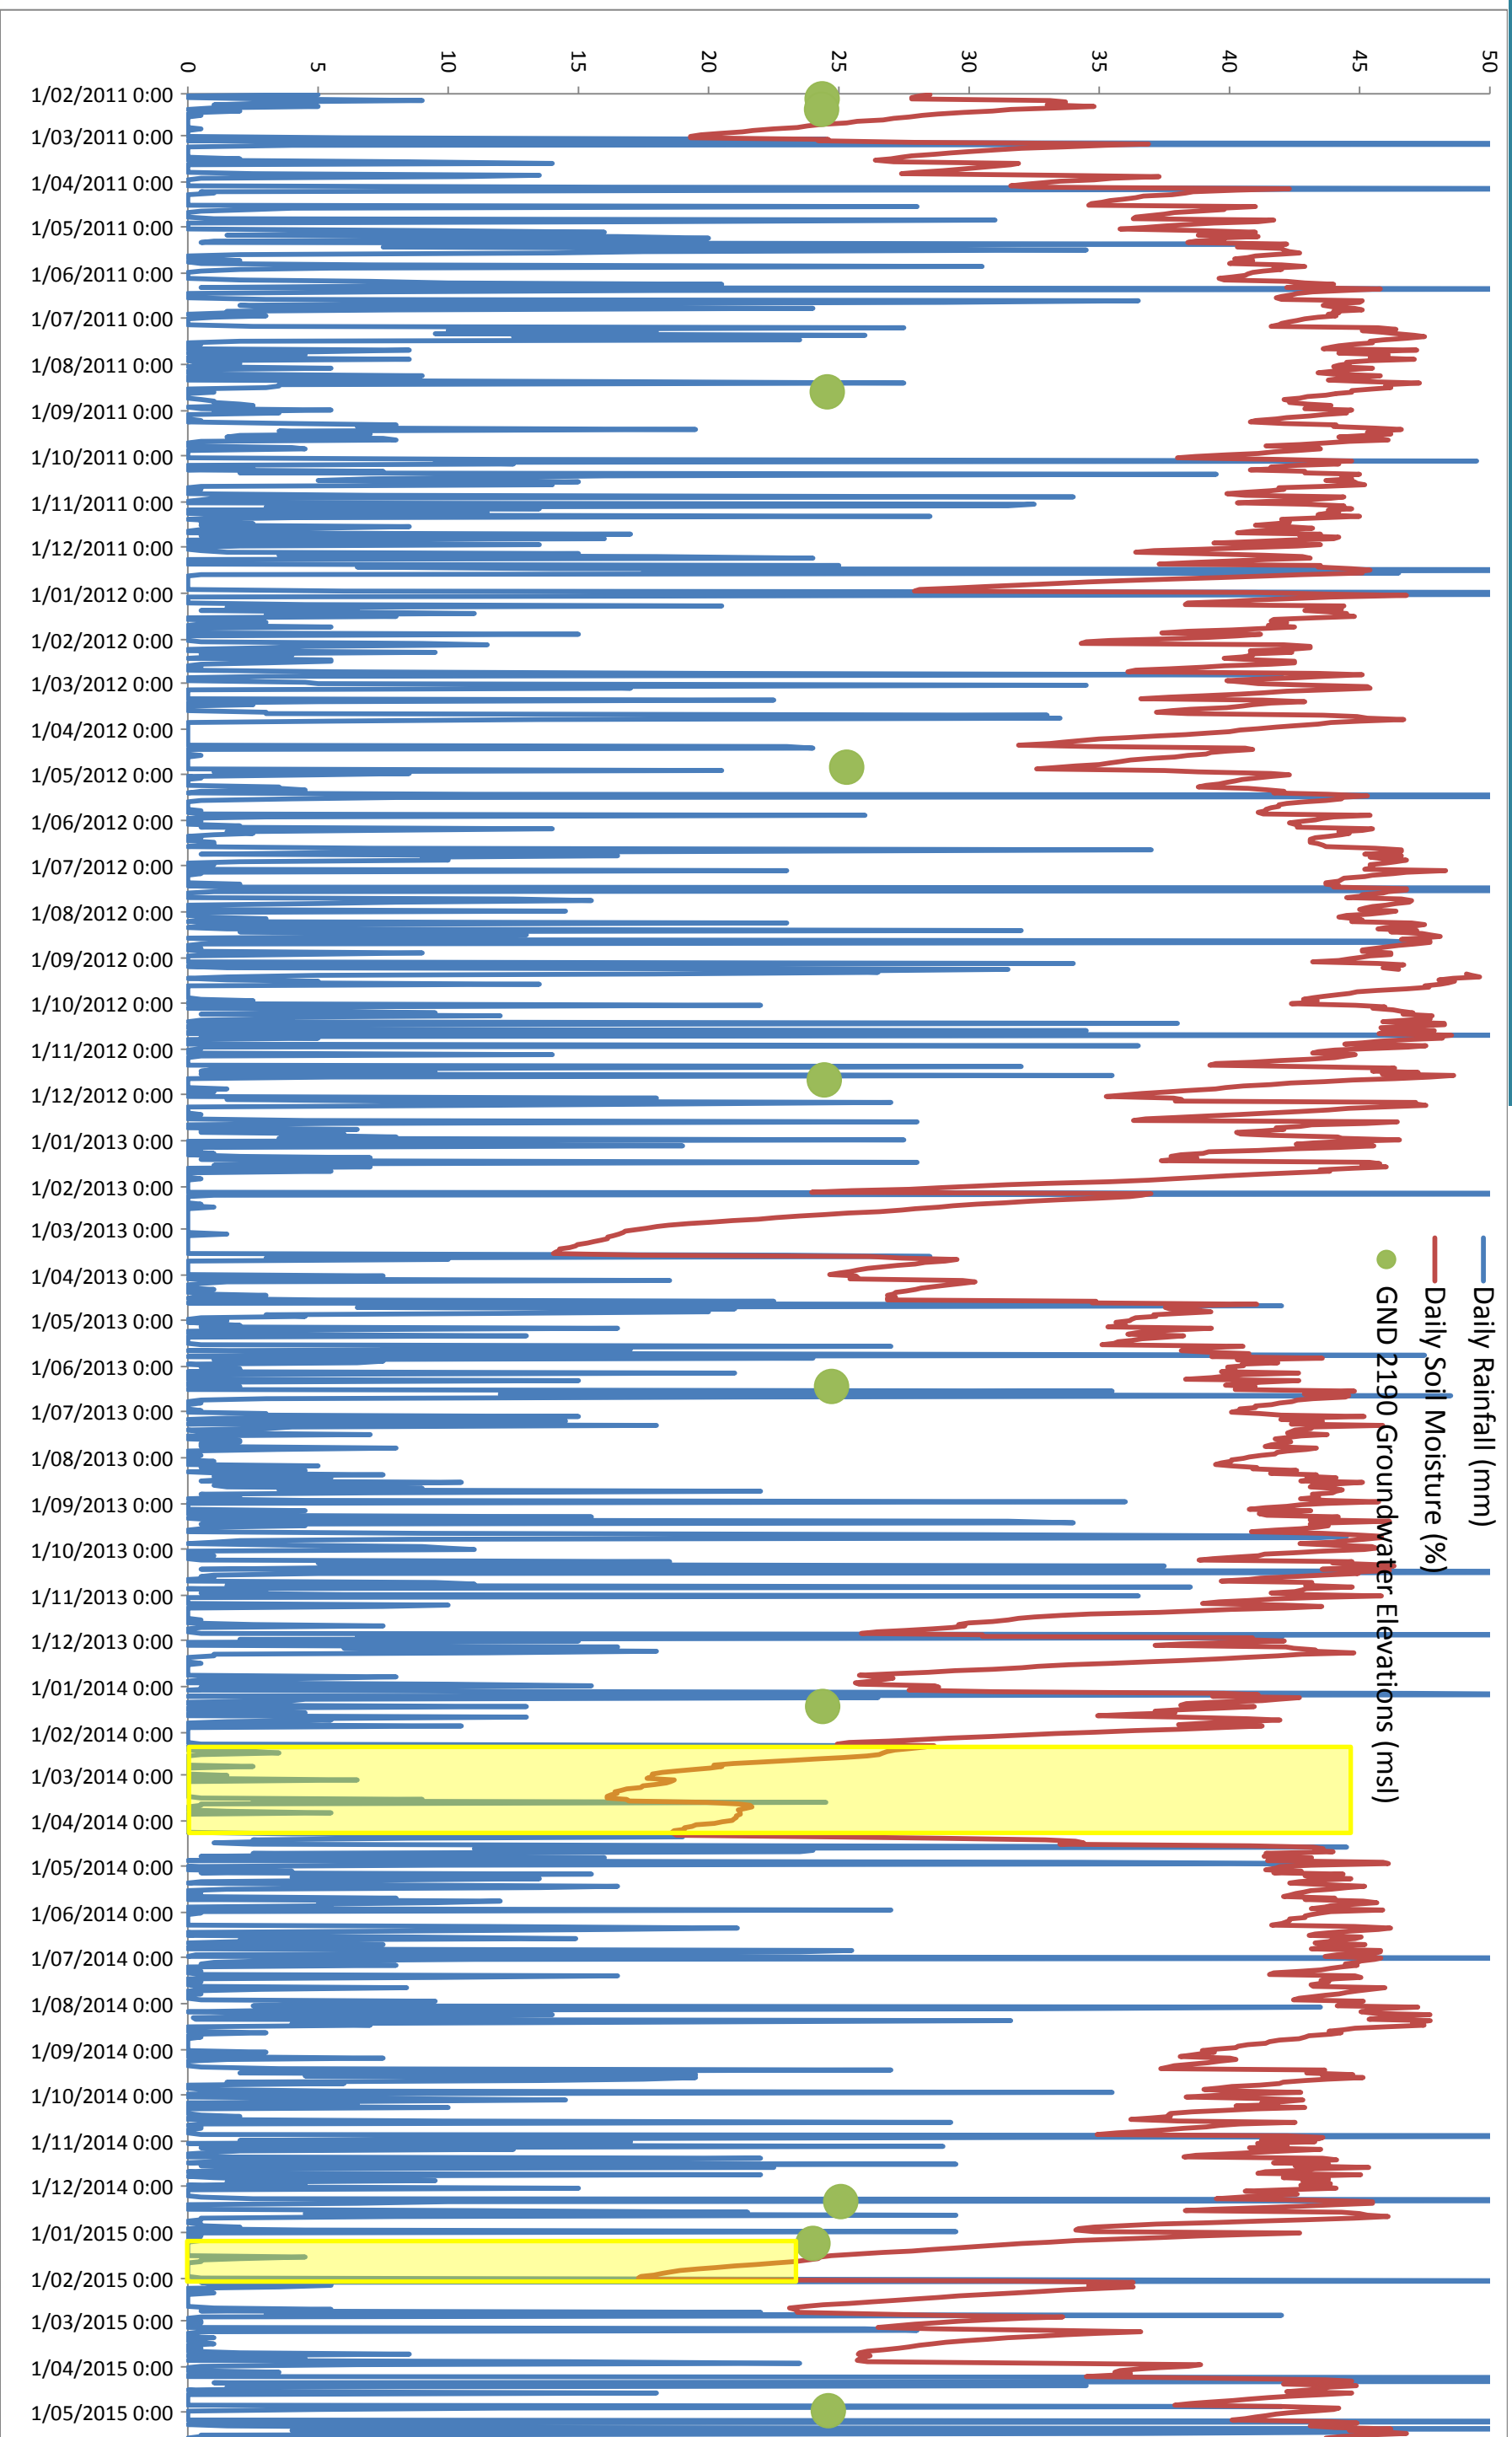
Examination of soil moistures (2003-2015), rainfall statistics, and available water chemistry data record elevated chloride within groundwater during periods of low rainfall and soil moistures (groundwater discharge to stream). During these periods groundwater levels (and most probably stream levels) are reduced (Table 2.1 & 2.2) and there is limited water within the hydrological system to attenuate the irrigated leachate. For example, the highly elevated chloride concentrations recorded in March 2014 in the Haehanga Stream and the monitoring bore GND 2190, coincided with the second lowest monthly rainfall total between 2003 and 2014, a very low soil moisture of 18% (yellow bars in figure below).

Uruti at Kaka Road Monthly Rainfall and Soil Moistures, yellow bars denote elevated Chloride concentrations in the Haehanga Stream and monitoring bore GND 2190

Appendix C goes some way to document how discharge/outflow events (i.e no rainfall, decreased soil moistures) and continued leachate irrigation results in elevated chloride concentrations in both the surface and groundwater resources. During these discharge events, where stream-flows are low over the summer months, the shallow groundwater table is most likely losing water to the Haehanga Stream. Therefore, limited water within the shallow groundwater table and the Haehanga Stream appears unable to attenuate the continued drainage losses of chloride through the soil profile as a result of continued irrigation.

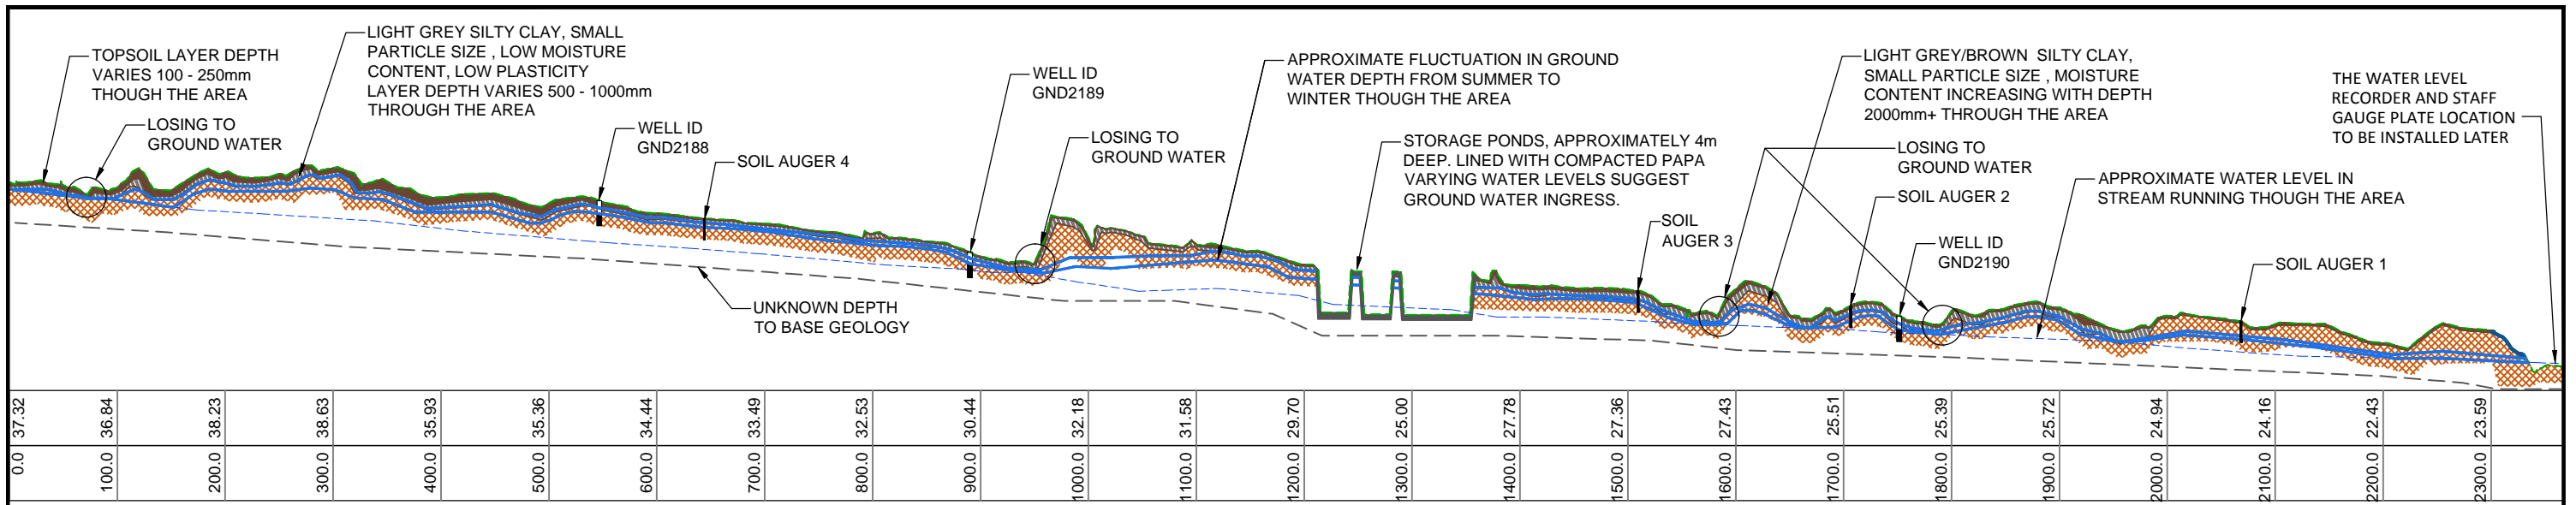
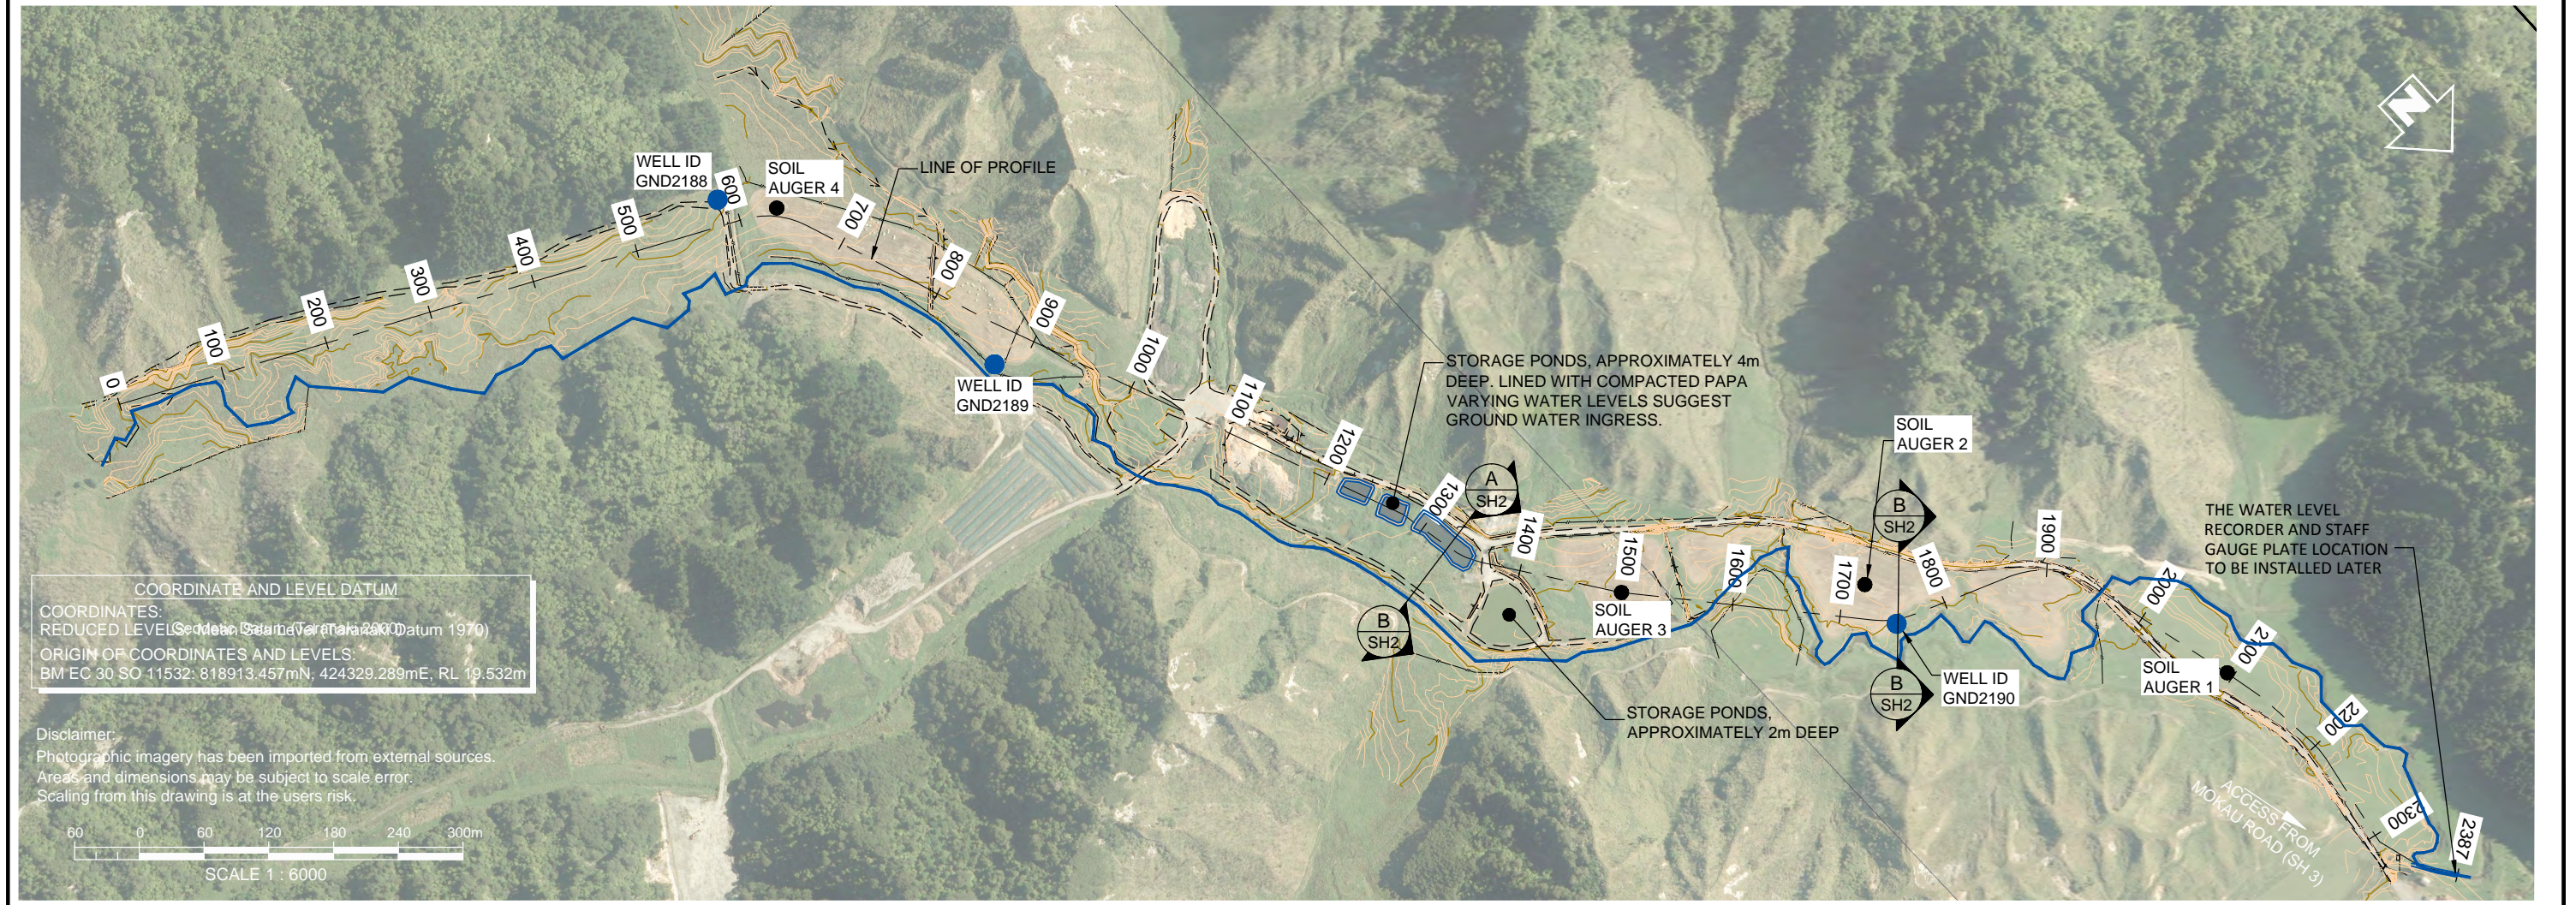
TITLE		REMEDATION (NZ) LTD	
		SOIL PROPERTIES	
		PLAN AND PROFILE	
ORIGINAL SIZE	DRAWING No.	SHEET	REVISION
A3	14745.01-01	1	00

PROFILE
 SCALE 1:6000 (A3) VERTICAL
 SCALE 1:600 (A3) HORIZONTAL

PLAN
 SCALE 1:6000 (A3)

The Topographic Survey formed the basis of the preliminary Conceptual Site Model (CSM) in Appendix D. The CSM was developed in Civil3E software, with all elevations in Mean Sea Level to the Taranaki 2000 Geodetic Datum. At present the CSM is unconfirmed and requires significantly more input to identify other potential contaminate sources and likely downstream receptors, both ecological and human. The preliminary CSM has however, defined the general hydrological setting in terms of hydraulic gradients down the Haehanga Stream, groundwater direction and hydrogeological interactions with the Uruti Composting Facility.

The preliminary Conceptual Site Model has been developed (Appendix D) but as yet is not confirmed. The CSM has identified potential hydrogeological 'exposure pathways' for contaminants in the Haehanga Catchment, such as the chloride loaded porous surface soils being in direct contact with the shallow water table, and the reaches of Haehanga Stream 'gaining' water from the groundwater table, adjacent GND 2190 in the lower irrigation zone. However, considerable more information is required to confirm the CSM, in particular the identification of downstream receptors for all contaminants potential leaving the site, not only chloride but also metal and hydrocarbons contaminants.

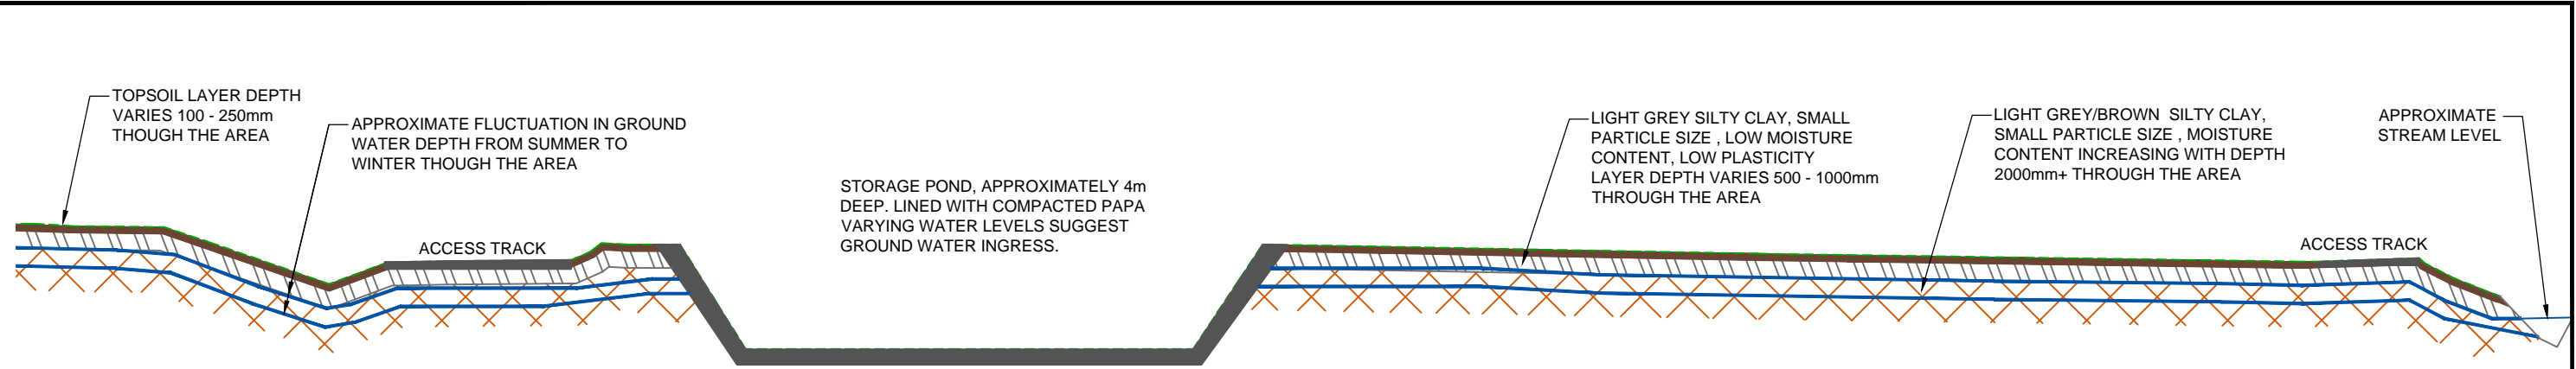
CROSS SECTION A-A
SCALE 1:250 (A3)

UNKNOWN DEPTH TO BASE GEOLOGY

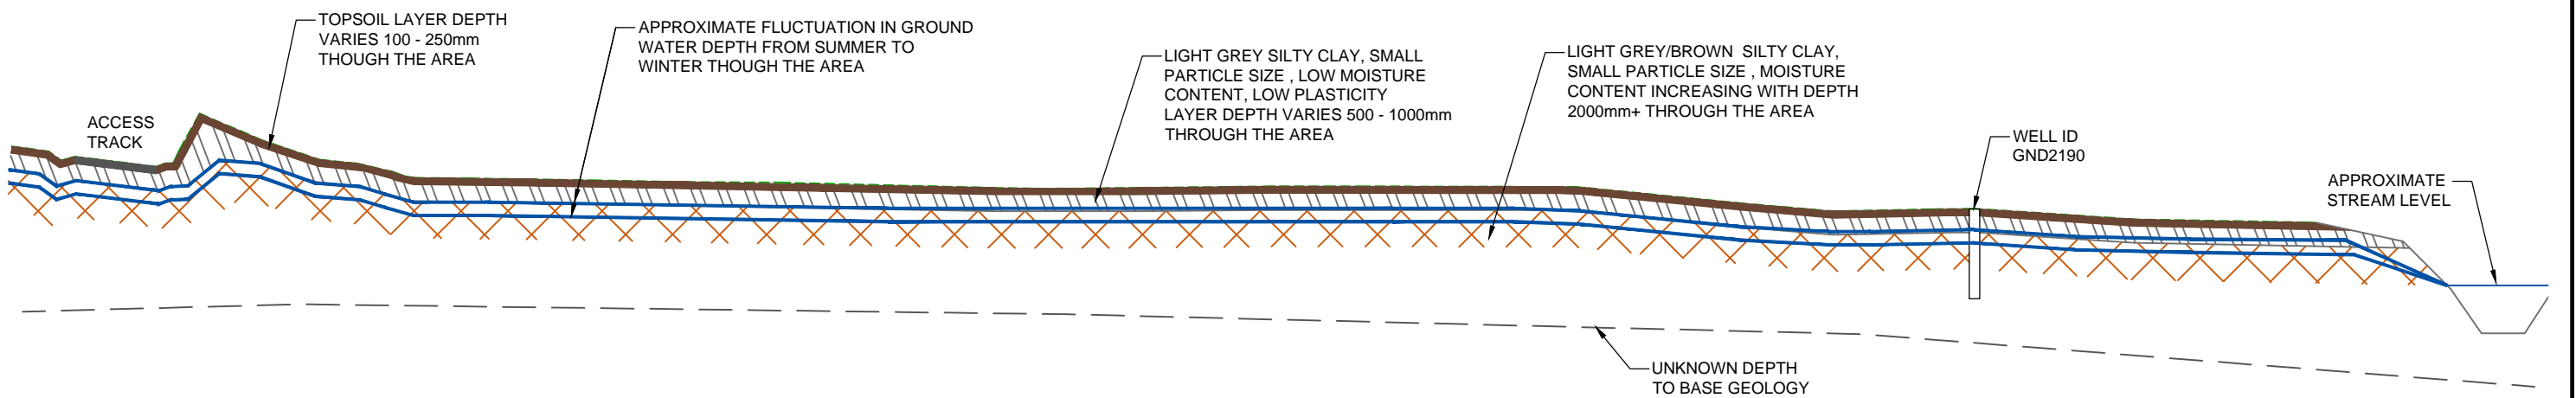
CROSS SECTION B-B
SCALE 1:250 (A3)

UNKNOWN DEPTH TO BASE GEOLOGY
