NPDC Coastal Structures
Monitoring Programme
Annual Report
2019-2020

Technical Report 2020-76

Taranaki Regional Council
Private Bag 713
STRATFORD
October 2020

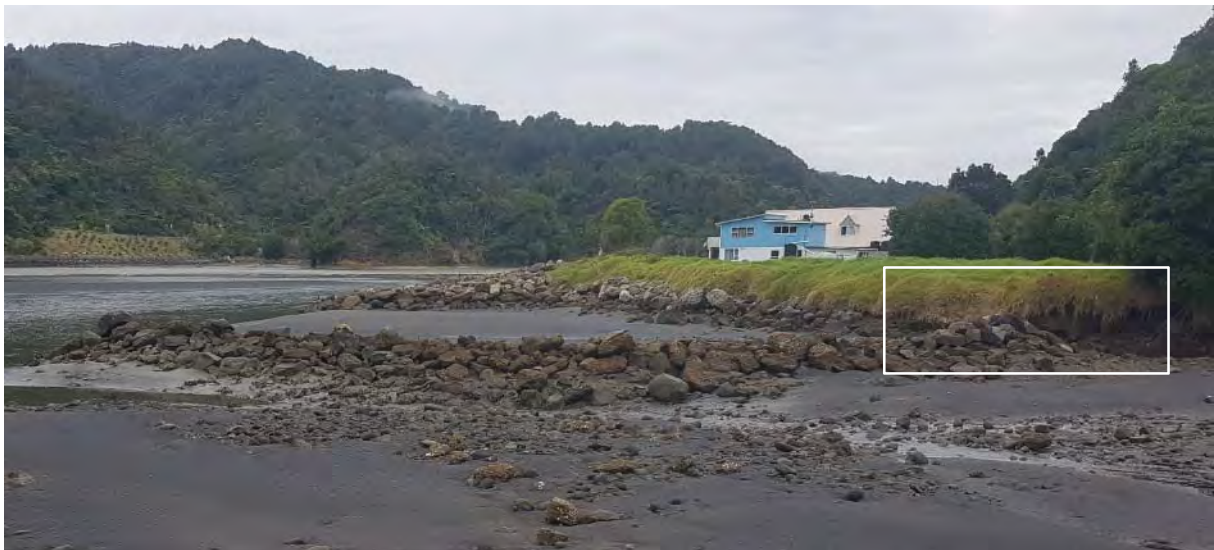
Rock groynes (permit 4818). The majority of this structure was found to be in good condition, however, a section of scoured bank had worsened since the previous inspection (Photo 1). Later in May, NPDC undertook maintenance works to resolve this issue. The groyne structure adjacent to the bank was built up in order to reduce the tidal currents that had been passing through and causing the erosion. During the inspection on 1 May, evidence was discovered of at least three penguin burrows in the land behind the rock work. As such, an additional inspection was carried out prior to the maintenance work in order to check for penguin burrows in close proximity to the work site. None were discovered.

Photo 1 Tongaporutu rock groynes with section of scoured bank in white box, 1 May 2020

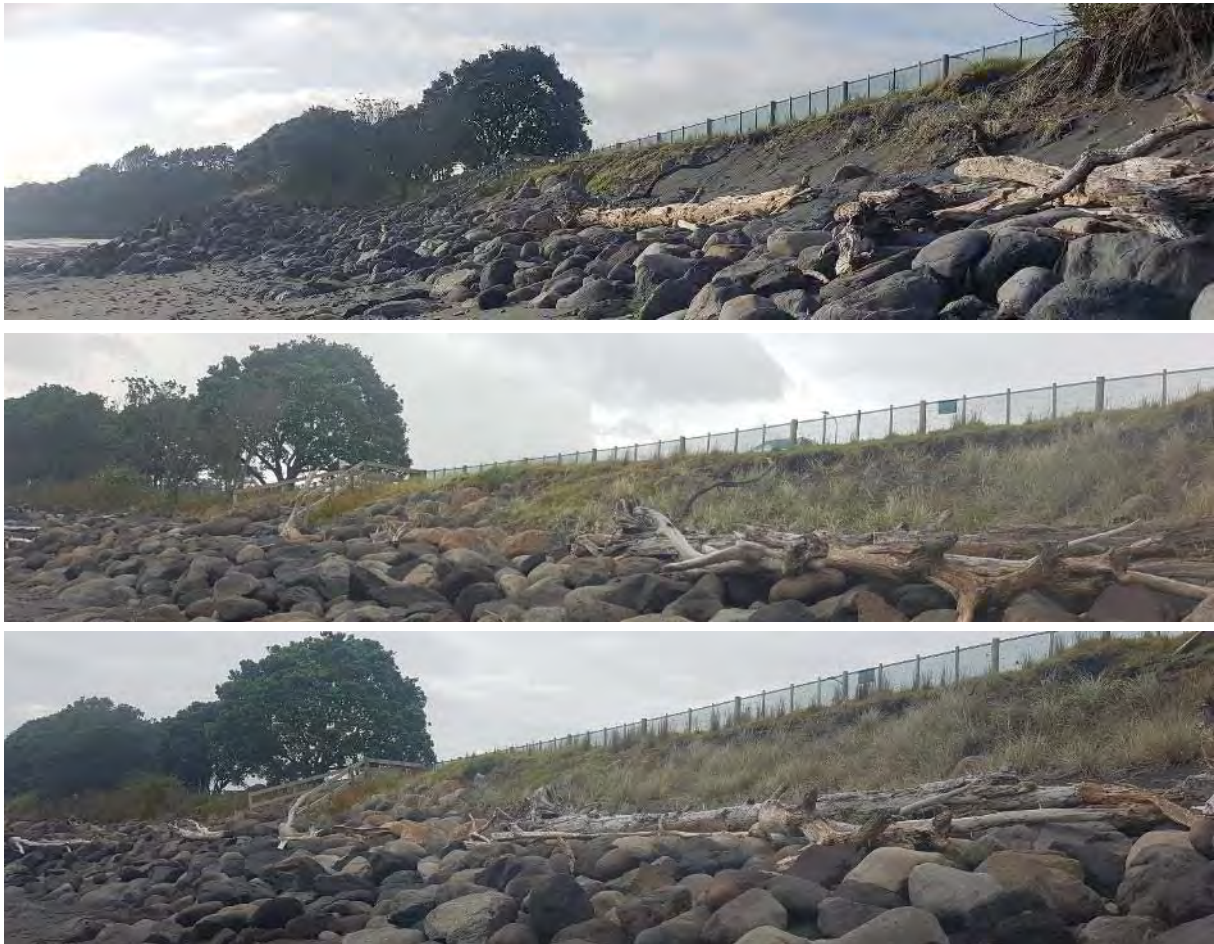
Urenui Beach rock rip rap seawall and half wall extension (permits 5761 and 7007). Aside from some minor scour at the top of the structure, the rock rip rap seawall had remained in good condition since the last inspection. No issues were noted with the half wall, either. Some sections along the foot of this structure were partially buried by sand. Behind the structure, the sand binding grasses now appeared to be fairly well established (Photo 2). Neither rip rap structure appeared to be causing end effects, based on these observations and photo comparisons. Numerous sets of penguin footprints were observed at this end of the beach, which is not unusual for this location.

Photo 2 Urenui Beach half-wall and dunes (top: May 2018, middle: May 2019, bottom: May 2020)

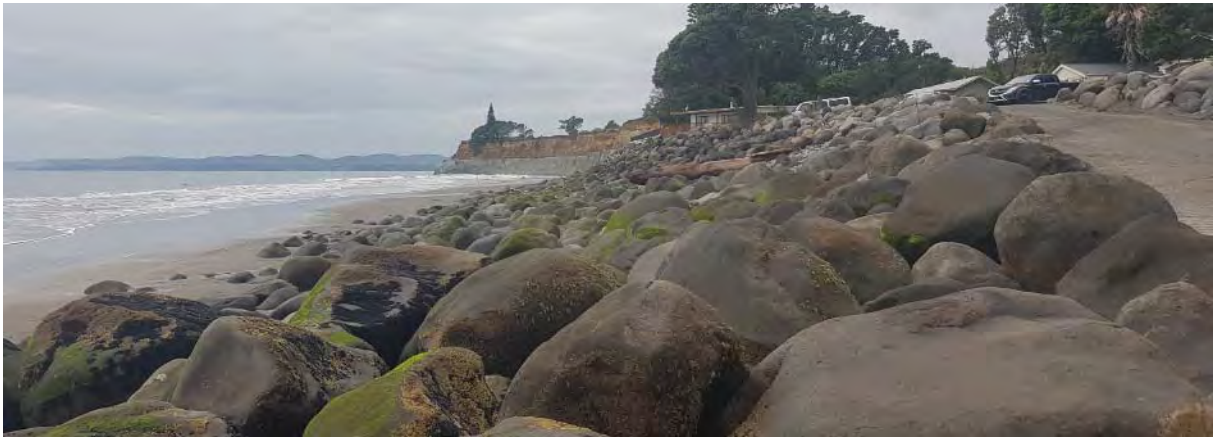
Rock rip rap seawall and incision repairs at Onaero settlement beach (permits 5035 and 10132). No major issues were noted with the seawall, and there did not appear to have been any obvious increase in erosion at the adjacent shoreline east of the structure. The lower half of this seawall appeared to be slumping slightly, with the gradient flattening out as it approached the beach (Photo 3). This will need to be monitored to ensure the structure does not deteriorate or increase its footprint by losing rocks and boulders down the beach. Further west along the beach, evidence of ongoing erosion was apparent, even behind the incision repairs themselves where sections of cliff were continuing to collapse (Photo 4). There appeared to be slightly more sand at the top of the beach than during the last inspection.

Photo 3 Onaero Beach seawall gradient, May 2020

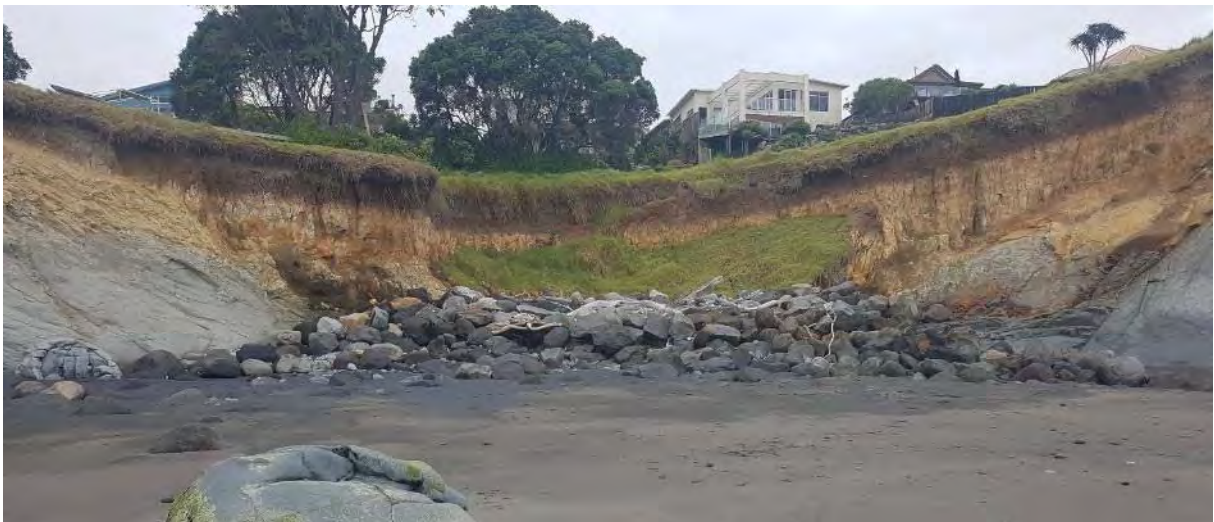
Photo 4 Onaero beach incision repair and eroding cliffs, May 2020

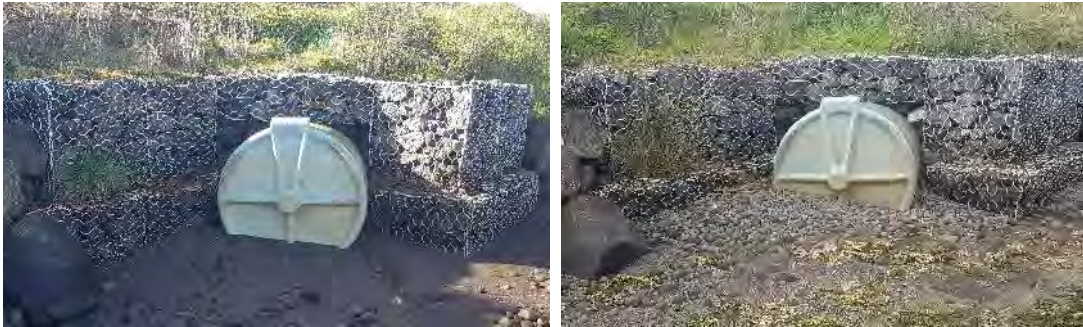
Stormwater outlet structure at the Atkinson Street/East Quay intersection (permit 6525). No major issues were identified with the outlet or surrounding gabion baskets, however, sand and gravel in front of the outlet was holding the flap shut (as it was during the previous inspection; Photo 5). The Council is not aware of any resultant drainage issues.

Photo 5 Atkinson/East Quay stormwater outlet (left: May 2019, right: May 2020)

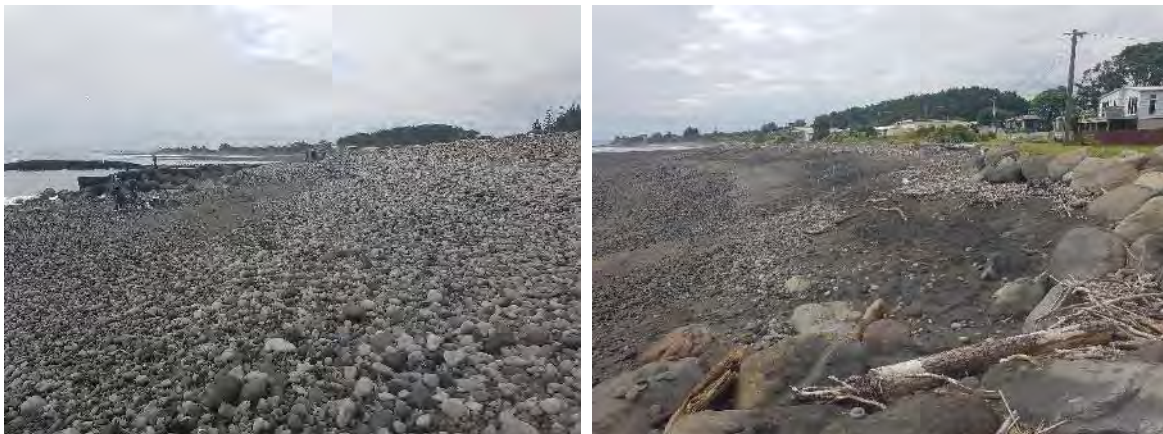
River mouth groyne structures (permits 4600 and 9328). The condition of the structures themselves did not appear to have changed markedly from the previous inspection. As per the previous inspection, the beach on the western side of the river mouth retained a high volume of mixed cobbles and sand. In comparison, the shoreline of the eastern beach was further landward, and there were less cobbles present (Photo 6). During recreational water quality monitoring undertaken earlier in the year, Council Officers observed the eastern beach shoreline eroding into the sea due to wave action at high tide. Following these observations, aerial imagery was examined with regard to this changing shoreline. The analysis is presented and discussed in Section 3.2.

Photo 6 Waitara West (left) and East (right) beaches (both photos facing east), May 2020

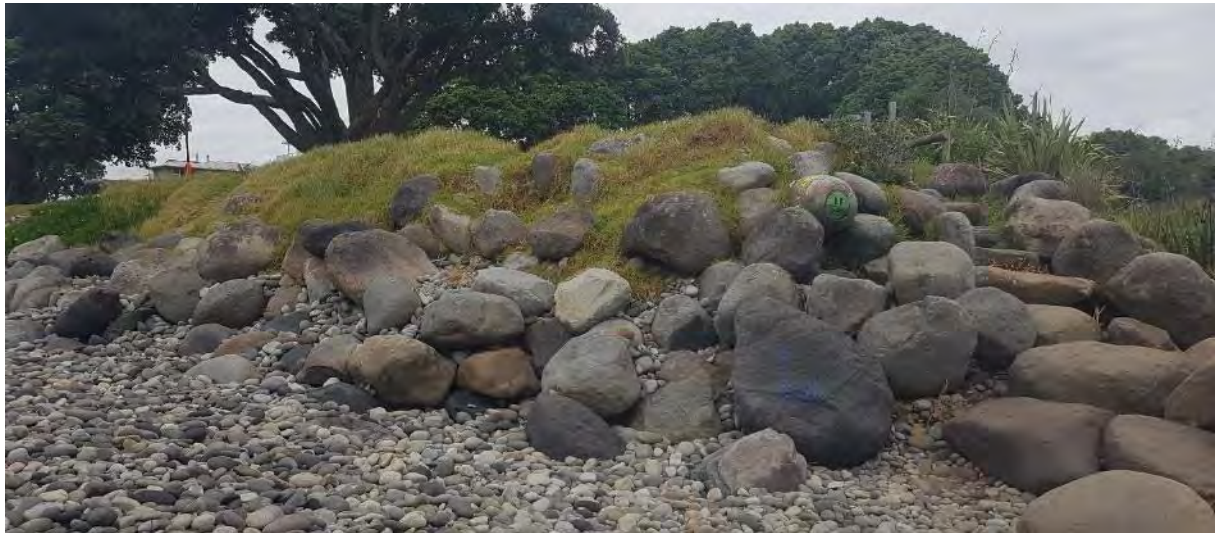
Bell Block rock rip rap seawall (permit 5102). The structure did not appear to have undergone any significant changes since the previous inspection. More cobbles had been pushed up the beach and were covering large sections of the seawall. The rock work surrounding the access steps had hollowed out, leaving some boulders in a slightly perched position (Photo 7). Upon closer examination of the foot of the seawall, some of the boulders appeared to be moving away from the structure and migrating down the beach (Photo 8). No obvious end effects or erosion issues were noted, based on this visual inspection.

Photo 7 Bell Block Beach access way, May 2020

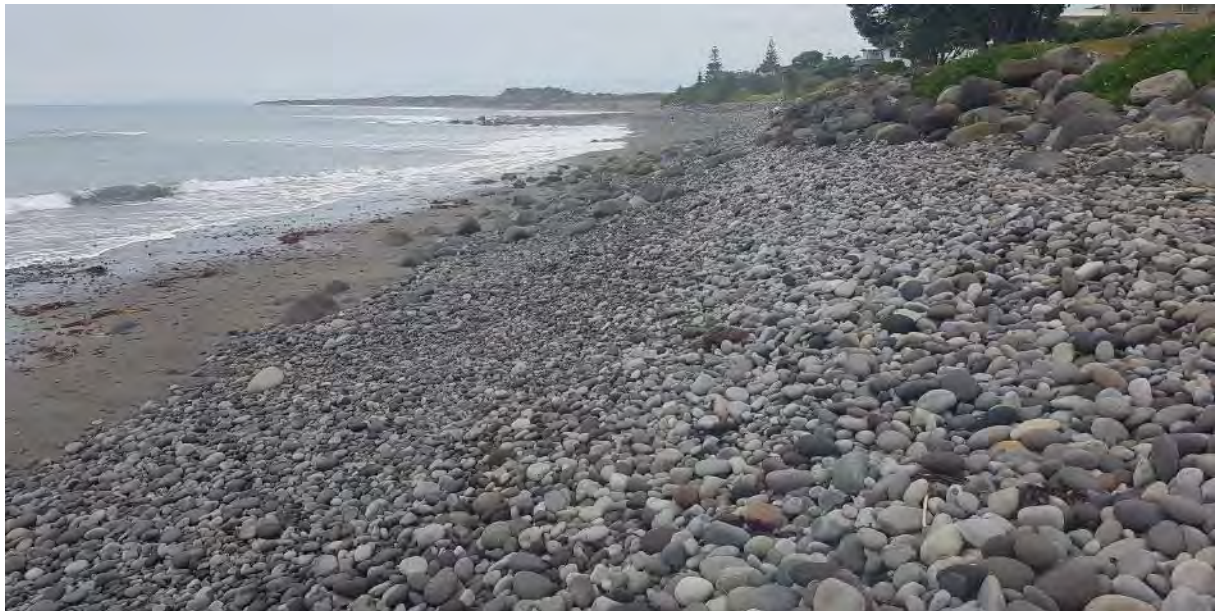
Photo 8 Bell Block seawall with some boulders further down the shore, May 2020

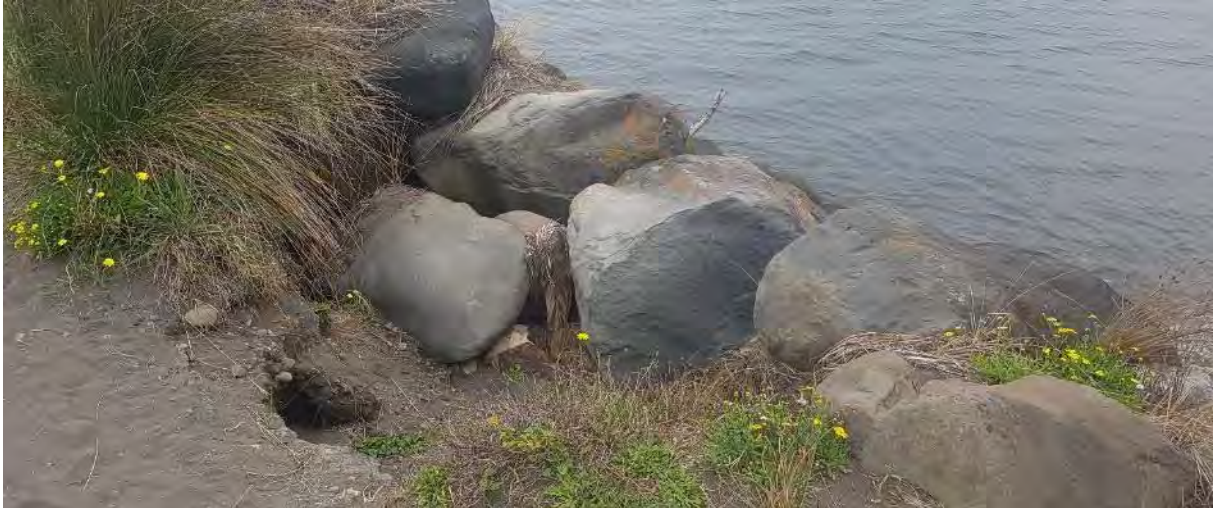
Waiwhakaiho groyne (permit 4585). No major issues were noted with the groyne itself. A small scoured section was noted at the top of the rock work, on the riverine side (Photo 9). The beach volume on the western side of the groyne was comparable to the previous inspection (Photo 10). No obvious end effects or erosion was noted, based on these visual observations.

Photo 9 Small scoured section on Waiwhakaiho groyne, May 2020

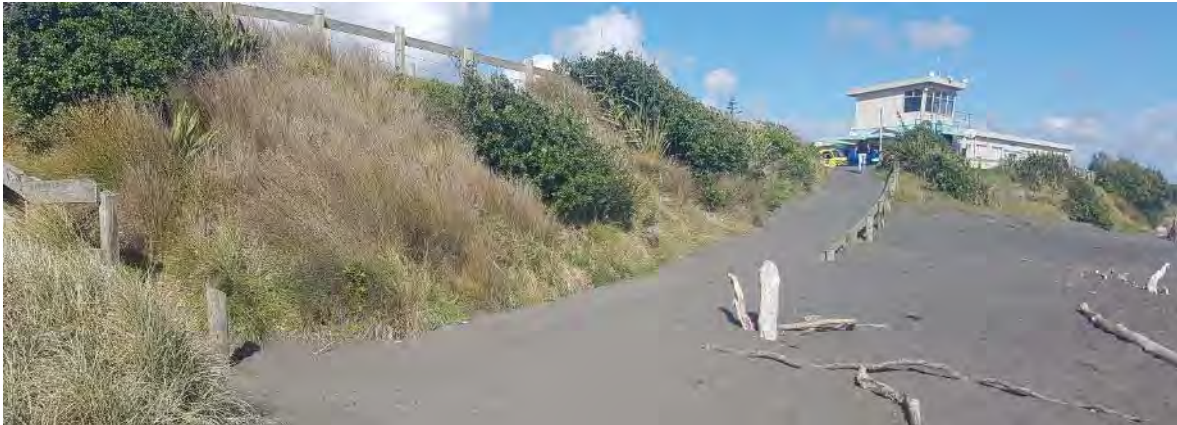
Fitzroy stormwater outlet, boat ramp and surf club protection structures (permits 4596 and 4586). The stormwater outlet structure was mostly buried by sand, and therefore could not be assessed. Similarly, the build up of sand in front of the surf club meant that the boat ramp and protection works were partially buried (Photo 11). Based on what was visible, the structures appeared to be in a satisfactory condition. The extent of the sand build up was such that NPDC undertook maintenance works in November 2019 to clear excess sand from the boat ramp, as the Fitzroy Surf Life Saving Club were unable to use it to launch their IRBs.

Photo 11 Sand build up on Fitzroy boat ramp, April 2020

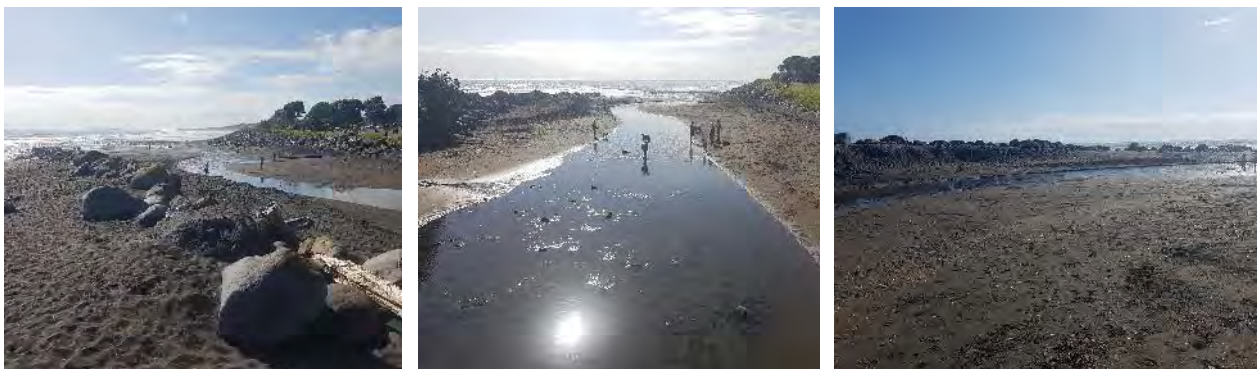
Te Henui stormwater outlet, river protection and groyne (permits 6096, 6242 and 4587). The gabion baskets associated with the stormwater outlet had not yet been repaired at the time of the inspection, and were still slumping inwards. The river protection rock work remained in good condition. On the seaward side of the bridge much of this structure was buried by sand. Similarly, a significant volume of sand had built up on the western side of the Te Henui groyne, and on the eastern river side, which was burying much of the rock work (Photo 12). Based on what was visible, the groyne appeared to be in good condition. These visual observations did not identify any end effects or erosion on the beach to the east of the structure.

Photo 12 Sand build up at Te Henui groyne, April 2020

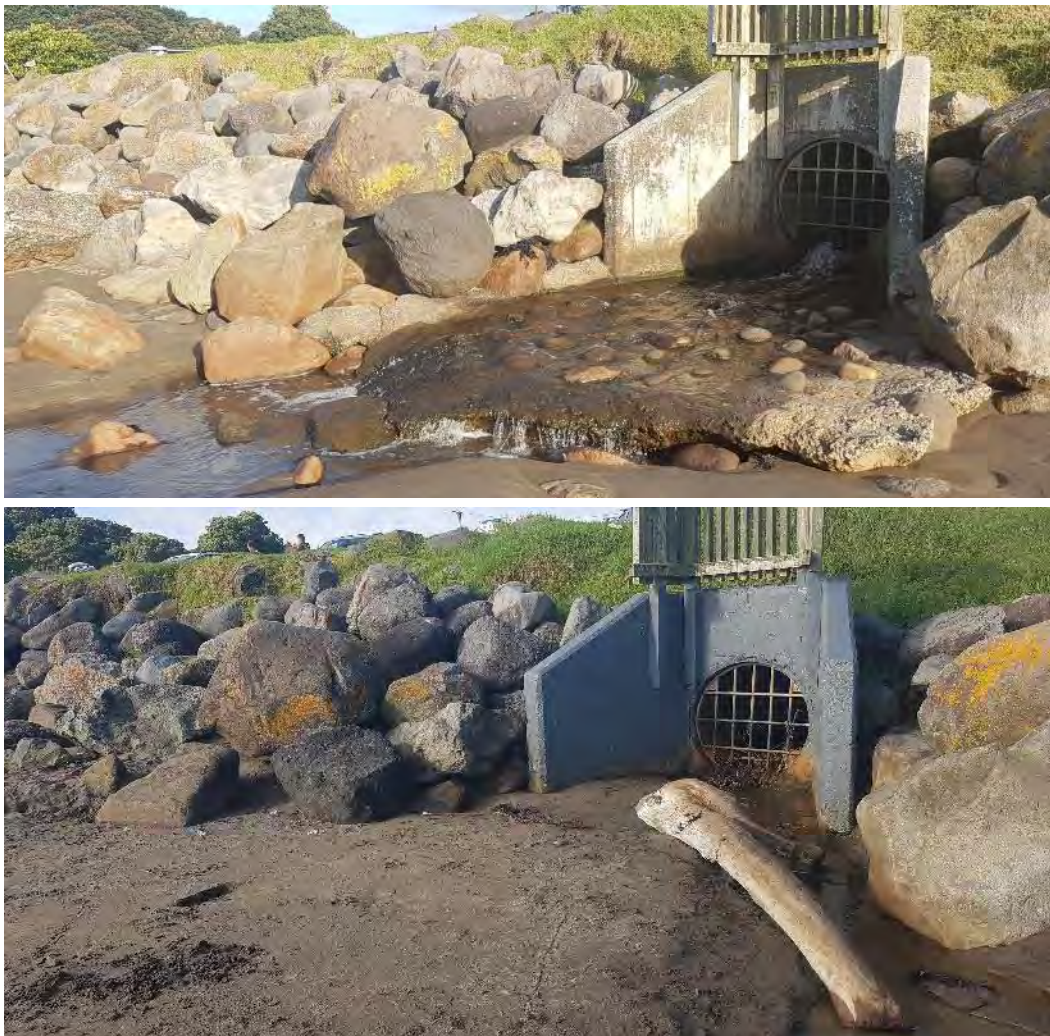
Ngamotu Beach central stormwater outlet and Hongihongi Stream outlet (permits 5182 and 4592). No issues were identified with either structure. Evidence of sand build up was apparent at both outlets, with the concrete pad beneath the central outlet being completely buried (Photo 13).

Photo 13 Ngamotu beach stormwater outlet (top: May 2019, bottom: April 2020)

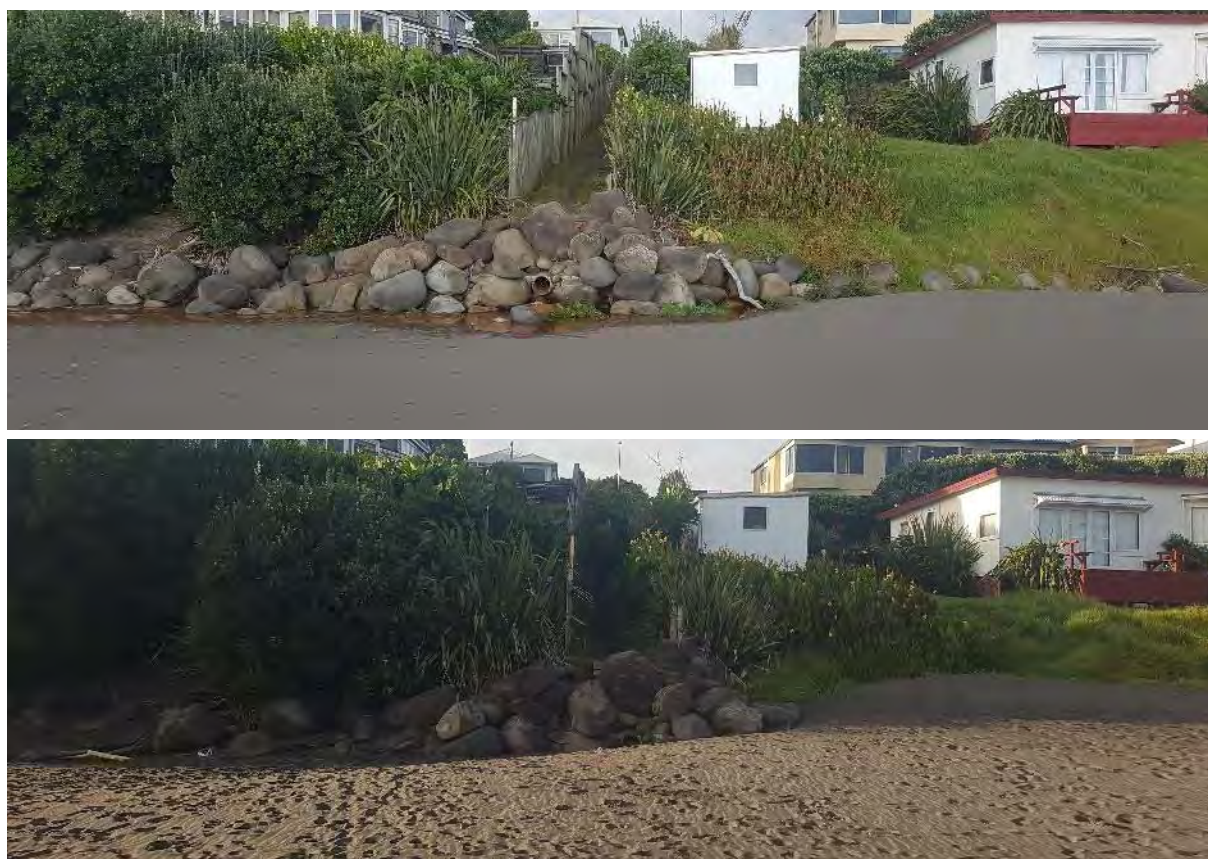
Messenger Terrace stormwater outlets (permits 5412 and 5223). Both structures appeared to be in a satisfactory condition. The sand volume on this area of the beach had increased considerably from the previous year (Photo 14). As a consequence, stormwater drainage at these outlets appeared to have worsened; causing pooling at the base of the outlets and subsequent tracking along the top of the beach.

Photo 14 Messenger Terrace stormwater outlet at beach access (top: May 2019, bottom: April 2020)

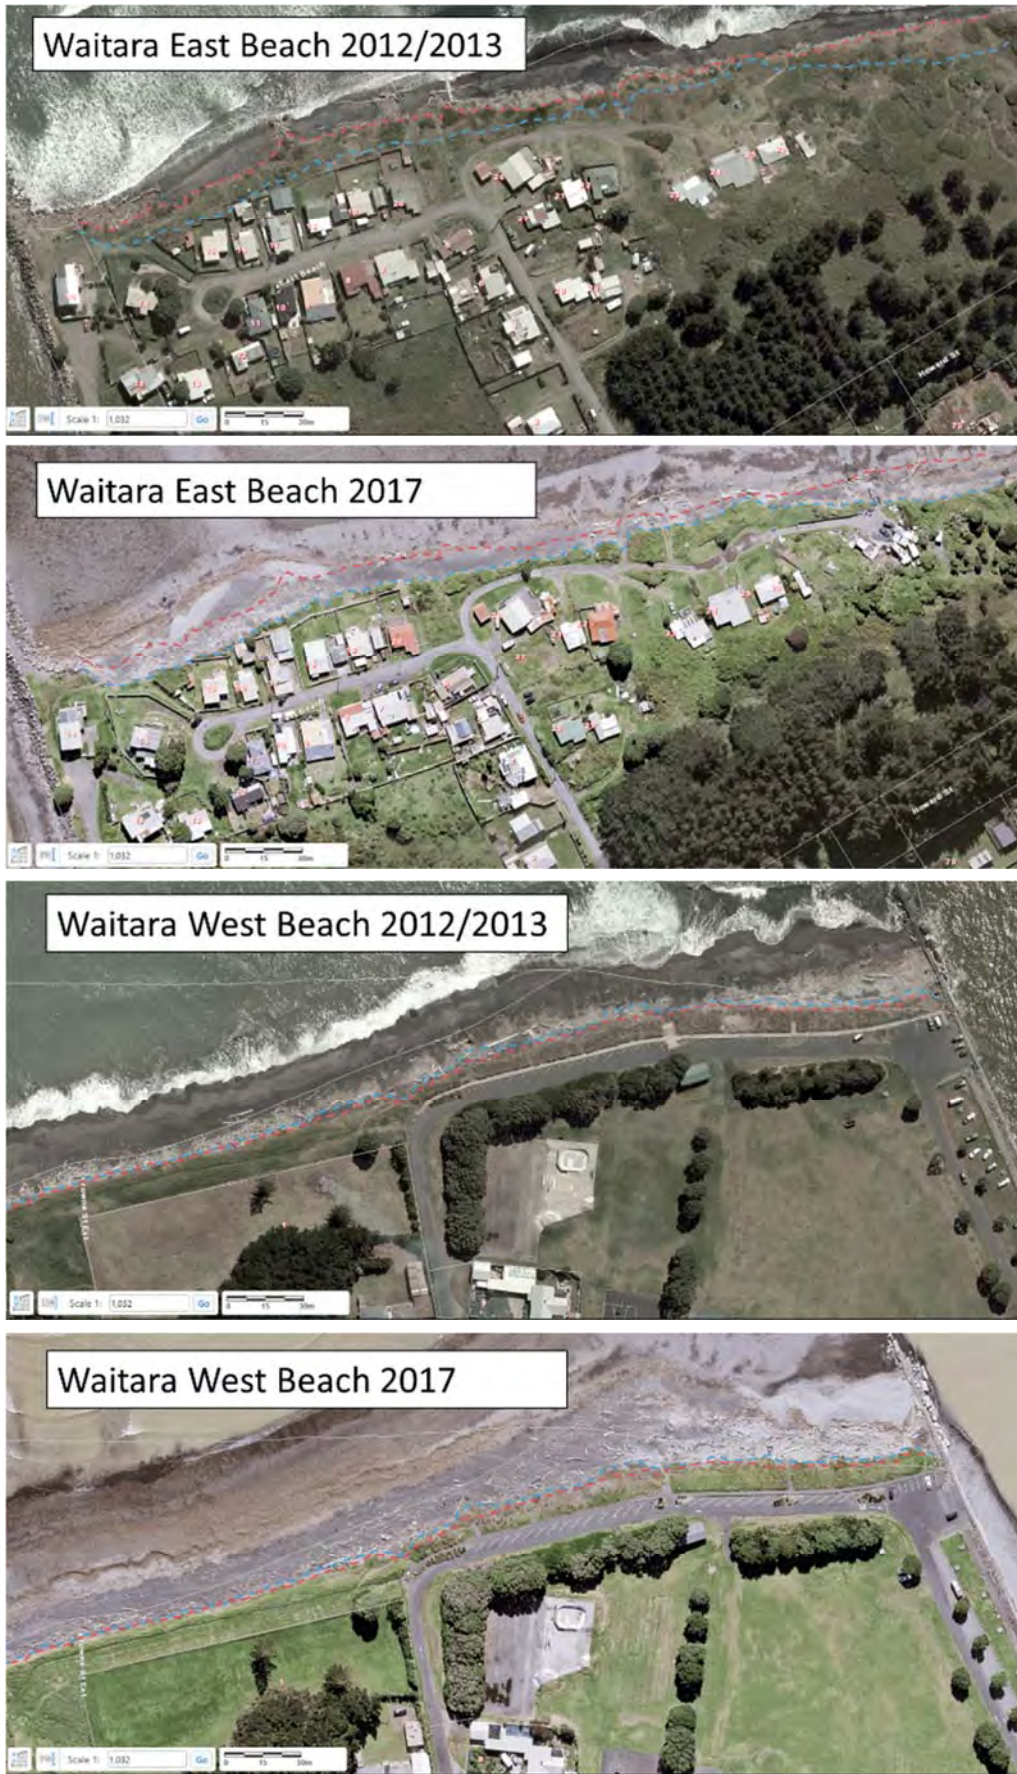
Figure 4 Waitara Beach shoreline change (red line: 2012/13 shoreline, blue line: 2017 shoreline)
