NPDC Coastal Structures
Monitoring Programme
Biennial Report
2012-2014

Technical Report 2014–89

March 2015

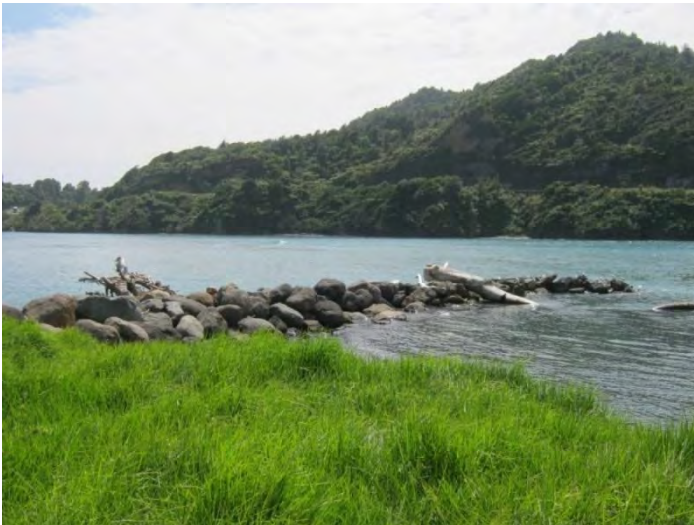
Photo 1 Rock groyne at Tongaporutu (May 2014)

There are two sections of gabion basket seawall and four groynes situated on the true left bank of the Tongaporutu River, within the coastal marine area of the Tongaporutu Estuary (Photo 1). The two sections of gabion basket seawall have been in existence for many years, and essentially protect the adjacent land from inundation, flooding, and erosion. While it is recognised that the four groynes affect long-shore sediment

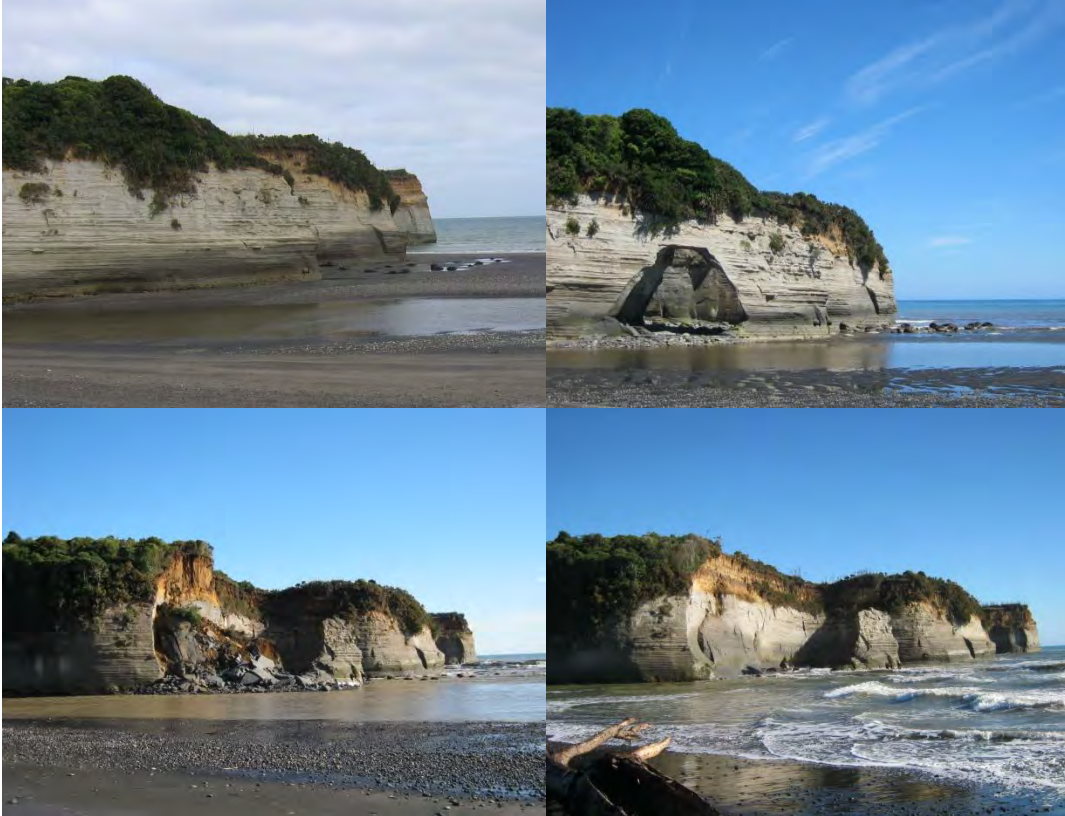
Photo 2 Urenui Beach coastal erosion
(Clockwise from top left - August 2009, December 2012, June 2013, May 2014)

An active program of sand push-ups and dune restoration is applied in order to help manage erosion on the beach (Photo 3).

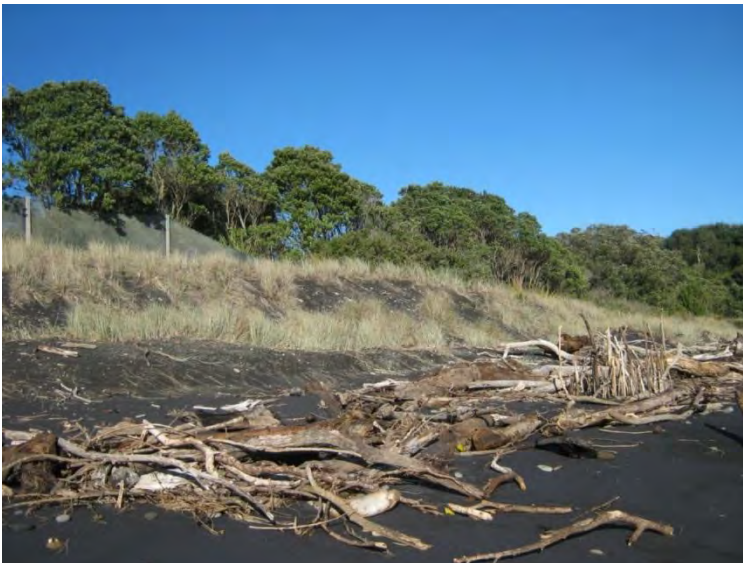
Photo 3 Sand push-up and dune restoration (May 2014)

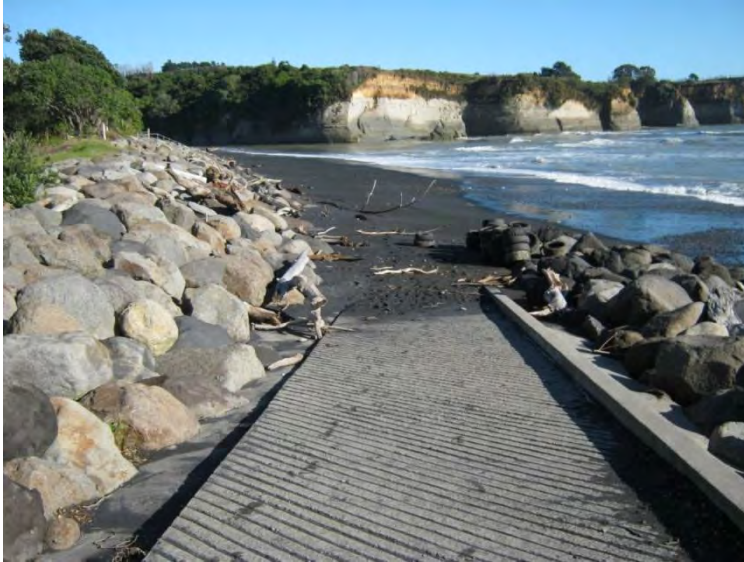
Photo 4 Urenui beach access and rip rap wall (May 2014)

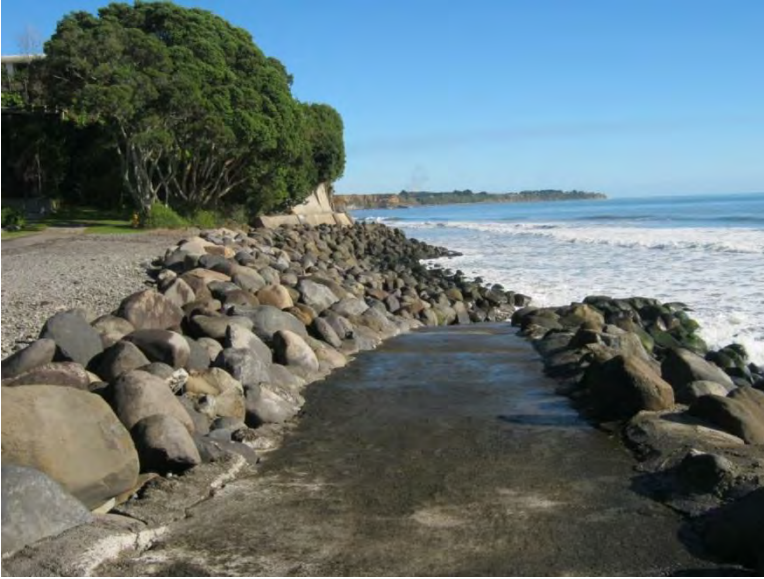
Onaero Beach is also a mixed sand and cobble beach situated between two papa headlands on the North Taranaki coast. The seawall is bounded on the east by papa cliffs with limited beach at low tide, with little to no beach present at high tide. The eastern end of the seawall protects private property containing a residential dwelling. The central section protects road reserve, again with limited beach at low tide, and little to no beach present at high tide. The western section predominantly protects Crown owned Recreation Reserve administered by NPDC around the middle headland. The seawall then ties into papa cliffs at its western end. These papa cliffs extend down about 300 m to the western headland. Differential erosion along this section is directly related to the variations in the top height of the papa layer. The western end of Onaero Beach beyond the seawall is characterised by a predominantly sandy beach backed by a cobble berm against the coastal cliff. This area is backed by NPDC owned Recreation Reserve, set up as a coastal hazard zone in recognition of the historical erosion rates within this area at the time of subdivision in the 1970's.

Photo 5 Onaero Beach seawall (May 2014)

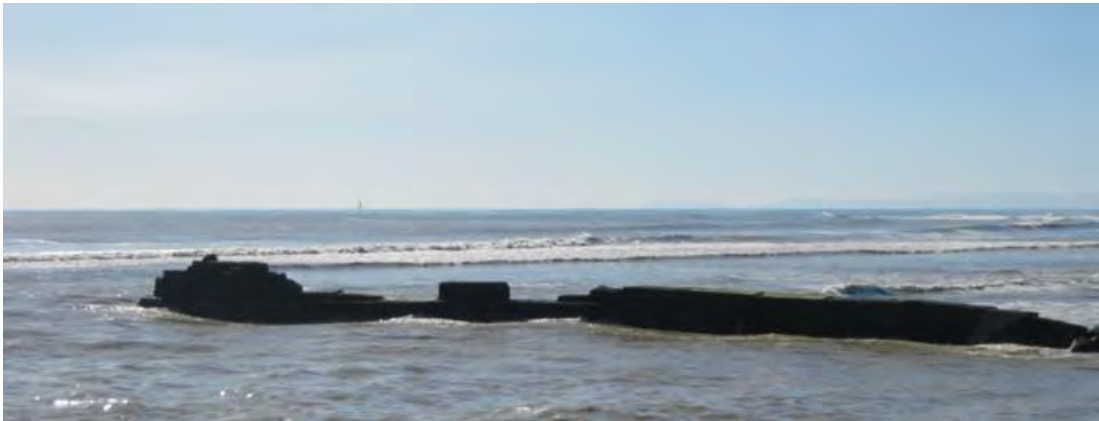
- 1885: Mouth confined to 70 m width between East and West Moles built of concrete;
- Floods during 1965, 1967 and 1971 demolished parts of the East Mole, resulting in a 110m long section being replaced with a half tide wall;
- A massive flood in 1990 further damaged the East Mole, partly demolishing the half-tide wall and inner concrete blocks. By 1996, only 60 m of the concrete blocks comprising the outer detached East Mole remained
- The West Mole has remained essentially intact (some outer blocks have tilted as a result of scour in the 1930's and 1950's but have remained *in situ*).

Photo 6 Remains of East Mole, Waitara River Mouth (May 2014)

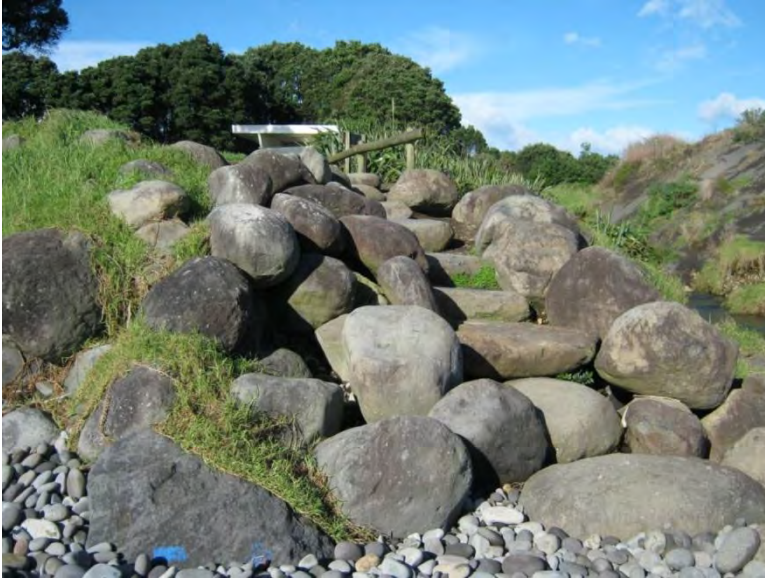
Larger rocks were placed to form a rock step access to replace the existing wooden steps that were used for public access to the beach (Photo 7). NPDC built a protection structure up the stream as far as the gabion retaining wall on the true right bank for the Mangati Stream. Consent 5102-2 expired in June 2008 and this was replaced by 5102-3 in May 2008.

Photo 7 Rock step access to Bell Block Beach (2014)

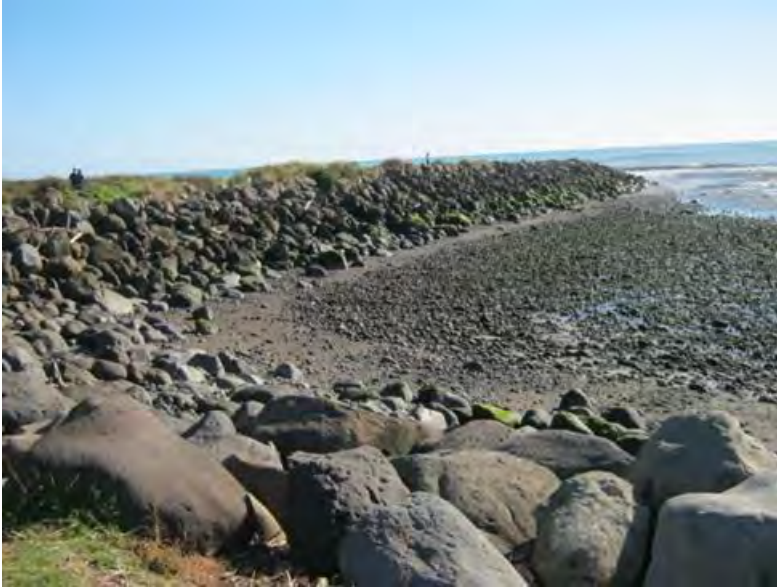
In June 1994 the Waiwhakaiho groyne was licensed by coastal permit **4585** under the RMA. In 1996 the tip of the groyne was reconstructed following its collapse. At this time it was noted that while the exact length of the groyne was not certain, the length should not exceed 100m.

The Tonkin & Taylor report (2001) noted that the groyne had trapped a large volume of sand material on Fitzroy Beach on the up-drift side of the structure, with a probable corresponding sediment starvation and possible accelerated erosion on the northeast side of the river. However, Tonkin & Taylor also noted that the up-drift fillet on Fitzroy Beach created by the groyne may be nearly full, with the beach extending the full length of the structure. Hence, if there are no alterations to the groyne, higher volumes of sediment are likely to bypass the structure in the future, resulting in a higher rate of supply to the beach to the northeast and a corresponding reduction in erosion potential.

Photo 8 Waiwhakaiho groyne (May 2014)

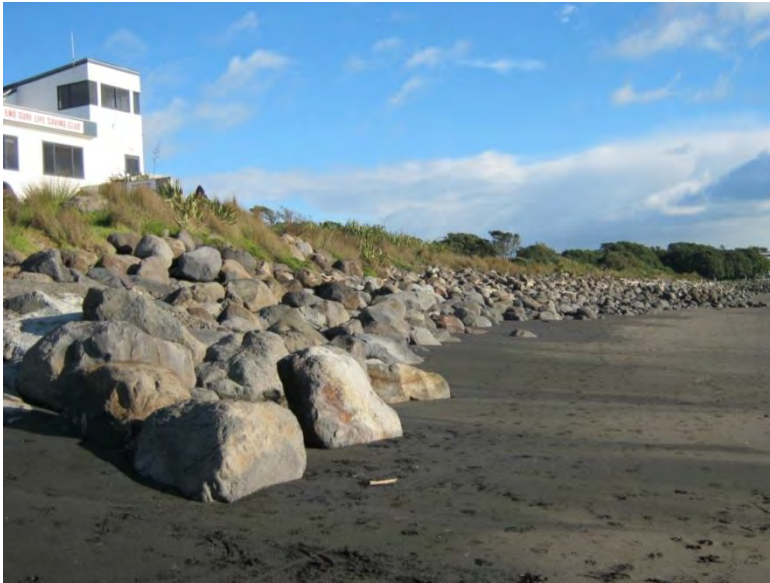
There is a concrete boat ramp and rock riprap seawall in front the East End Surf Life Saving Club. This was built before 1930, with additions made in 1954 and boulder armour placed in 1980 (Tonkin & Taylor 2001). In 1994 NPDC applied for a coastal permit to construct a boulder rock rip rap seawall extending from East End to the mouth of the Te Henui Stream a distance of about 290 m, (Photo 9). Following a notified consent process coastal permit **4523** was granted in November 1994. An application for a change to consent conditions of coastal permit 4523 to provide for a variation in the cross-sectional design was granted in May 1995. The seawall was subsequently constructed in June/July 1995. It is noted that surveys of beach profiles prior to construction (January 1995) were forwarded to Council in July 1995. In accordance with the requirements of special condition 3 of coastal permit 4523, four beach profiles were set up and surveyed in August 1995 for monitoring purposes.

Changes to consent 4523 were granted in May 2005. These changes allowed an extension of the seawall from 290 m to 355 m.

Photo 9 Rip rap seawall in front of East End Surf Life Saving Club (June 2013)

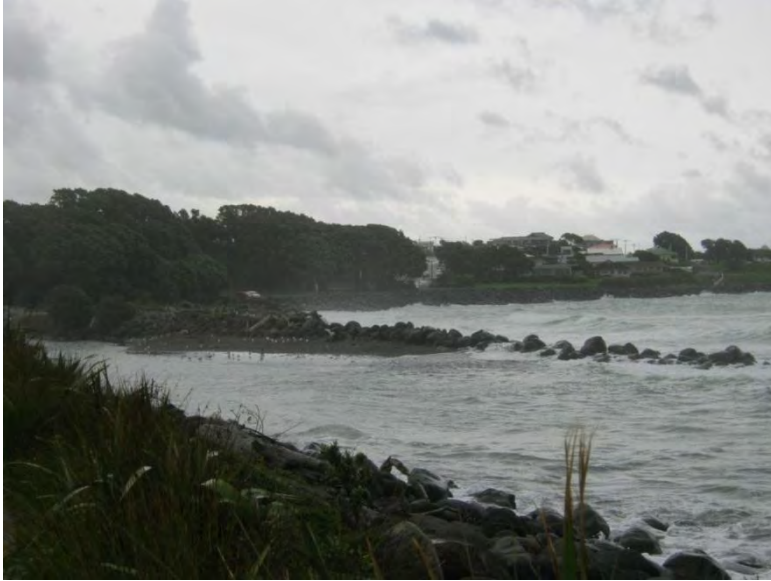
The Te Henui groyne (Photo 10) was licensed as an existing structure in June 1994 by way of coastal permit **4587**. The groyne structure was built in 1979, is located on the true left bank of the Te Henui Stream, and extends at an oblique angle (about 20 degrees of perpendicular toward the northeast).

Photo 10 The Te Henui groyne (April 2012)

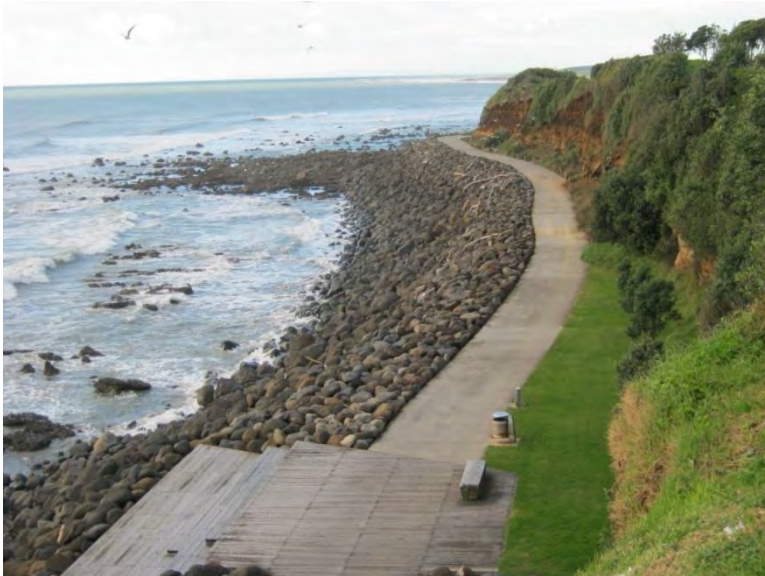
Photo 11 New Plymouth coastal walkway with rip rap seawall protection (June 2014)

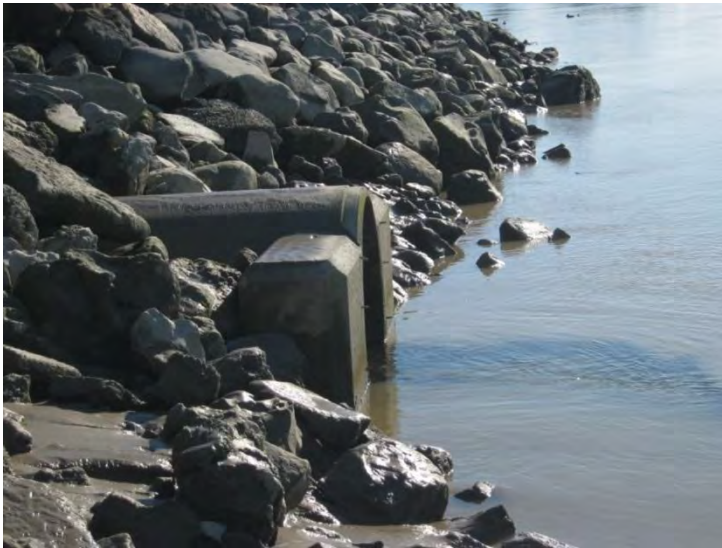
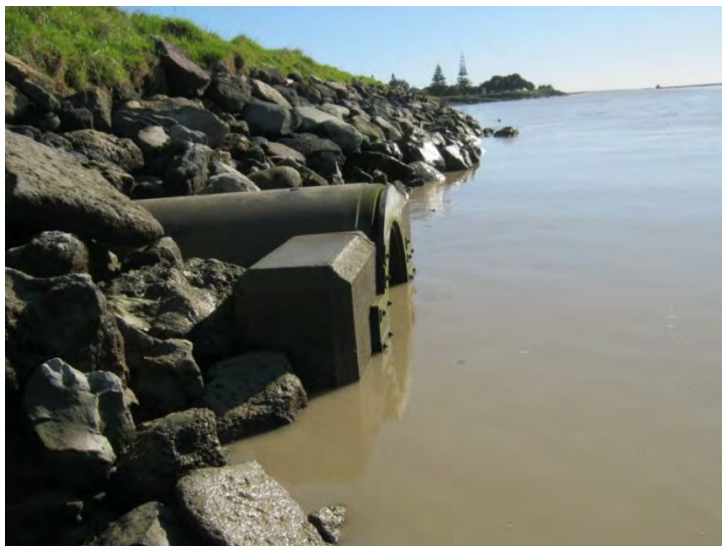
NPDC held coastal permit **4900** to use and maintain a stormwater outfall structure in the coastal marine area on the true left bank of the Waitara River Estuary. This permit expired on 1 June 2009. It was replaced by coastal permit **4900-2**, to use and maintain a stormwater outfall structure (Photo 12) in the coastal marine area on the true left bank of the Waitara River Estuary, and to occupy the related coastal space, was issued by the Council on 11 May 2009 as a resource consent under Section 87(c) of the RMA. It is due to expire on 1 June 2027.

Photo 12 Stormwater outlet structure McNaughton Street, Waitara (June 2013 and May 2014)

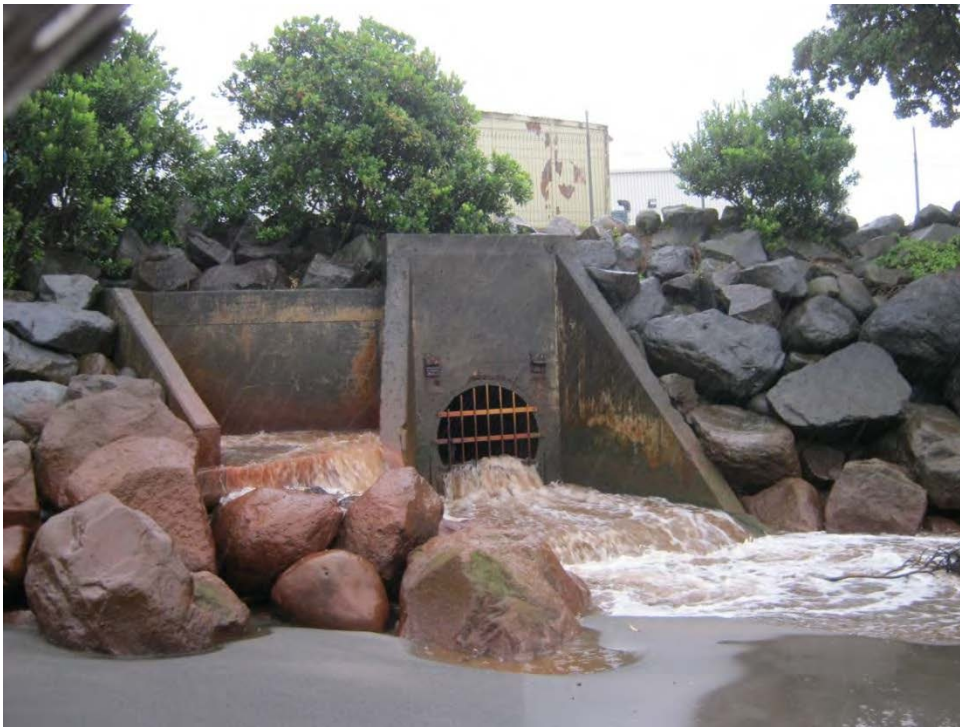
NPDC hold coastal permit **4592-2** to erect, place and maintain an outlet structure from the Hongihongi Stream (Photo 13) within the coastal marine area and to occupy the associated coastal space. This permit was issued by the Council on 27 March 2008 as a resource consent under Section 87(c) of the RMA. It is due to expire on 1 June 2026.

Photo 13 Hongihongi Stream outlet structure (April 2012)

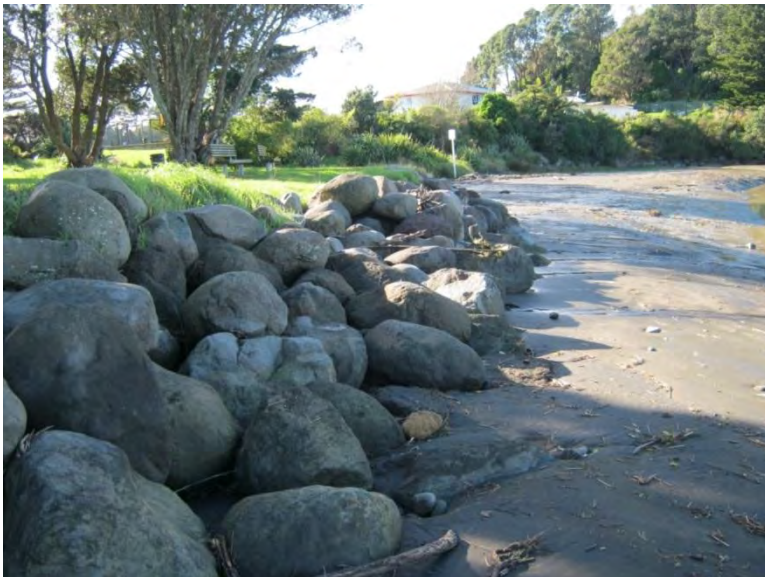
Urenui Beach was visited on 21 June 2013 and 27 May 2014. The riverbank protection works by the boat ramp (permit 4019) were in good condition. The riverbank protection works around the Manager's residence (permit 4183) and the boat ramp (permit 4065) was satisfactory with no obvious end effects.

Photo 14 The riverbank protection works by the boat ramp (June 2013)

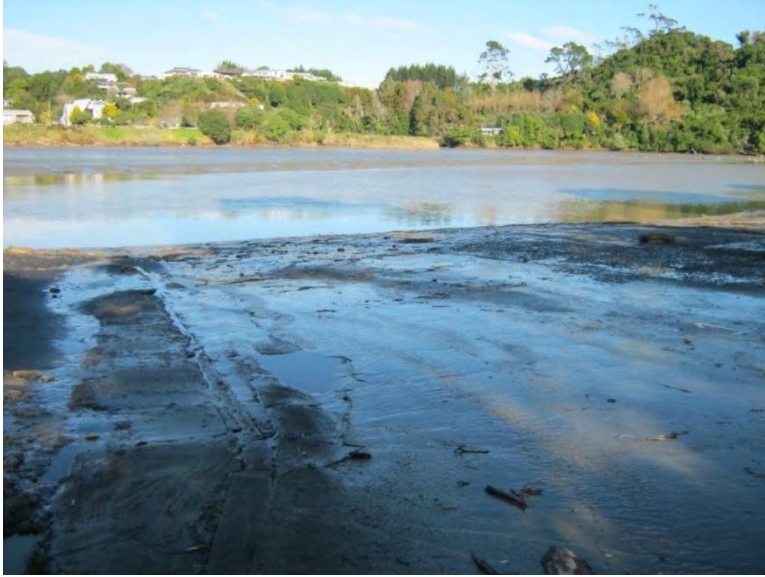
Photo 15 The Urenui boat ramp (June 2013)

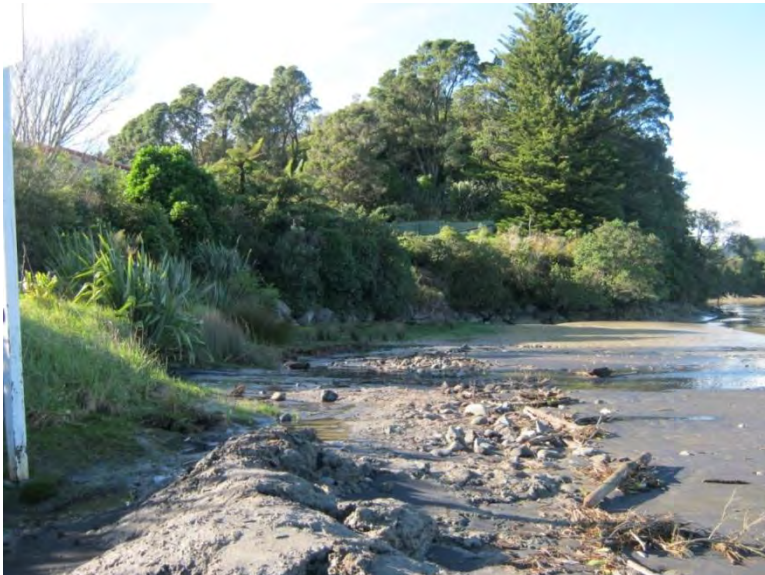
Photo 16 The riverbank protection works around the Manager's residence (June 2013)

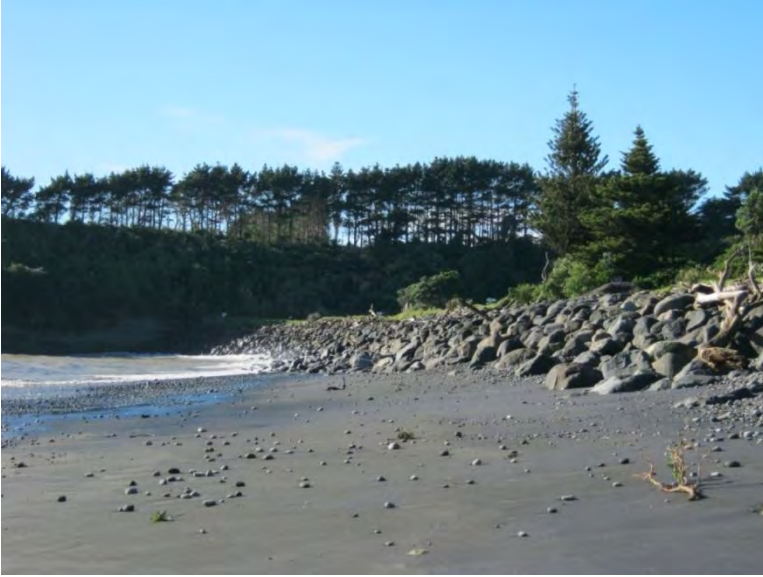
The rock rip rap seawall (permit **5761**) was in good condition. Condition 9 of this consent requires a report on the erosion of this seawall; which was due in May 2009. This report will be included in the coastal structure monitoring undertaken by Tonkin & Taylor which is currently being finalised and is due to start in the 2015-2016 period.

Photo 17 Urenui rip rap protection seawall (June 2013)

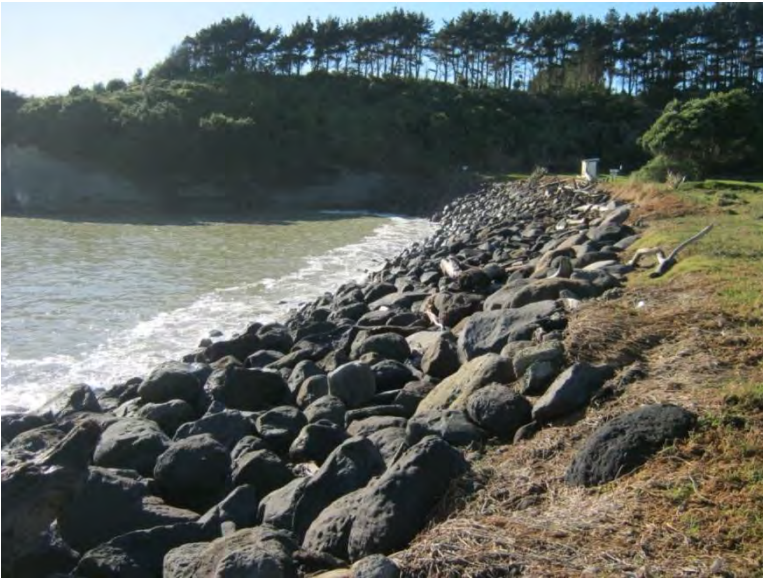
Photo 18 Urenui Rip rap protection seawall (May 2014)

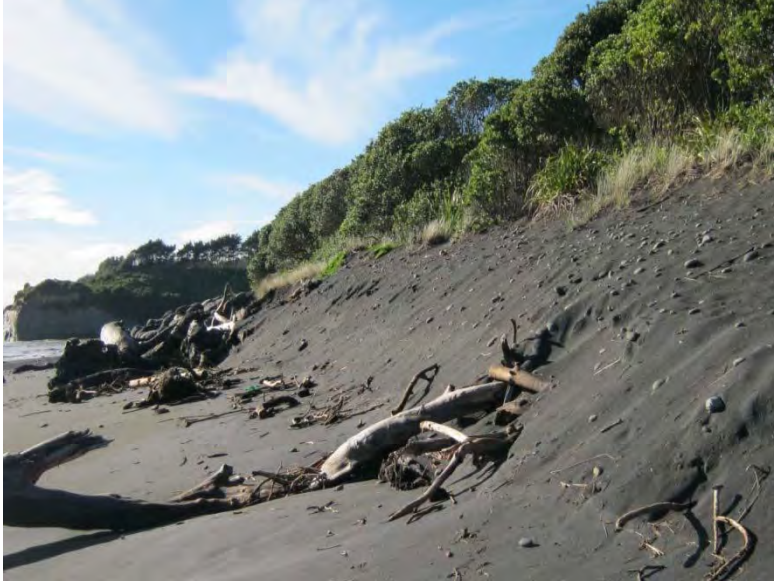
The rip rap protection wall extension, authorised by permit 7007 appeared to be causing erosion at the south west end of the beach resulting in observable end effects (Photo 19 and Photo 20). At the Urenui River mouth the dune planting appeared to be stabilising the dune.

Photo 19 Urenui Rip rap protection wall extension (June 2013)

Maintenance undertaken by NPDC at Urenui Beach during the monitoring year included a sand push-up on the beach on 28 November 2012.

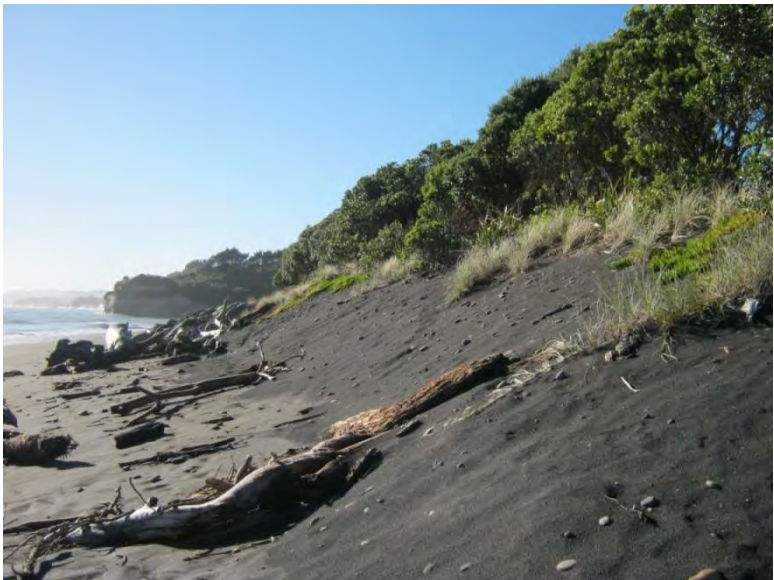
Photo 20 Urenui Rip rap protection wall extension (May 2014)

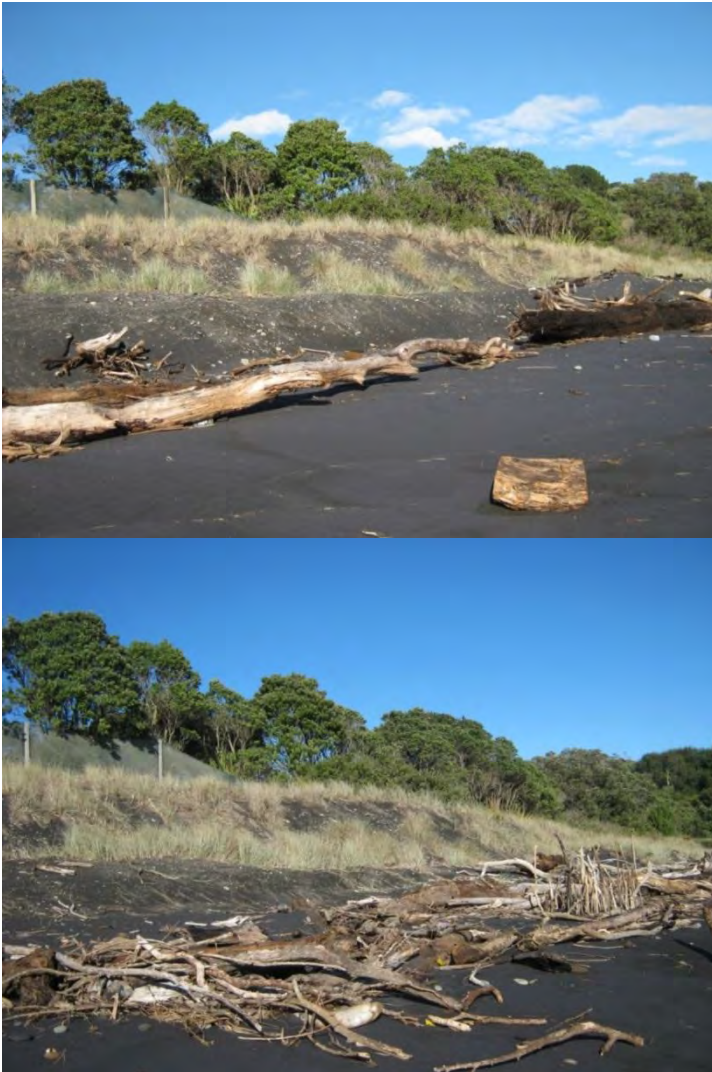
Photo 21 Dune planting at Urenui (top June 2013, bottom May 2014)

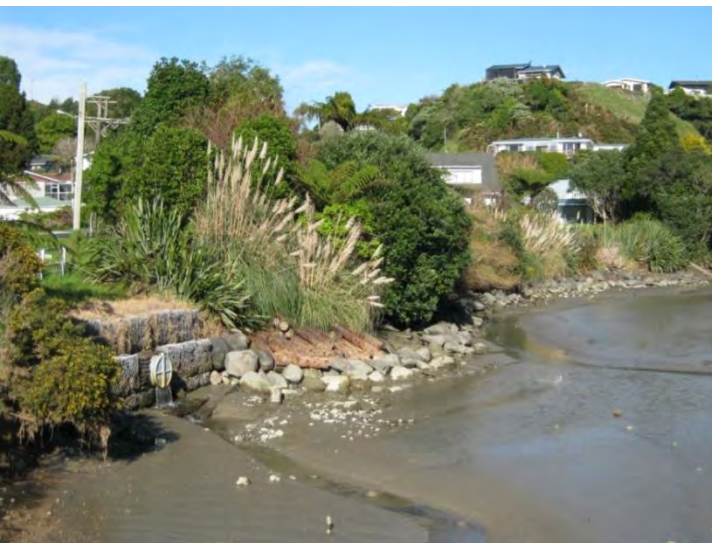
The gabion basket and rip rap in the estuary (permit 6411) were all in good order (Photo 22).

Photo 22 Urenui rip rap in the June 2013, May 2014)

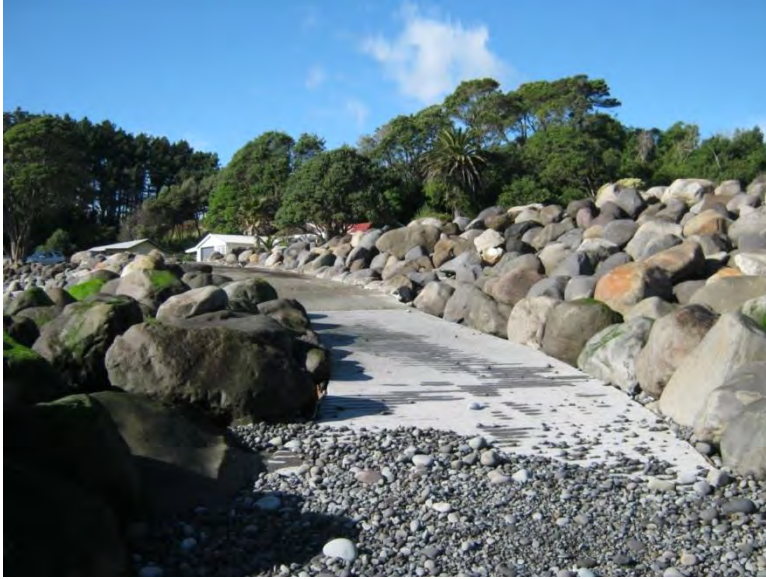
Photo 23 Onaero boat ramp and seawall (June 2013)

In addition, in August 2012 rock groynes were constructed at Onaero Domain under permit 9287.

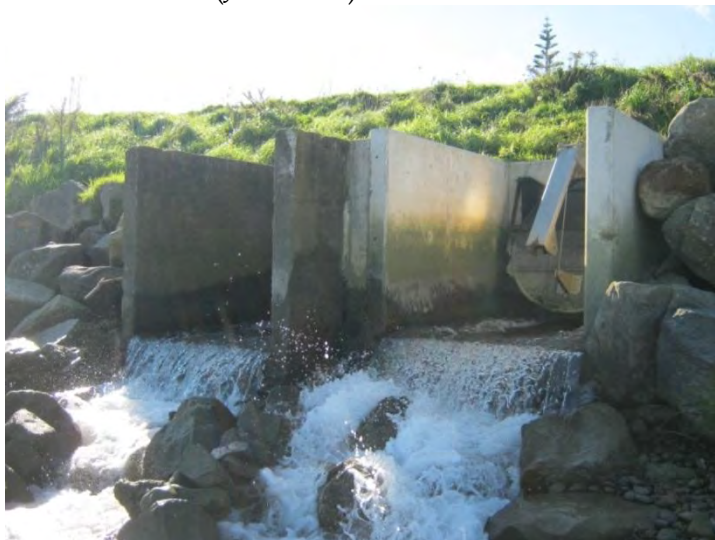
Coastal structures at Waitara were visited on 21 June 2013 and 27 May 2014 in relation to five coastal permits. The stormwater outlet structure downstream of Atkinson Street (permit **4598**) was in good condition: one of the outlets had been replaced and the new gabion protection had been placed surrounding the outlet for erosion control purposes (Photo 24). Stormwater outlet structure downstream of Atkinson Street (June 2013).

Photo 24 Stormwater outlet structure downstream of Atkinson Street (June 2013)

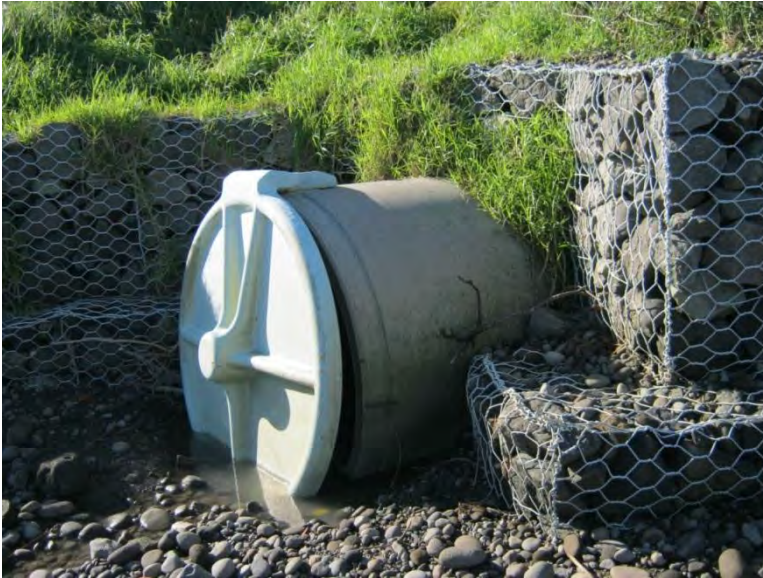
The stormwater outlet structure on McNaughton Street (permit 4900) appeared to be in satisfactory condition. The plate on the end of the pipe had been replaced between the 2013 and 2014 inspection. The stormwater outlet by the Atkinson Street/East Quay intersection (permit 6525) was in good condition although there was a fine build-up of stones in front of the outlet pipe, which was deemed to be of no concern (Photo 25).

Photo 25 The stormwater outlet by the Atkinson Street/East Quay intersection (June 2013)

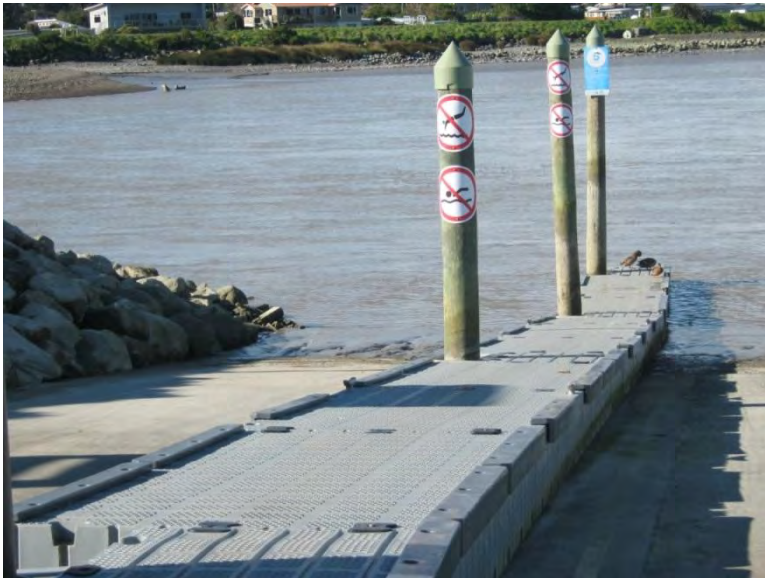
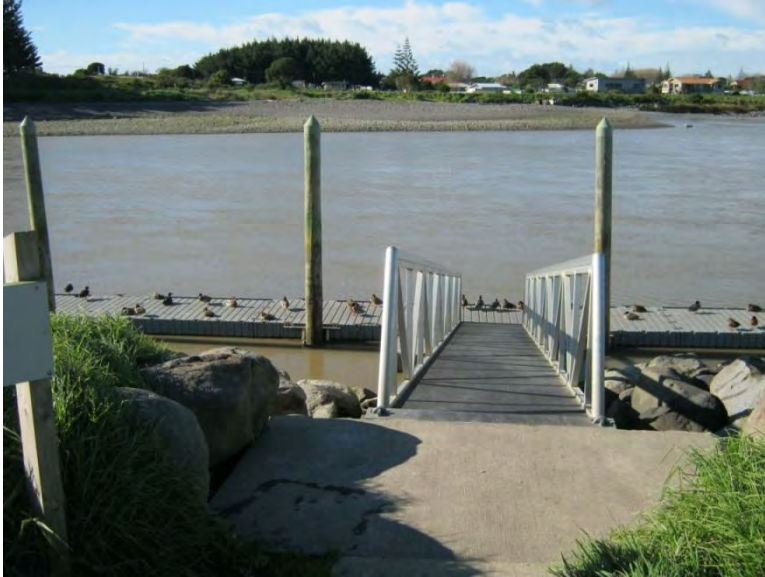
The inspections showed that the boat ramp and jetty (permit 7255) were in satisfactory condition (Photo 26 and 27) and no maintenance was required during this monitoring period.

Photo 26 Boat ramp at Waitara (June 2013)

Photo 27 Jetty at Waitara (June 2013)

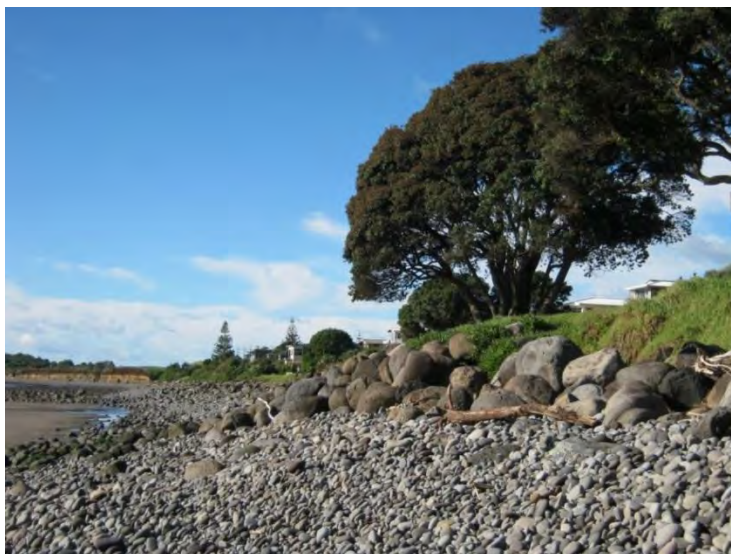
An inspection took place on 21 June 2013 and 27 May 2014 of the seawall (permit 5102). The inspections showed that the seawall was generally in good condition. There was a build-up of stones on the access path, which is a normal occurrence in the area. Due to the build-up of stones, NPDC undertook maintenance work at the boat ramp/access path in January and February 2014.

Photo 28 Bell Block seawall (June 2013)

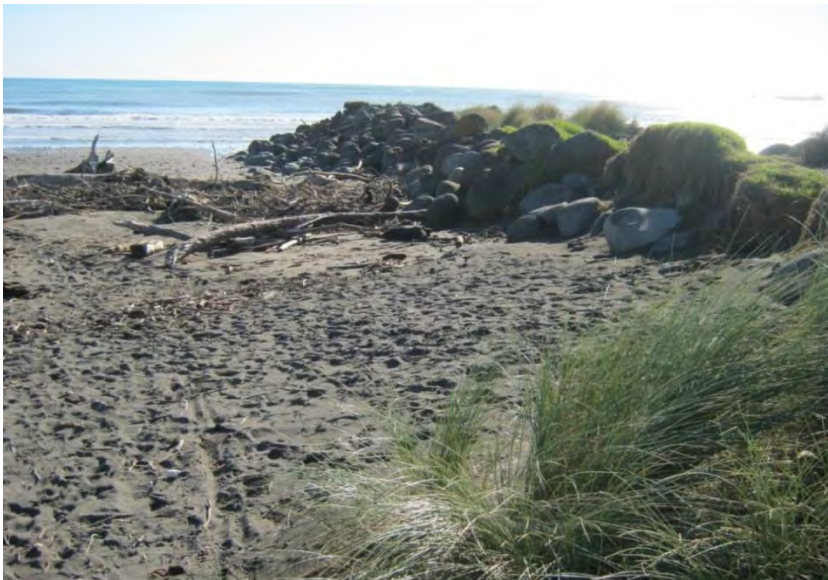
The inspections found that the groyne and associated rock rip rap (permit 4585) were in a good condition. NPDC had undertaken work to repair a hole at the top of the groyne during June 2013.

Photo 29 Waiwhakaiho groyne (May 2014)

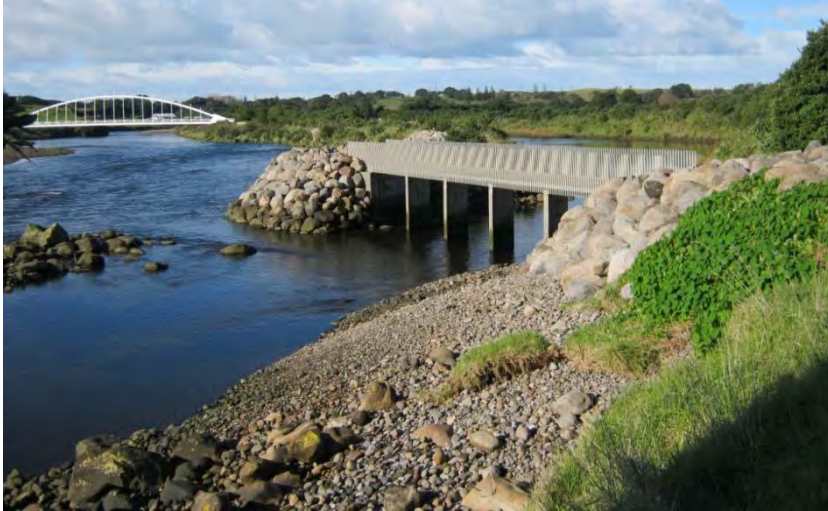
Extensive works were undertaken on the Waiwhakaiho foot bridge (permit **4603**) in 2009 and 2010. The inspections undertaken in 2013 and 2014 showed that the bridge remained in good condition (Photo 30). Permit **7442** was granted in February 2009 with construction of the bridge occurring later in 2009 and into 2010. The inspection in relation to this coastal permit showed that the bridge remained in excellent condition (Photo 31).

Photo 30 Foot bridge over the Waiwhakaiho River (June 2013)

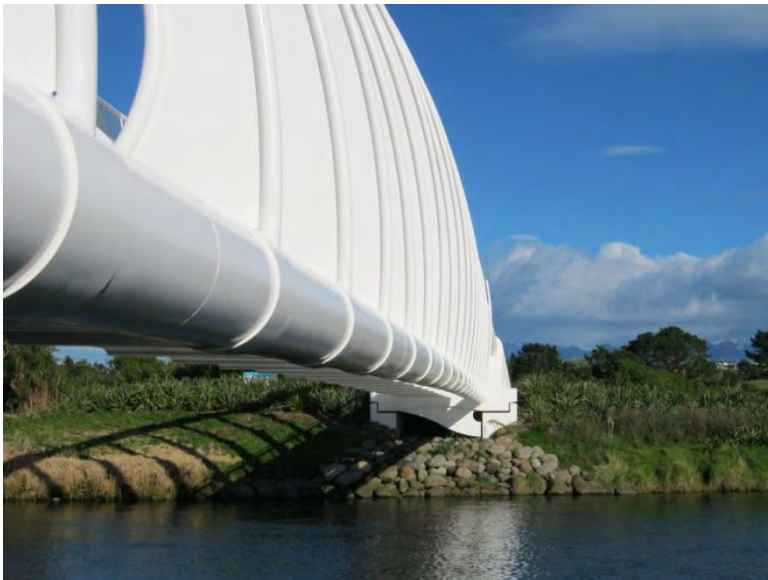
Photo 31 Te Rewarewa bridge over the Waiwhakaiho River (June 2013)

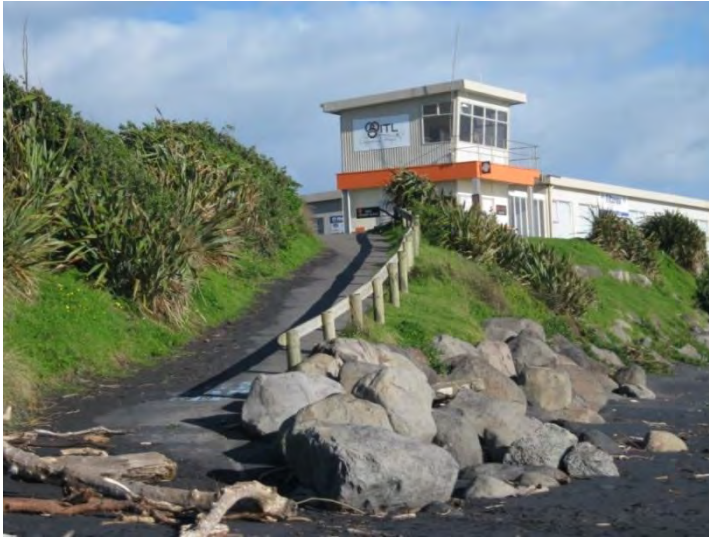
The boat ramp in front of Fitzroy Surf Life Saving Club (permit 4586) was in satisfactory condition at the time of the inspection (Photo 32). Minor erosion evident on the seawall in front of Fitzroy Surf Life Saving Club in previous inspections was not observed during the 2013 and 2014 inspections (Photo 32). However there was an area of obvious erosion between the New Plymouth Surf Riders Club and Fitzroy Surf Life Saving Club where the bank appeared to be used as an access point i.e. the erosion appeared to have occurred as a result of human foot traffic (Photo 33).

Photo 32 Boat ramp and rock protection works in front of Fitzroy Surf Lifesaving Club (June 2013)

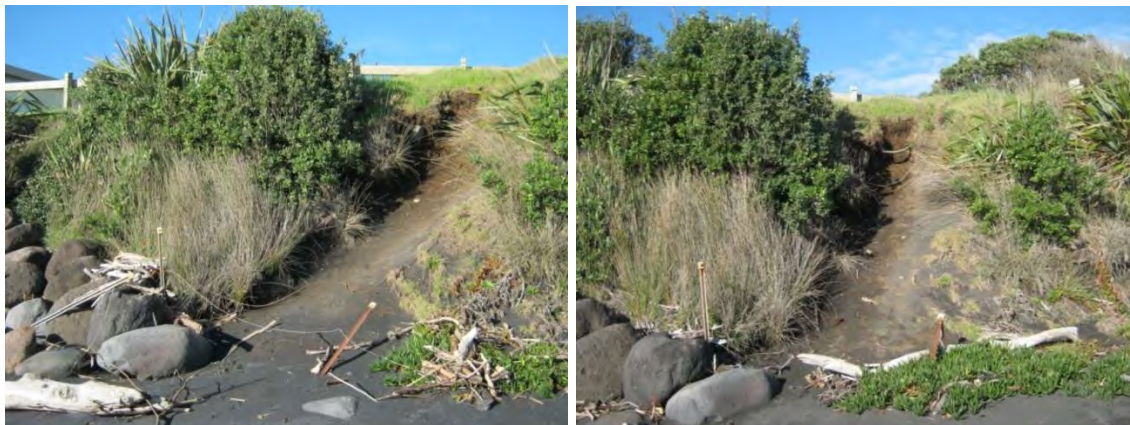
Photo 33 Close up of erosion present in front of Board Riders club caused by human foot traffic (June 2013 and May 2014)

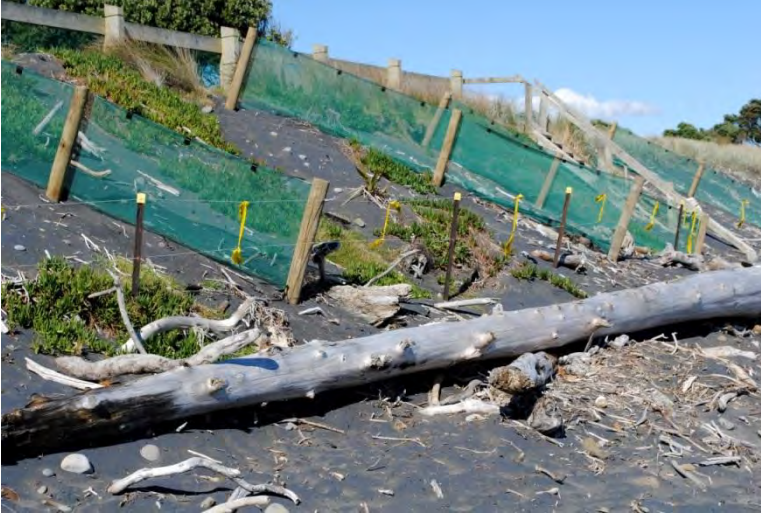
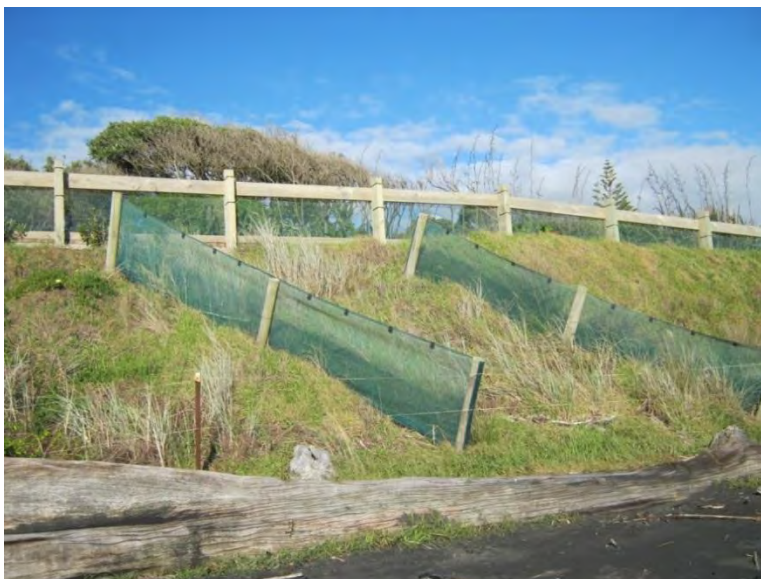
The plantings that have occurred in front of the New Plymouth Surf Riders Club have made major improvements in preventing erosion of the bank (Photo 34). The area is also well fenced.

Photo 34 Plantings in front of the New Plymouth Surf Riders Club (April 2010 and May 2014)

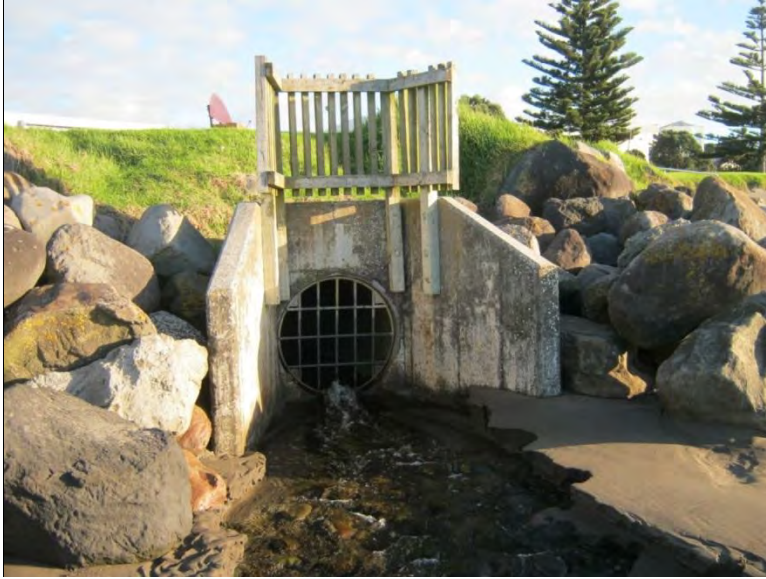
The stormwater outfall on Ngamotu Beach (permit 5182) was clear of debris and in suitable condition (Photo 36).

Photo 36 The Bayly road stormwater outfall on Ngamotu Beach (May 2014)

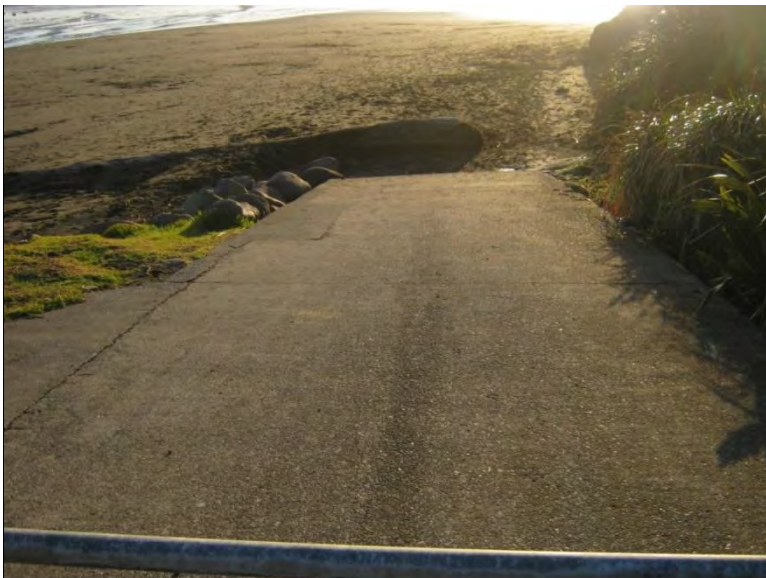
Inspections of the boat ramp (permit 6553) on 21 June 2013 and 27 May 2014, found the ramp to be in reasonably good order. The ramp was free of weeds and grass (Photo 37) observed covering the sides of the ramp in previous inspections.

Photo 37 Boat ramp at Back Beach (May 2014)

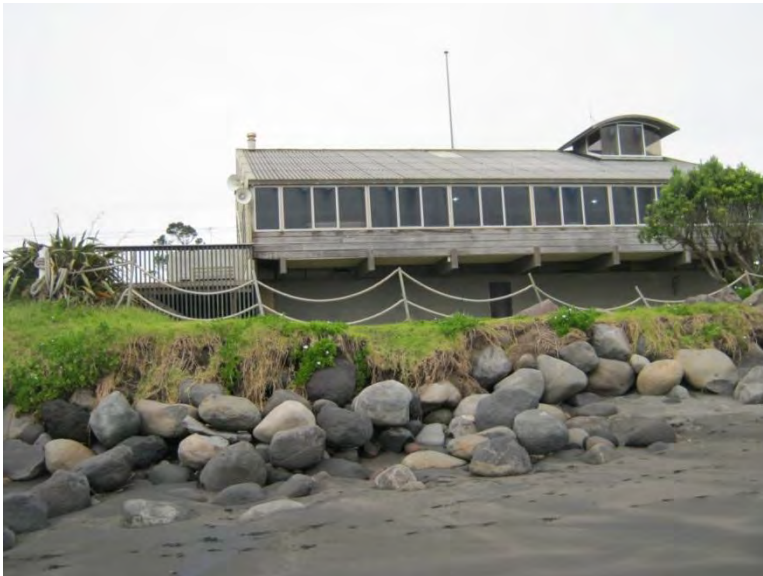
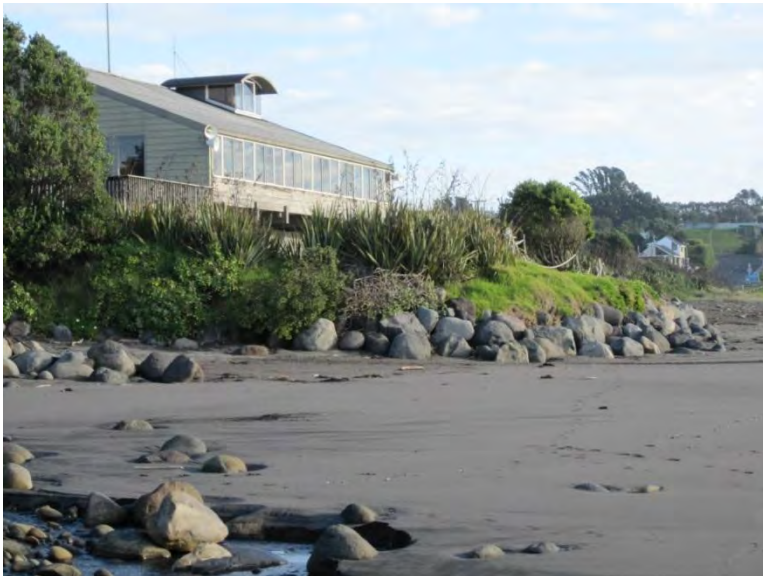
The boat ramp and foreshore protection works at Oakura Beach (permit 4584) were in variable condition. The boat ramp was found to be in a good condition. In contrast, the protection works (Photo 38) showed signs of erosion at the top of the wall.

Photo 38 Protection works in front of Oakura Surf Lifesaving Club (June 2013 and May 2014)
