NPDC Coastal Structures
Monitoring Programme
Annual Report
2014-2015

Technical Report 2015–113

May 2016

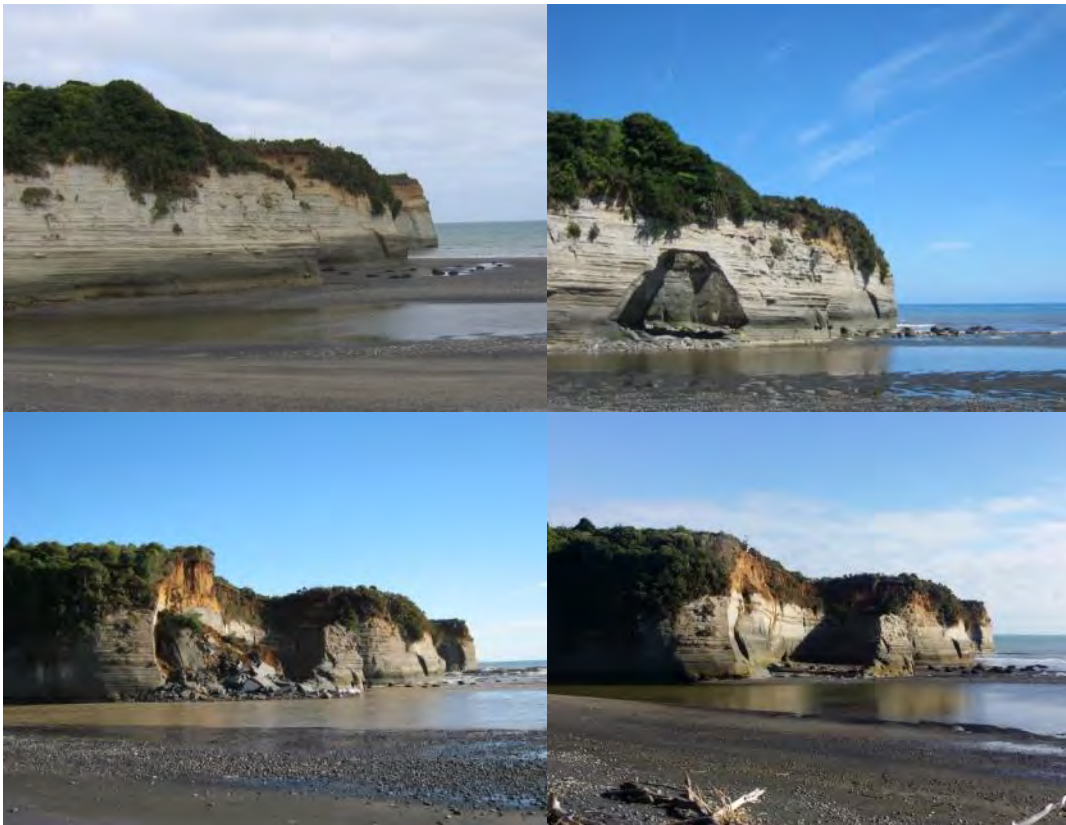
Photo 3 Urenui Beach cliff erosion
(Clockwise from top left - August 2009, December 2012, June 2013, May 2015)

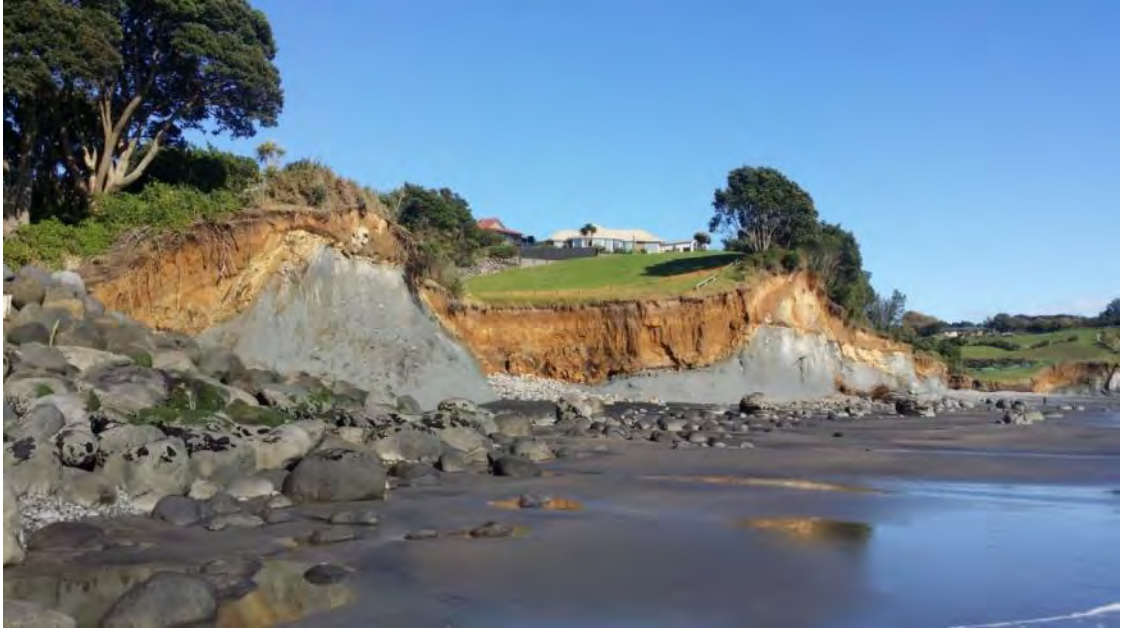
In July 2001 concern was raised by locals, through the NPDC, regarding erosion of the reserve situated to the west of the seawall (Photo 7). In this regard it was noted that the reserve was specially set aside as a Coastal Hazard Zone at the time of the subdivision. The setback distance was calculated to provide for 100 years of erosion.

Photo 7 Eroding cliffs to the west of the seawall at Onaero (May 2015)

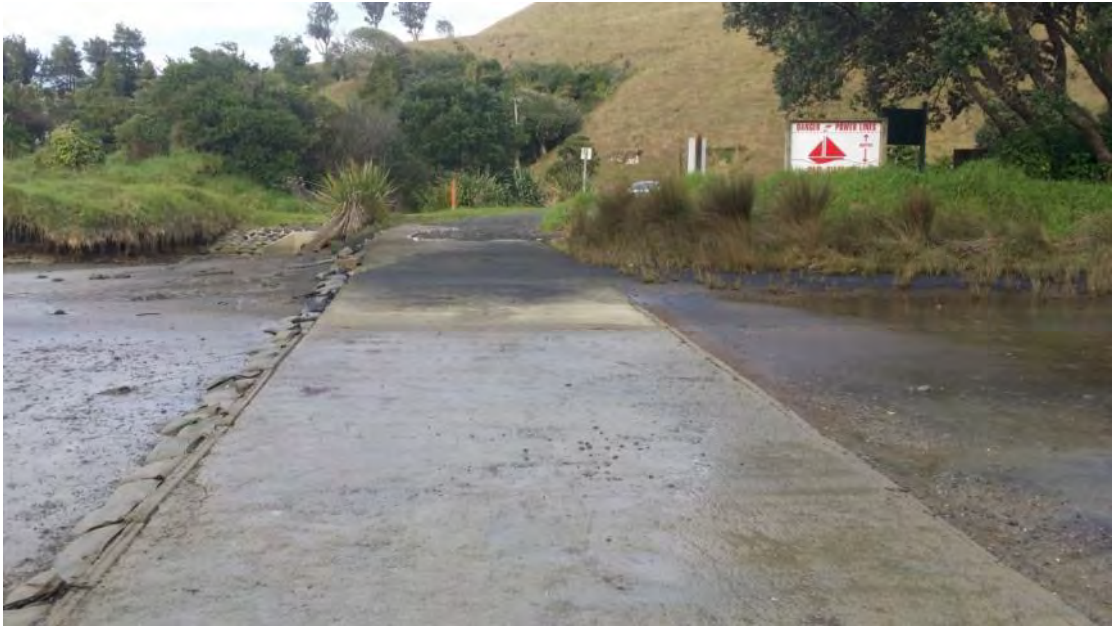
Photo 16 Boat ramp at Tongaporutu (May 2015)

No maintenance work was undertaken by NPDC during the monitoring period.

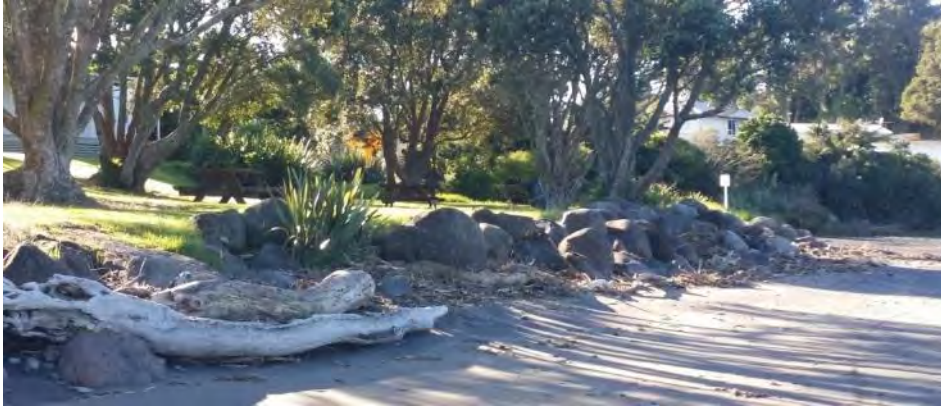
Photo 17 Riverbank protection works by the boat ramp (May 2015)

Urenui Beach was visited on 27 May 2015. The riverbank protection works by the boat ramp (permit 4019) were in good condition. The riverbank protection works around the Manager's residence (permit 4183) and the boat ramp (permit 4065) was satisfactory with no obvious end effects.

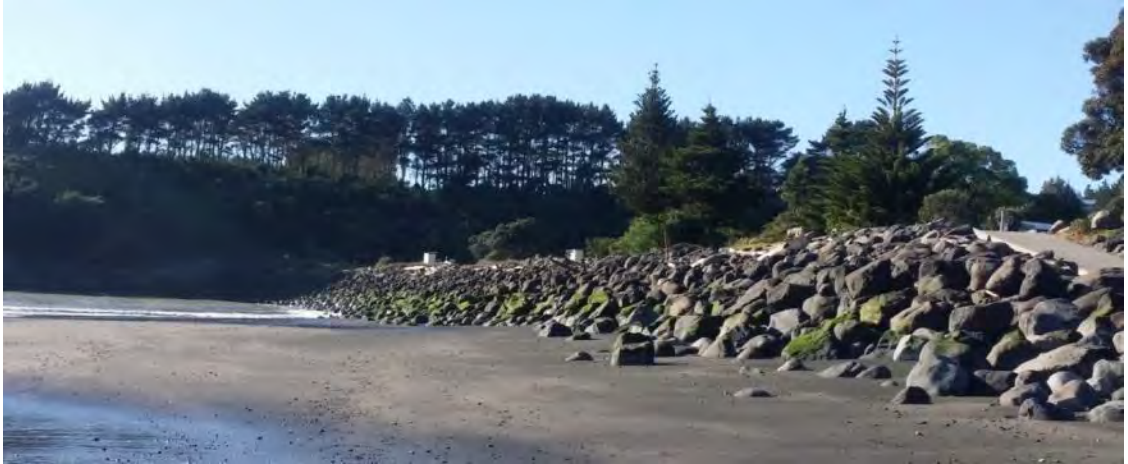
Photo 20 Urenui Beach rip rap protection east seawall (May 2015)

The rock rip rap seawall at the east of Urenui Beach (permit 5761) was in good condition.

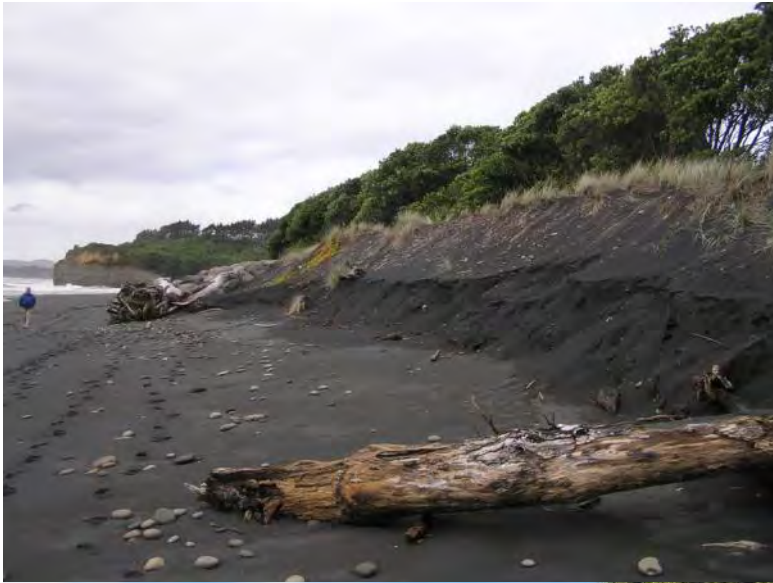
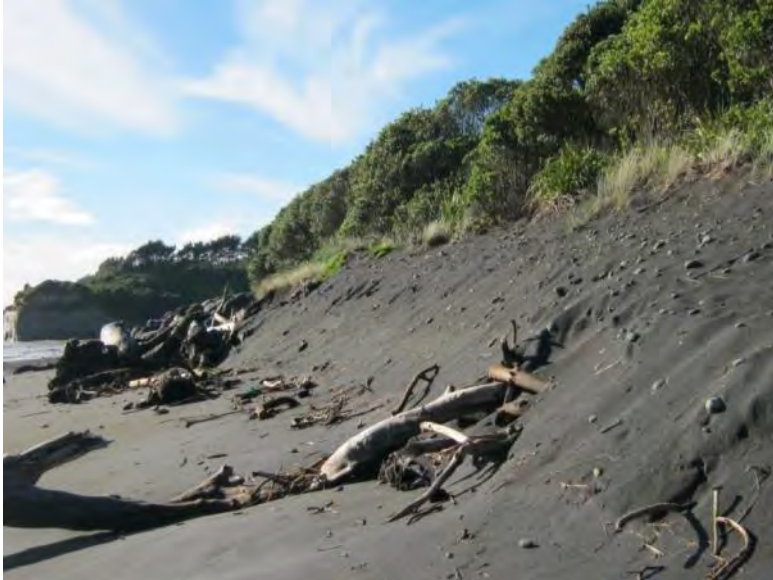
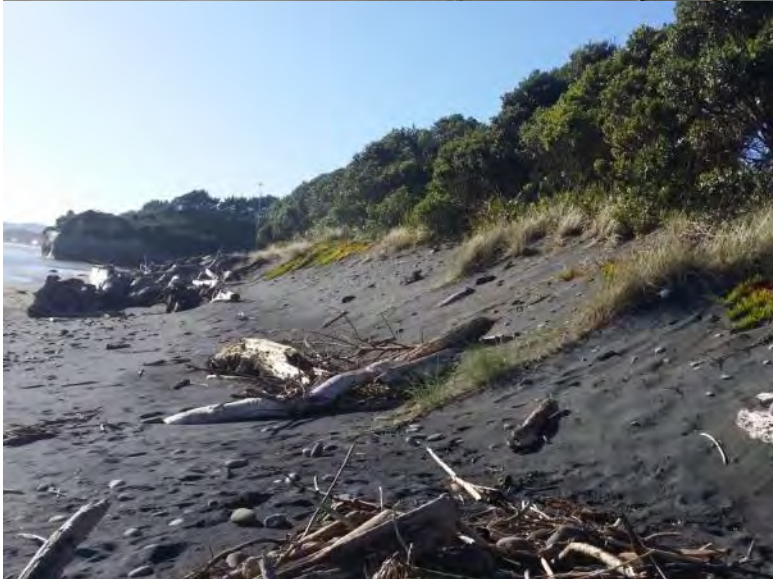
Photo 21 Urenui Rip rap protection wall extension
(top May 2011, middle June 2013, bottom May 2015)

The area of sand dune to the south west of the rip rap protection wall extension, authorised by permit 7007 is susceptible to erosion, previously resulting in observable end effects (Photo 21). In the May 2015 inspection, greater sand build up and vegetation growth was observed on the bank, relative to recent years (Photo 21). However, this area remains susceptible to end effects.

Maintenance undertaken by NPDC at Urenui Beach during the monitoring year included a sand push-up on the beach.

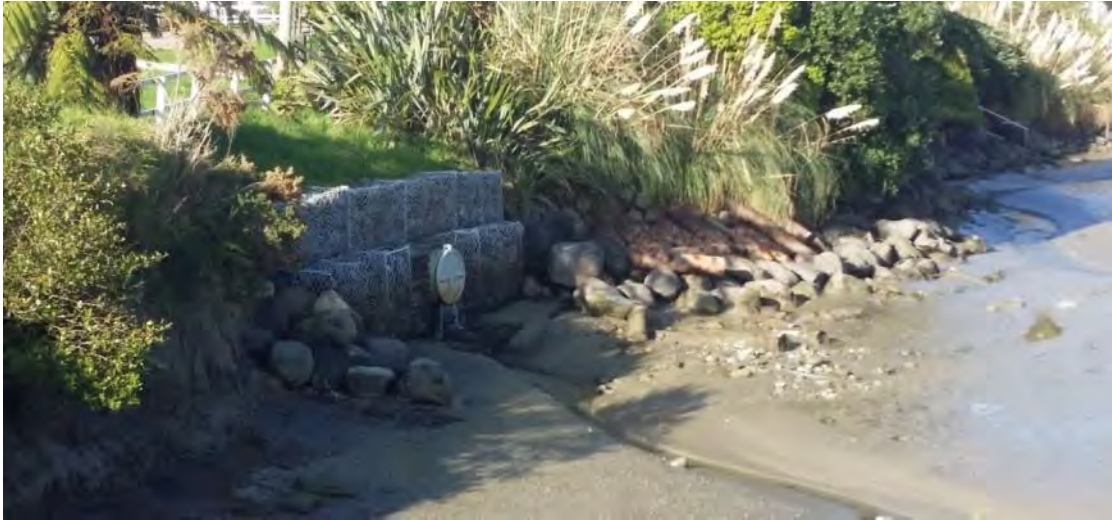
Photo 22 Urenui rip rap (May 2015)

The gabion basket and rip rap in the estuary (permit 6411) were all in good order (Photo 22).

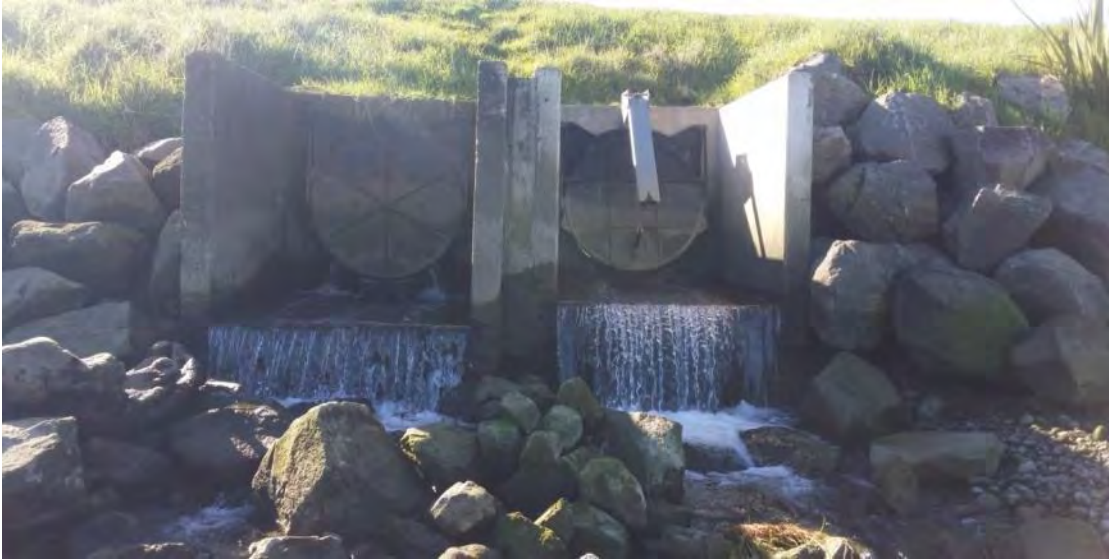
Photo 24 Stormwater outlet structure downstream of Atkinson Street (May 2015)

Coastal structures at Waitara were visited on 27 May 2015 in relation to five coastal permits. The stormwater outlet structure downstream of Atkinson Street (permit 4598) was in good condition and there was no evidence of erosion (Photo 24).

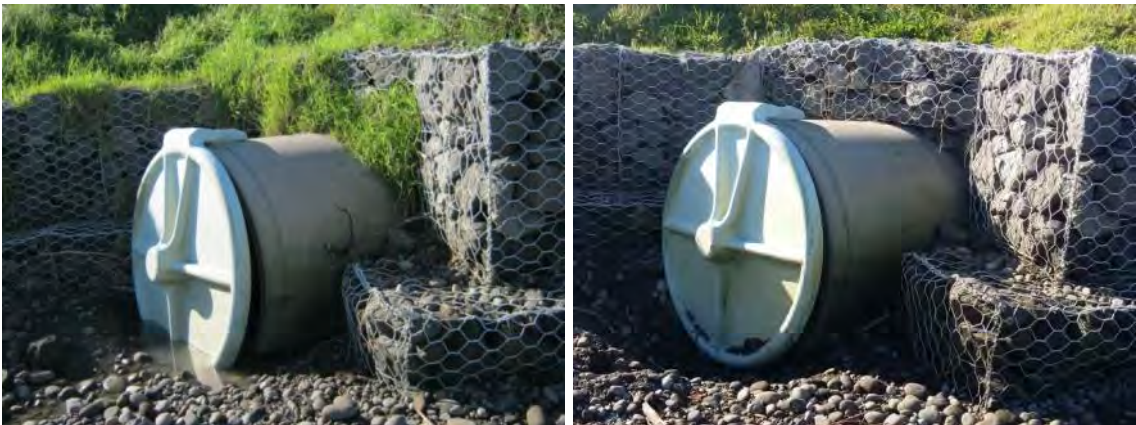
Photo 25 The stormwater outlet by the Atkinson Street/East Quay intersection (June 2013 and May 2015)

The stormwater outlet by the Atkinson Street/East Quay intersection (permit 6525) was in good condition. The build-up of stones in front of the outlet pipe, observed during the June 2013 inspection, was not present during the May 2015 inspection (Photo 25).

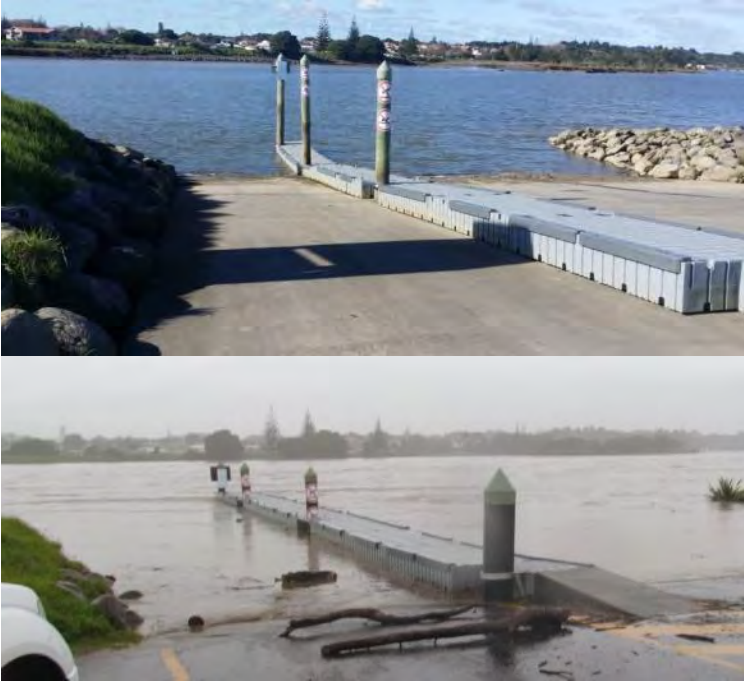
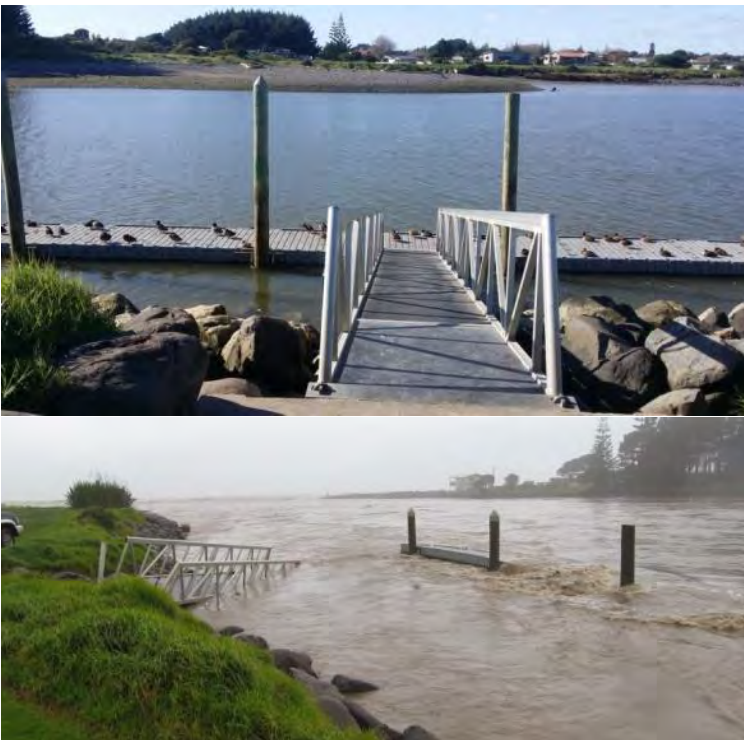
The boat ramp and jetty (permit 7255) were in good condition at the time of inspection (Photo 26 and 27). NB Flooding on 20 June 2015 (post inspection) badly damaged the jetty (Photo 27). During the year the boat ramp was cleared and maintenance was carried out on the structures.

Photo 26 Boat ramp at Waitara (May 2015 and June 2015)

Photo 27 Jetty at Waitara (May 2015 and June 2015)

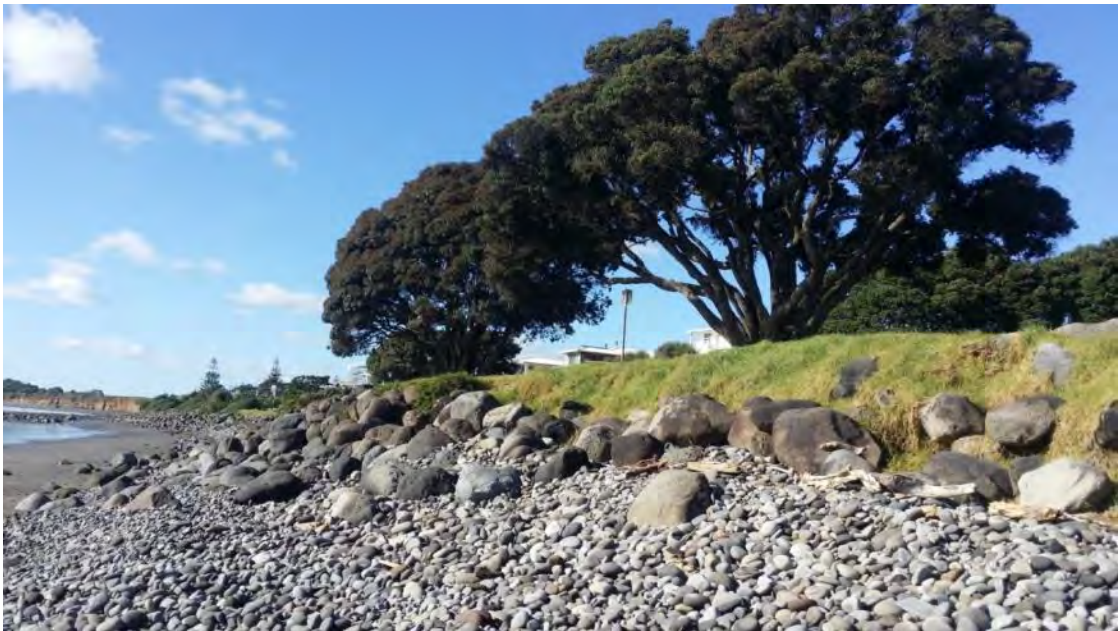
Photo 28 Bell Block seawall (May 2015)

An inspection took place on 27 May 2015 of the seawall (permit 5102). The inspections showed that the seawall was generally in good condition with no obvious end effects (Photo 28). There was no major build-up of stones on the access ramp during the 2015 inspection (Photo 29). NPDC had cleared the boat ramp of stones during the period under review.

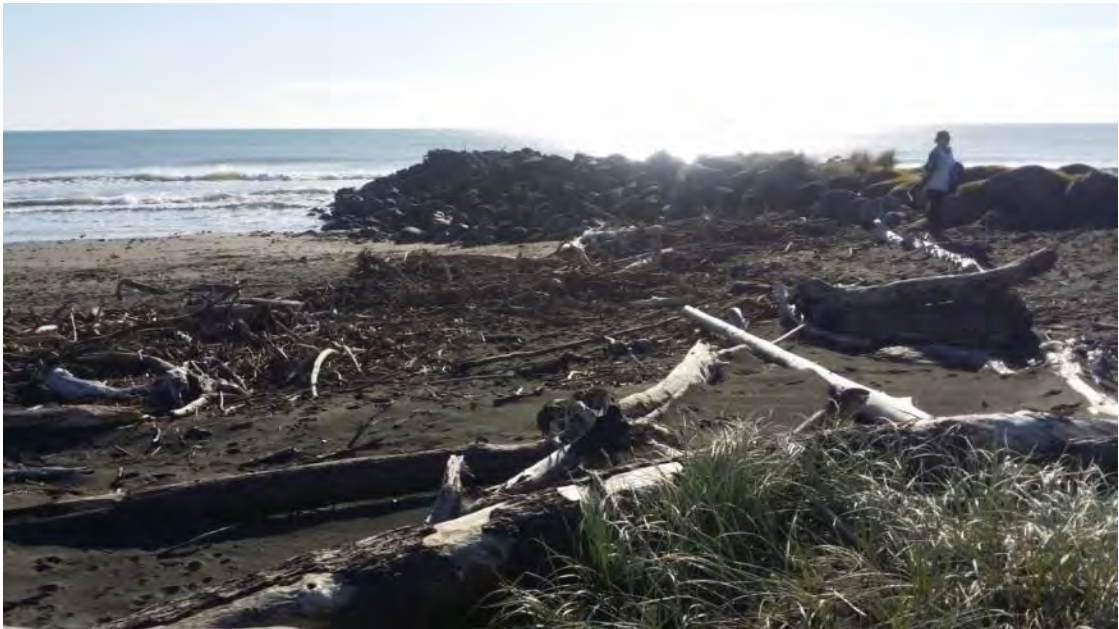
Photo 30 Waiwhakaiho groyne (May 2015)

The inspections found that the groyne and associated rock rip rap (permit 4585) were in a good condition.

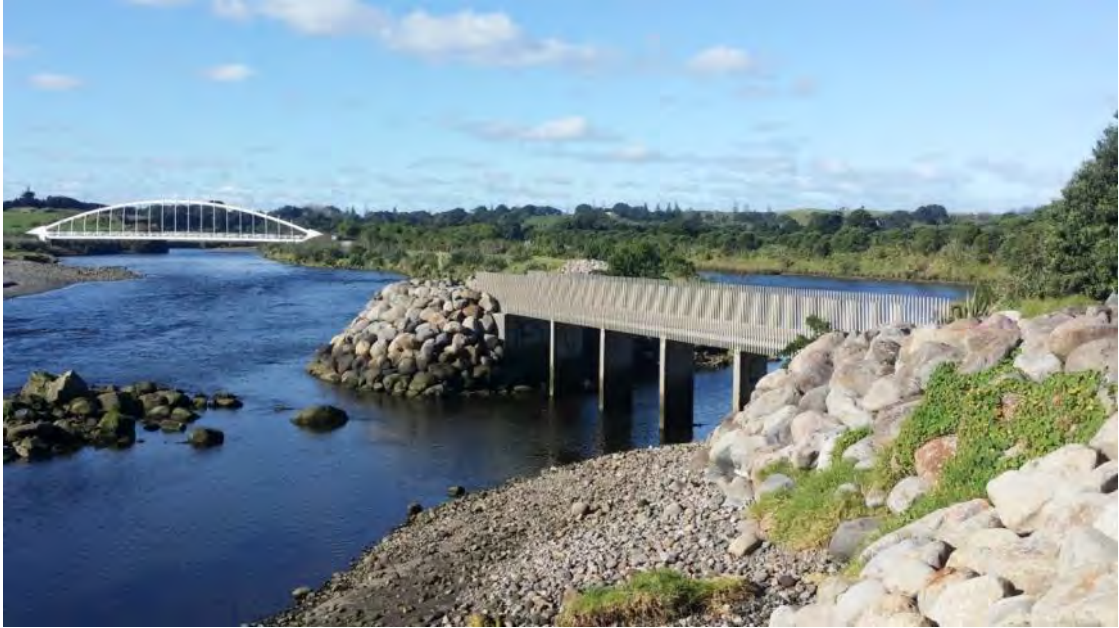
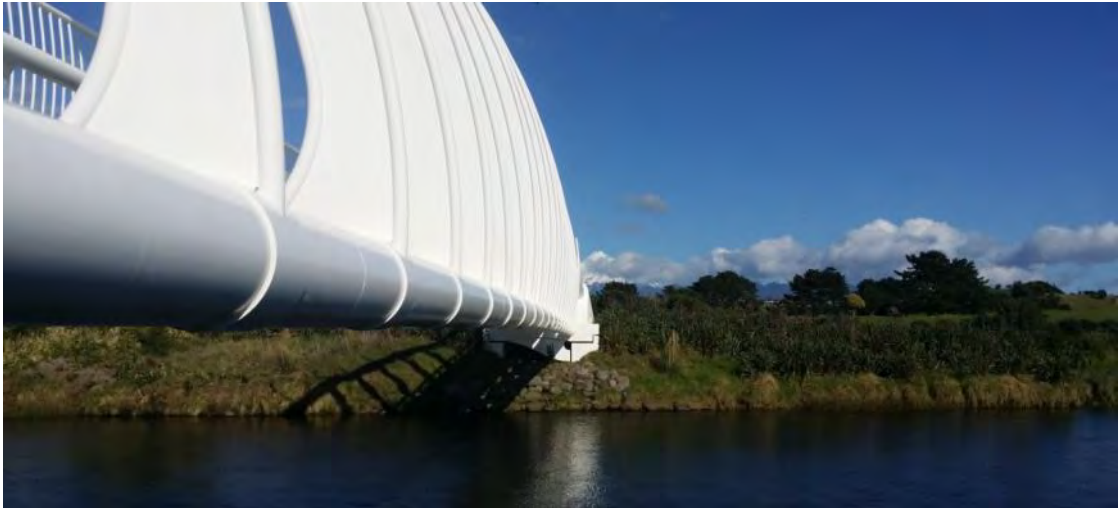
Extensive works were undertaken on the Waiwhakaiho footbridge (permit 4603) in 2009 and 2010. The inspection undertaken in 2015 showed that the bridge remained in good condition (Photo 31). Permit 7442 was granted in February 2009 with construction of the Te Rewarewa Bridge occurring later in 2009 and into 2010. The inspection in relation to this coastal permit showed that the bridge remained in excellent condition with no obvious signs of erosion (Photo 32).

Photo 31 Footbridge over the Waiwhakaiho River (May 2015)

Photo 32 Te Rewarewa bridge over the Waiwhakaiho River (May 2015)

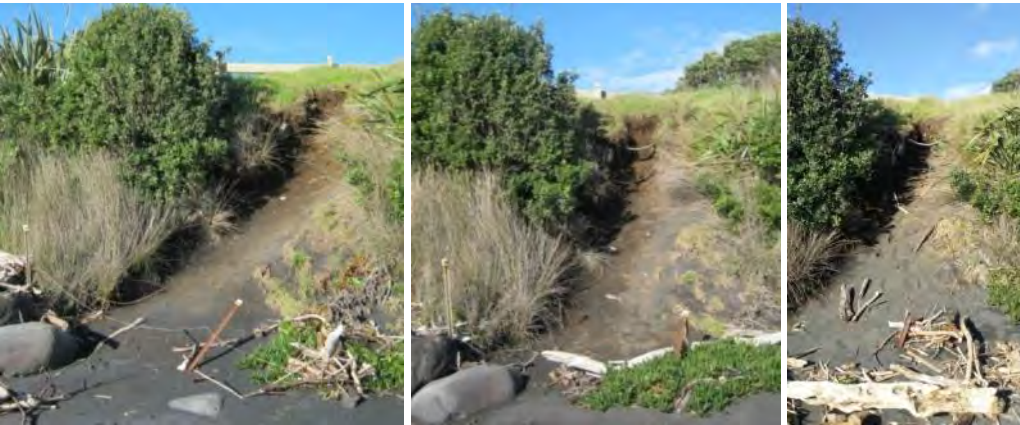
As noted in previous inspections, there was an area of obvious erosion between the New Plymouth Surf Riders Club and Fitzroy Surf Life Saving Club where the bank appeared to be used as an access point i.e. the erosion appeared to have occurred as a result of human foot traffic (Photo 35).

Photo 35 Close up of erosion present in front of Board Riders club caused by human foot traffic
(June 2013, May 2014 and May 2015)

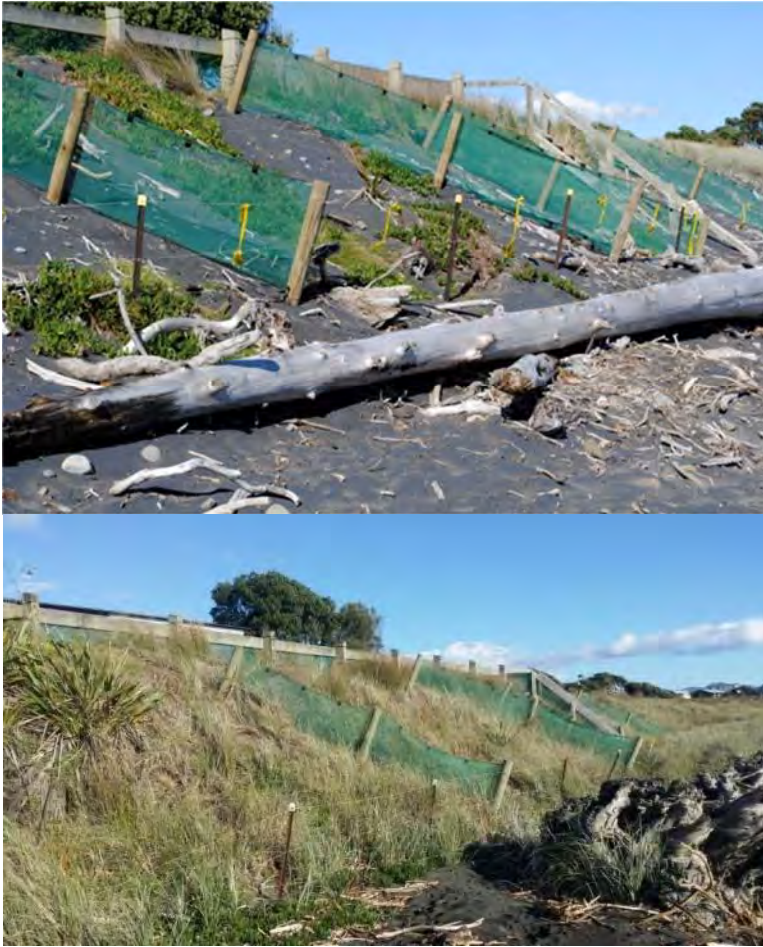
The plantings in front of the New Plymouth Surf Riders Club have made major improvements in preventing erosion of the bank (Photo 36). The area is also well fenced.

Photo 36 Plantings in front of the New Plymouth Surf Riders Club (April 2010 and May 2014)

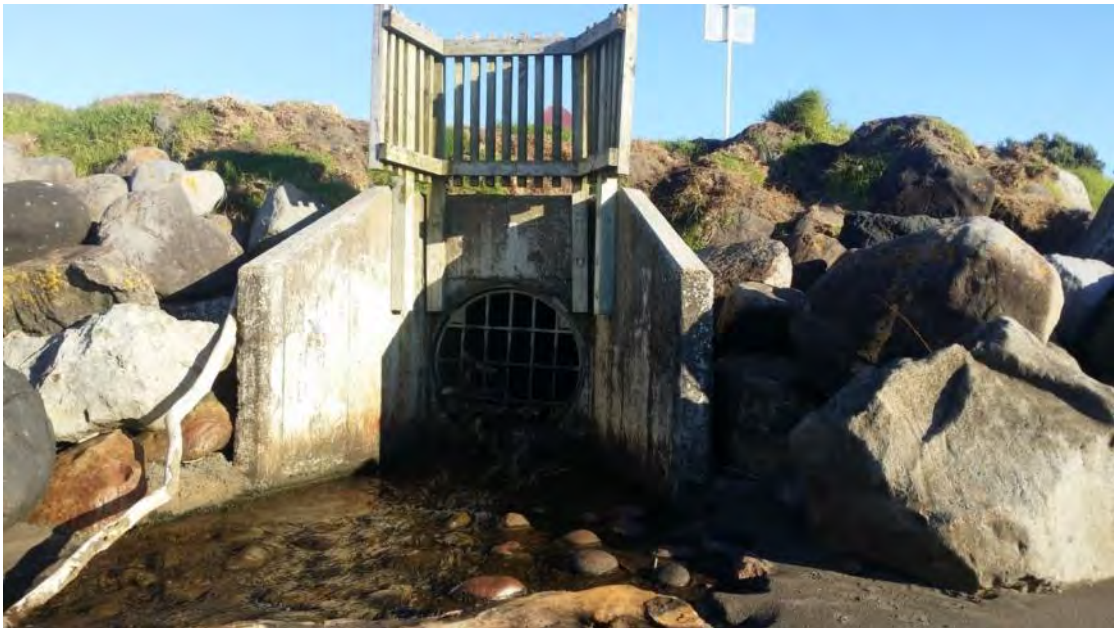
Photo 40 The Bayly road stormwater outfall on Ngamotu Beach (May 2015)

The stormwater outfall on Ngamotu Beach (permit 5182) was clear of debris and in suitable condition (Photo 40).

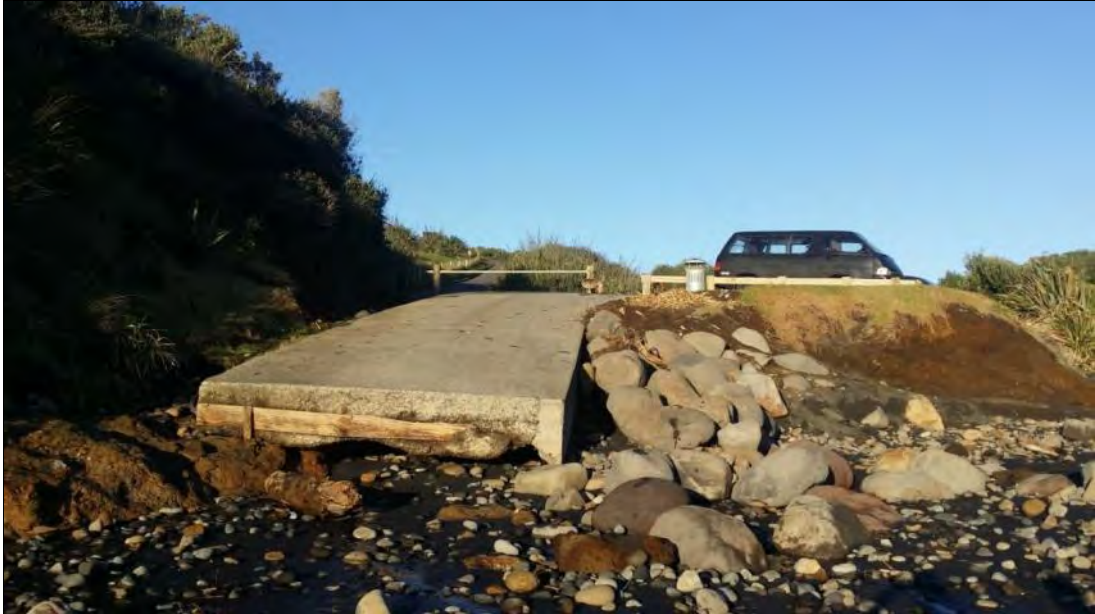
Photo 41 Boat ramp at Back Beach (May 2015)

resulting in the toe of the ramp being undermined. In Photo 41 the cavity beneath the structure, which formed due to erosion, can be clearly seen. At the time of the inspection NPDC were in the process of organising repairs. Shortly after the inspection, boulders and rocks were placed at the toe of the structure and the cavity was filled with the aim of preventing further damage to the ramp and making public access easier/safer.

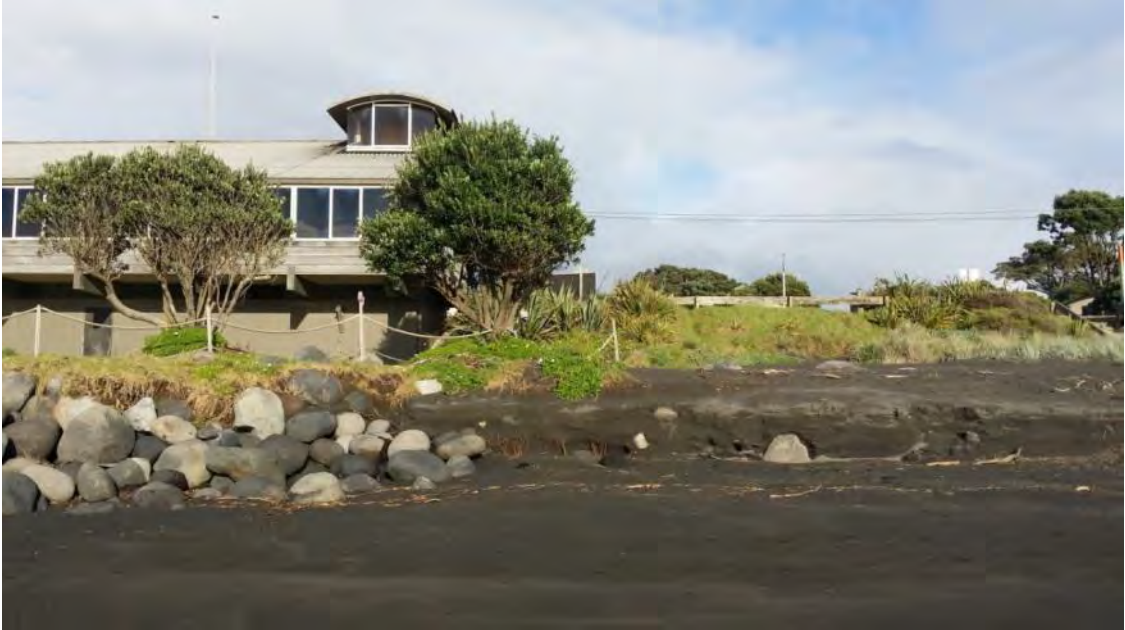
The boat ramp and foreshore protection works at Oakura Beach (permit 4584) were in variable condition. The boat ramp was found to be in a good condition. In contrast, the protection works (Photo 42) showed some signs of erosion at the top of the wall. Erosion of the bank/dunes was evident to the west of the Surf Lifesaving Club (Photo 42). Without expert assessment it is difficult to determine the extent the erosion was due to end effects of the rip rap wall relative to effects of the Waimoku Stream.

Photo 42 Protection works in front of Oakura Surf Lifesaving Club showing erosion of the bank/dunes to the west of the club (June 2015)
