NPDC Coastal Structures
Monitoring Programme
Annual Report
2017-2018

Technical Report 2018–27

Taranaki Regional Council
Private Bag 713
STRATFORD
November 2018

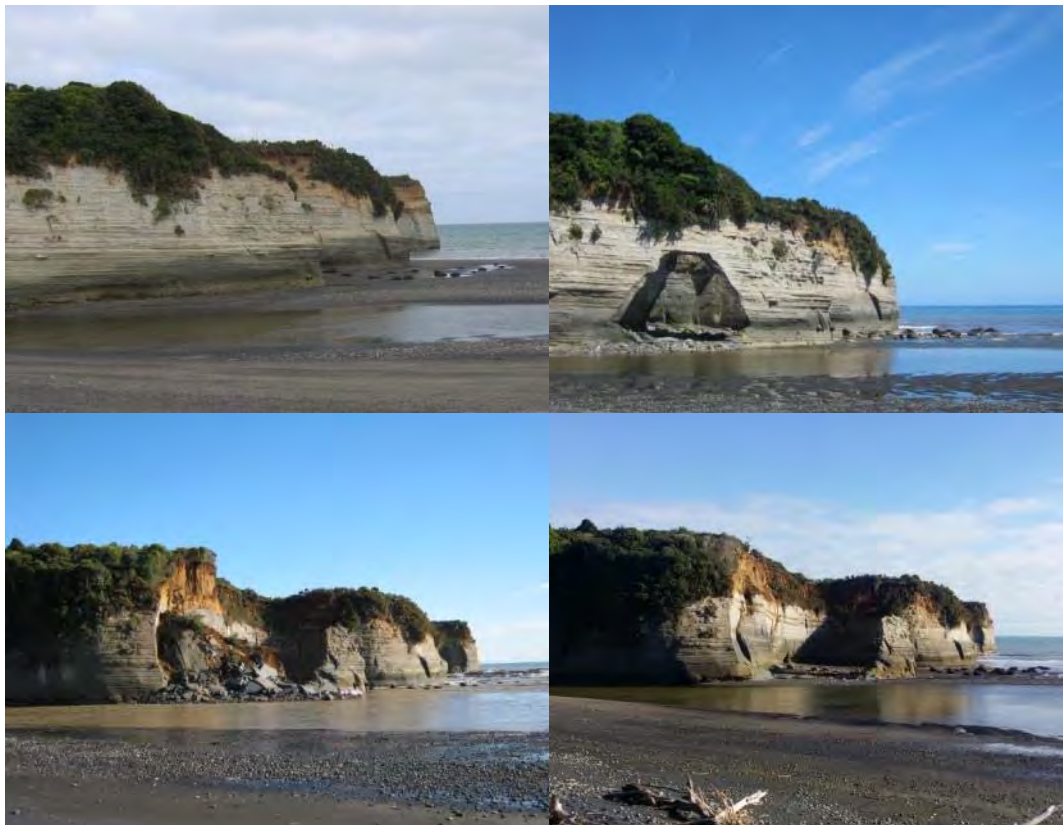
Urenui Beach is a mixed sand and cobble beach situated between two papa headlands on the North Taranaki coast (Photo 3). The Urenui River is situated at the western end of Urenui Beach, flowing between the beach and the western headland. Depending on river conditions the Urenui River can flow straight out adjacent to the western headland, slightly to the northeast, or at times flow almost parallel with the Urenui Beach foreshore. An extensive wave cut platform, armoured with cobbles and visible at low tide, tapers away from the western headland to the east, ending at about midway along the beach.

Photo 3 Urenui Beach cliff erosion (Clockwise from top left - August 2009, December 2012, June 2013, May 2015)

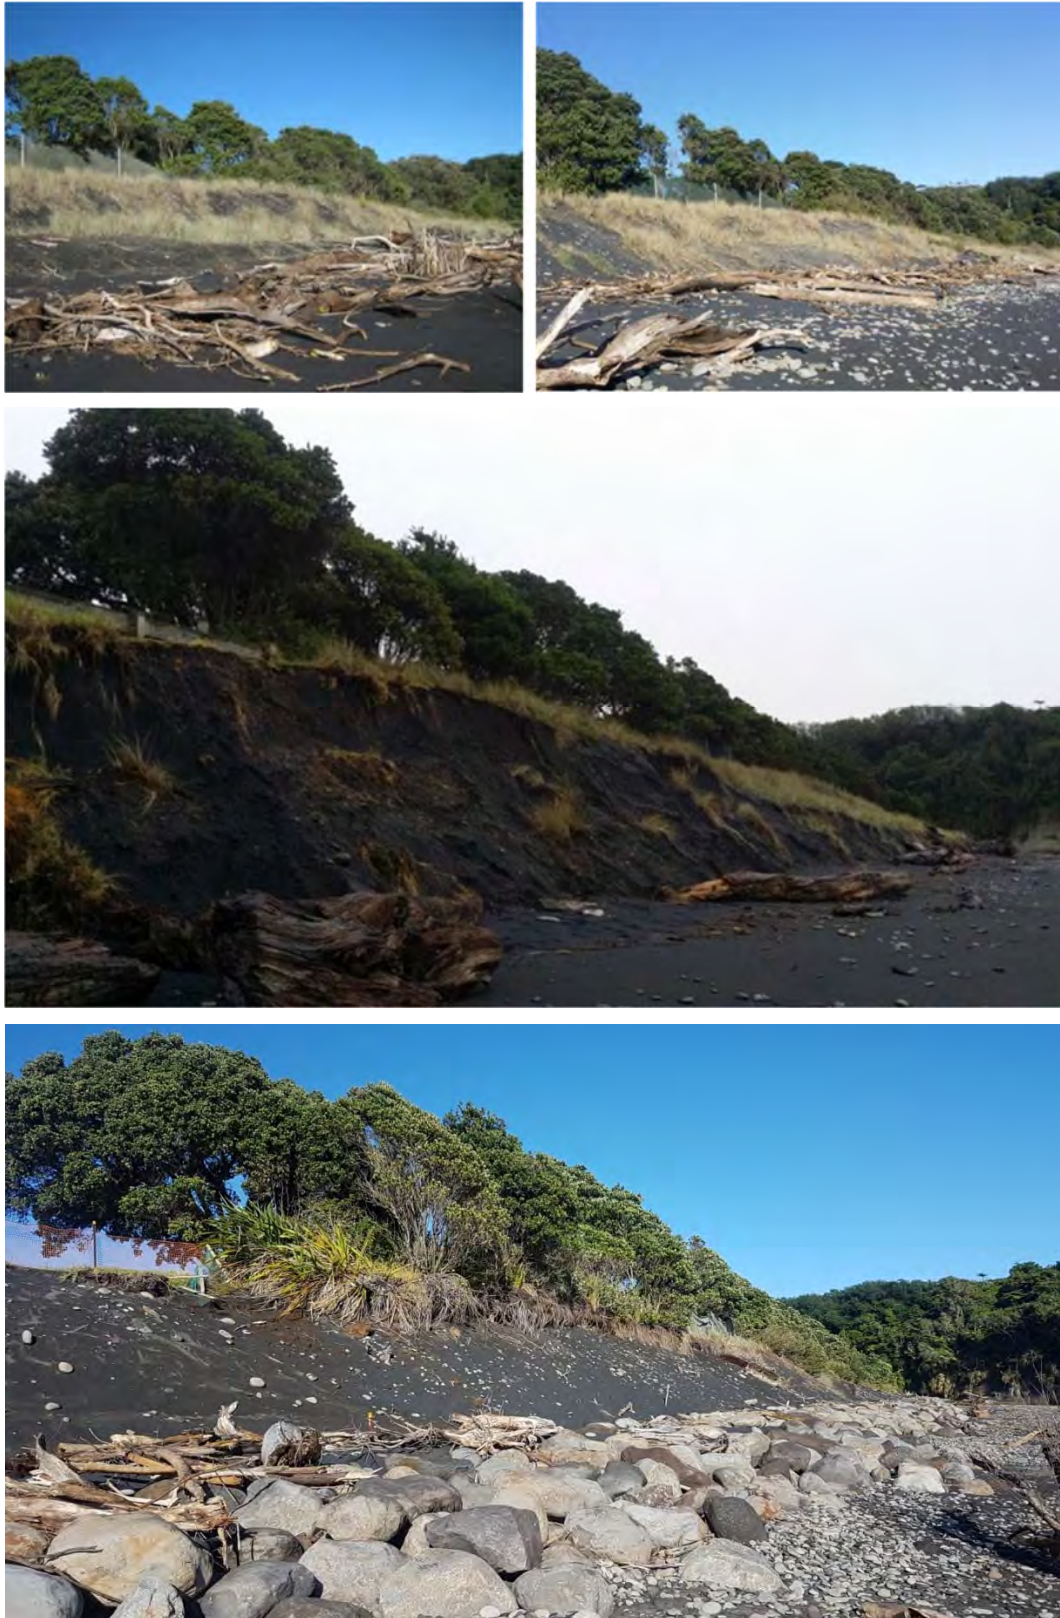
Photo 4 Sand push-up and dune restoration May 2014 and May 2015, major erosion June 2016, seawall extension May 2017

An active program of sand push-ups has been applied to remedy the effects of coastal erosion of the foredunes. Dune restoration at Urenui has consisted of a combination of the sand-push-ups and planting of sand binding species seaward of the erosion scarp (Photo 4).

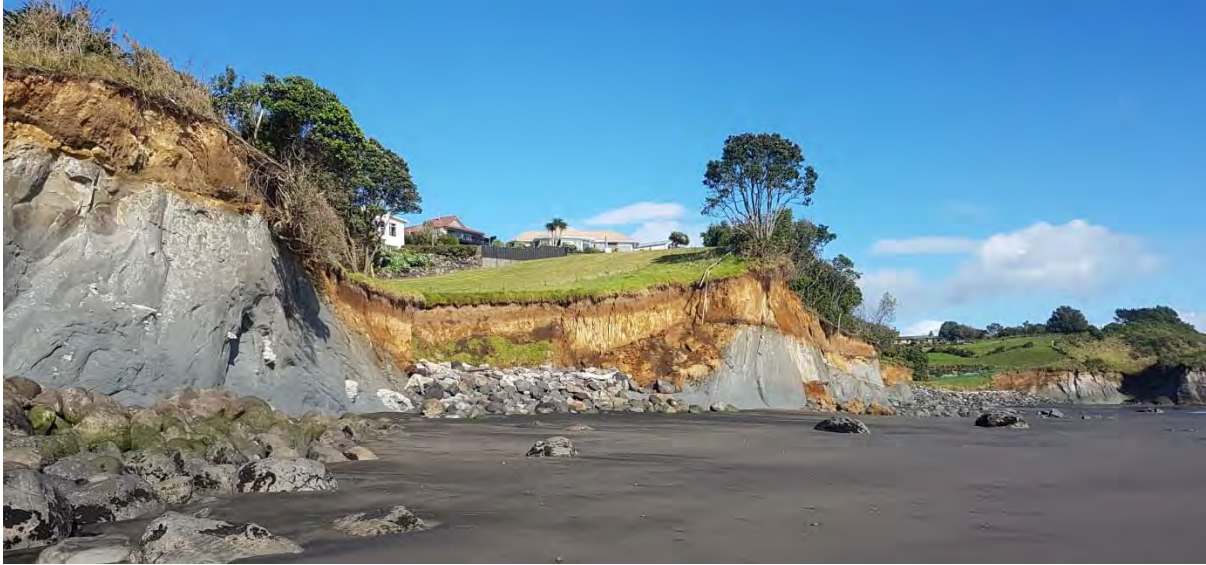
In July 2001 concern was raised by locals, through NPDC, regarding erosion of the reserve situated to the west of the seawall (Photo 7). In this regard it was noted that the reserve was specially set aside as a Coastal Hazard Zone at the time of the subdivision.

Photo 7 Eroding cliffs to the west of the seawall at Onaero (May 2017)

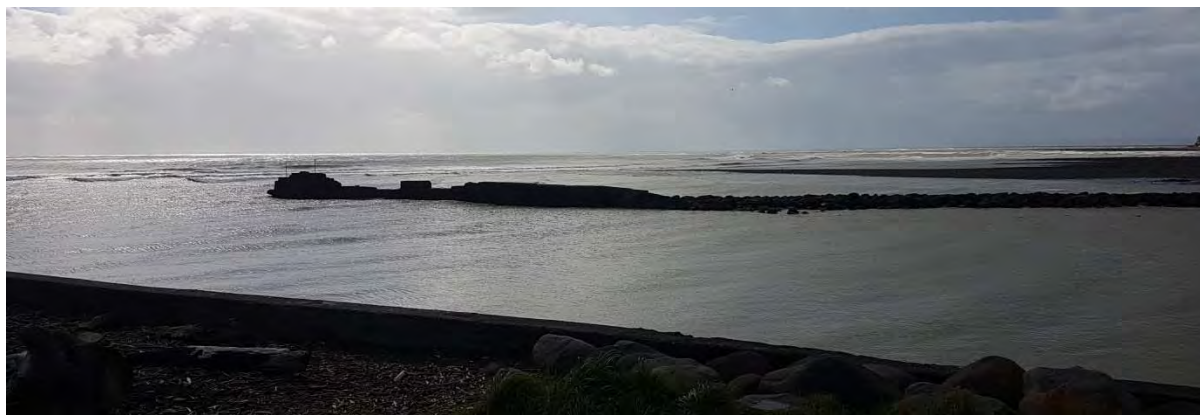
A massive flood in 1990 further damaged the East Mole, partly demolishing the half-tide wall and inner concrete blocks. By 1996, only 60 m of the concrete blocks comprising the outer detached East Mole remained;

Photo 8 Remains of East Mole, Waitara River Mouth (May 2017)

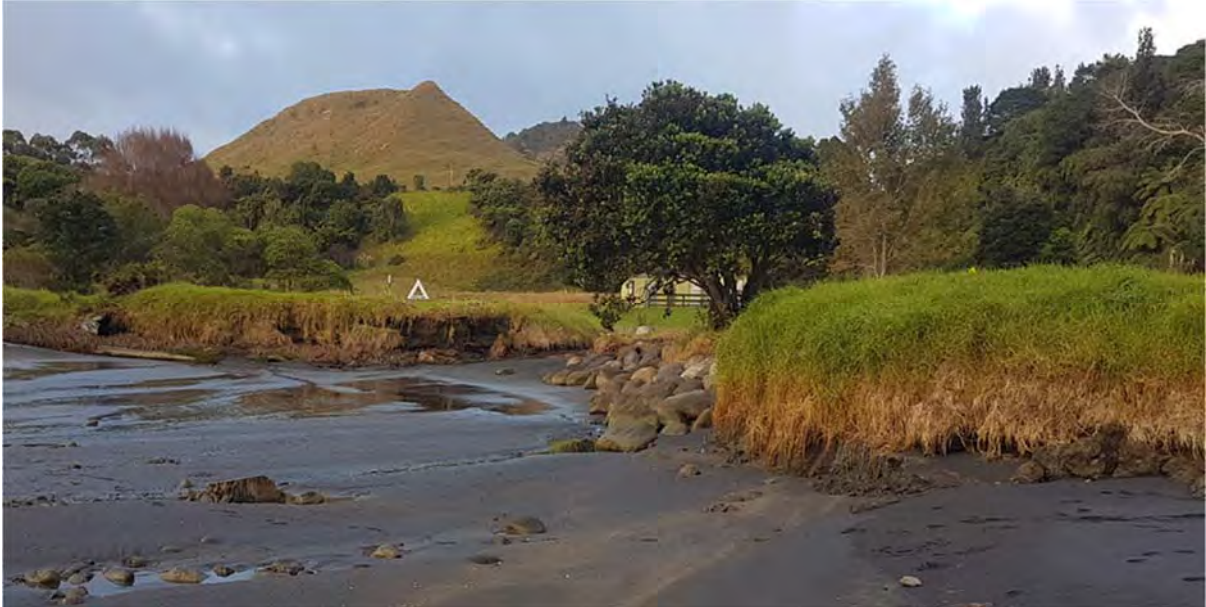
An inspection took place at Tongaporutu on 9 May 2018. Overall, the boat ramp (permit 4004) and four groynes (permit 4818) appeared to be performing well, though some of the bank between two of the groynes was being undercut (Photo 16).

Photo 16 Undercut banks between groynes at Tongaporutu (May 2018)

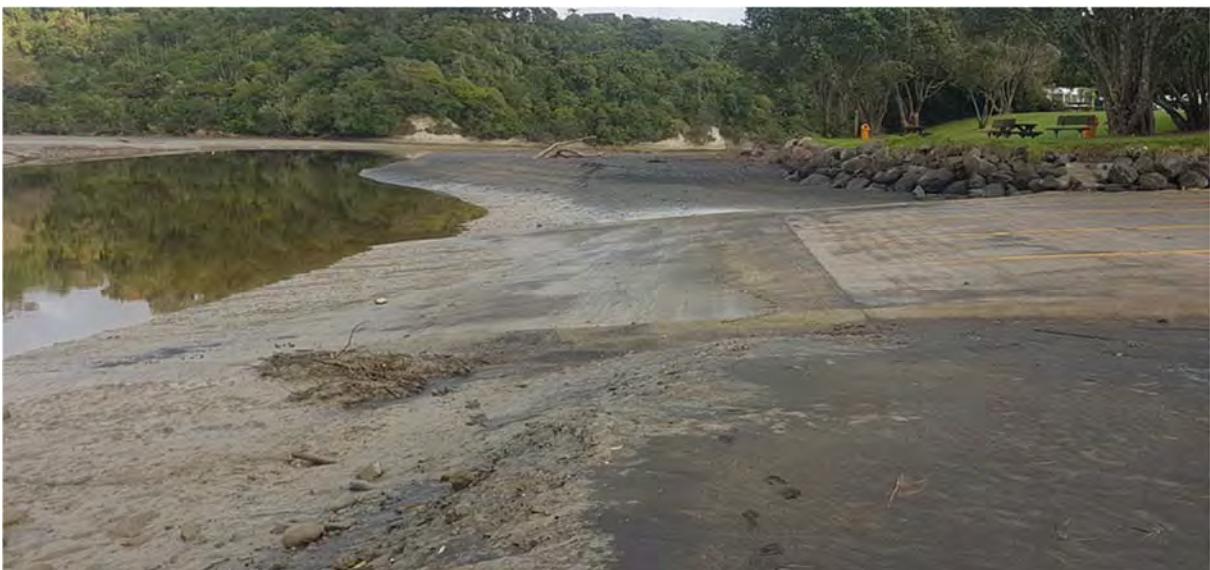
Urenui Beach was visited on 9 May 2018. The riverbank protection works by the boat ramp (permit 4019) were in good condition. The riverbank protection works around the Manager's Residence (permit 4183) and the boat ramp itself (permit 4065) were satisfactory with no obvious end effects (Photo 17).

Photo 17 Urenui boat ramp (May 2018)

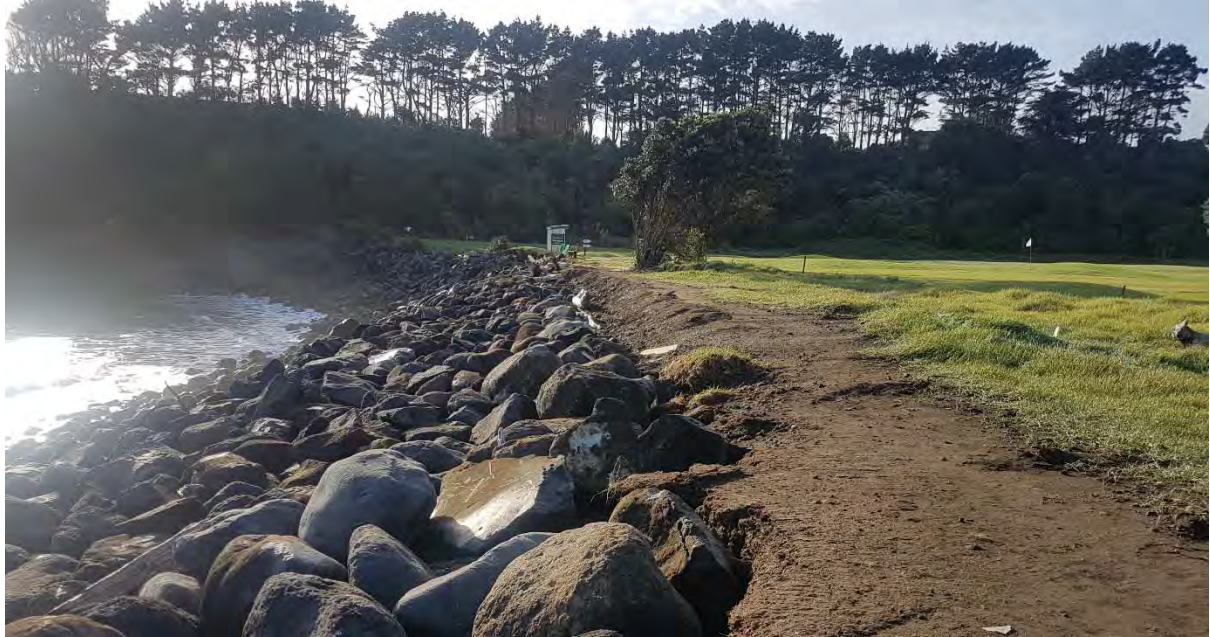
The rock rip rap seawall at the eastern end of Urenui Beach (permit 5761) was in good condition. Maintenance works had been undertaken at the top of the wall after it was scoured during Cyclone Fehi at the beginning of February (Photo 18).

Photo 18 Urenui Beach rip rap protection east seawall (May 2018)

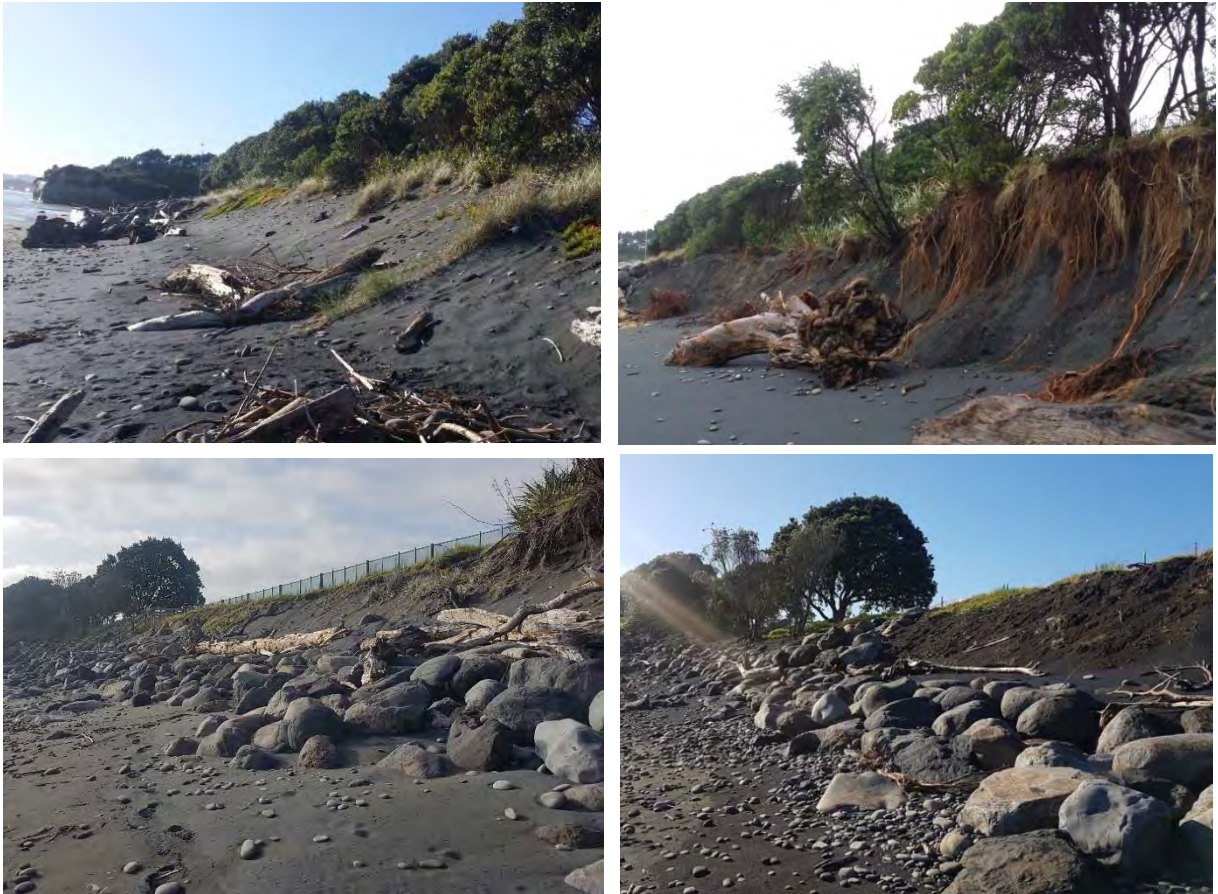
The rock rip rap seawall extension was found in good condition and appeared to be protecting the dunes from further erosion, when inspected in May 2018. Sand binding grasses were beginning to establish on the dune (Photo 19). Blue Penguin footprints were found from the water leading up the beach and through the rip rap. Maintenance was undertaken on the seawall during the period under review, after a boulders were displaced from a small section near the steps.

Photo 19 Recovery from end effects at Urenui Beach (clockwise from top left May 2015, June 2016, May 2017 and May 2018)

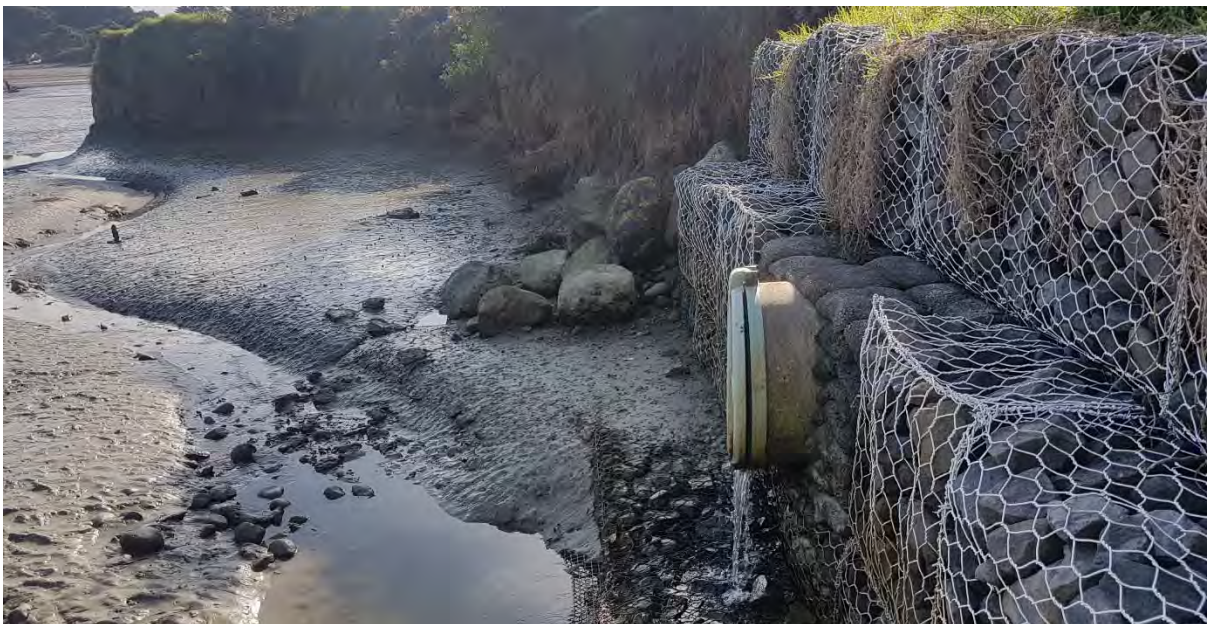
The gabion basket and rip rap in the estuary (permit 6411) were all in good order at the time of inspection (Photo 20).

Photo 20 Urenui gabion basket (May 2018)

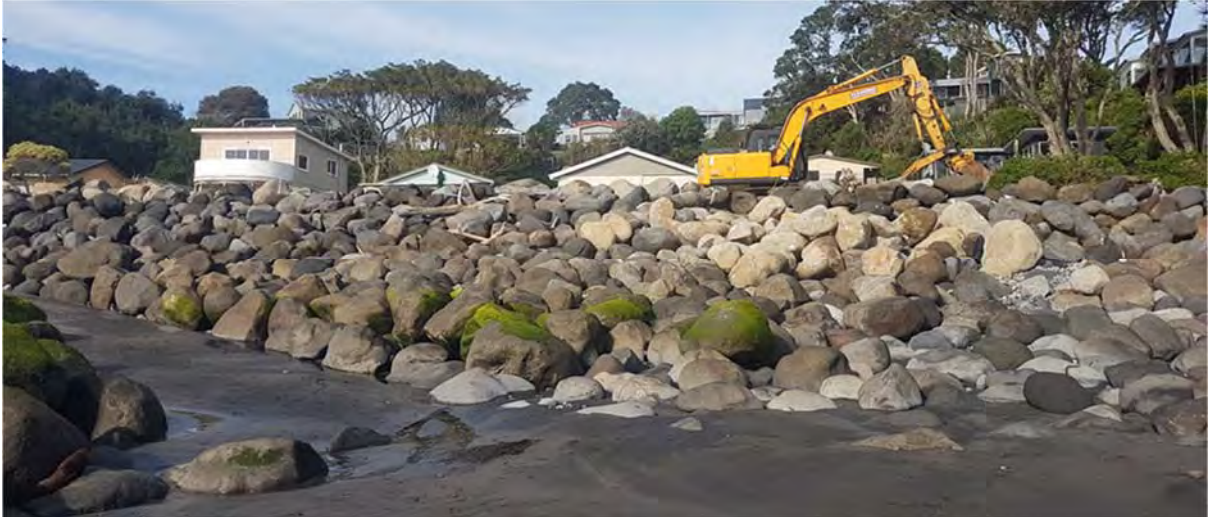
A maintenance contractor was on site replacing material during the inspection of the seawall (Photo 21). The repairs were required after the wall sustained storm damage earlier in the year. Overall, the structure appeared to be in good condition.

Photo 21 Onaero seawall repairs (May 2018)

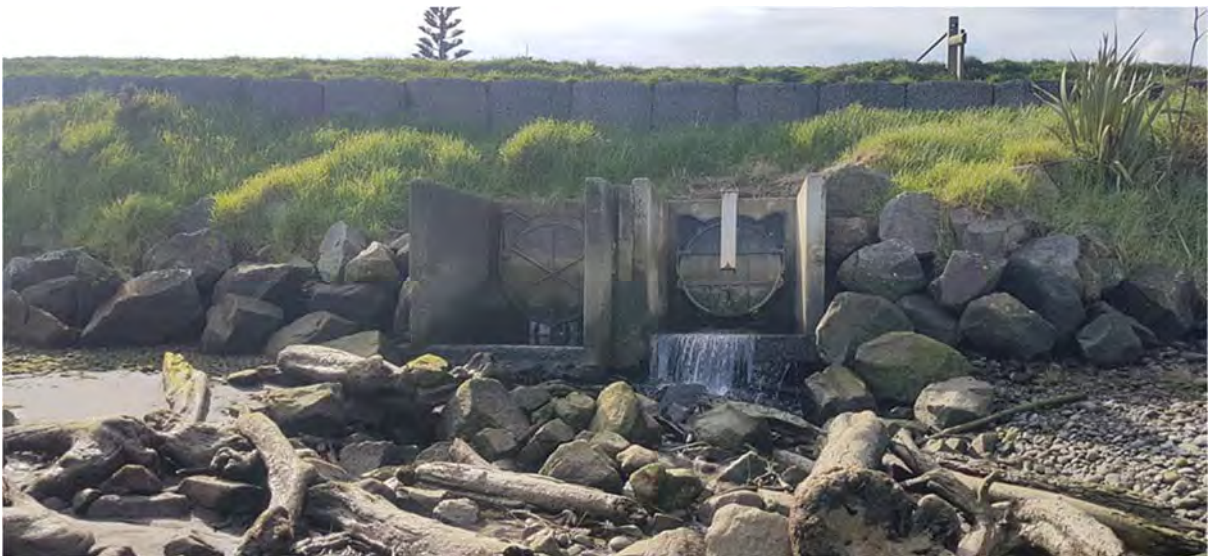
Coastal structures at Waitara were visited on 9 May 2018 in relation to five coastal permits. The stormwater outlet structure downstream of Atkinson Street (permit 4598) was in good condition and there was no evidence of erosion (Photo 22).

Photo 22 Stormwater outlet structure downstream of Atkinson Street (May 2018)

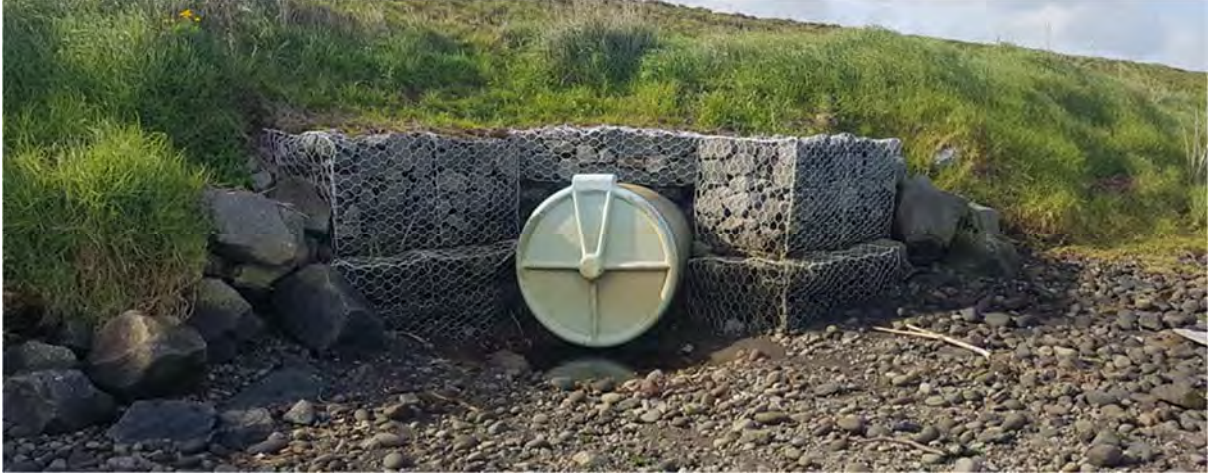
The stormwater outlet by the Atkinson Street/East Quay intersection (permit 6525) was also in good condition (Photo 23).

Photo 23 The stormwater outlet by the Atkinson Street/East Quay intersection (May 2018)

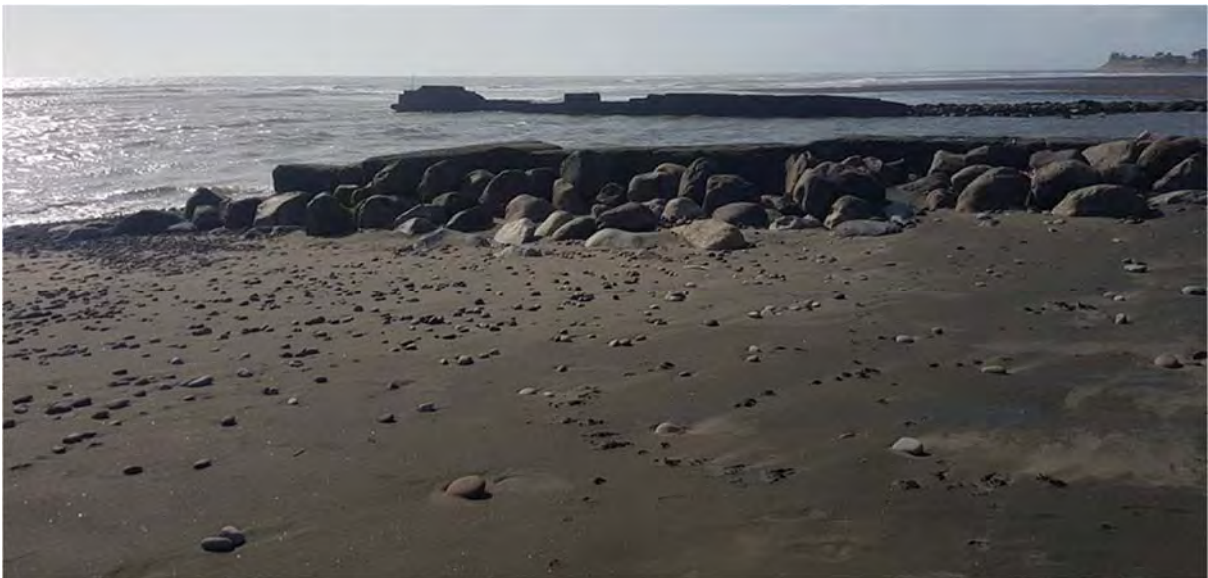
The groynes at the Waitara River mouth appeared to be in a reasonable condition at the time of the inspection (permit 4600; Photo 24). Maintenance works were required for structures on the eastern side of the river mouth to replace material lost during the period under review.

Photo 24 Groynes at Waitara River Mouth (May 2018)

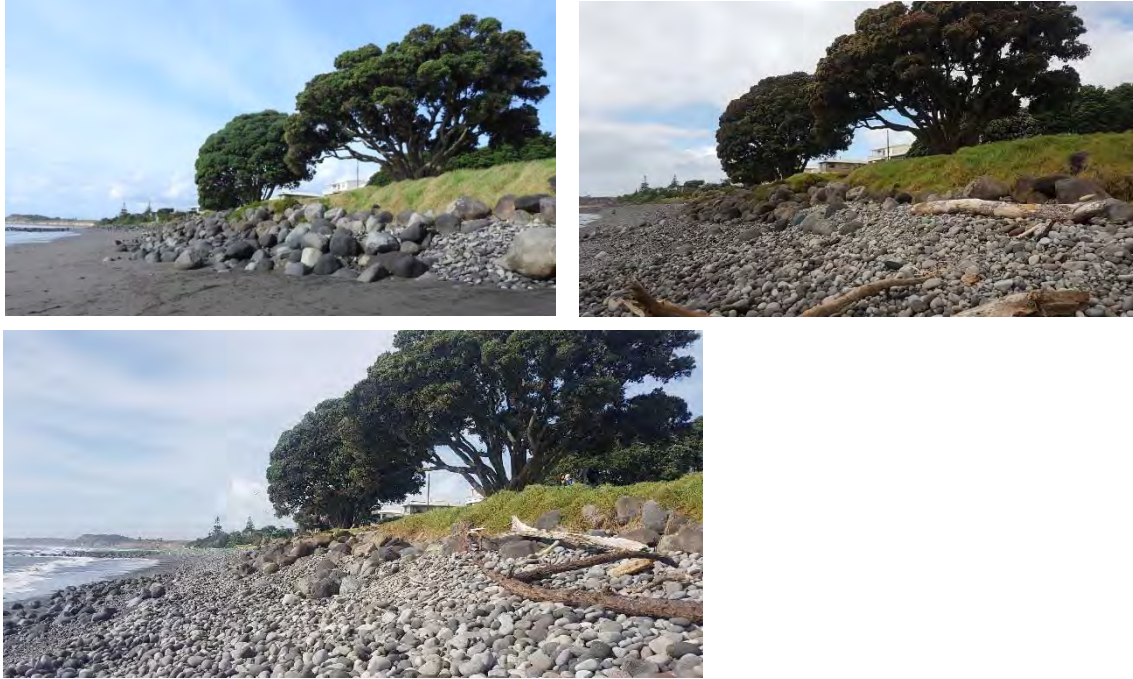
An inspection took place on 9 May 2018 of the seawall at Bell Block Beach (permit 5102). The structure itself appeared to be in a good condition and no end effects were apparent. The volume of cobble and rock on the beach appeared to have built up even more than what was observed the previous year (Photo 25, Photo 26). NPDC cleared rocks from the boat ramp in December.

Photo 25 Bell Block seawall (Clockwise from top left; May 2016, May 2017 and May 2018)

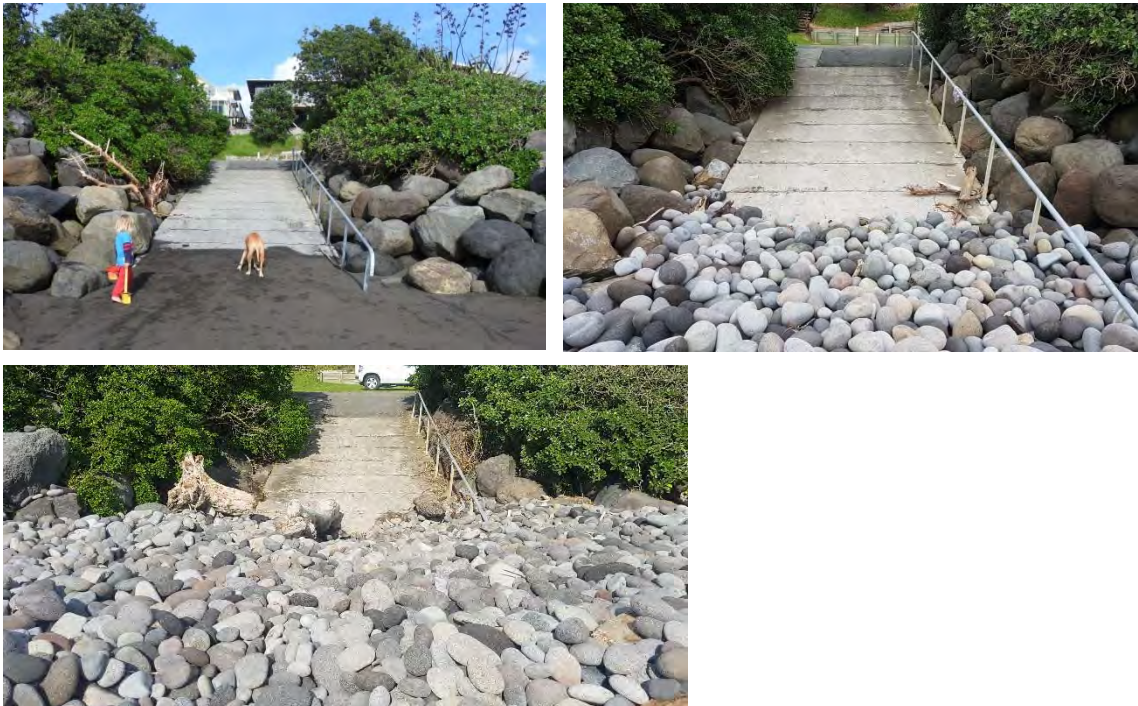
Photo 26 Bell Block seawall (Clockwise from top left; May 2016, May 2017 and May 2018)

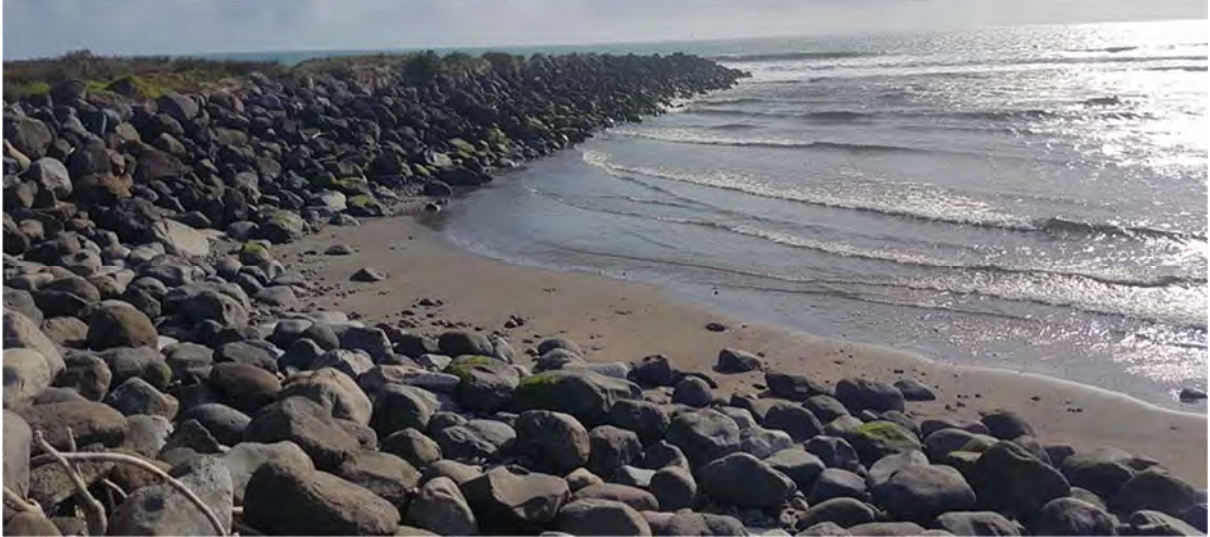
The groyne and associated rock rip rap (permit 4585) appeared to be in a good condition (Photo 27).

Photo 27 Waiwhakaiho groyne (May 2018)

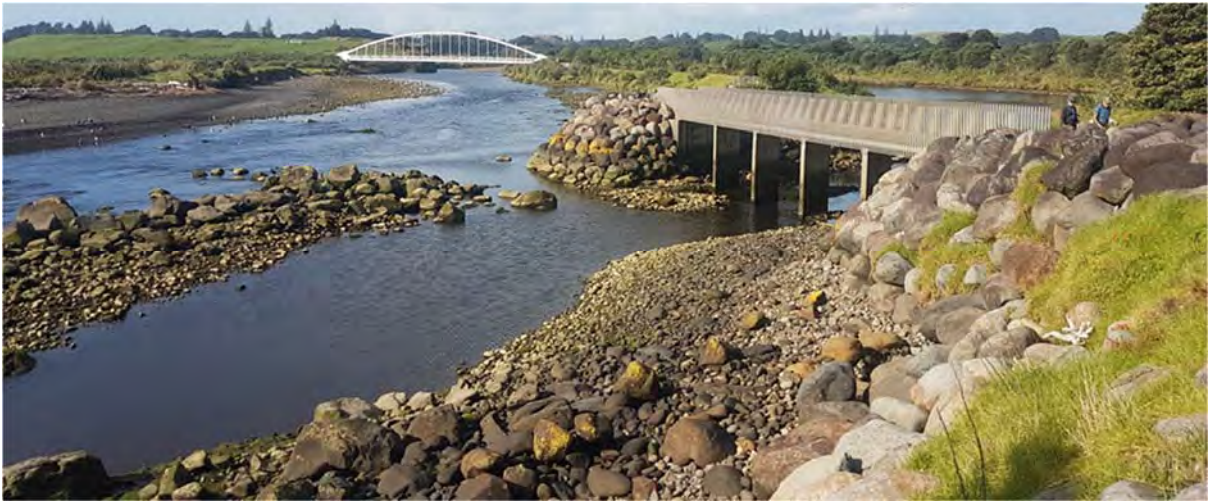
No issues were observed with the foot bridge or associated protection structures (permit 4603) during the May inspection (Photo 28). NPDC undertook minor repair works on the rip rap near the footbridge during the period under review.

Photo 28 Footbridge over the Waiwhakaiho River (May 2018)

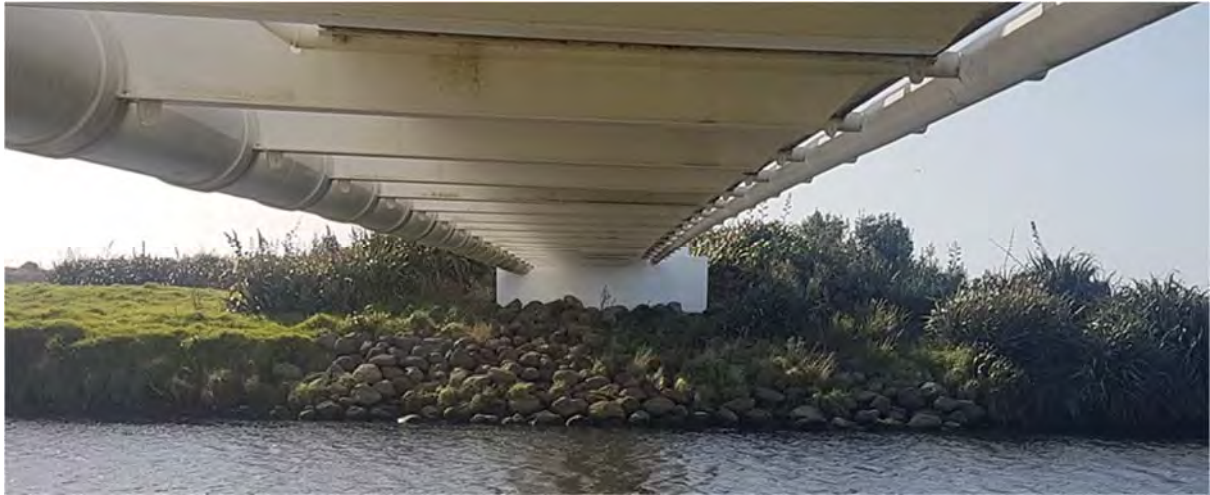
The Te Rewa Rewa Bridge and protection structures (permit 7442) appeared to be in reasonable condition; there were no obvious signs of riverbank erosion or scouring in the vicinity of the bridge (Photo 29).

Photo 29 Te Rewa Rewa bridge over the Waiwhakaiho River (May 2018)

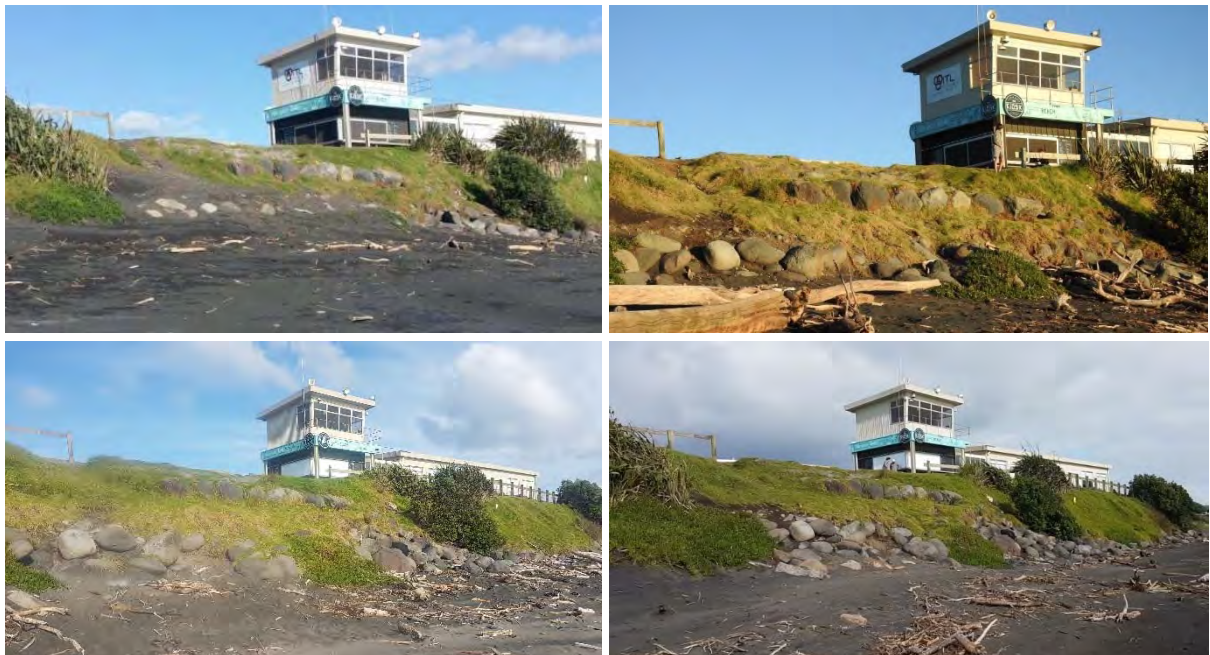
Coastal permit 4586 covers both the boat ramp and rock protection works in front of and adjacent to the Fitzroy Surf Life Saving Club. The boat ramp was in satisfactory condition at the time of the inspection. The condition of the bank appears to have remained stable over the last four years, with sand having built up at the base of the structure (Photo 30).

Photo 30 Fitzroy Beach rock rip rap (clockwise from top left; May 2015, June 2016, May 2017 and May 2018)

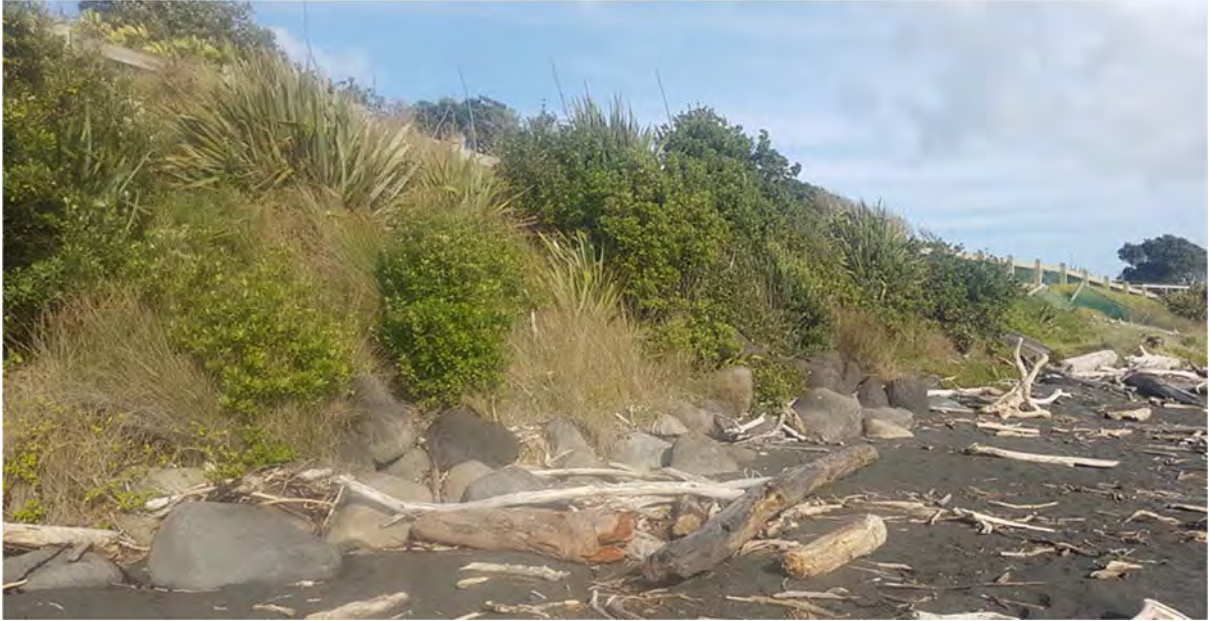
No issues were observed along the western extent of the structure between the Fitzroy Surf Club and New Plymouth Boardriders Club (Photo 31).

Photo 31 Rock rip rap and vegetated bank between the Fitzroy Surf Club and New Plymouth Board Riders Club

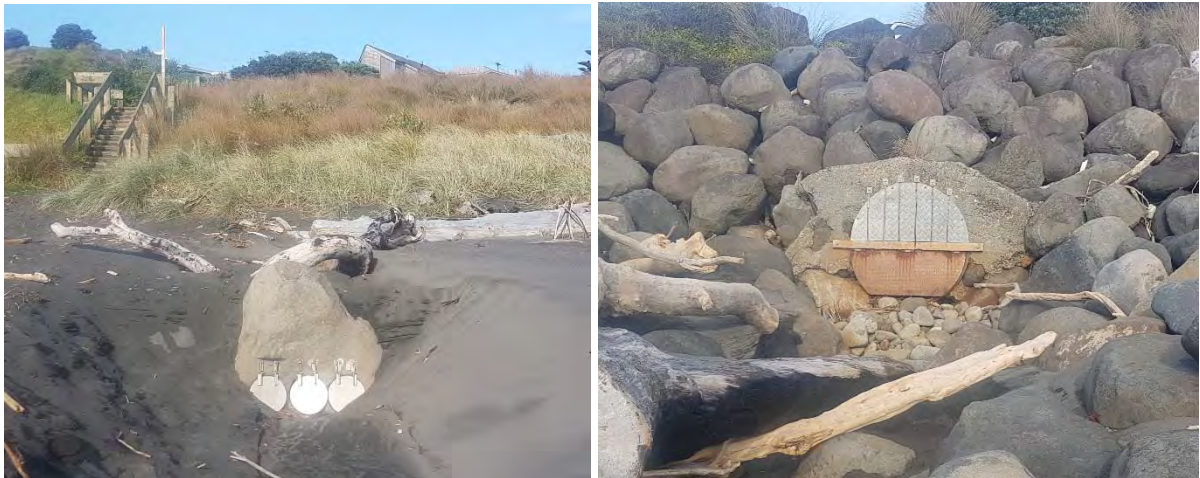
Coastal permit 4596 enables the maintenance of two stormwater outlets, one being just north of the East End Surf Life Saving Club and the other west of the Fitzroy Surf Life Saving Club. No issues were observed at either structure during their inspection in May (Photo 32).

Photo 32 Fitzroy and East End stormwater outlets (permit 4596; May 2018)

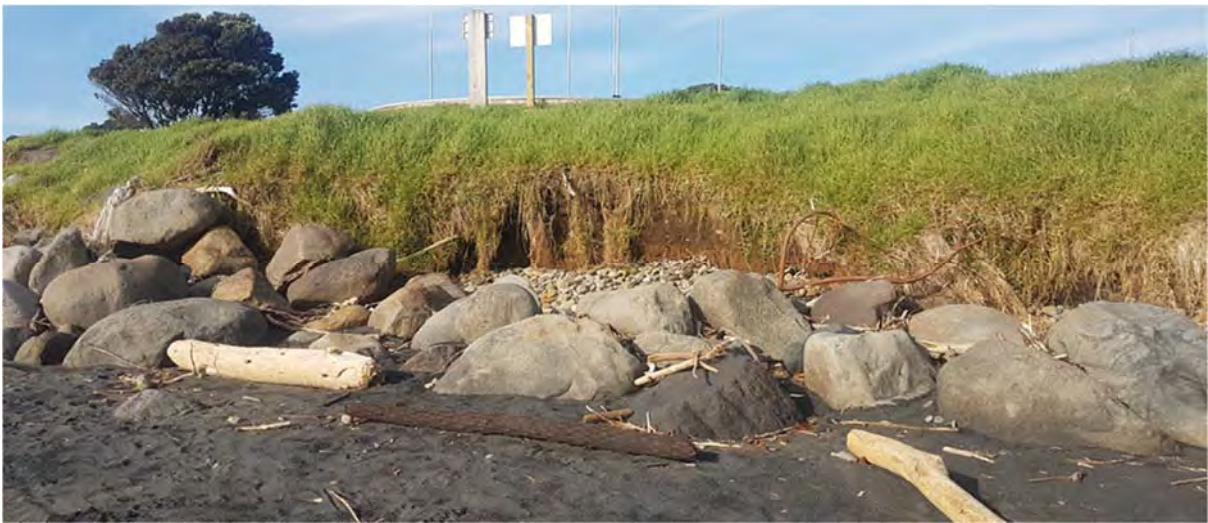
Photo 34 Scouring on true right bank of Te Henui river mouth (May 2018)

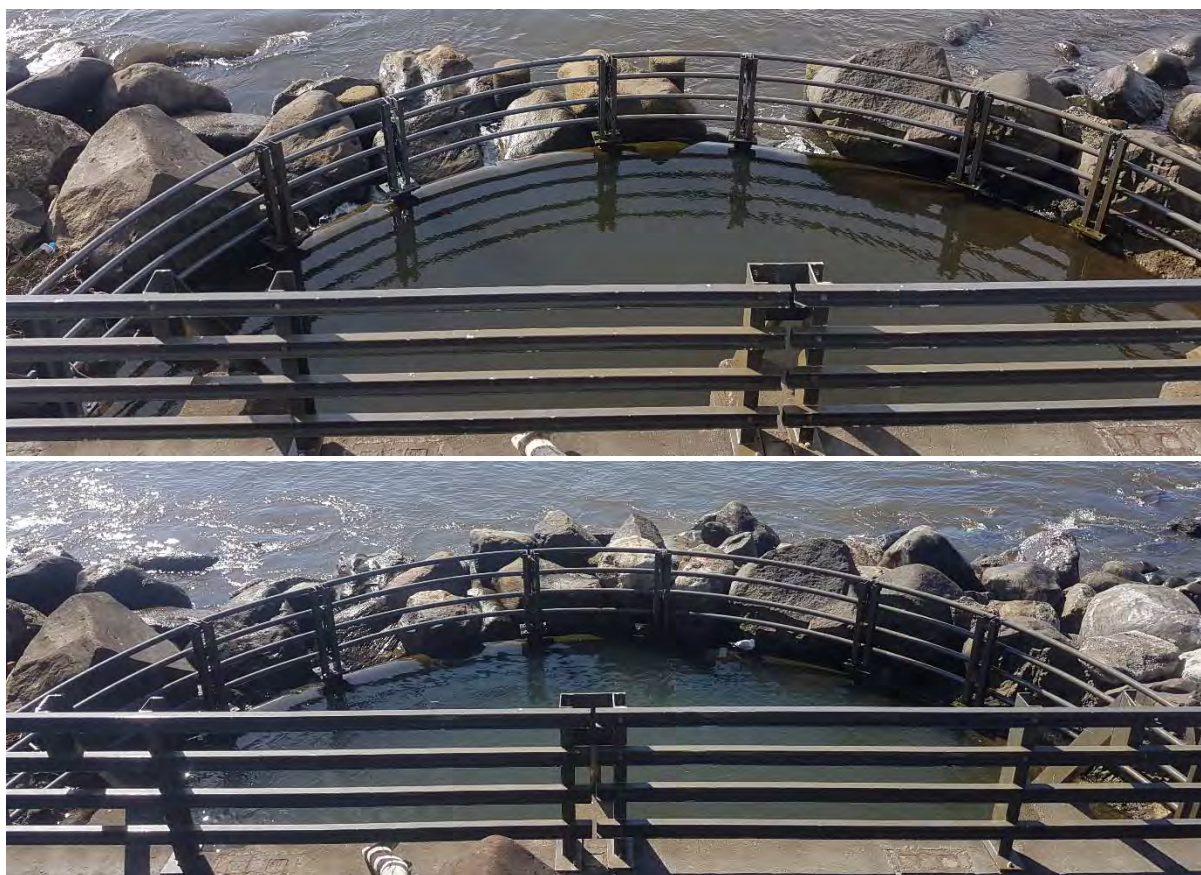
The outlet structure from the Mangaotuku Stream (at the Lee Breakwater; permit 4594) was in a satisfactory condition when inspected in May (Photo 35). Earlier in the year, maintenance works were required under permit 4602 to ensure adequate protection of the outlet after boulders had been moved following a storm.

Photo 35 Mangaotuku Stream outlet before and after repair works (top; 8 Mar 2018, bottom; 9 Mar 2018)

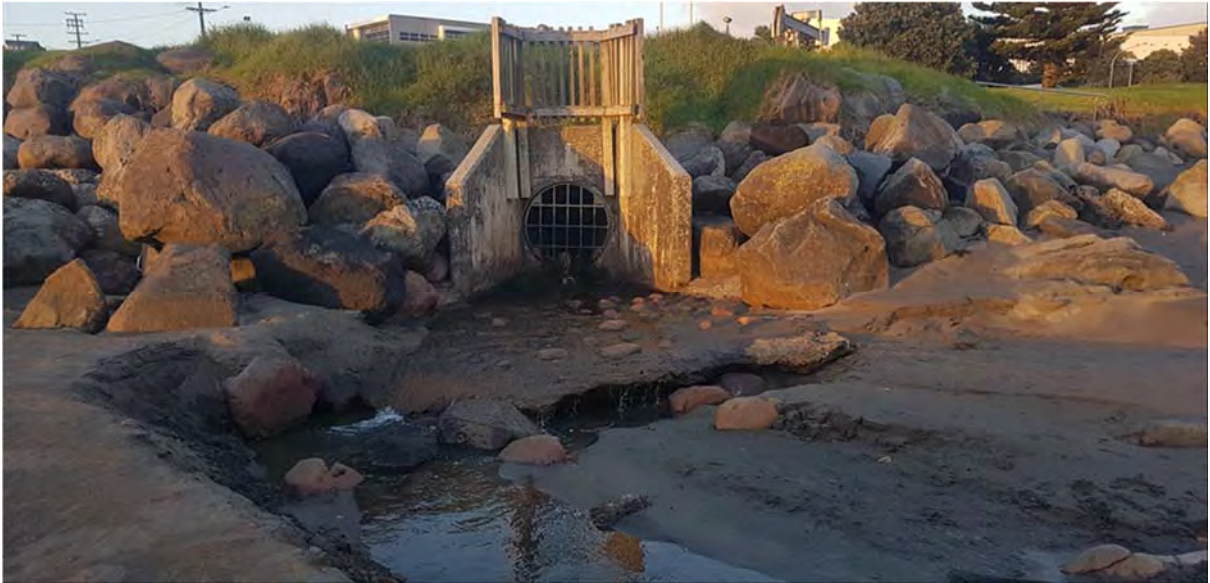
Photo 36 The Bayly Road stormwater outfall on Ngamotu Beach (May 2018)

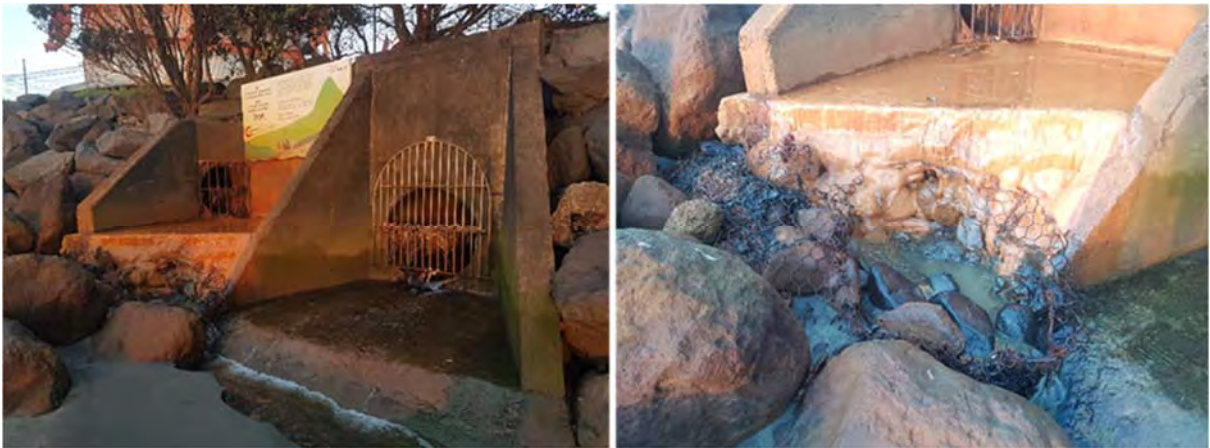
Photo 37 Hongihongi Stream outlet structure and rusted wire (May 2018)

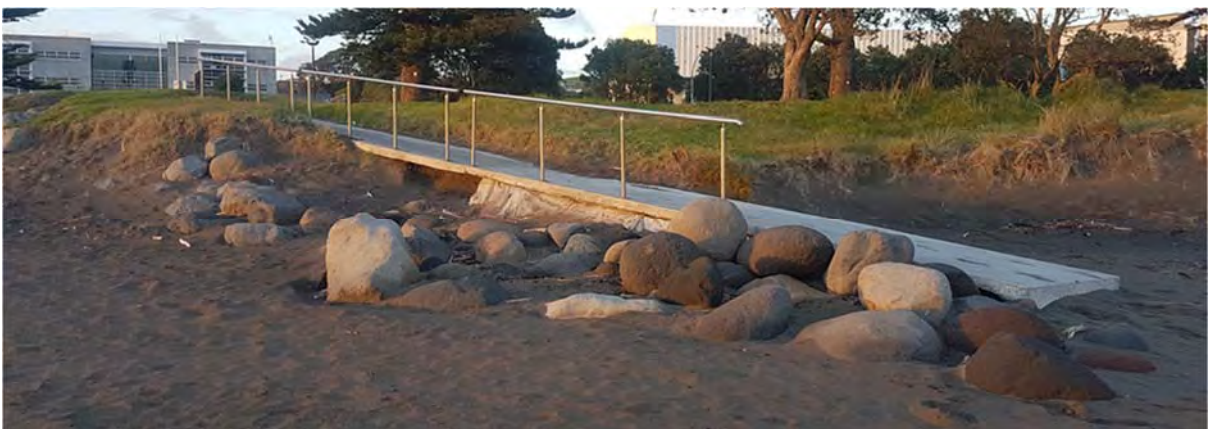
Ngamotu Beach access structures, located outside the CMA, appeared to have suffered storm damage during the year under review (Photo 38).

Photo 38 Damaged access structure at Ngamotu Beach (May 2018)

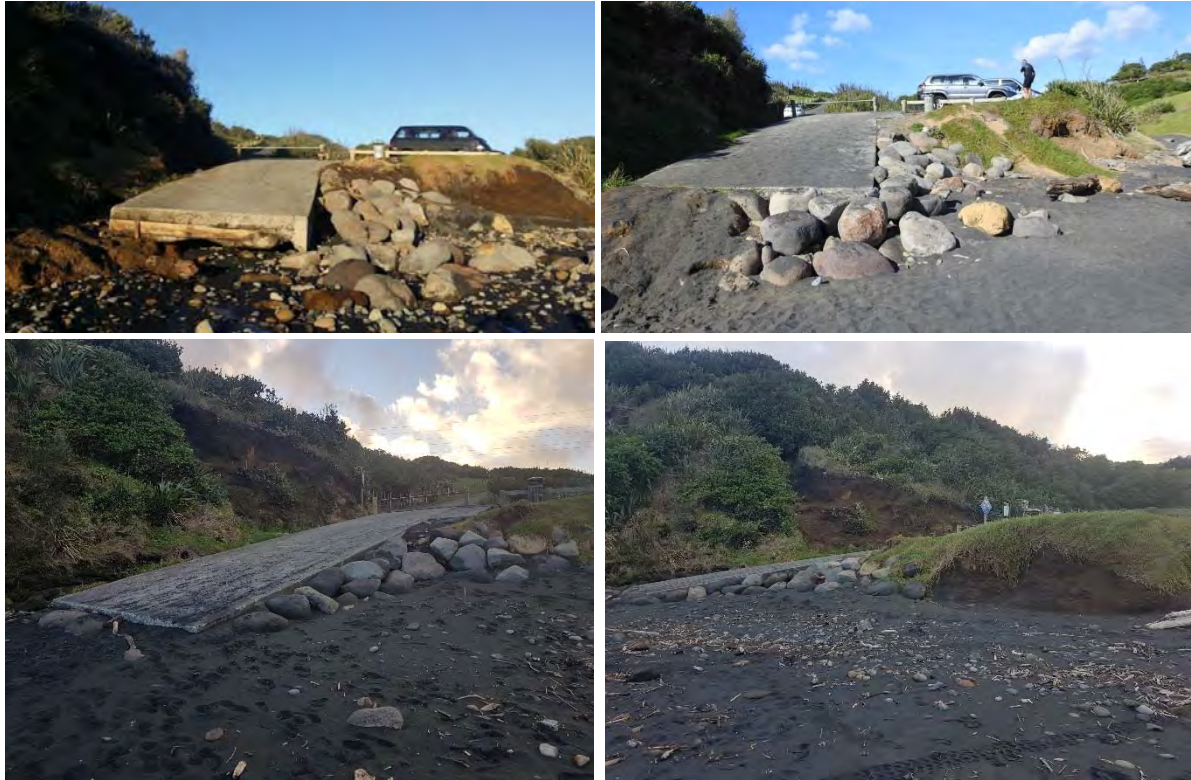
An inspection of the boat ramp (permit 6553) was undertaken on 8 May 2018. The ramp was in good condition and was not being affected by any obvious erosion processes. The beach appeared to be in an accretion phase considering the volume of sand that had built up around the ramp (Photo 39). The eroding bank immediately west of the ramp did not appear to have worsened.

Photo 39 Boat ramp at Back Beach (top left; May 2015, top right; April 2016, bottom; May 2018)
