NPDC Coastal Structures
Monitoring Programme
Annual Report
2017-2018

Technical Report 2018–27

Taranaki Regional Council
Private Bag 713
STRATFORD
November 2018

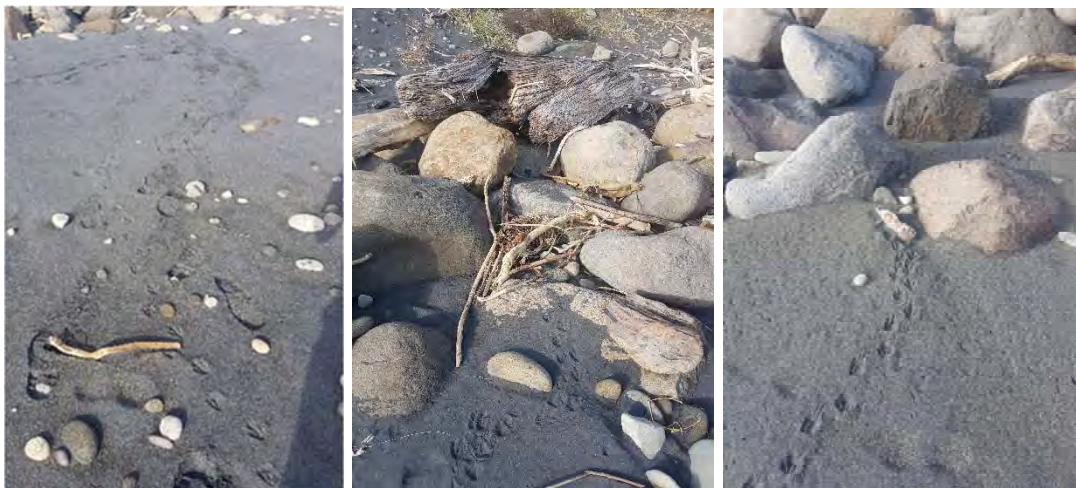
The seawall extension at Urenui Beach (permit 7007) appears to have been effective in preventing further erosion on the coast. Furthermore, the structure is still providing beach access for the Blue Penguins which nest in the back dune. Footprints were found leading up the beach and through the rip rap during the inspection in May (Photo 41).

Photo 41 Penguin tracks on Urenui Beach (May 2018)
