Ballance Agri-Nutrients (Kapuni) Ltd
Monitoring Programme
Annual Report
2019-2020

Technical Report 2020-81

Taranaki Regional Council
Private Bag 713
STRATFORD
November 2020

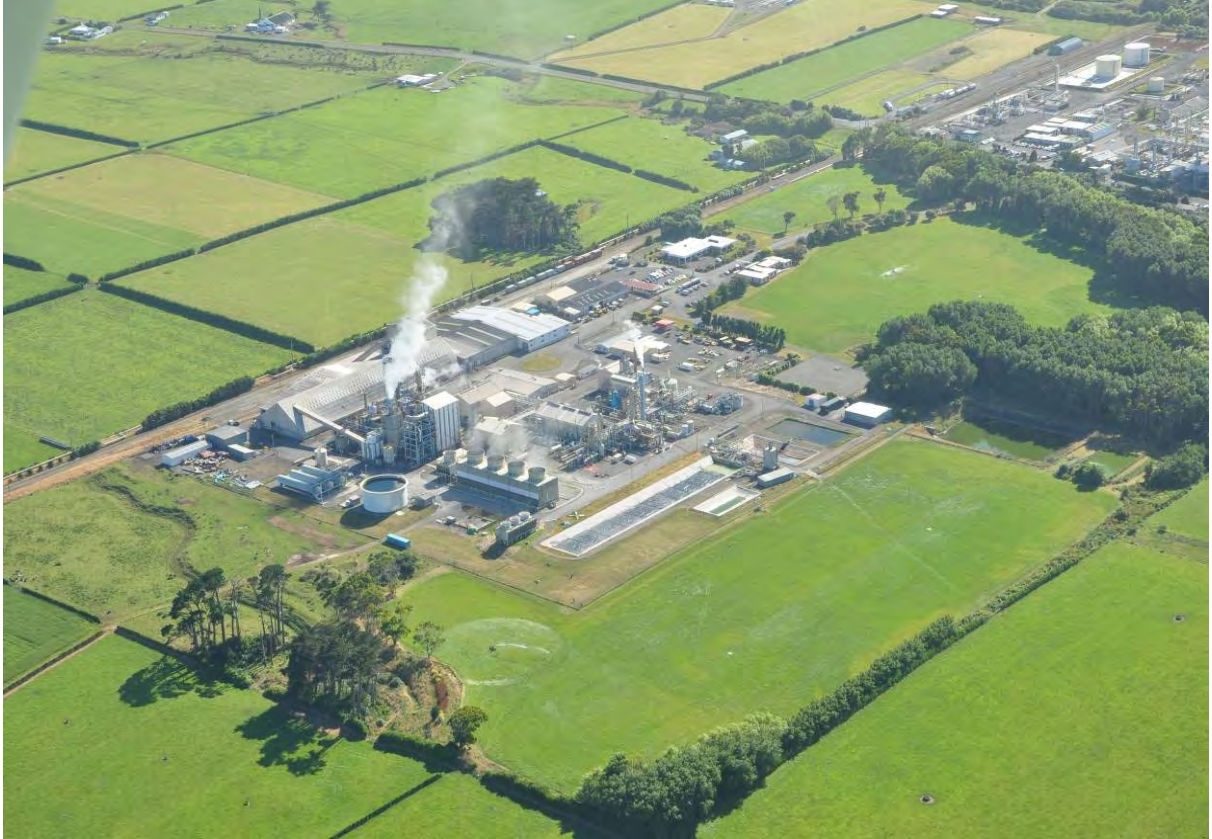
Photo 1 Ballance Agri-Nutrients ammonia urea plant (viewed looking towards the north-west)

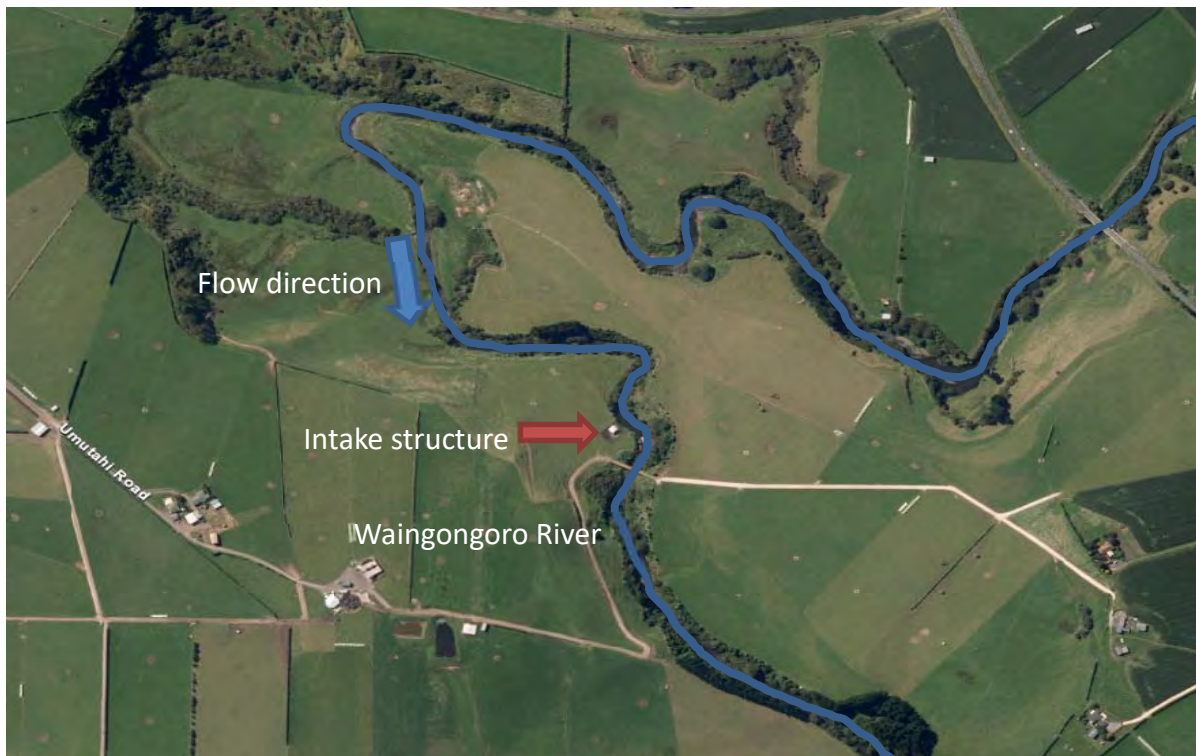
Process and operation water for the site is pumped from the Waingongoro River, which is located 7.2 km east from the Company site (Figure 1). Water is pumped at a rate of approximately 140 m³/h (3,360 m³/d or 39 L/s). The consented daily volume limit, of 3,456 m³ at a maximum rate of 100 L/s, was increased by 15% to 4,000 m³, without an instantaneous limit, under replacement consent 0596-3 in August 2012.

Figure 1 Map showing water intake structure adjacent to the Waingongoro River

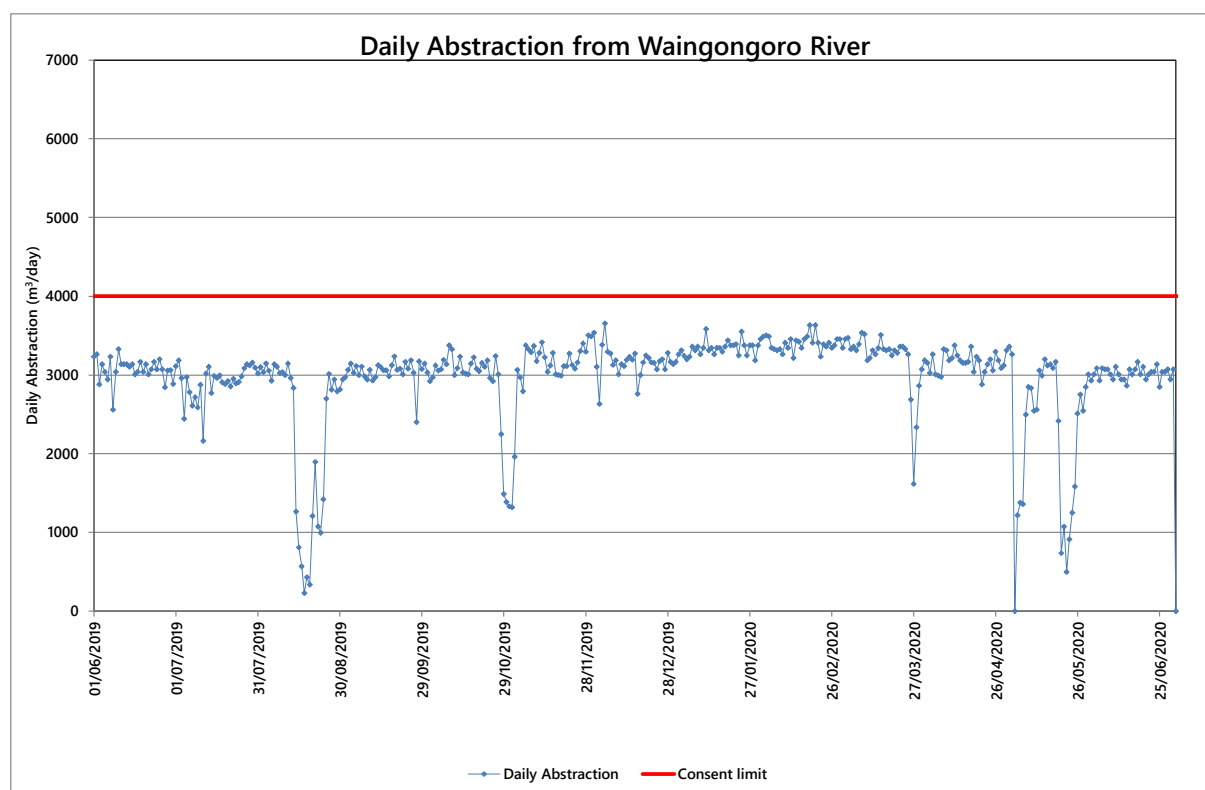
Figure 2 Daily water abstraction by the Company, July 2019 – June 2020

The record shows that the consent limit of 4,000 m³/d on maximum abstraction volume was complied with throughout the 2019-2020 review period. The minimum daily recorded volume was 0 m³/d and the maximum recorded daily volume was 3,656 m³, or 91% of the limit.

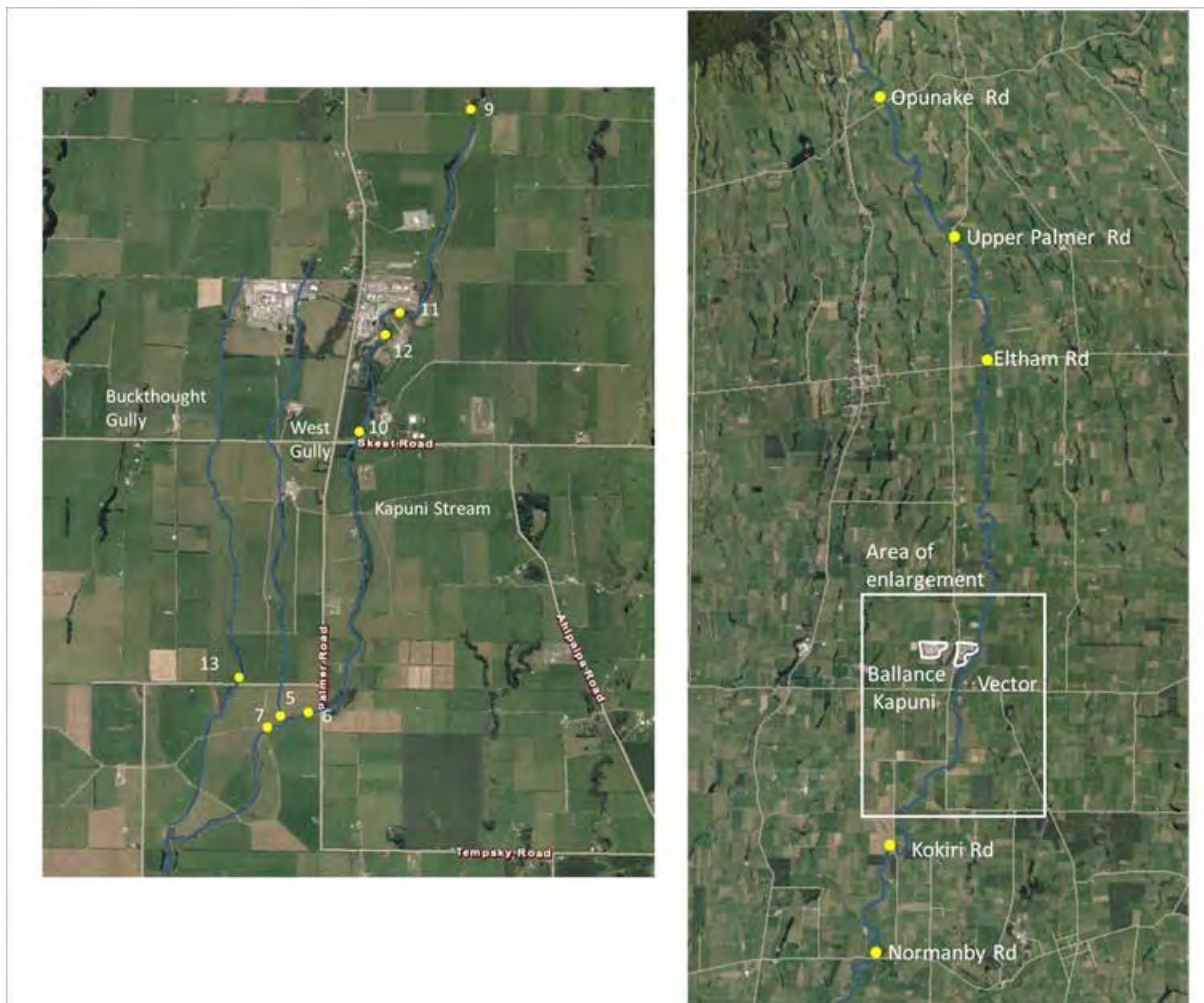
The programme involved assessment of changes in the abundance and diversity of the macroinvertebrates and fish communities. Seven sites in the Kapuni catchment, five on the main stream and two in gullies that run through the irrigation area were monitored quarterly for benthic macroinvertebrates and biannually for fish by electric fishing (Figure 3). A further four sites on the main stream are sampled once a year in spring in conjunction with the other monitoring for both macroinvertebrates and fish. Monitoring results and their interpretation are forwarded to the Council quarterly.

Figure 3 Biomonitoring sites in the Kapuni Catchment

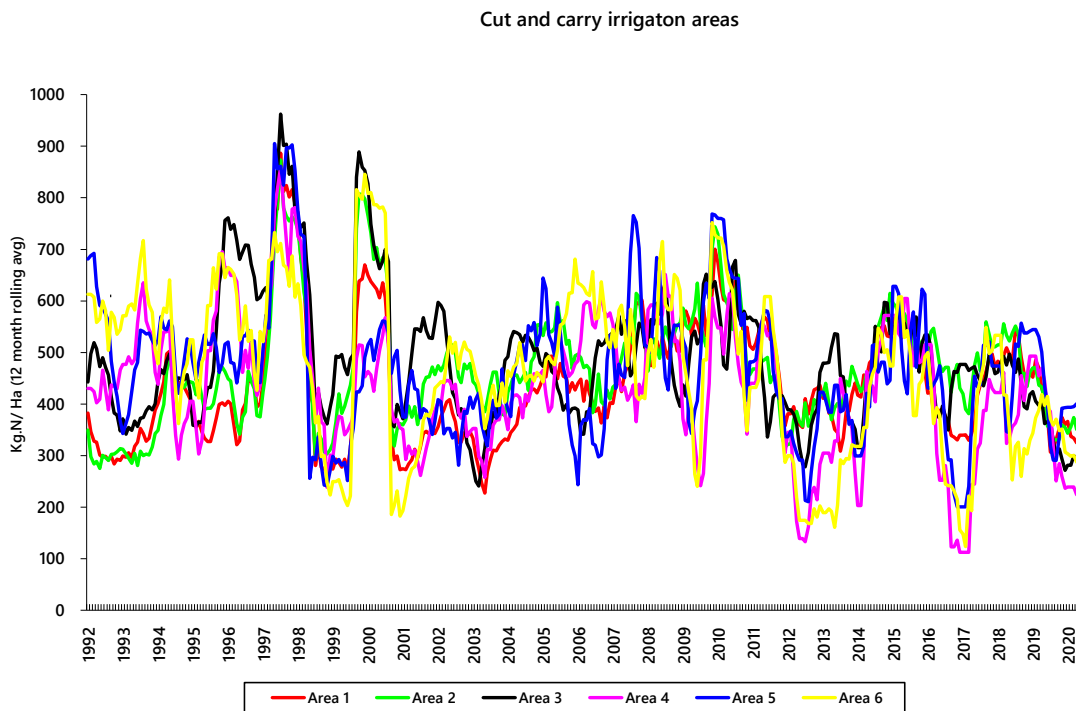
The Company also has an internal target for cut and carry areas of 600 kgN/ha to promote good pasture health which was also achieved. Long term compliance with the nitrogen loadings have always been observed though there have been periods where the internal goal has not been achieved Figure 5.

Figure 5 Nitrogen applications rates on cut and carry spray irrigation areas

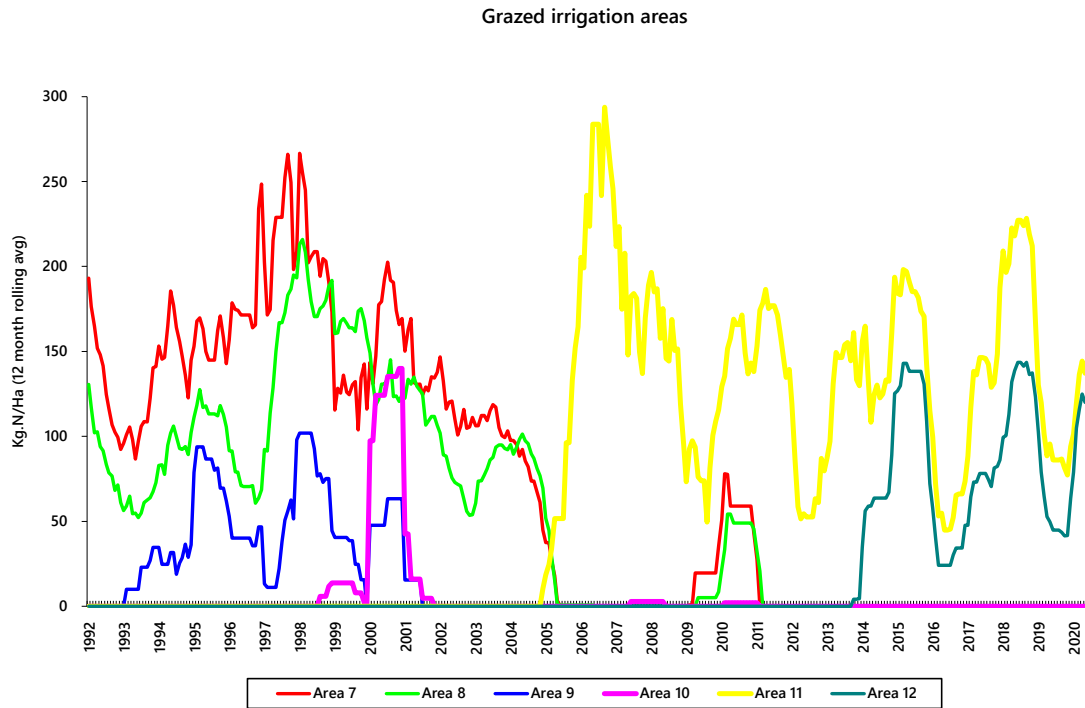
Long term compliance with the nitrogen loadings have always been observed for grazed areas Figure 6. It should be noted that the areas referred to as Area 7 and Area 8 have not been used since the 2010-2011 monitoring year, Area 9 since 2001-2002 monitoring year and Area 10 since the 2007-2008 monitoring year.

Figure 6 Nitrogen applications rates on grazed spray irrigation areas

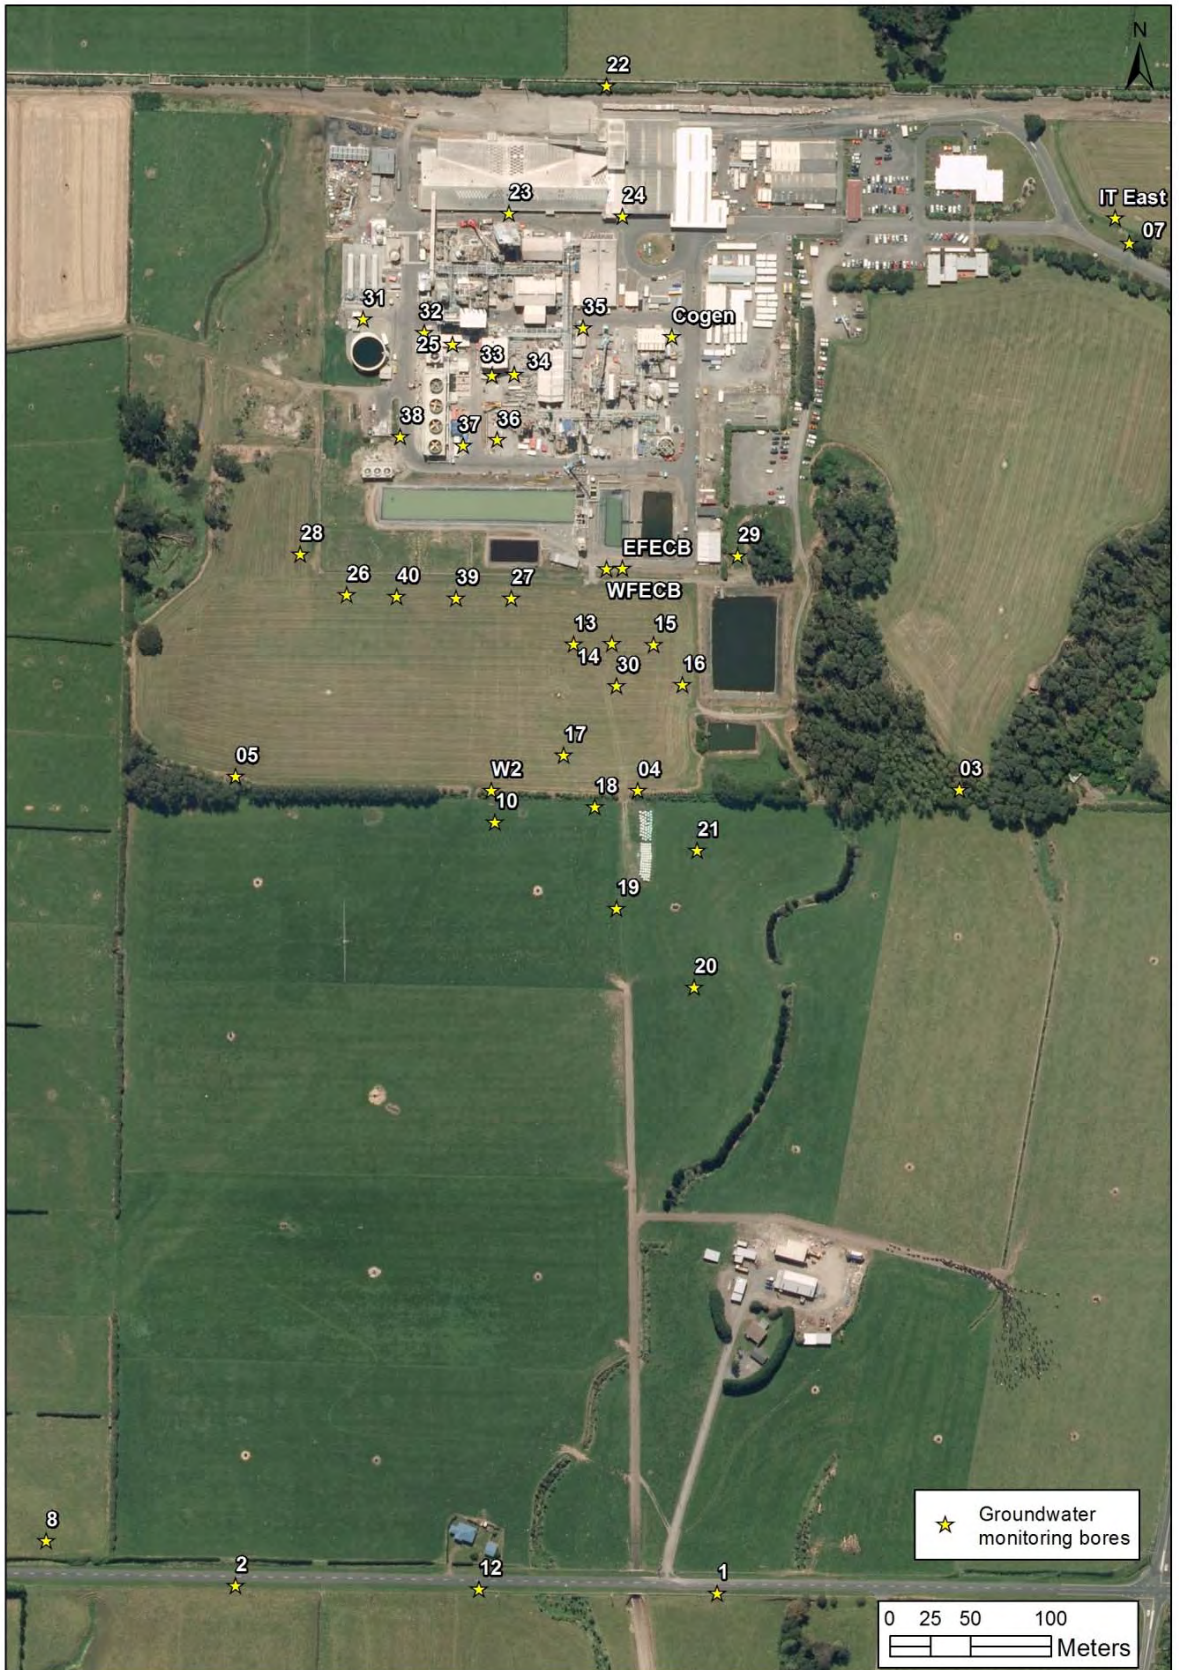
Figure 7 Locations of groundwater monitoring bores

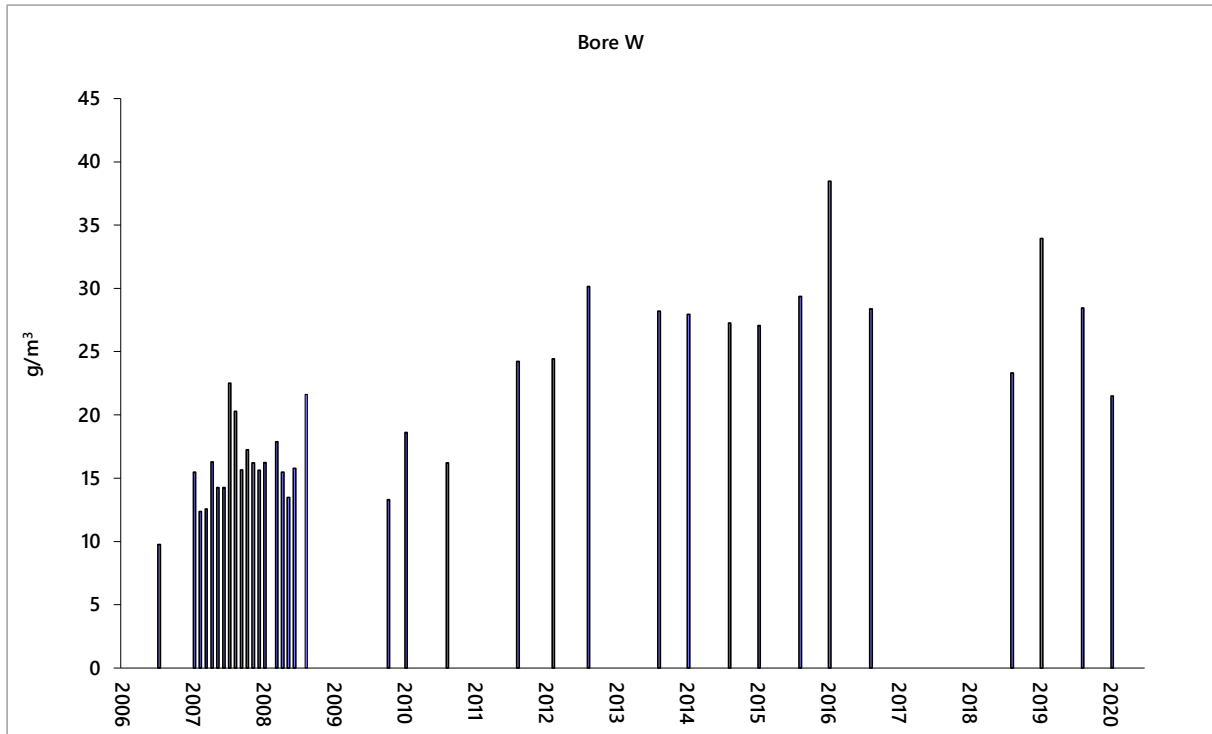
Figure 8 Total nitrogen concentrations in groundwater beneath spray irrigation area (Bore W)

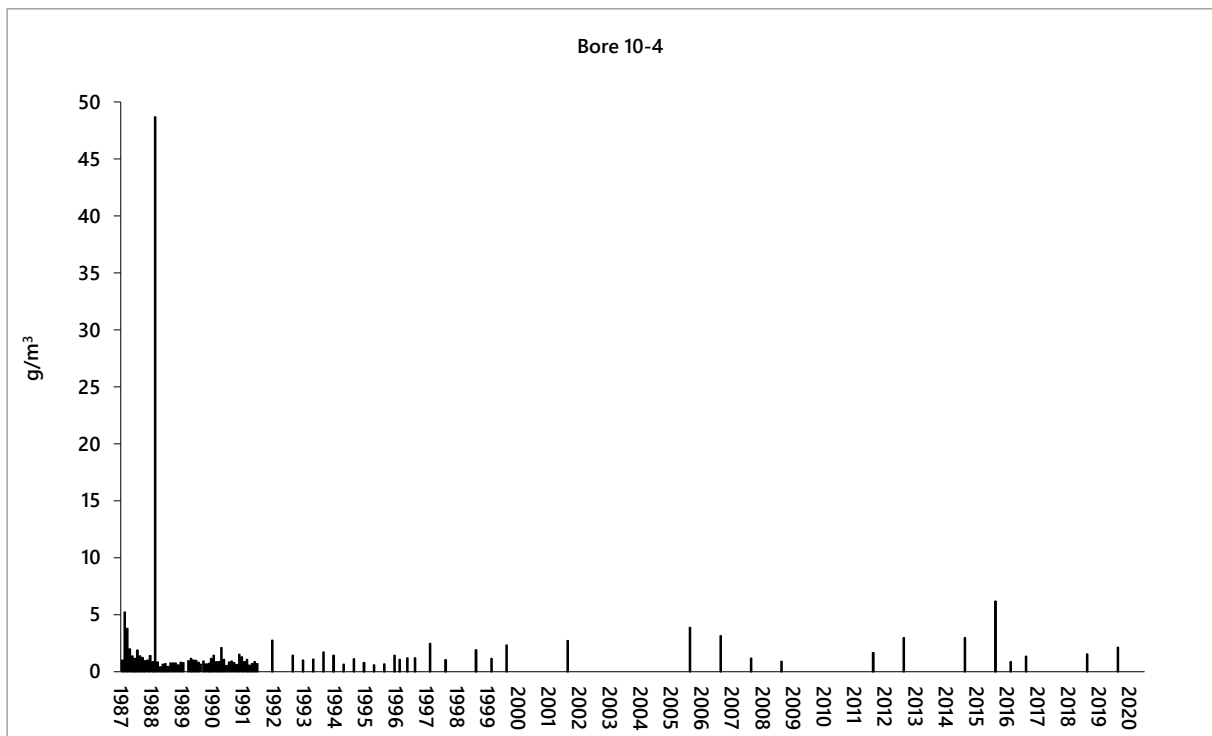
Figure 9 Total nitrogen concentrations in groundwater beneath spray irrigation area (Bore 10-4)

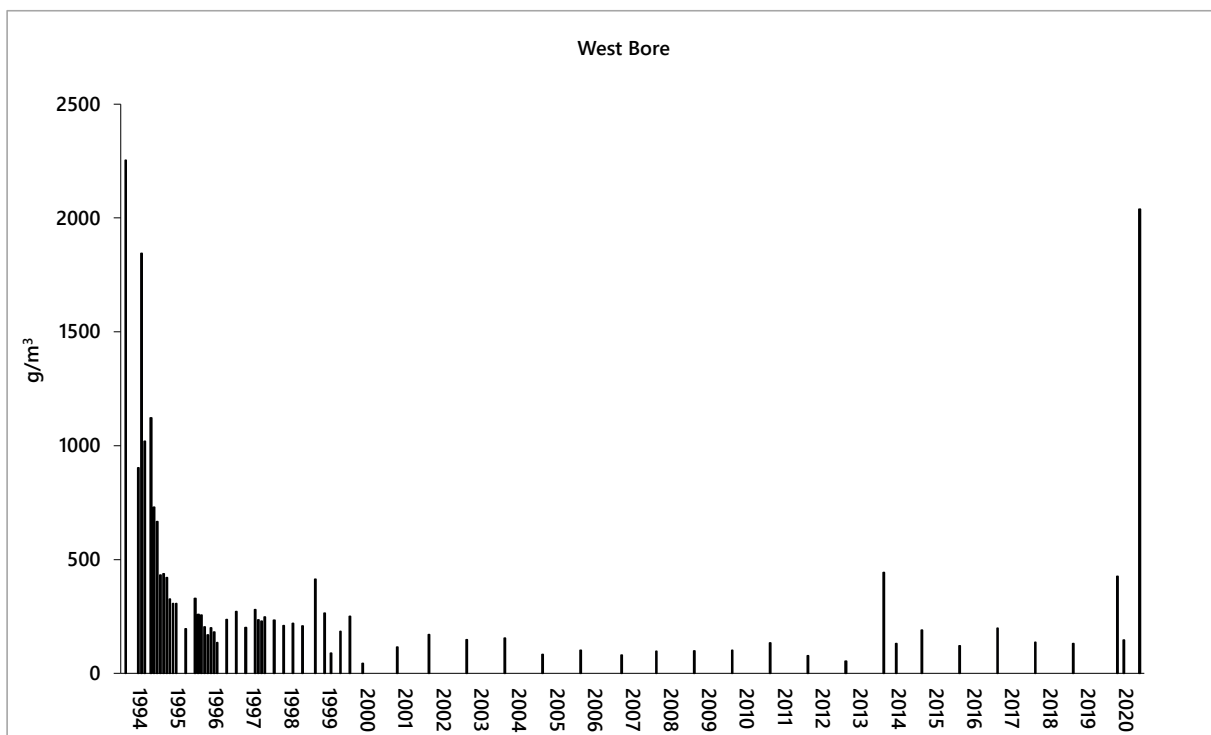
Monitoring of the down gradient bores shows the plume has migrated. At West Bore (WFECB), which is located immediately downslope of the FECB, nitrogen levels have been relatively stable after the last liner was installed. Nitrogen levels have fluctuated between 44 and 198 g/m^3 since 1999, with a spike in 2013, when a value of 444 g/m^3 was measured. However, for the current monitoring year it recorded its second highest result ever of 2,038 g/m^3 on May 2020 (Figure 10). This suggests either another leak or inadequate abstraction of the groundwater at the bore.

Figure 10 Total nitrogen concentration in groundwater associated with the FECB plume from West Bore

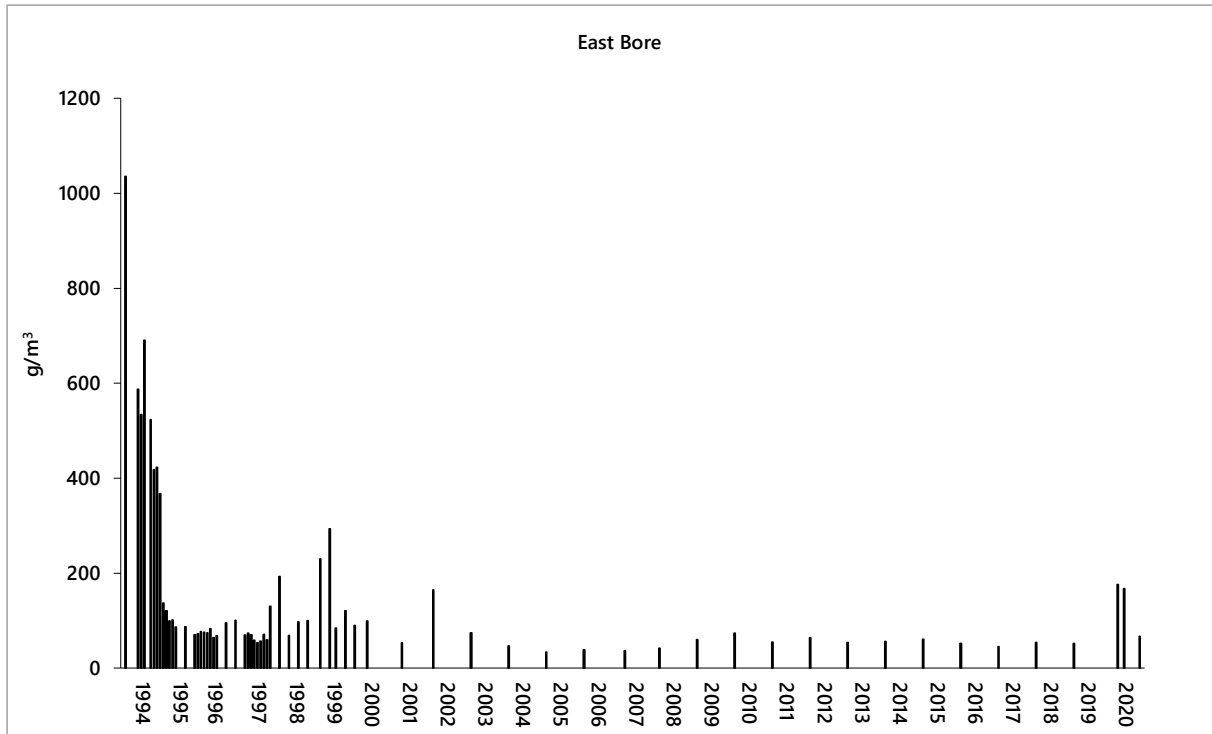
At East Bore (EFECB), which is located immediately downslope of the FECB and slightly to the east of West Bore, nitrogen levels have been relatively stable after the last liner was installed (Figure 11). Nitrogen levels have fluctuated between 34 and 165 g/m^3 since 1999. For the current monitoring year it recorded its highest result since 1999 of 176 g/m^3 . However, this increase was relatively minor compared with that at West Bore which suggests the plume migration was localised.

Figure 11 Total nitrogen concentration in groundwater associated with the FECB plume from East Bore

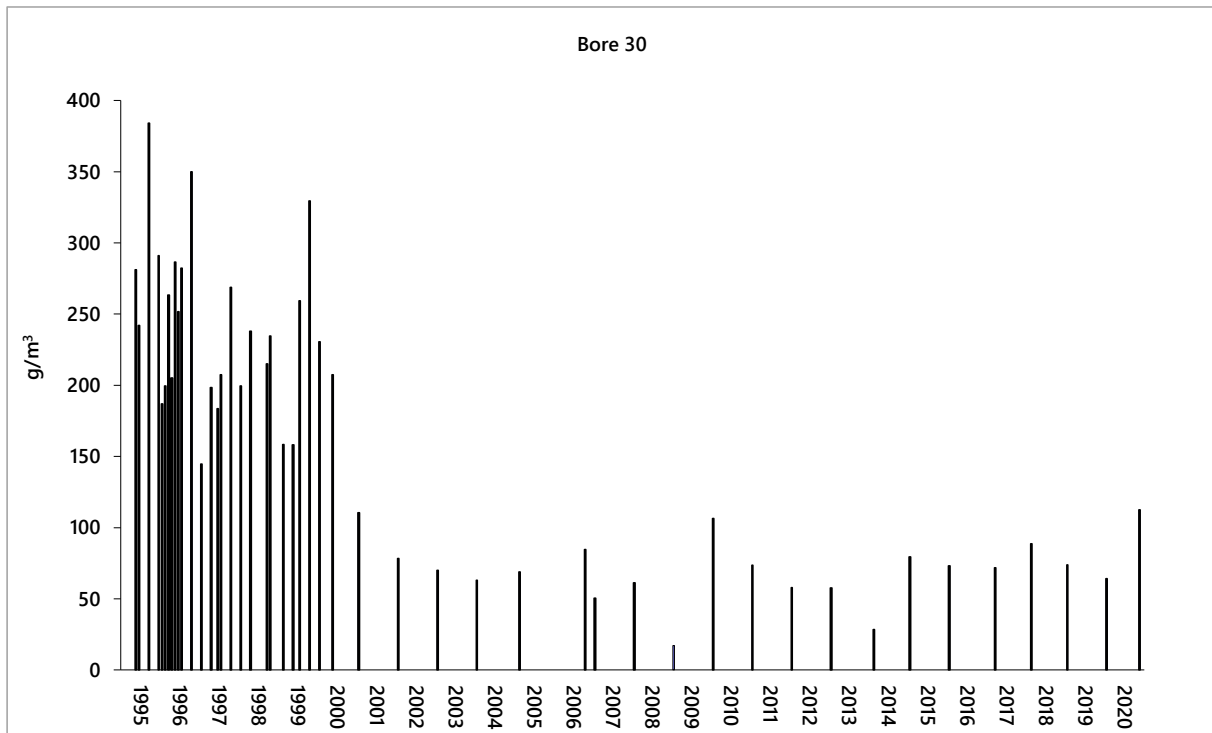
Bore 30 is the other down gradient pumping bore (Figure 12). Nitrogen levels at this bore are potentially affected by both the ammonia plume and by irrigation of wastewater. Overall, total nitrogen concentrations have remained stable since 1999 when the last FECB leak occurred. The current result was consistent with post 1999 results though the result of 113 g/m³ was the highest result recorded since 1999.

Figure 12 Total nitrogen concentration in groundwater associated with the FECB plume from Bore 30

The total nitrogen concentrations in Bore 4 and Bore 17, located further down gradient, whilst being elevated have remained relatively stable. Pumping from East Bore, West Bore and Bore 30 should continue along with monitoring of the other bores.

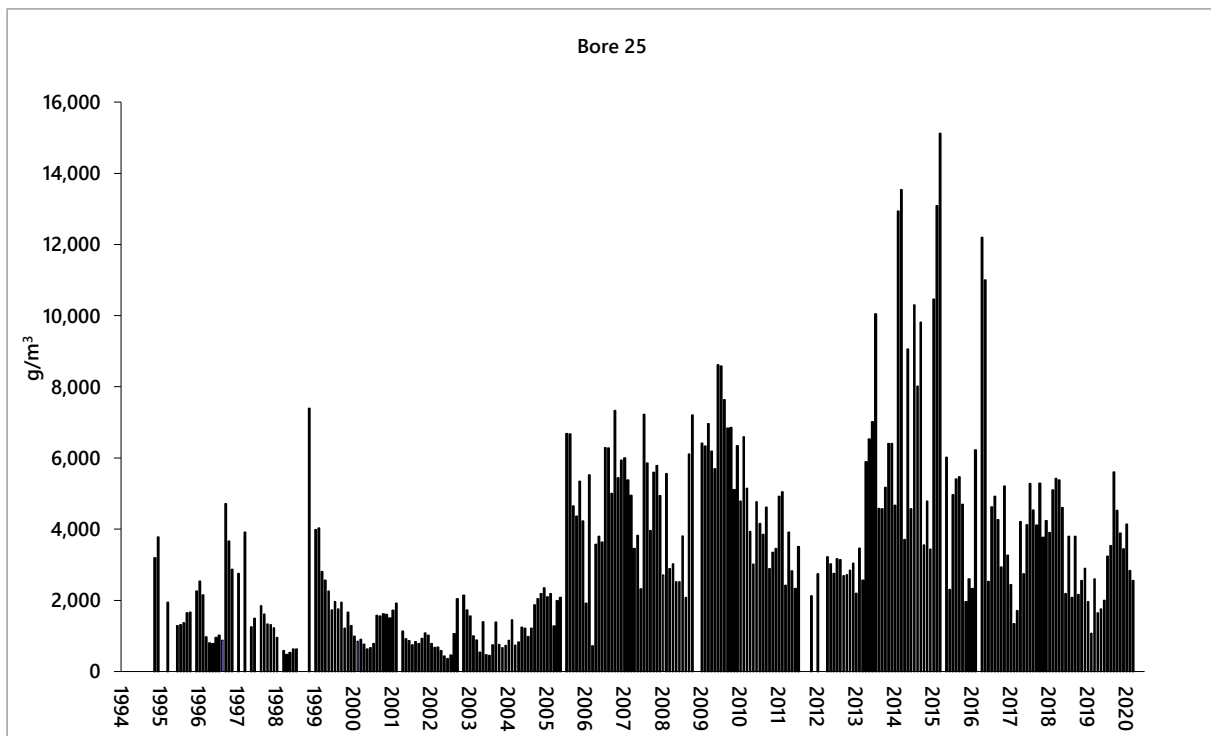
Figure 13 Total nitrogen concentration in groundwater near the urea processing areas from Bore 25

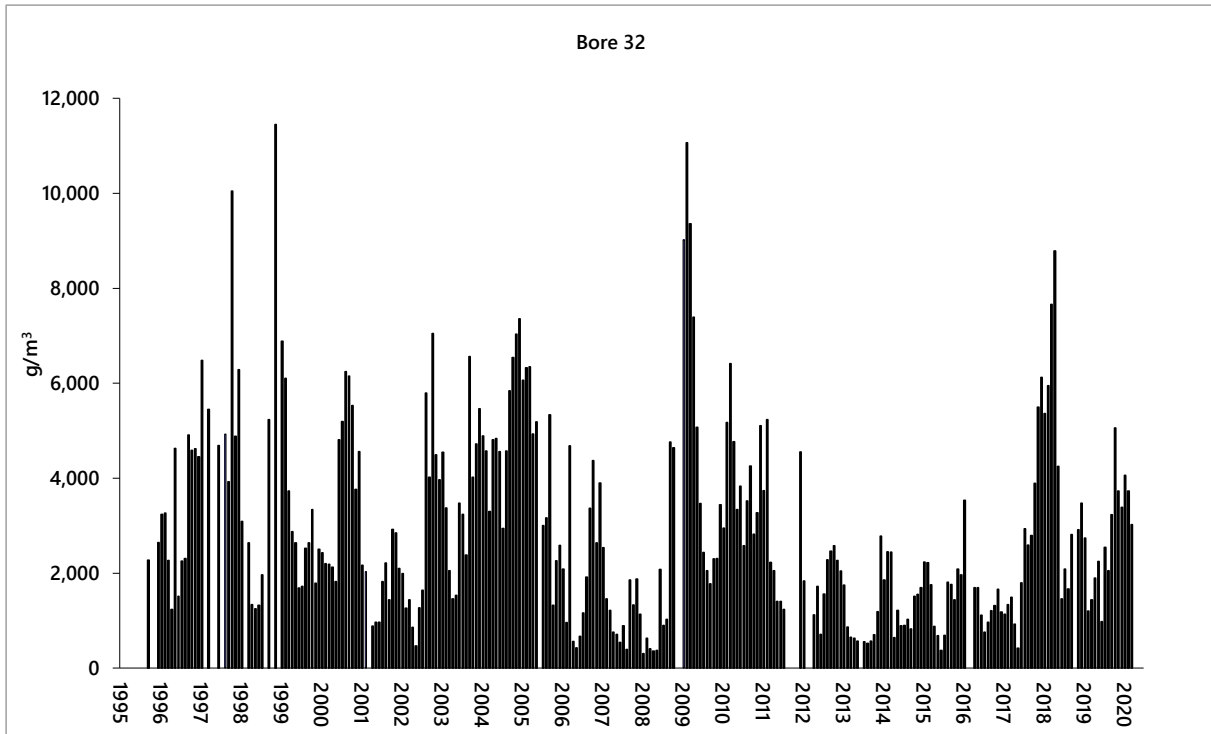
In 2008-2009, there was a spike in total nitrogen at Bore 32, to 11,000 g/m³, as the result of there being no pumping and treatment during a plant maintenance shutdown. For the current period nitrogen levels were relatively low compared with previous years with an average monthly amount of 3,423 g/m³). Further down gradient at Bores 39 and 40 total nitrogen concentrations have been much lower. Bore 39 has ranged from 97-410 g/m³ but the result for the monitoring year under review was a disappointing record high of 525 g/m³ (Figure 15). The next highest result of 410 g/m³ was recorded the previous year and suggests an upward trend at this site. Bore 40 had a range from 35-336 g/m³ with the last result, in June 2019, of 69 g/m³ being relatively low. Further monitoring is recommended to identify significant trends in this area.

Figure 14 Total nitrogen concentration in groundwater near the urea processing areas from Bore 32

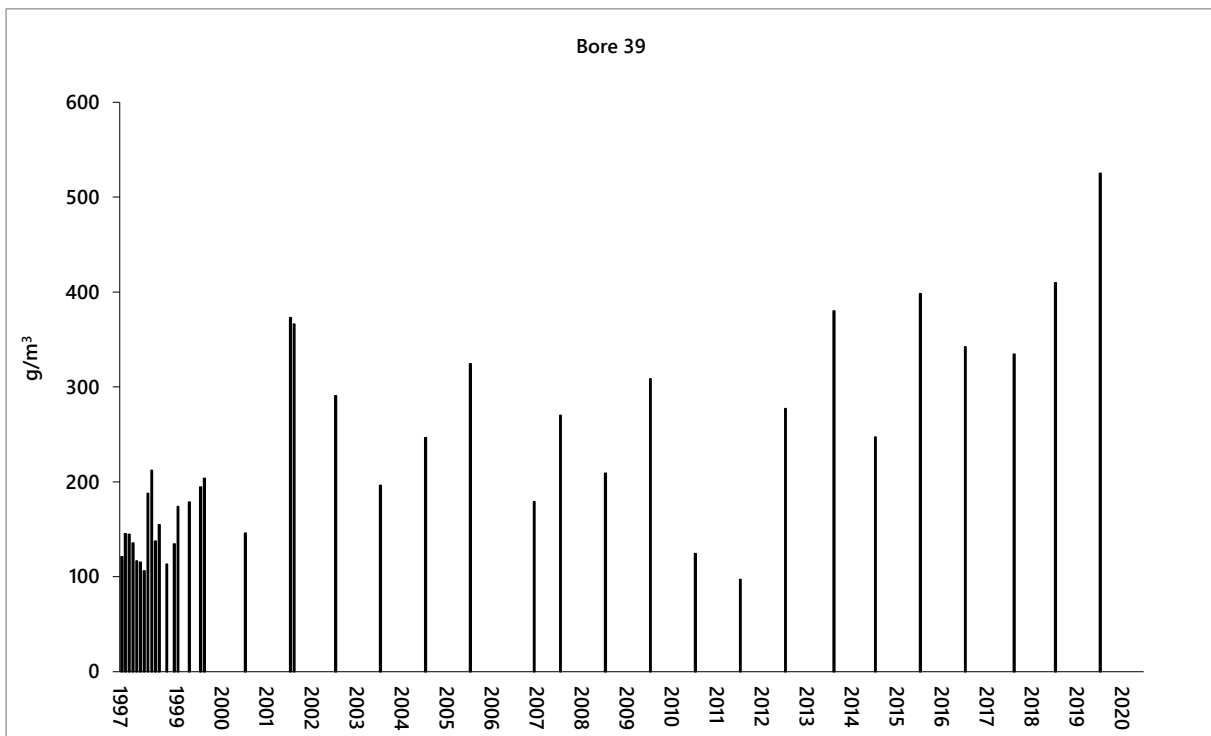
Figure 15 Total nitrogen concentration in groundwater near the urea processing areas from Bore 39

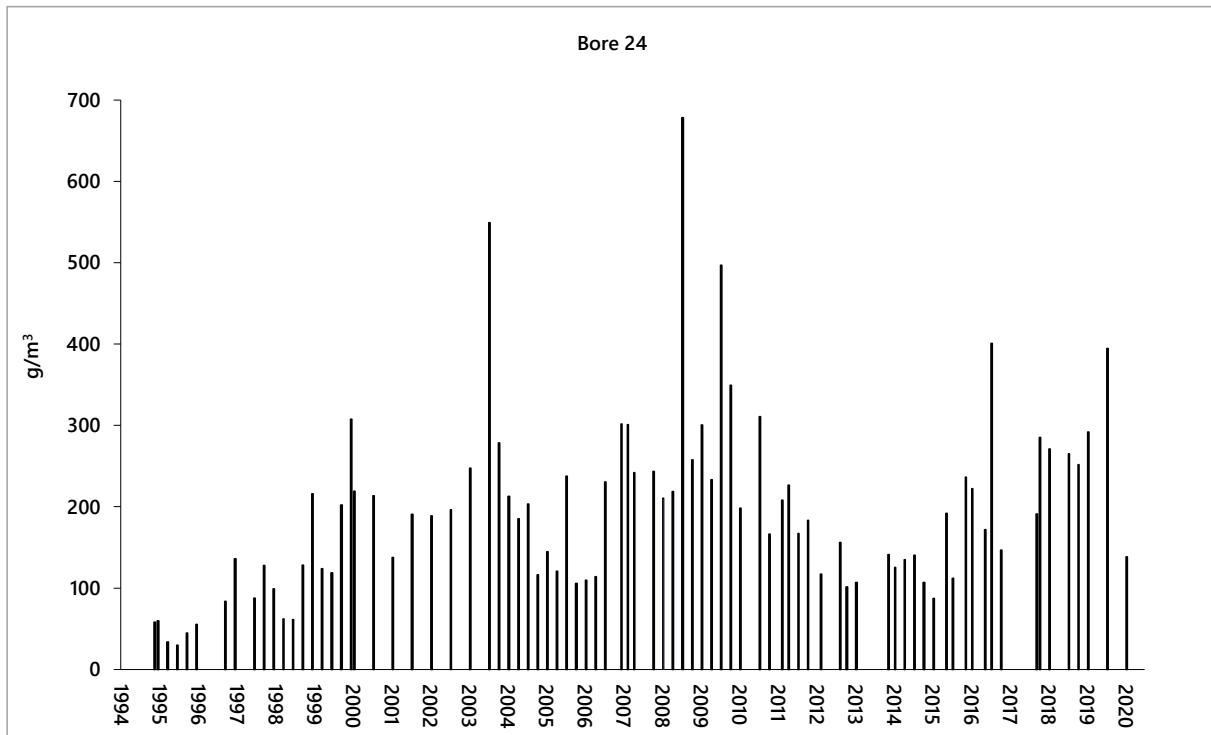
Monitoring of groundwater in the vicinity of the bulk urea load out area at Bore 24 has been undertaken since November 1994 (Figure 16). Nitrogen levels have fluctuated between approximately 87-300 g/m³, with occasional spikes of up to 678 g/m³. A relatively high result of 401 g/m³ was recorded in July 2016, the highest result recorded since July 2009. However, the following result in October 2016 was only 147 g/m³,

which was a more typical value for the site. Recent results were between consistent with previous years (191-292 g/m³) with the latest result of 138 g/m³ recorded on January 2020 the lowest result in five years. Monitoring at Bore 23 down gradient of the bulk storage area has shown no clear trend in nitrogen concentrations but data has not been collected since 2014 due to water leaking into the bore casing.

Figure 16 Total nitrogen concentration in groundwater in the vicinity of bulk storage area (bore 24)

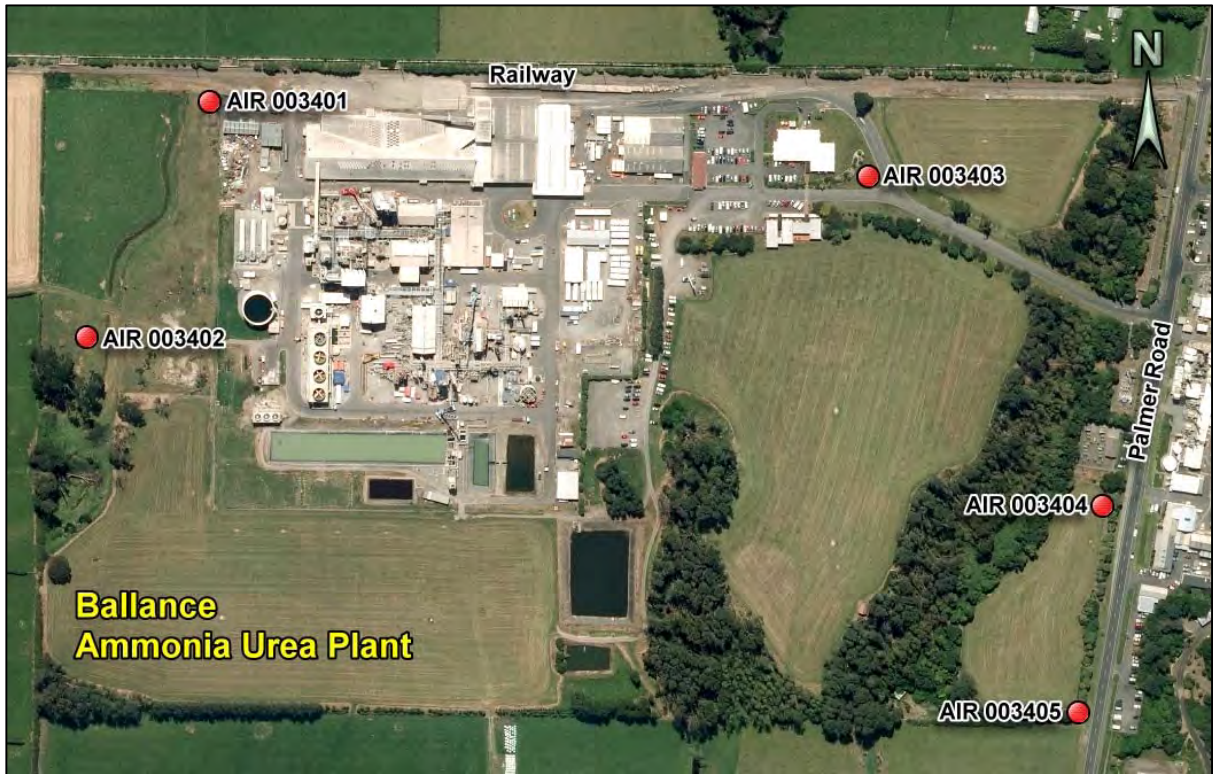
Figure 17 Location of deposition gauge sites

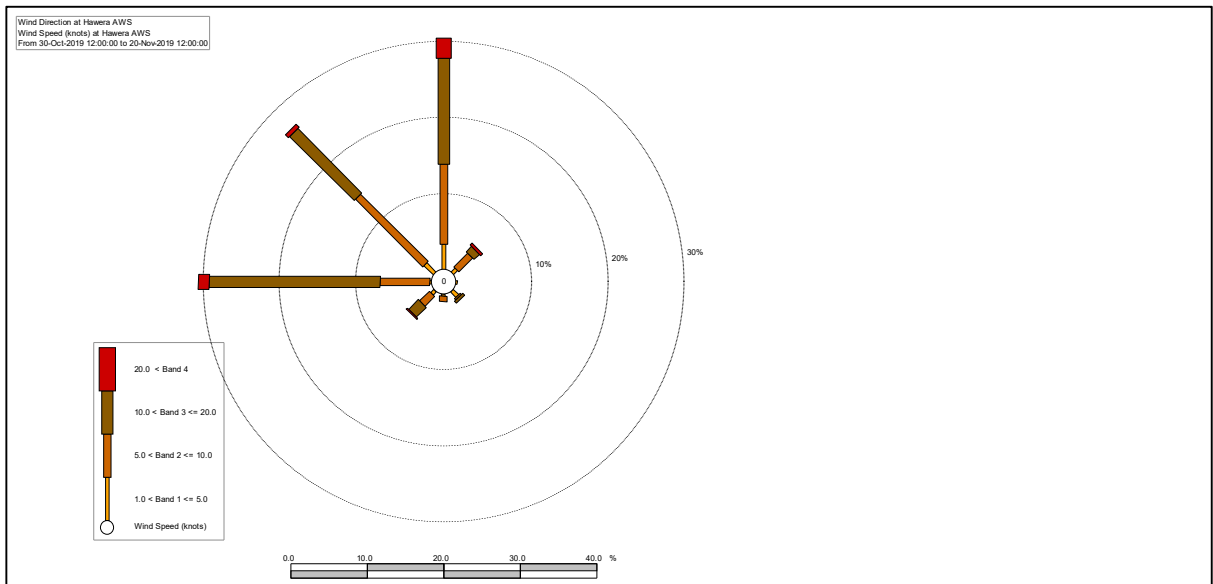
Figure 18 Wind-rose for Hawera weather station during deployment of deposition gauges, 30 October to 20 November 2019

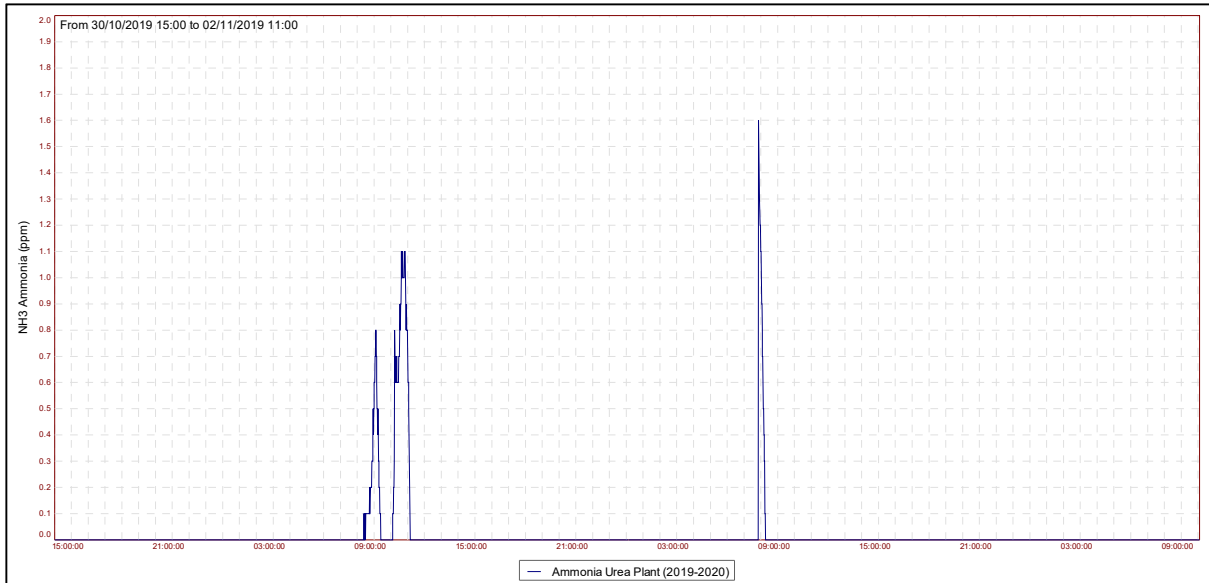
Because the lower explosive limit of methane in air is about 5%, then a reading of 1% LEL is equivalent to an actual concentration of 1% of 5% that is, an actual concentration of 0.05%. The meter is used for screening purposes, to determine whether further investigations are warranted. It is known that gases other than the nominated target gas can interfere with results. In particular, the Council has found during use that the meter will sometimes register the presence of ammonia when none is present, and also that ammonia, carbon monoxide, and volatile organic gases will give spurious LEL results. The carbon monoxide detector will react to some volatile organic gases. The exact numbers shown in the attached graphs and tables should therefore be interpreted with caution. The data for ammonia and carbon monoxide for the monitoring run are presented graphically in Figure 20 and Figure 21 (no combustible gas was detected).

Figure 20 Graph of ambient ammonia gas levels in the vicinity of ammonia urea plant (2019-2020)

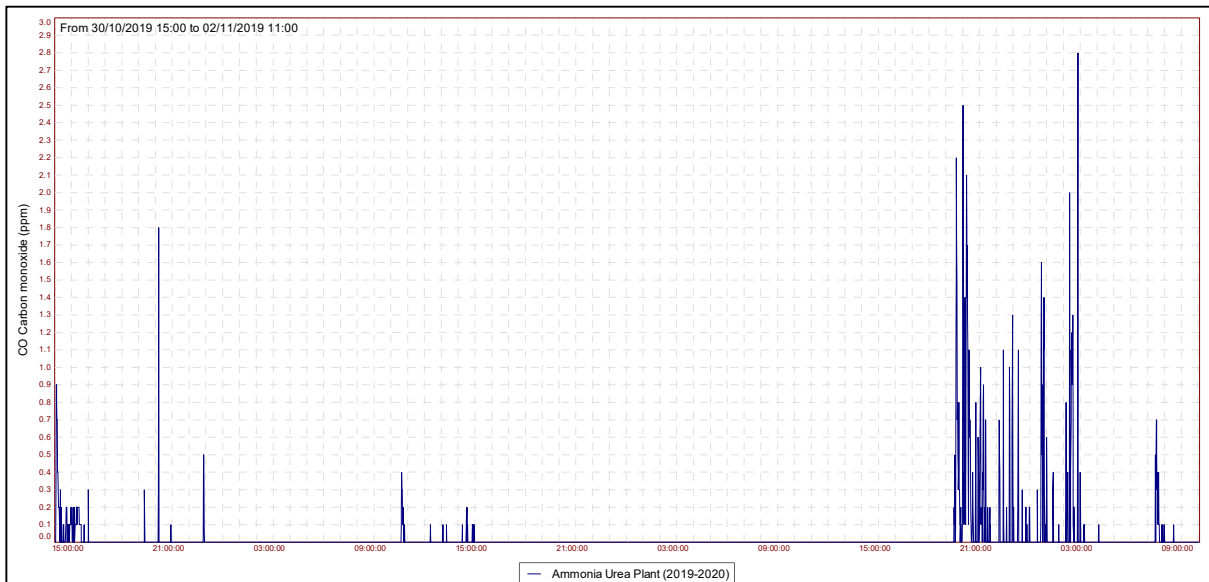
Figure 21 Graph of ambient carbon monoxide levels in the vicinity of the ammonia urea plant (2019-2020)

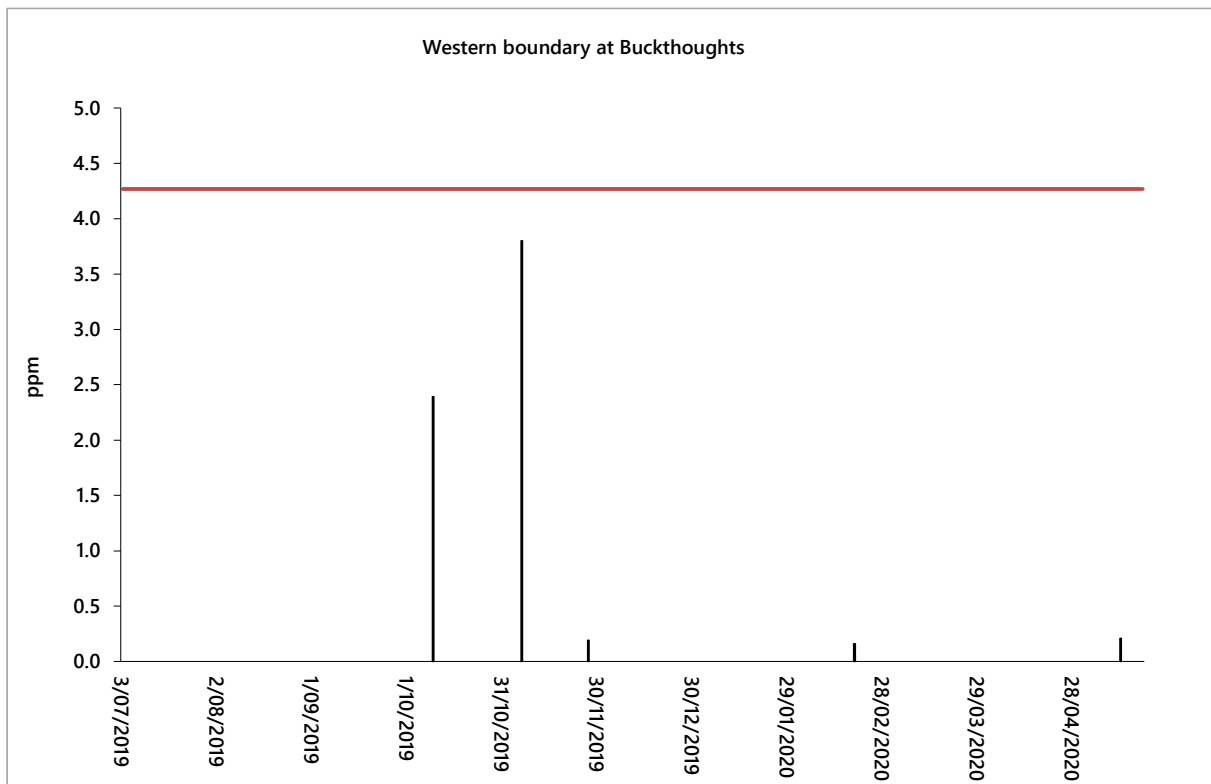
Figure 22 Atmospheric ammonia concentration at ground level on the site boundary (consent limit 4.27 ppm one hour average)

The ammonia concentration based on a one hour average was below the consent limit of 4.27 ppm for both site boundaries.

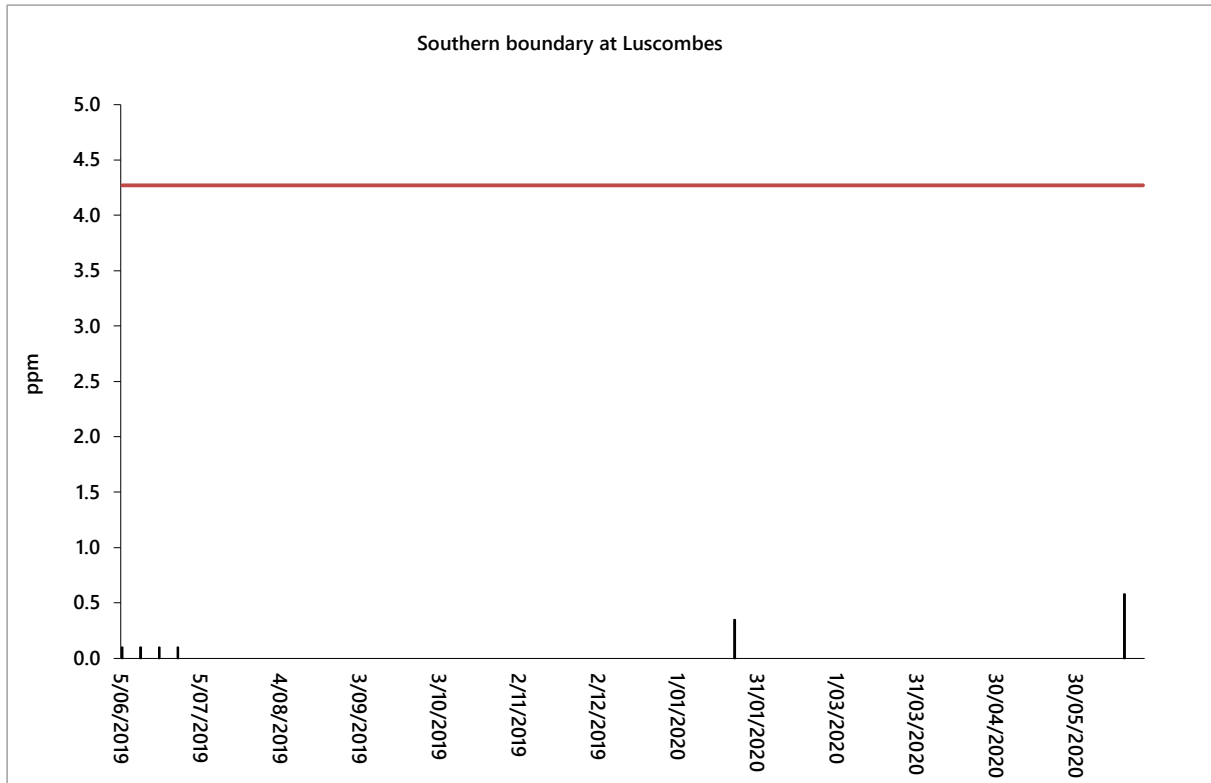
Figure 23 Atmospheric ammonia concentration at ground level on the site boundary (consent limit 4.27 ppm one hour average)
