Ballance Agri-Nutrients (Kapuni) Ltd
Monitoring Programme
Annual Report
2019-2020

Technical Report 2020-81

Taranaki Regional Council
Private Bag 713
STRATFORD
November 2020

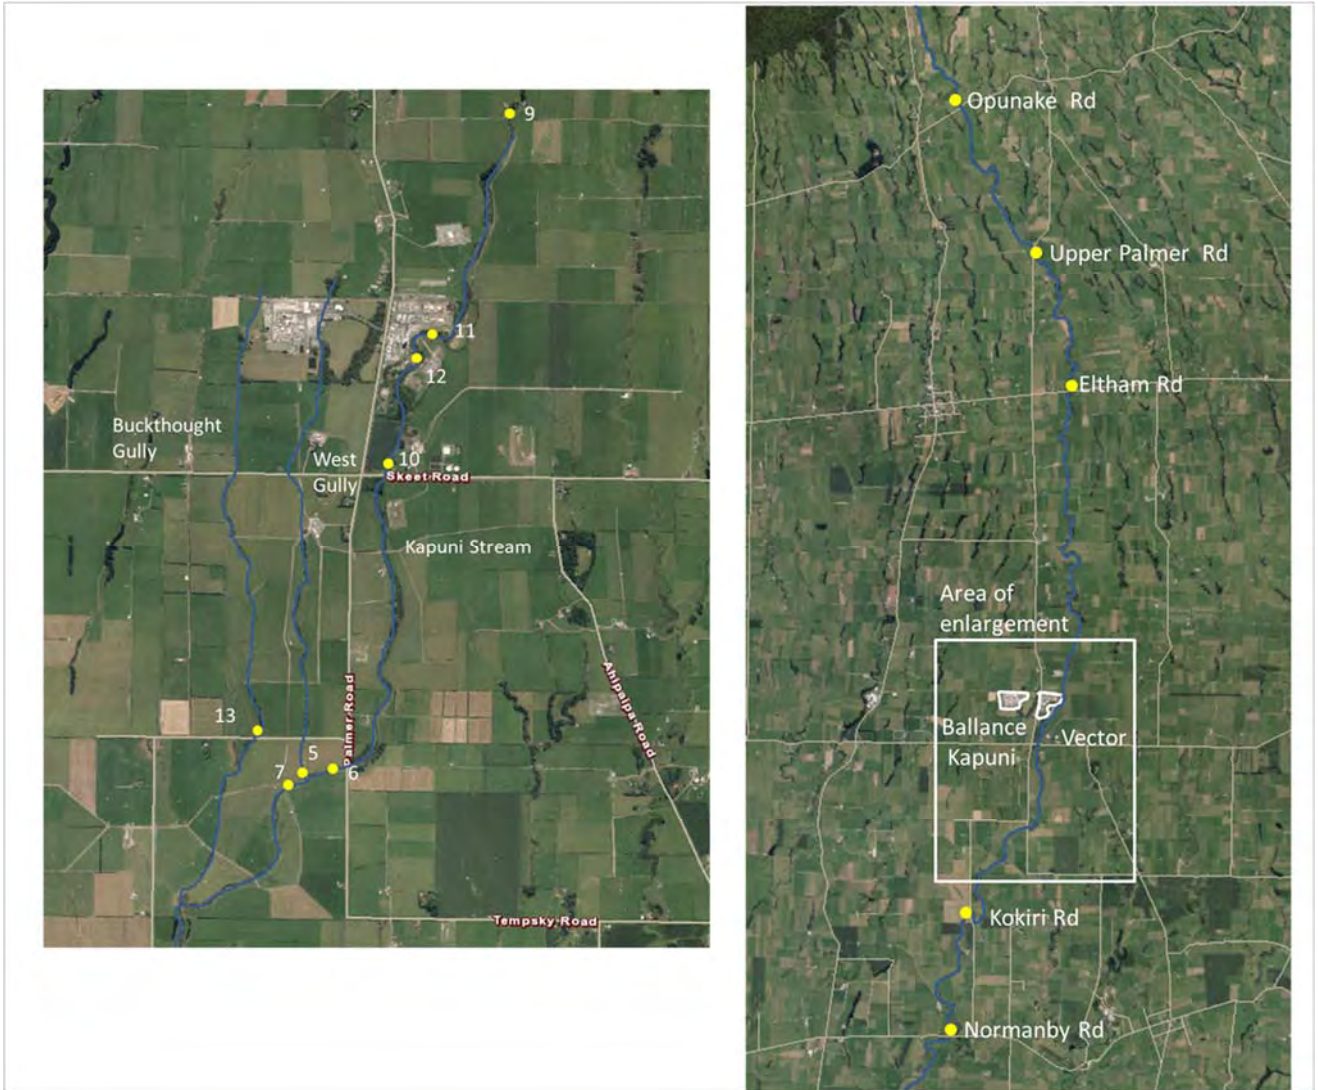
Figure 1 Biomonitoring sites in the Kapuni Catchment
