# Port Area Industrial Catchments

Monitoring Programme

Annual Report

Technical Report 2021-72

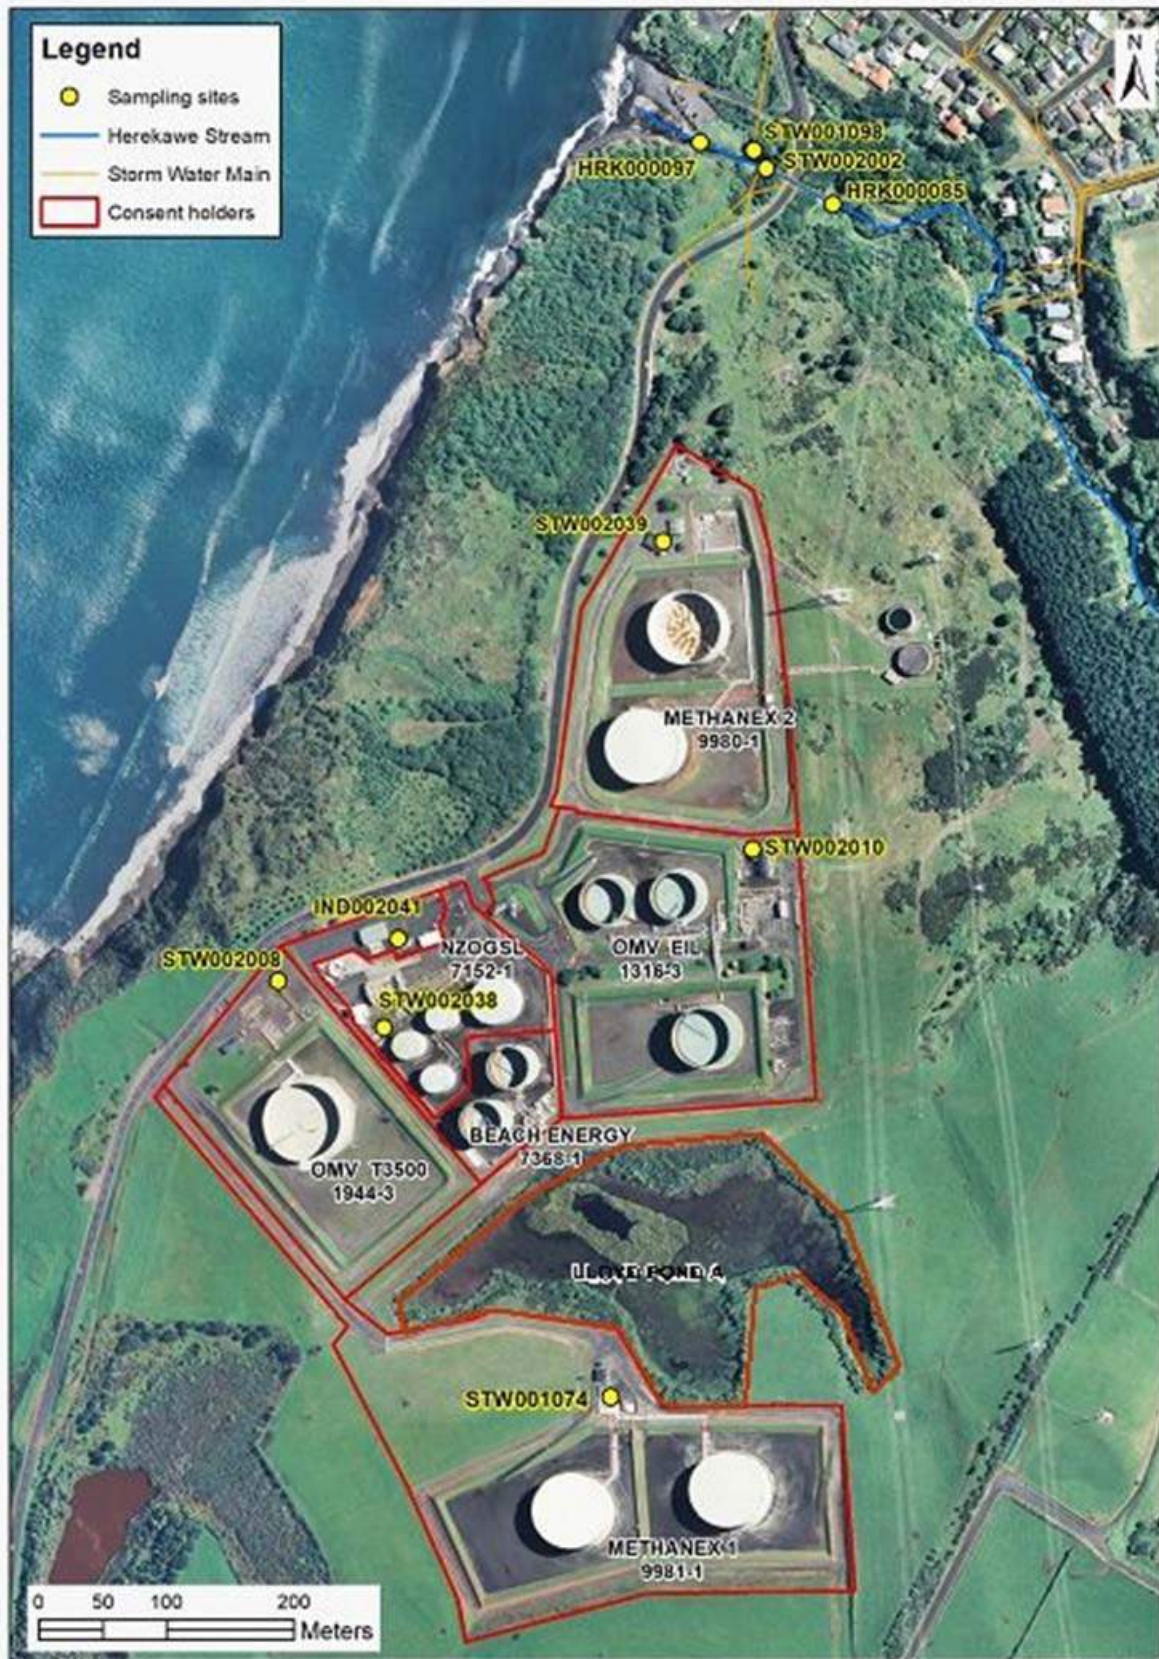
The operational boundaries of the consents monitored in the Herekawe catchment covered in this section are identified in Figure 1.

Figure 1 Consent holder property boundaries in the Herekawe catchment

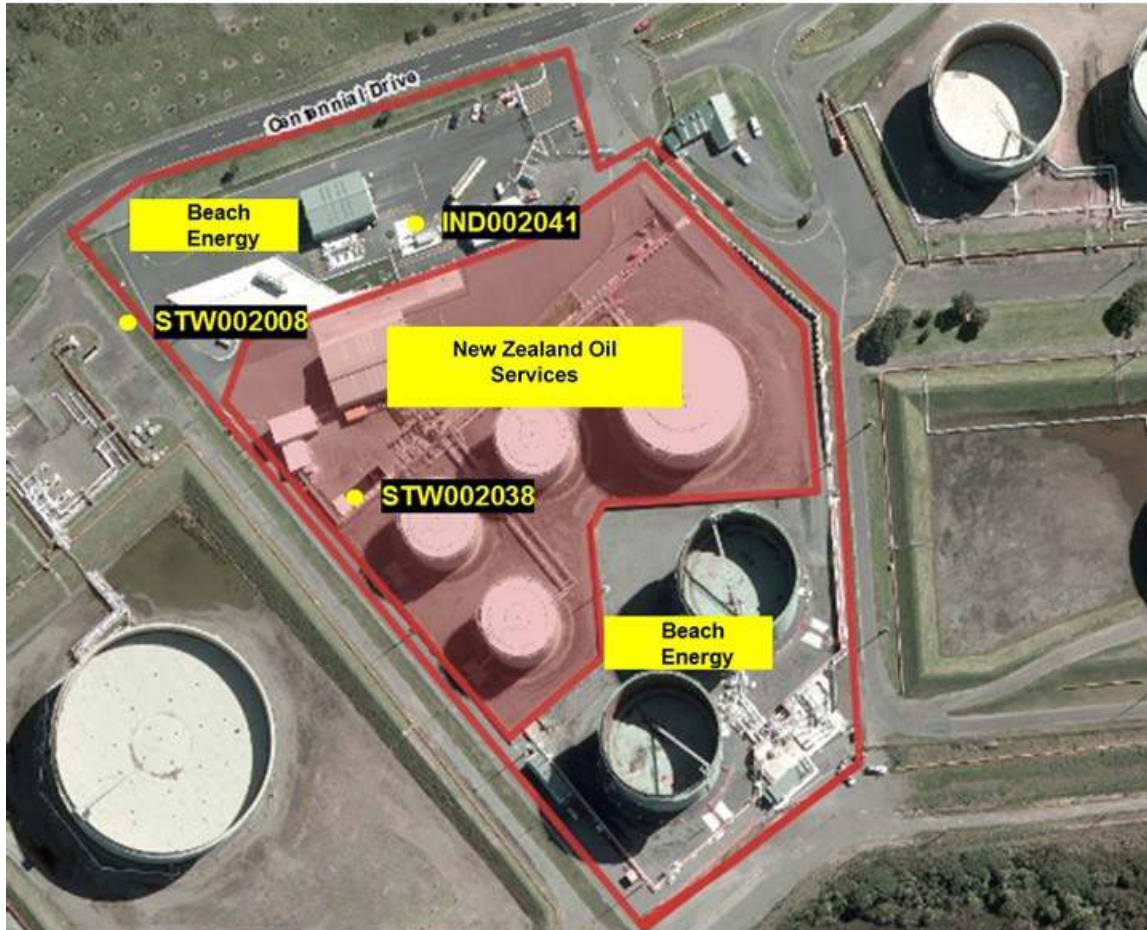
Beach Energy Resources New Zealand (Kupe) Ltd (Beach Energy) operates the Kupe Omata Tank Farm located on Centennial Drive, New Plymouth. The Tank Farm is a hydrocarbon storage facility covering approximately 1.5 hectares of land adjacent to the New Zealand Oil Services Limited storage facility (Figure 2).

Figure 2 Aerial photography of Beach Energy and NZOSL sites

The southern part of the site includes two hydrocarbon storage tanks. The northern part of the site, along the road frontage, includes a tanker unloading building, staff facilities and the stormwater treatment system. The stormwater treatment oil separator has a capacity of 9.6 m<sup>3</sup>. Stormwater directed to the treatment system includes the bunded area for the tanks and stormwater from the tank roofs. In the unlikely event that there are any spills in the tanker unloading facility, they are directed to an underground storage sump.

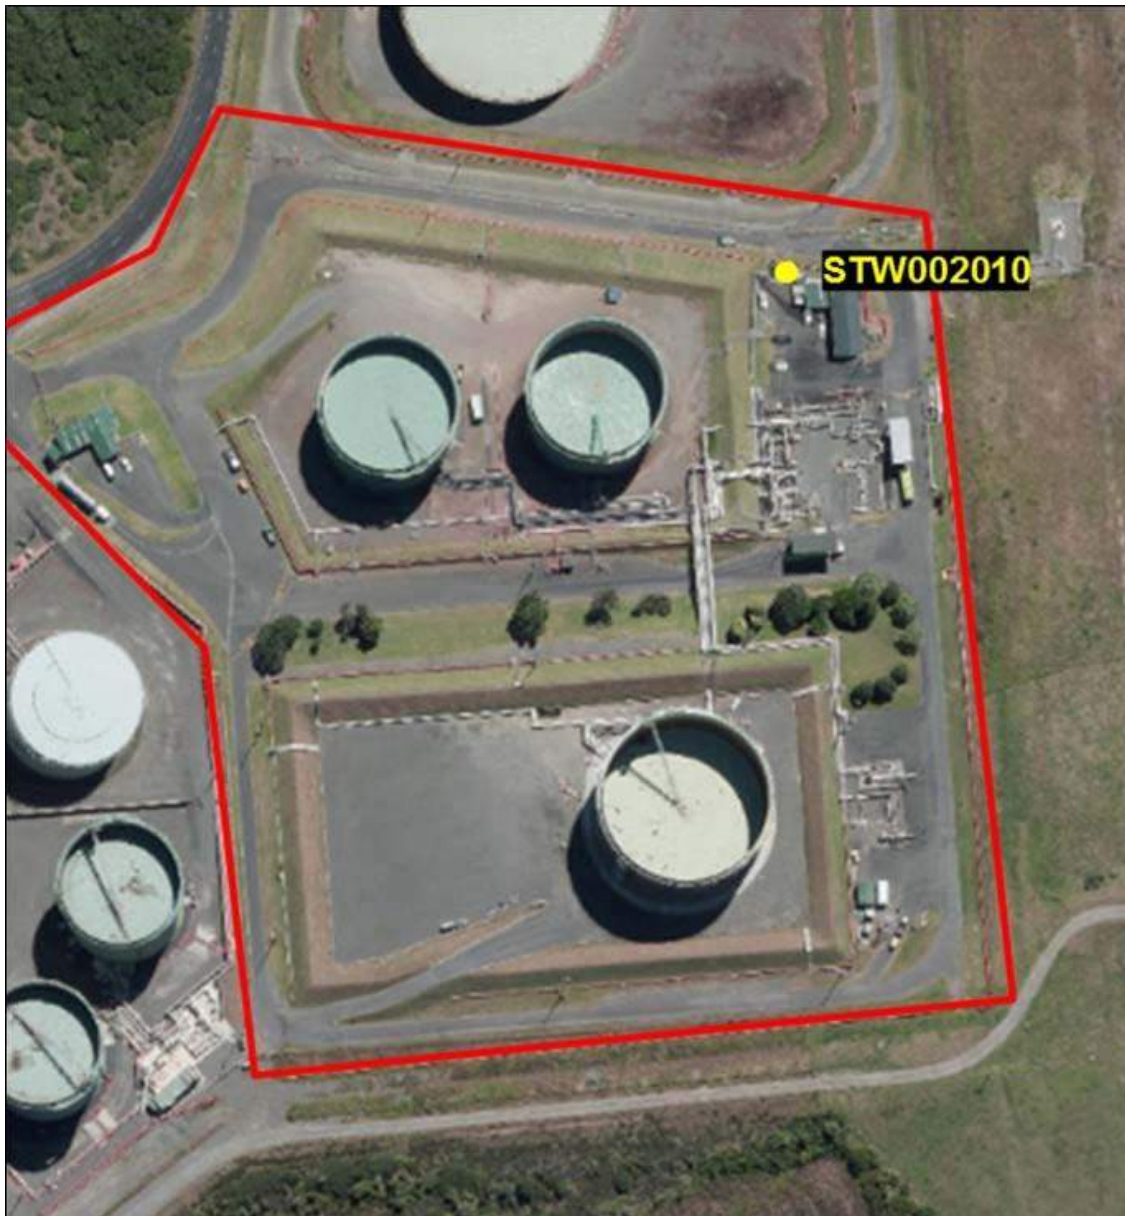
The OMV Taranaki Ltd (OMV) EIL site includes three crude oil storage tanks and an 18 inch pipeline to the Newton King wharf for load out of product. A road tanker unloading facility, export pumps and a control room are included within the facilities. Crude oil from the McKee, Waihapa, Kaimiro, Maui, Ngatoro and Pohokura fields is collected and stored in the storage tanks prior to shipping through Port Taranaki. Stormwater from the site (Figure 3) is sampled to confirm compliance with consent conditions prior to being directed to an oil/water separator for treatment and discharge to the Herekawe Stream.

Figure 3 Aerial photograph of the OMV EIL site

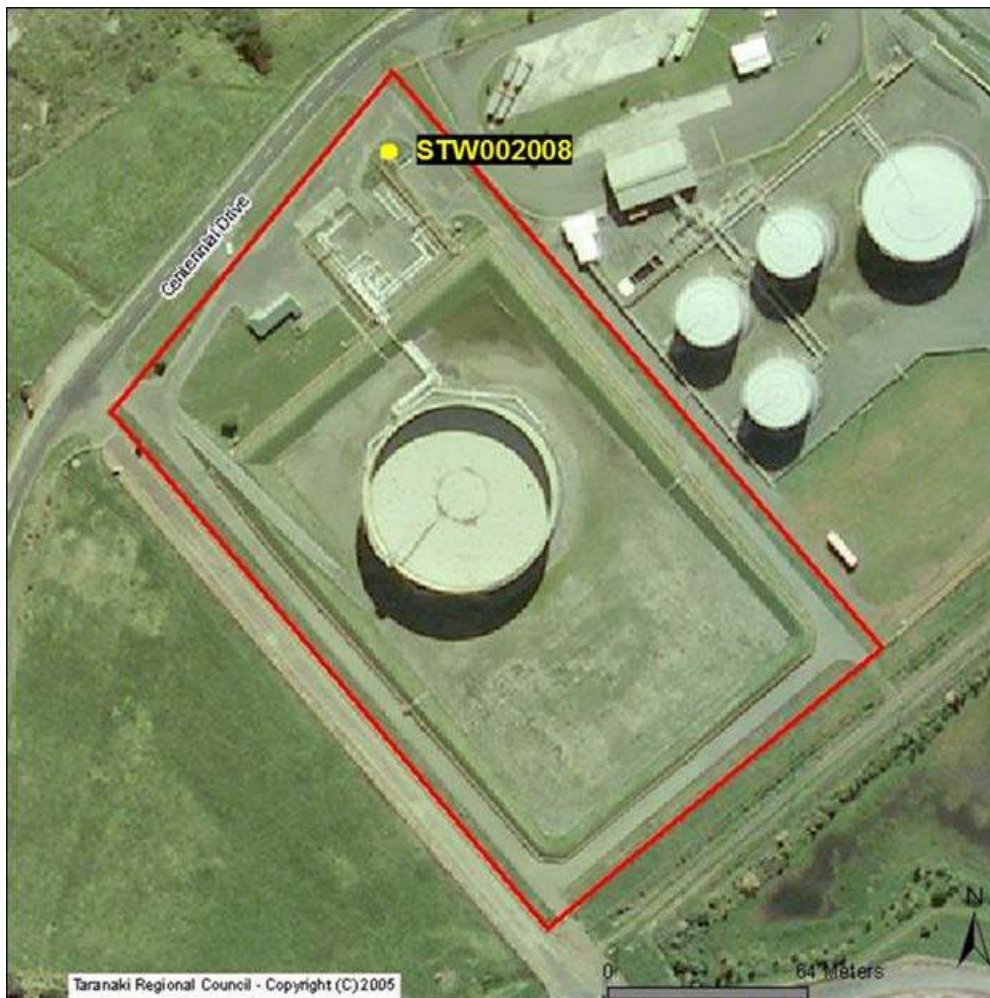
OMV holds discharge permit **1944-3** which allows the discharge of uncontaminated stormwater and treated stormwater onto land and into the Herekawe Stream, via the existing piped stormwater drain. The consent also allows for discharge of wastewater which is a by-product of maintenance activities at the Maui condensate storage facility, including hydrostatic test water and tank dewatering water, onto land.

Figure 4 Aerial photograph of the OMV T-3500 site

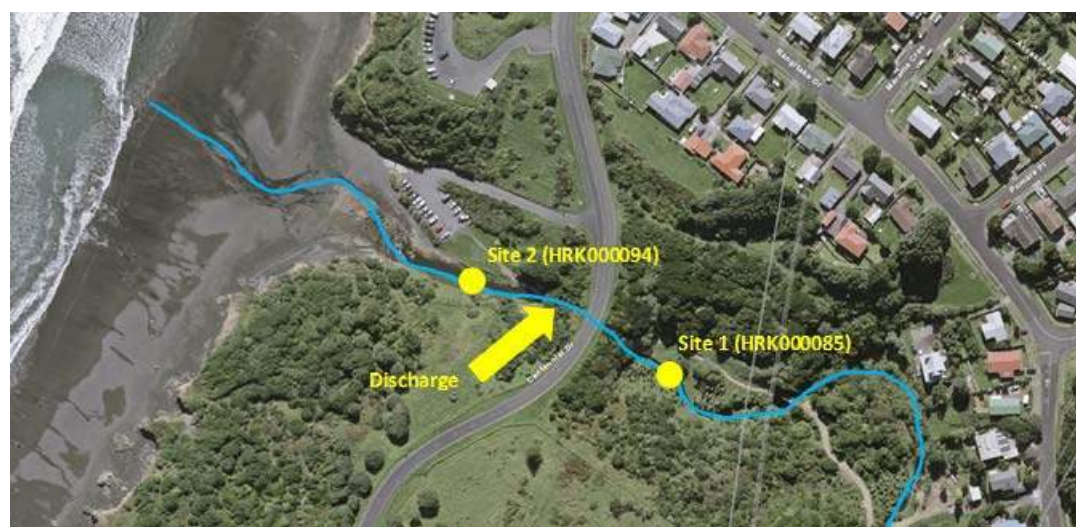
The Council collected streambed macroinvertebrates from the Herekawe Stream to investigate the effects of storm water discharges from the Omata Tank Farm on macroinvertebrate health. The Council's standard 'kick-sampling' technique was used at two established sites (Figure 5) in October 2020 and February 2021 to collect streambed macroinvertebrates from the Herekawe Stream. The different types of macroinvertebrate from samples were identified, the number of different types counted (taxa richness), and MCI and SQMCI scores were calculated for each site.

Figure 5 Biomonitoring sites in the Herekawe Stream

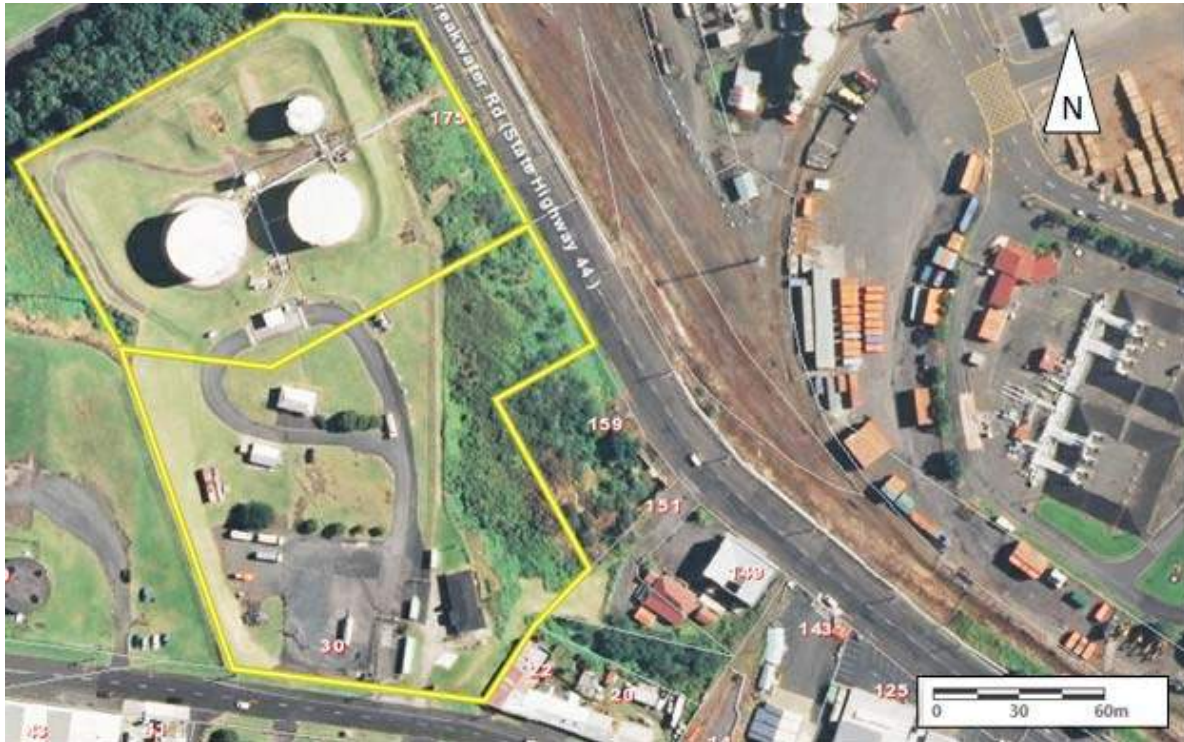
to processing through the separator. Treated stormwater and operational water is discharged into Port Taranaki's stormwater system on Breakwater Road which drains to the middle of the bay between the Newton King tanker terminal and Moturoa wharf.

Operations ceased late in 2017, however, the site still discharges stormwater following wet weather.

Figure 7 Aerial photograph of the NZOSL Centennial Drive site

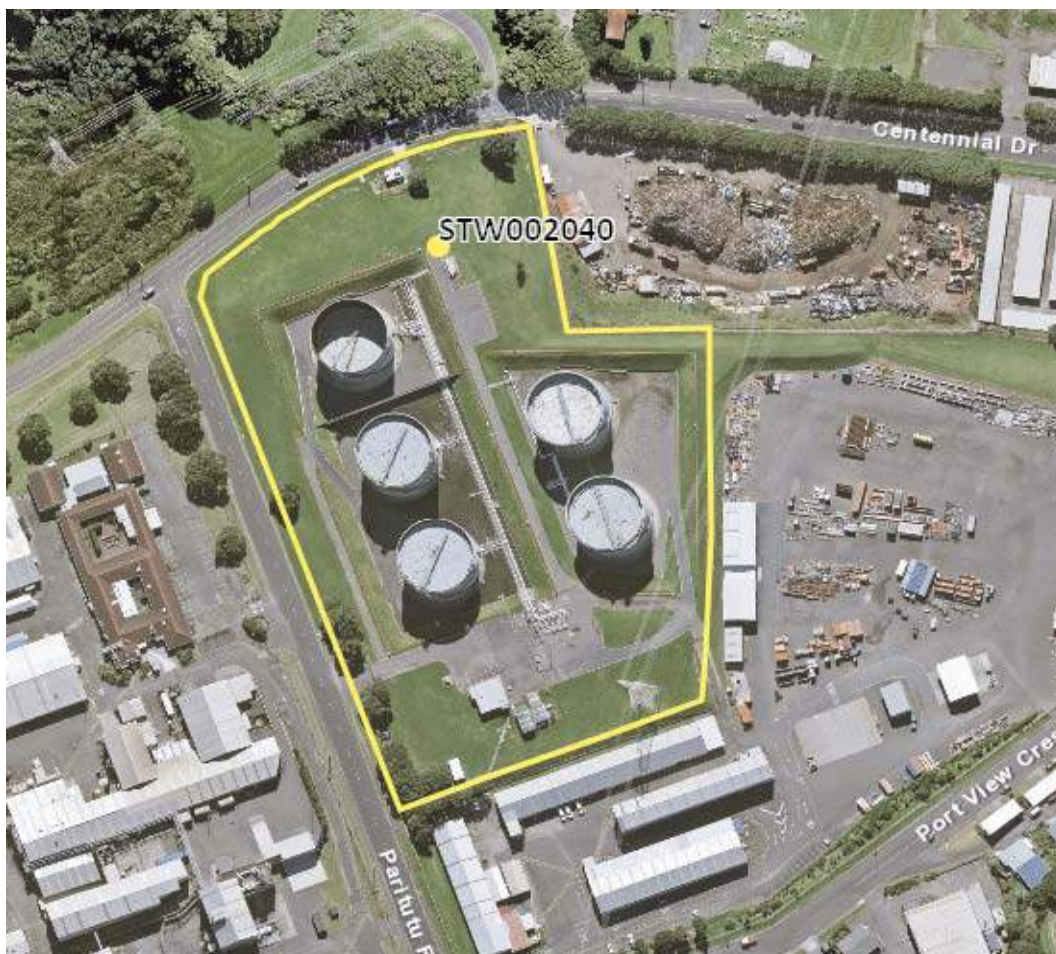
OMV hold coastal discharge permit **5542-2** to discharge treated and untreated stormwater from a petrochemical storage tank facility and hydrostatic test water into the coastal marine area of the Hongihongi Stream.

Figure 8 Aerial photograph of the OMV Paritutu Tank Farm

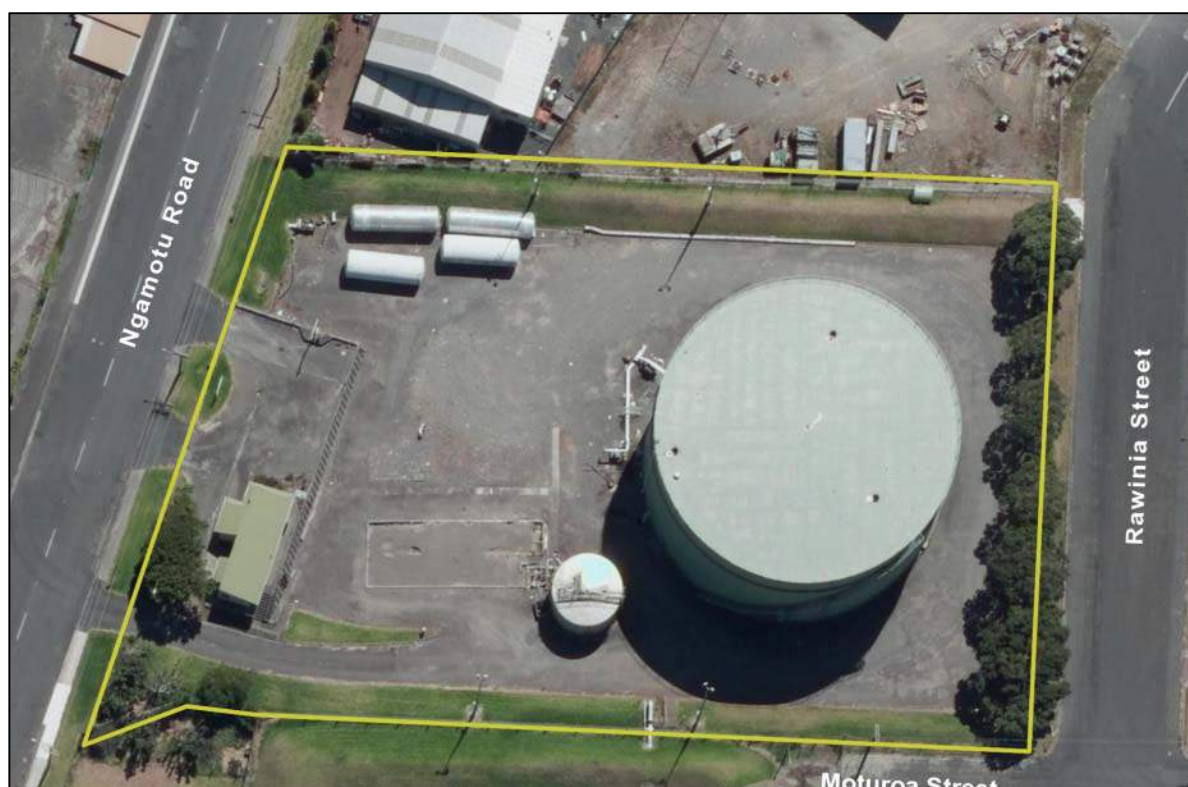
This facility (Figure 9) was constructed to treat de-ballast water from vessels docked at the port. However, it has not been used for this purpose since 1996. Greymouth Petroleum Ltd took over the site from Methanex in 2008 to use the bunded area of the site as a holding facility for drilling fluids and produced water related to land based well-site drilling activities. The site no longer discharges any treated water to the Hongihongi Stream from this area. As the site surface is in generally poor condition and permeable, all stormwater collected within the bunded areas discharges into land through soakage. Port Taranaki Ltd (Port Taranaki) took over the site for fire water storage, with consent **9978-1** to discharge stormwater onto and into land from a bulk storage facility transferred to them on 25 July 2016.

Figure 9 Aerial photograph of the Port Taranaki fire water storage facility

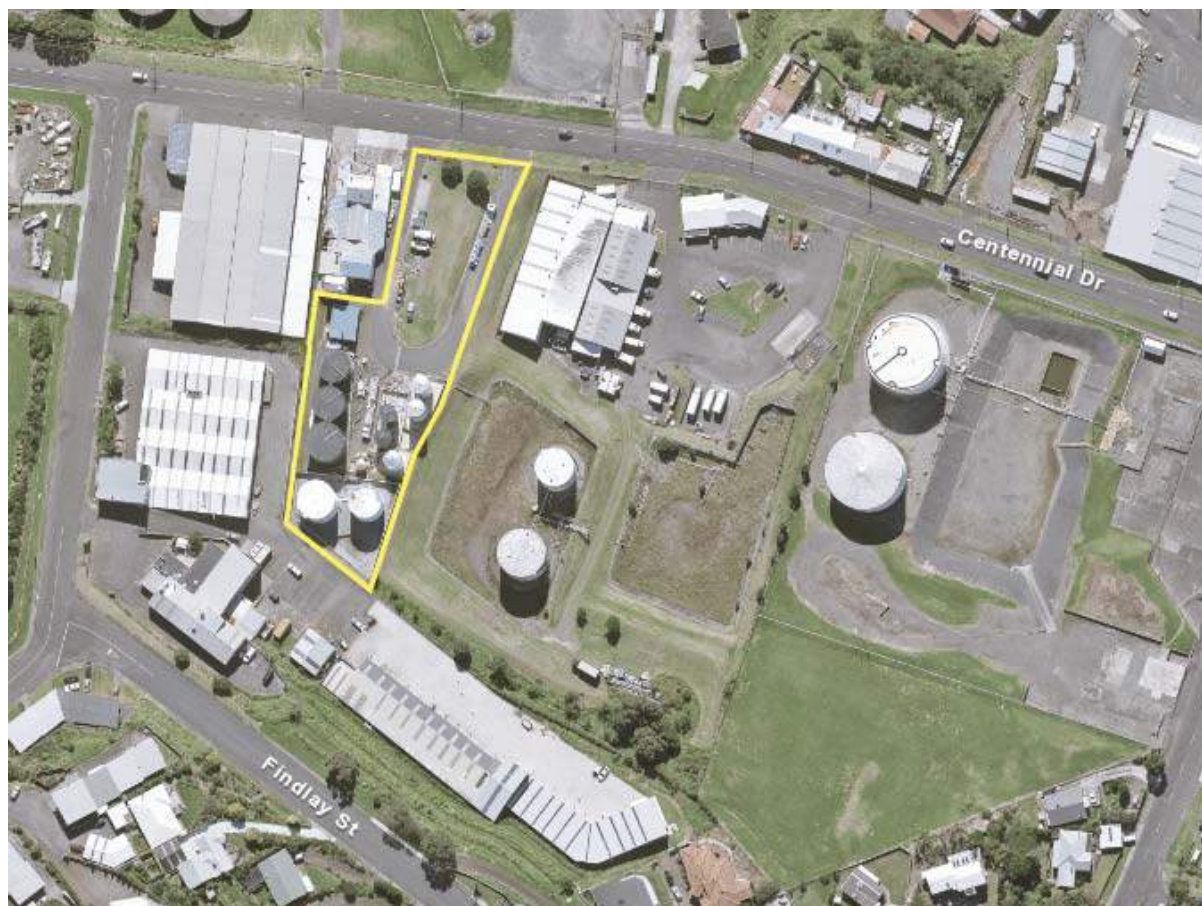
Quantem operates a chemical storage facility on Centennial Drive, New Plymouth (Figure 10). Chemicals are transported to and from the facility by road tanker and by pipeline to the port. The resource consent for the site was formerly held by and is referred to in earlier Annual Reports as Bulk Storage Terminals Ltd (BST); this was changed in March 2020.

Figure 10 Aerial photograph of the Quantem site

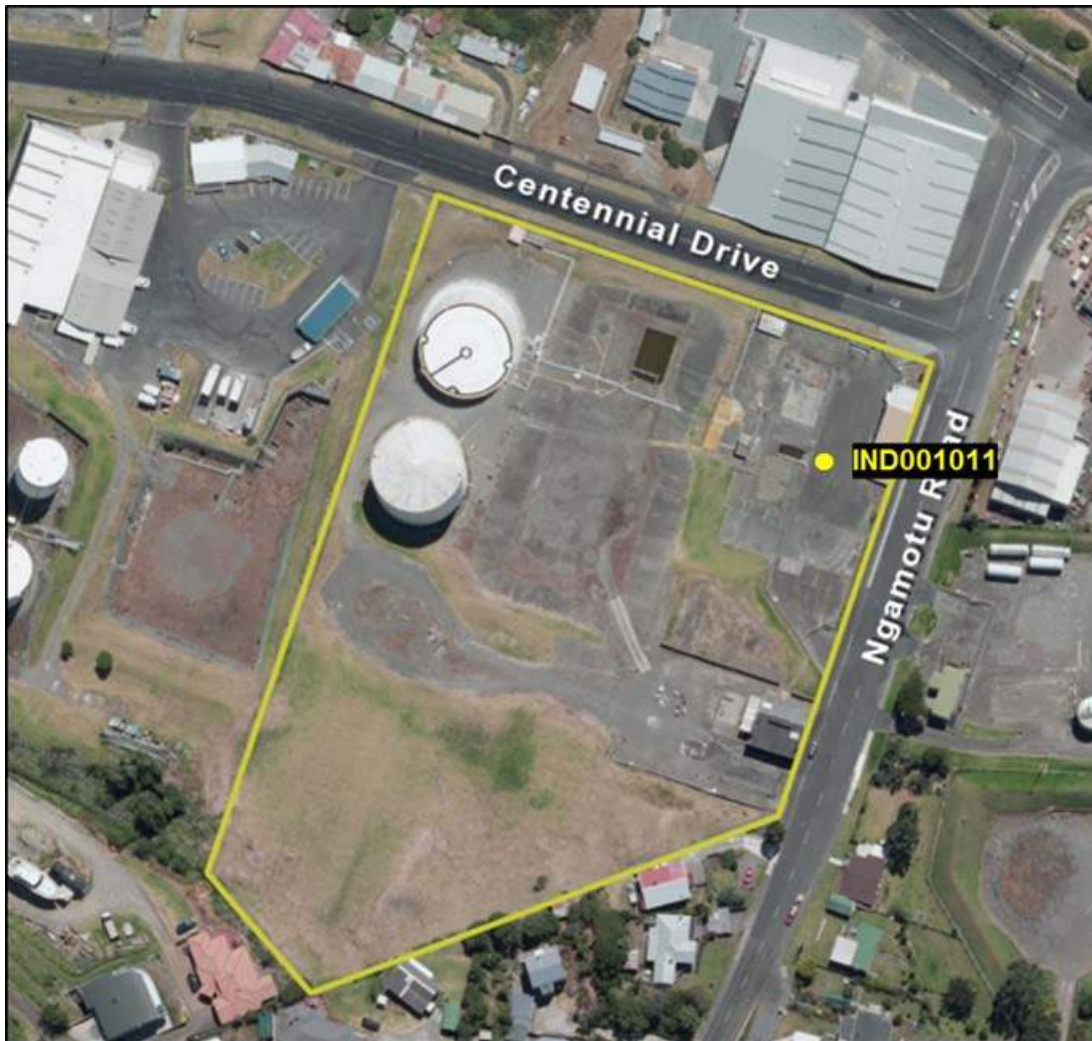
Z Energy holds discharge permit **1020-4** to discharge stormwater and treated wastewater from a petroleum storage facility into the Coastal Marine Area of Ngamotu Beach (via the Hongihongi Stream). The installation was primarily used for the storage of diesel which was then distributed from the site to a Centennial Drive site, or bunkered to vessels at Port Taranaki. Currently the site is held by Z Energy as a non-operating facility (Figure 11).

Figure 11 Aerial photograph of the Z Energy Ltd Ngamotu site

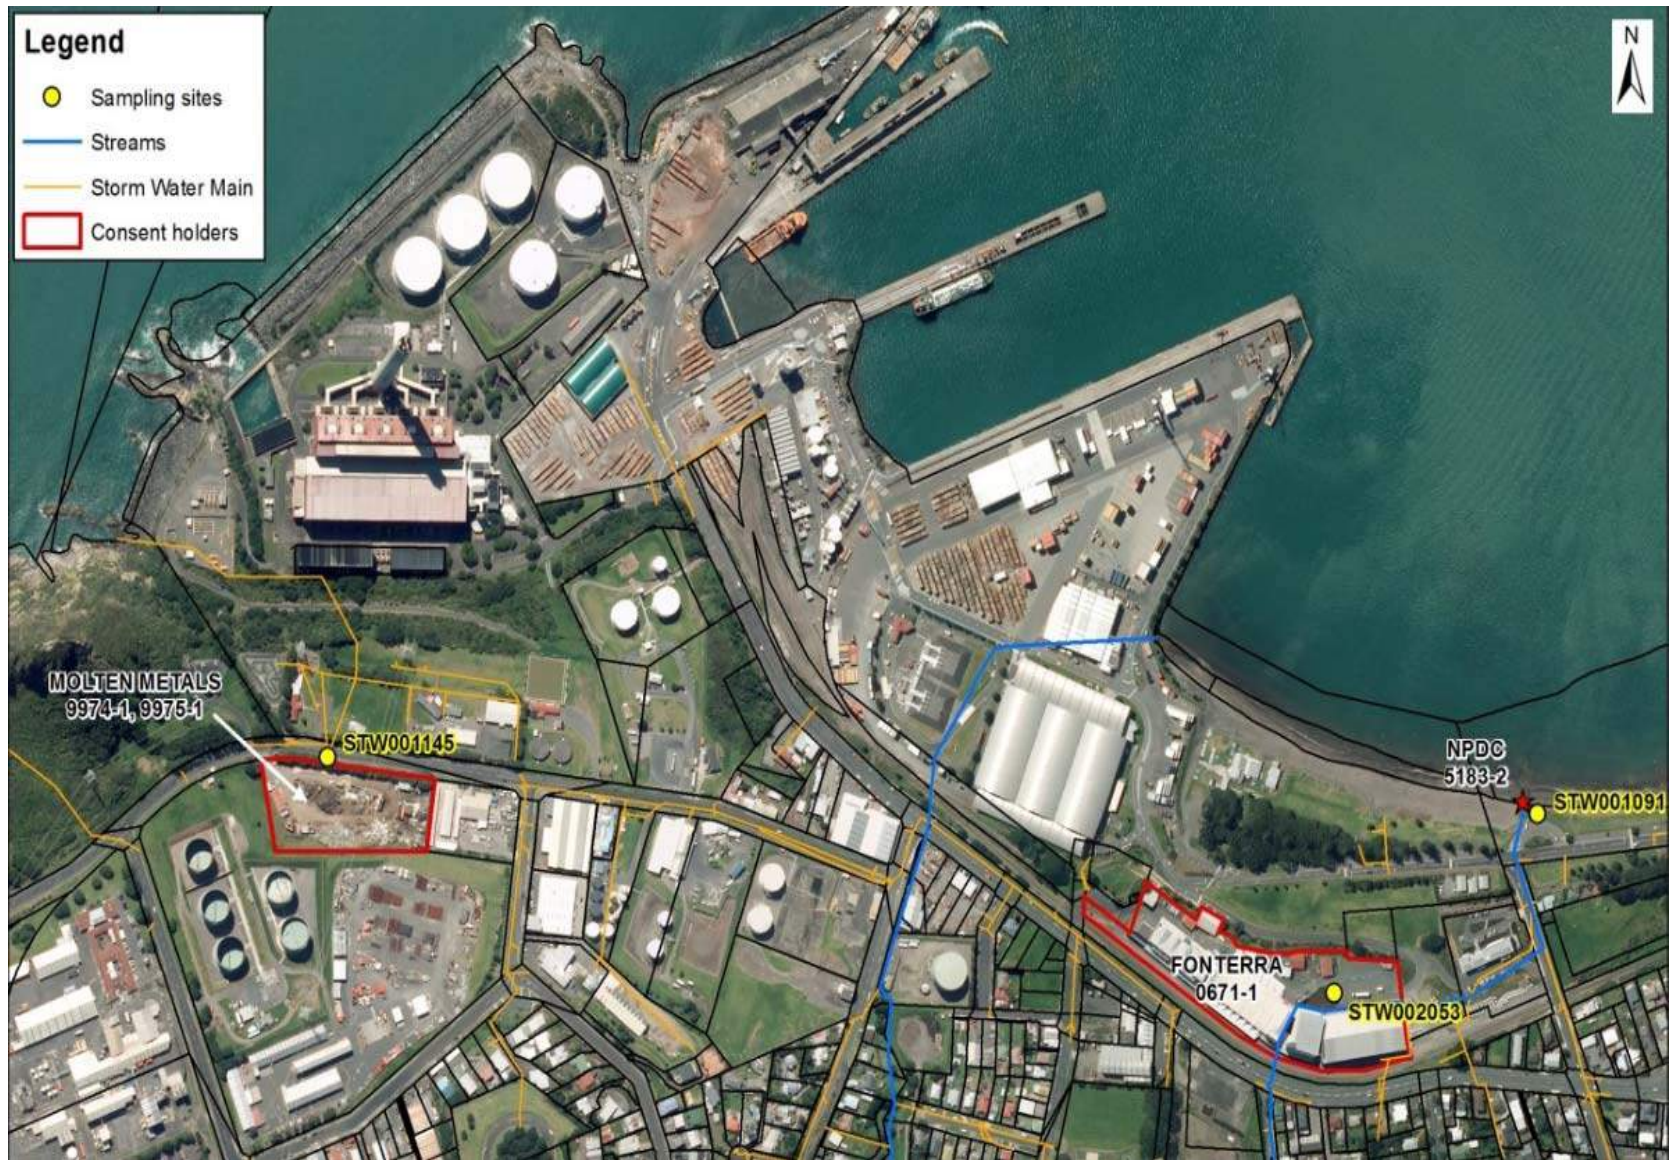
Figure 12 Other consented discharges to the CMA in the port area

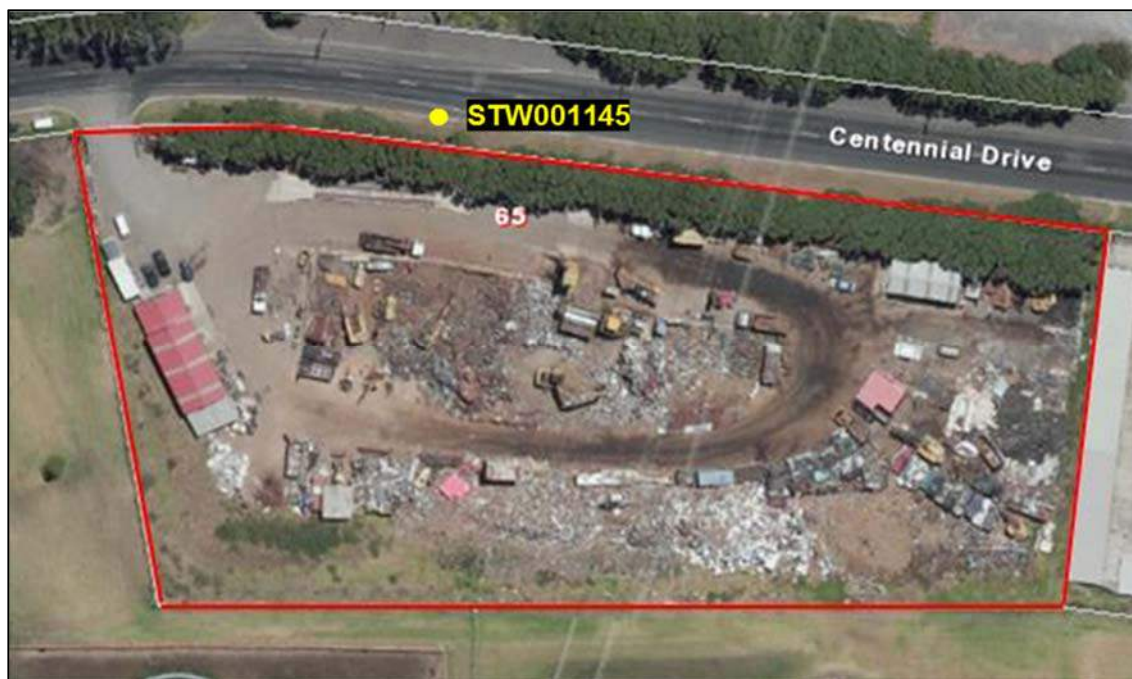
Materials are received at the site and stored on an unsealed surface; the materials being stored are not covered and so as they begin to degrade contaminants are discharged onto and into land, which have the potential to become entrained within the stormwater discharges. In most instances the materials brought onto site are processed into smaller pieces to enable easier transport, which can result in contaminants discharging onto and into land, and therefore have the potential to become entrained within the stormwater discharges.

Molten Metals hold discharge permit **9974-1** allowing the discharge of stormwater from scrap metal storage and processing into the NPDC reticulated stormwater system, and discharge permit **9975-1** allowing the discharge of contaminants onto and into land associated with scrap metal storage and processing.

Figure 13 Aerial photograph of the Molten Metals site

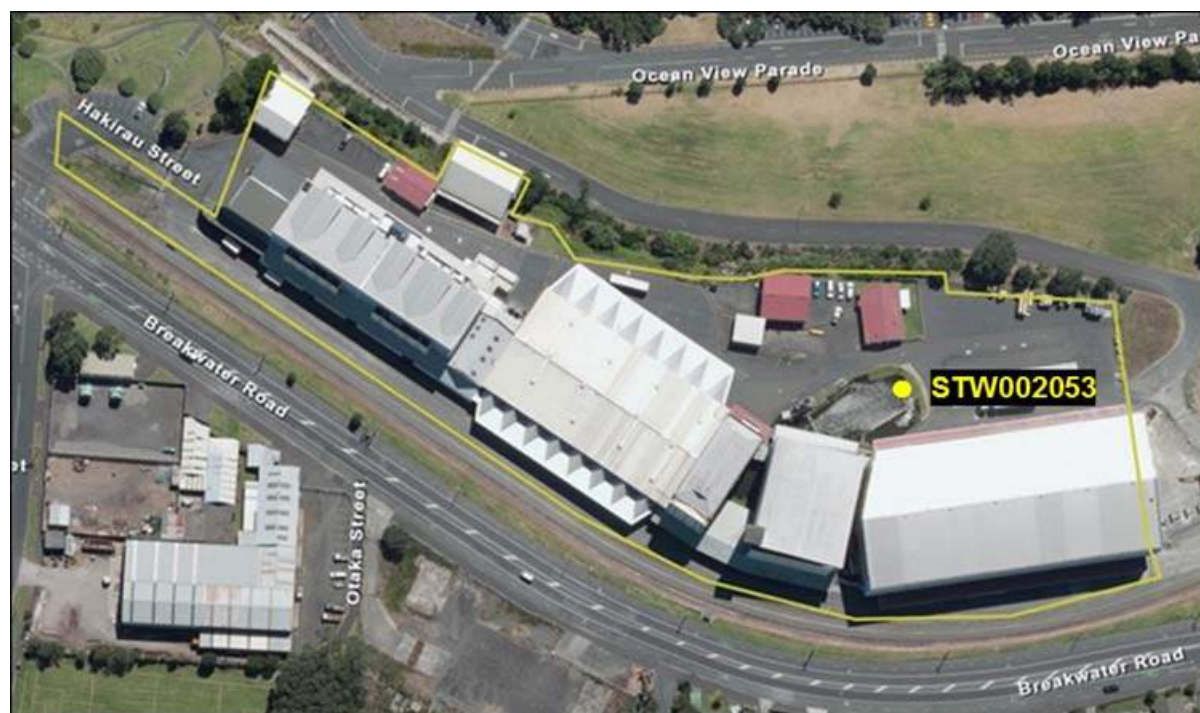
Seaport Land Company Ltd (Seaport) operates a site in New Plymouth that was formerly held by Fonterra Ltd and operated as a coolstore since 1896 (Figure 14). Water used for cooling was discharged to a holding pond on the site, which overflows via a stormwater drain onto Ngamotu Beach. Oily water seeping from a disused oil well on the site, that was active between 1910 and 1920, is discharged through a separator to the holding pond. The site is no longer operating as an active coolstore, however the infrastructure is still in place.

Seaport holds coastal discharge permit **0671-3** allowing the discharge of up to 960 m<sup>3</sup>/day of cooling water and 7.2 m<sup>3</sup>/day of groundwater seepage from a reservoir at the rear of the Company's installation via a stormwater drain onto Ngamotu Beach.

Figure 14 Aerial photograph of the Seaport site
