Port Area Industrial Catchments
Monitoring Programme
Annual Report
2015-2016
Technical Report 2016–97

Taranaki Regional Council
Private Bag 713
STRATFORD

March 2017

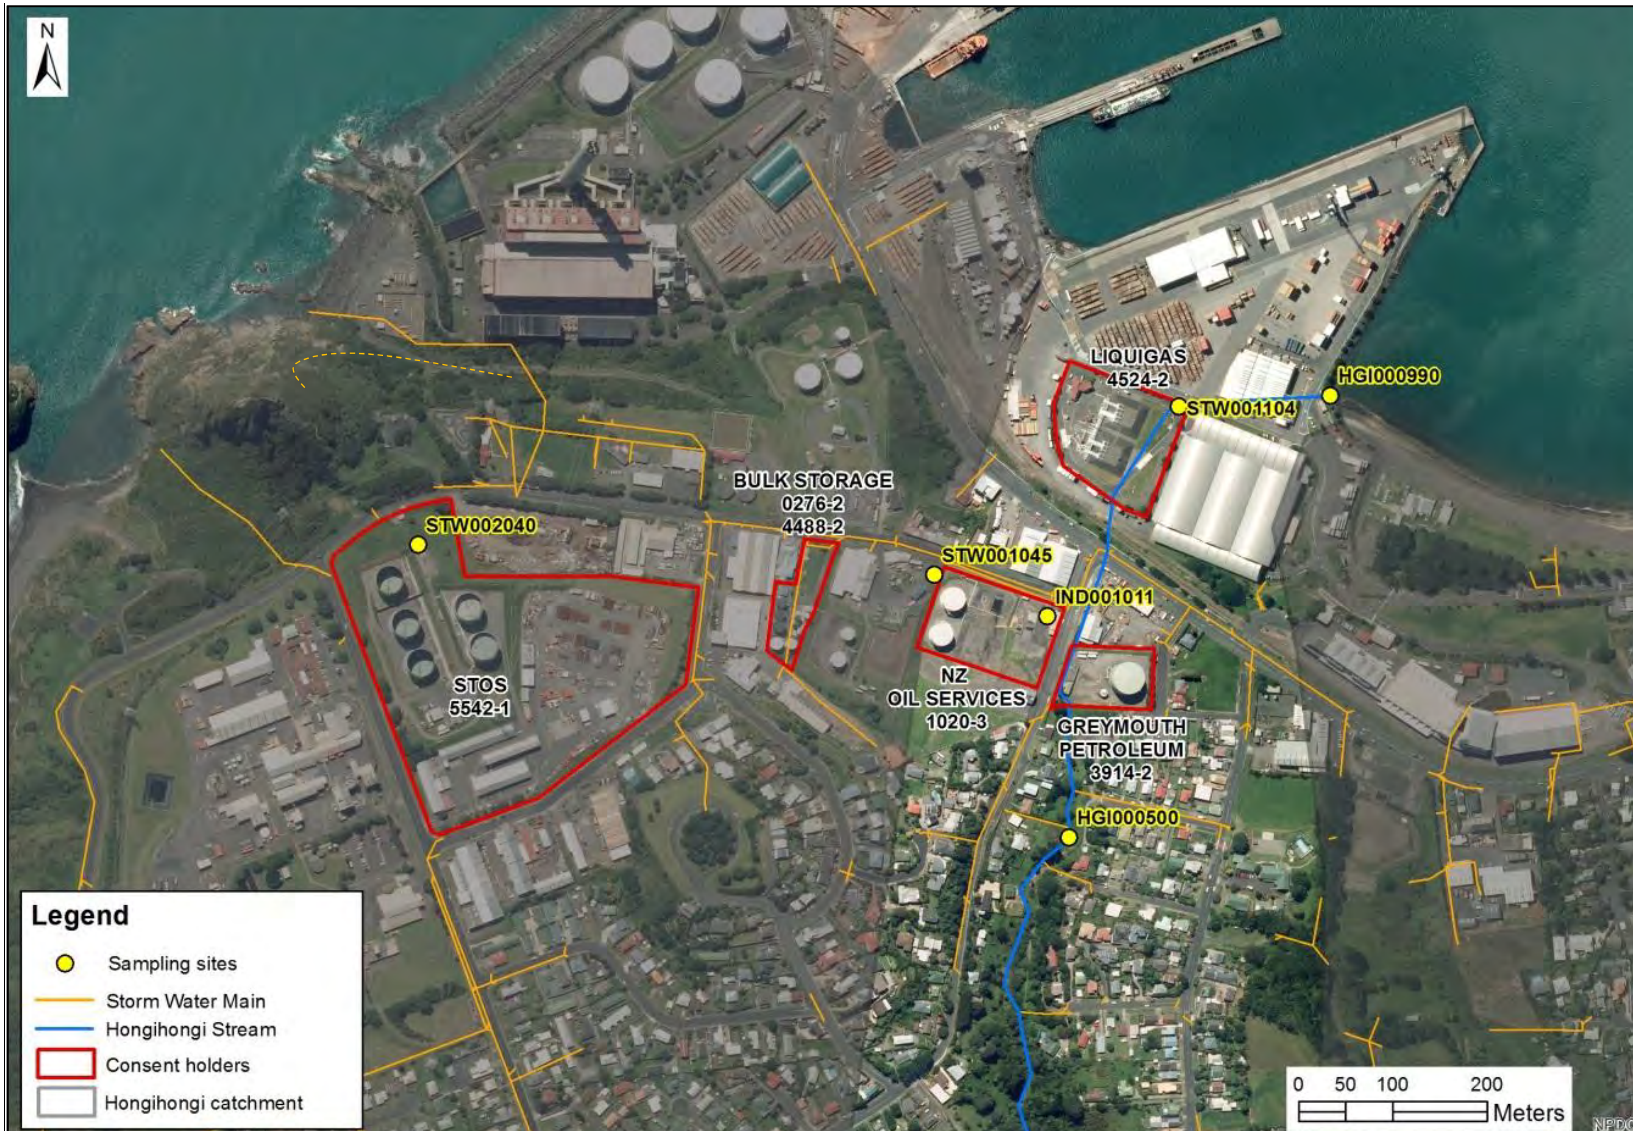
Figure 1 Consents and sampling points for discharges via the Hongihongi Stream outfall

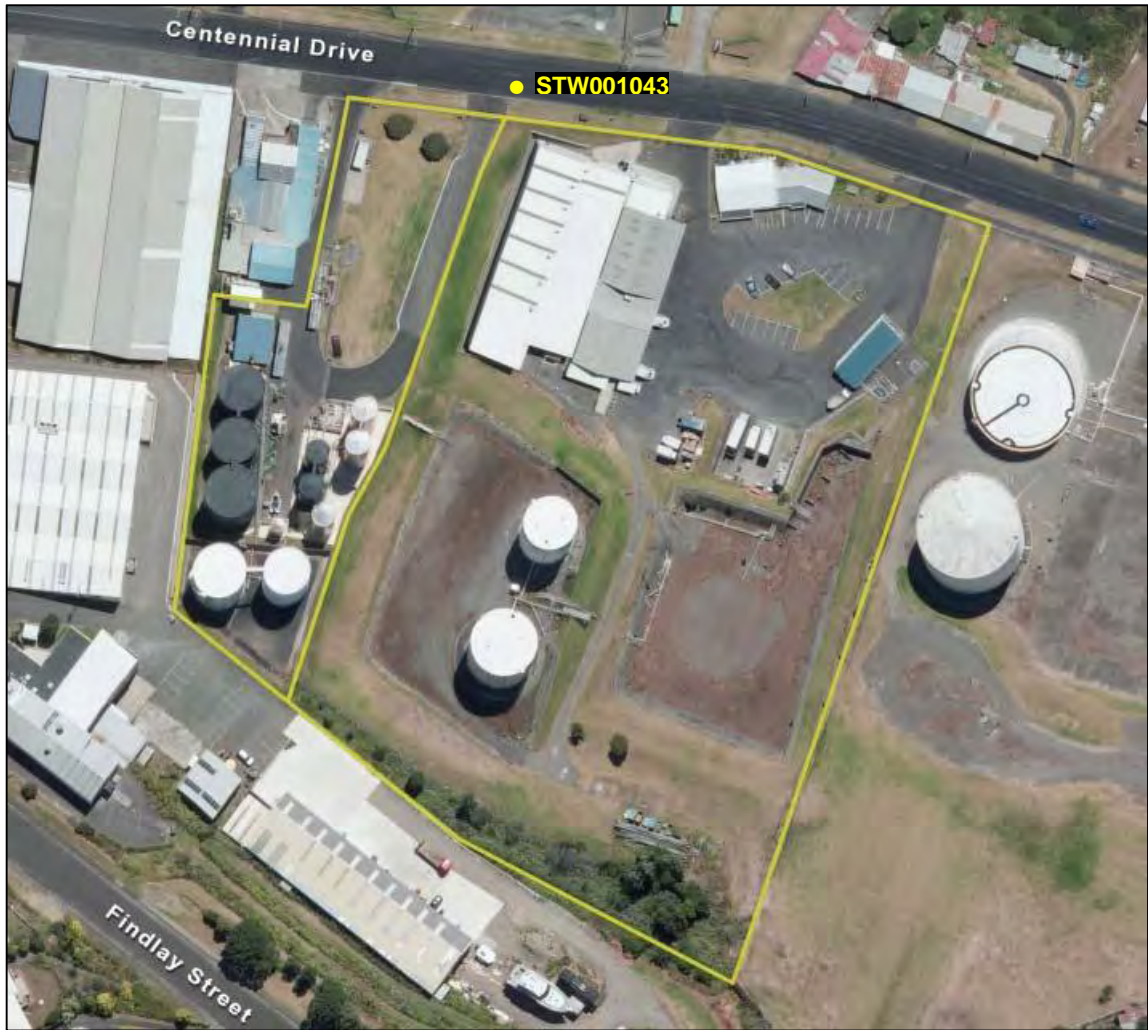
Figure 2 Aerial photograph of the Bulk Storage Terminals Ltd site

On each occasion the tank bunds, stormwater drains, and separators were checked, and an odour survey conducted, and no issues were noted (for example bunds and stormwater drains were free of any evidence of contaminants). Company staff usually accompanied the Council inspector.

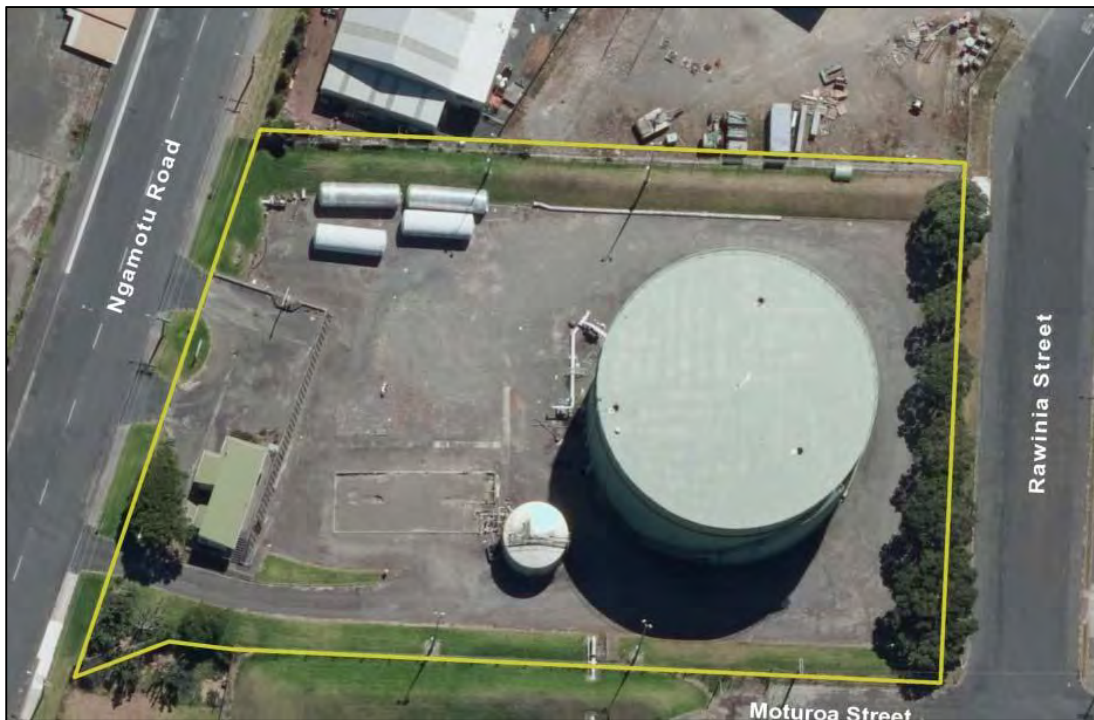
This facility (Figure 3) was constructed to treat deballast water from vessels docked at the port. However, it has not been used for this purpose since 1996. Greymouth Petroleum Ltd (Greymouth Petroleum) took over the site from Methanex in 2008 and currently use the bunded area of the site as a holding facility for drilling fluids and produced water related to land based well-site drilling activities. The site no longer discharges any treated water to the Hongihongi Stream from this area. As the site surface is in generally poor condition and permeable, all stormwater collected within the bunded areas discharges into land through soakage.

Figure 3 Aerial photograph of the Greymouth bulk storage facility

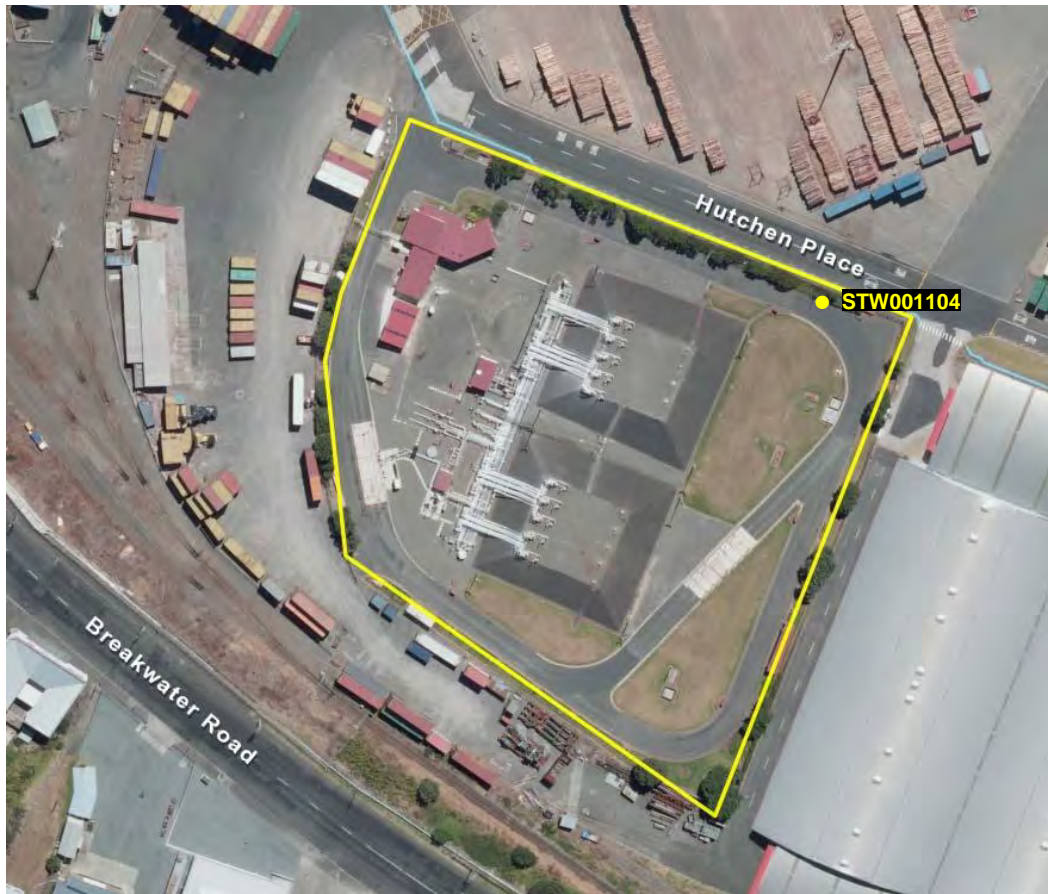
Figure 4 Liquigas site and sampling point

These results are indicative only as the only accessible sampling point is actually downstream of Liquigas' discharges in the stormwater network (containing stormwater water and the Hongihongi Stream). Therefore the results obtained would have contributions from all upstream sources. Based on the results of the immediately downstream of the site, in conjunction with visual inspection, the discharge from the Liquigas was likely to be compliant with consent conditions.

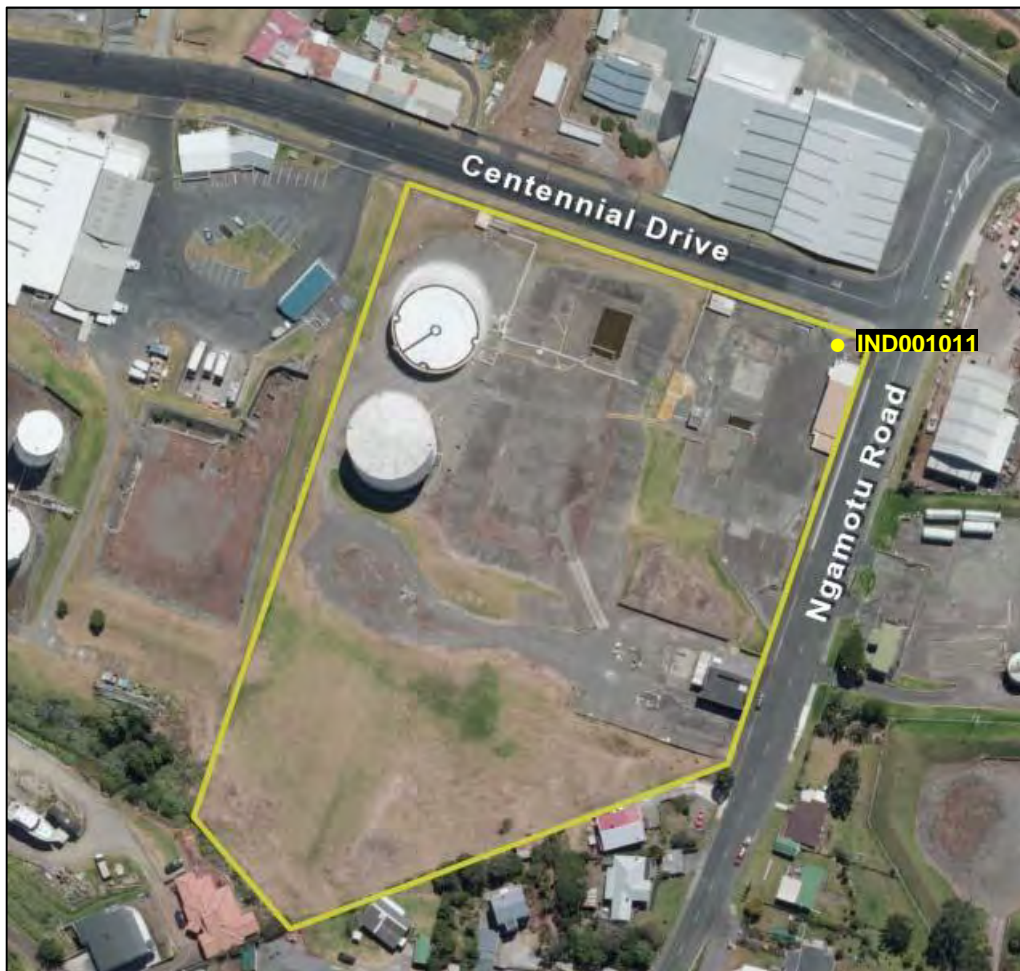
Hydrostatic testing is undertaken at least once every five years. Most operational water generated on the site now comes from condensation or water entrained in the cargos; this and any stormwater is treated via the separator before discharging to the NPDC stormwater system.

Figure 5 Aerial photograph of the New Zealand Oil Services Ltd Ngamotu Road site

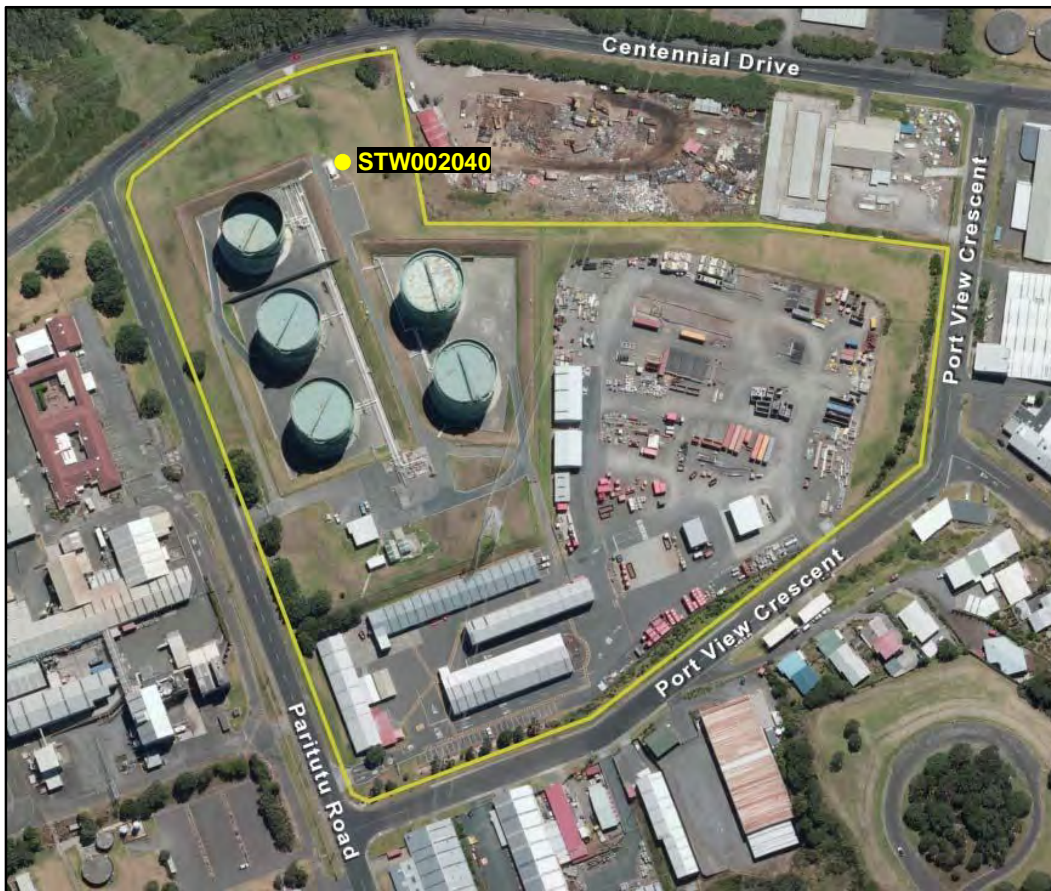
Stormwater from the site is sampled to confirm compliance with consent conditions prior to being directed to the API separator for treatment and discharge to the NPDC stormwater system on Centennial Drive to the coastal marine area via the piped Hongihongi Stream.

Figure 6 Aerial photograph of the Shell Todd Oil Services Ltd Paritutu Tank Farm

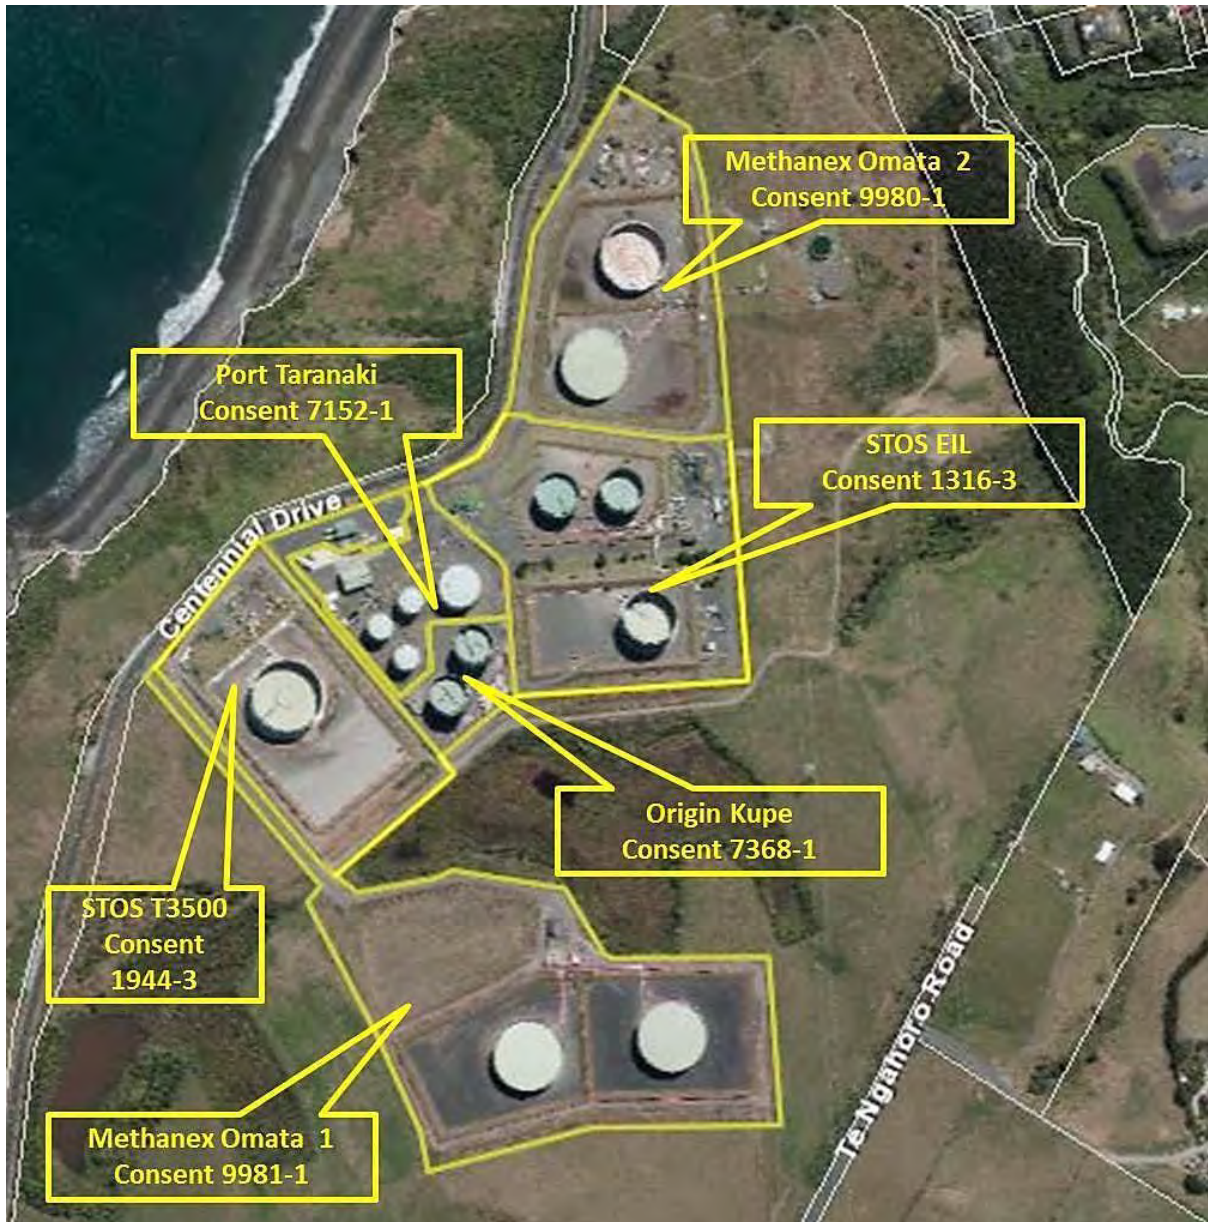
Figure 7 Consent holders' property boundaries in the Herekawe catchment

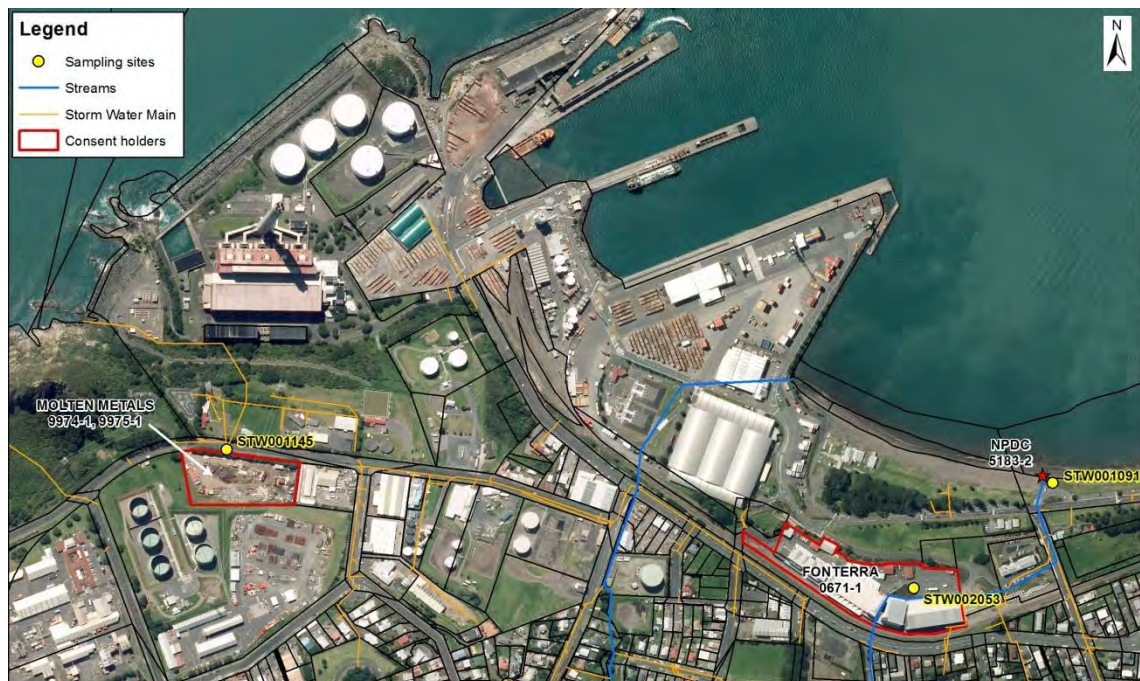
Figure 13 Other consented CMA discharges in the port area

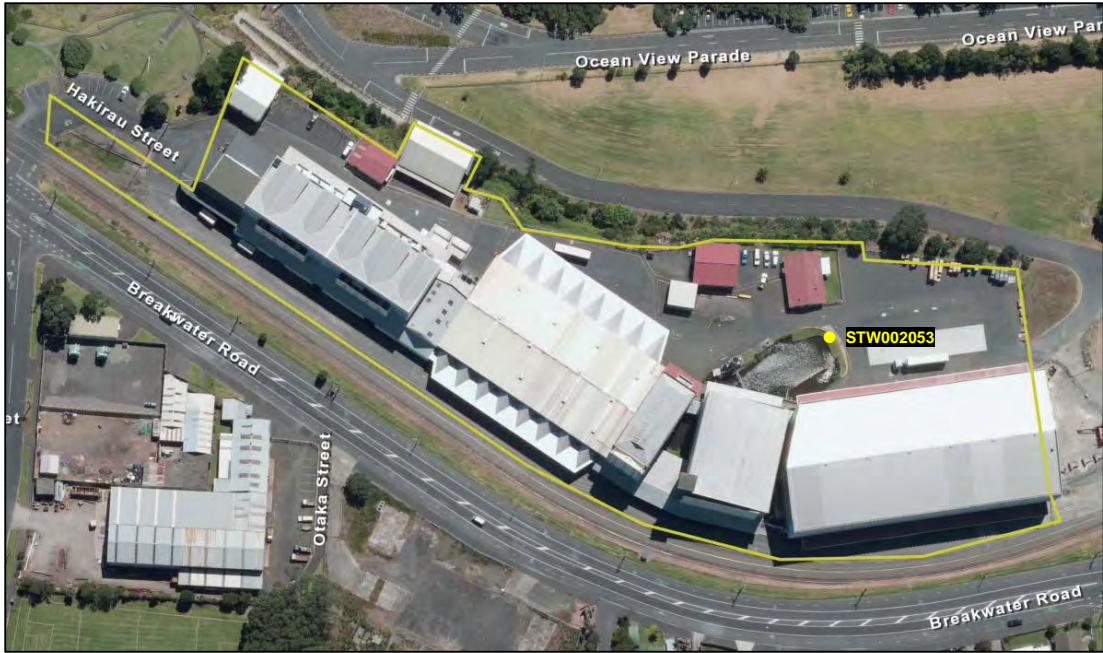
Figure 14 Aerial photograph of Fonterra New Plymouth Coolstores

Fonterra Ltd (Fonterra) operates a coolstore on a site in New Plymouth where there has been a coolstore since 1896 (Figure 14). Water used for cooling is discharged to a holding pond on the site, which overflows via a stormwater drain onto Ngamotu Beach. Oily water seeping from a disused oil well on the site, that was active between 1910 and 1920, is discharged through a separator to the holding pond.

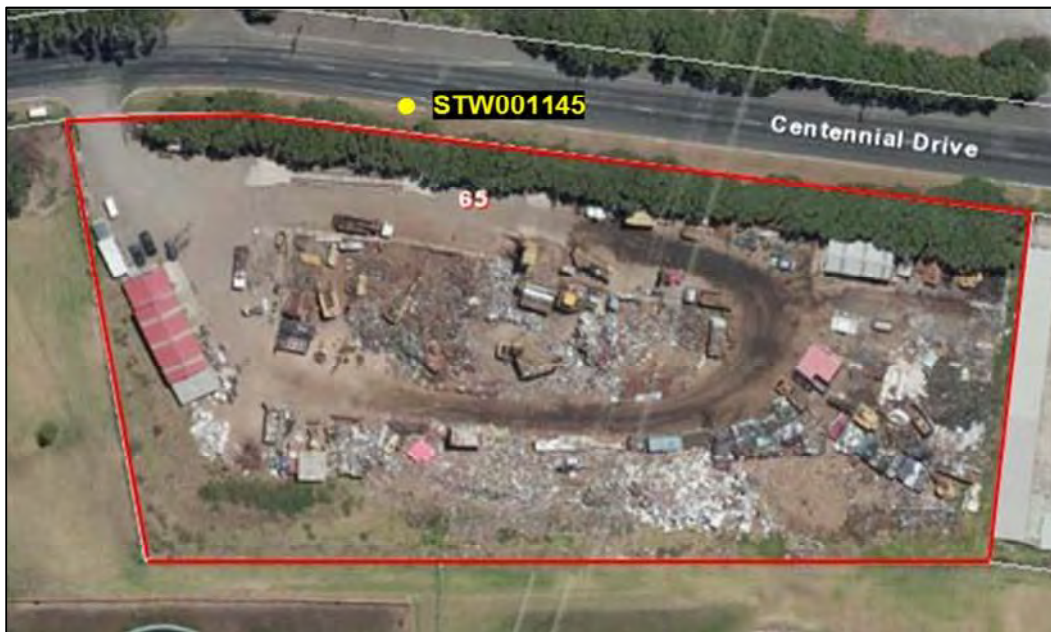
Molten Metals receives, stores, and processes scrap metals in various forms. The site is approximately 1.28 hectares and is located on Centennial Drive in New Plymouth (Figure 15). Although the site is classified as being within the Herekawe Stream catchment, stormwater discharges which leave the site enter the NPDC reticulation network along Centennial Drive.

Figure 15 Aerial photograph of the Molten Metals site

Materials are received at the site and stored on an unsealed surface; the materials being stored are not covered and so as they begin to degrade contaminants are discharged onto and into land, which have the potential to become entrained within the stormwater discharges. In most instances the materials brought onto site are processed into smaller pieces to enable easier transport, which can result in contaminants discharging onto and into land, which also have the potential to become entrained within the stormwater discharges.
