McKechnie Aluminium Solutions Ltd
Monitoring Programme
Annual Report
2017-2018

Technical Report 2018-20

Taranaki Regional Council
Private Bag 713
STRATFORD
February 2019

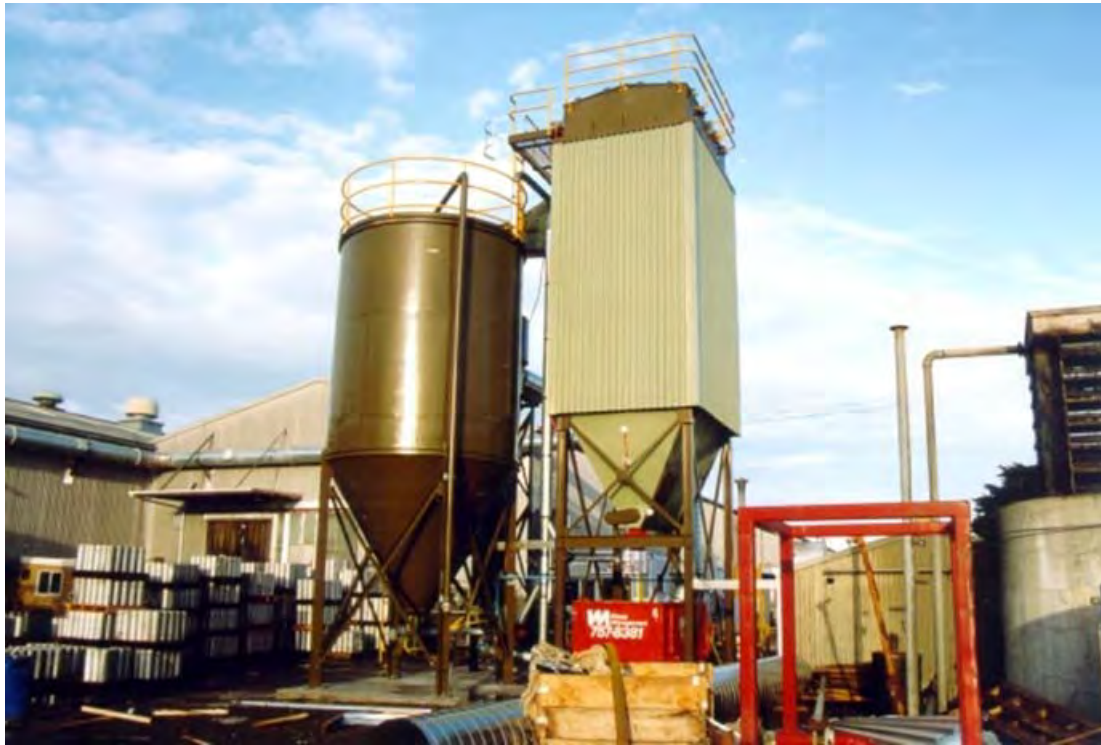
exhaust gases directly to the stacks if the incoming gases exceed the limits set. This avoids the superheated gases damaging the baghouse or its components. This type of discharge is still subject to conditions 1 and 2 of consent 4034-3, which require the consent holder to adopt the 'best practicable option' to minimise adverse effects upon the receiving environment from the discharges.

Photo 1 MASL baghouse

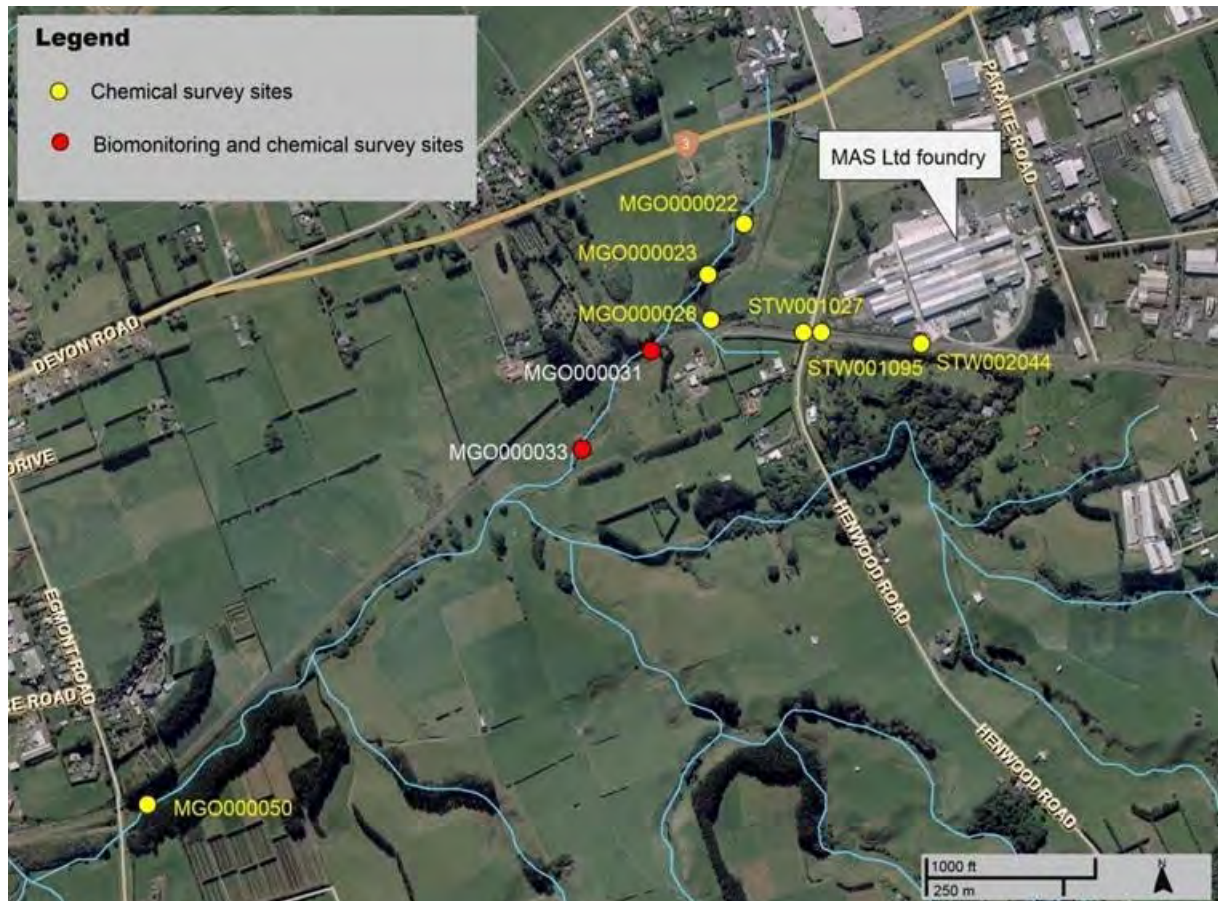
Figure 2 Location of the MASL plant in Bell Block and related water quality monitoring sites

Samples were taken by the Council from several permanent sampling points under dry conditions on 22 November 2017 and in wet weather conditions on 26 June 2018. The results are presented in Table 2.

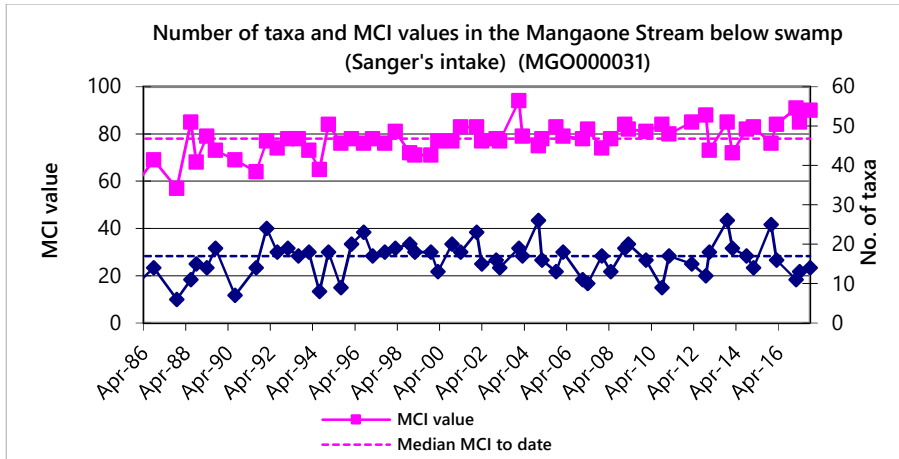
Figure 2 Taxa numbers and MCI scores recorded to date at site 3

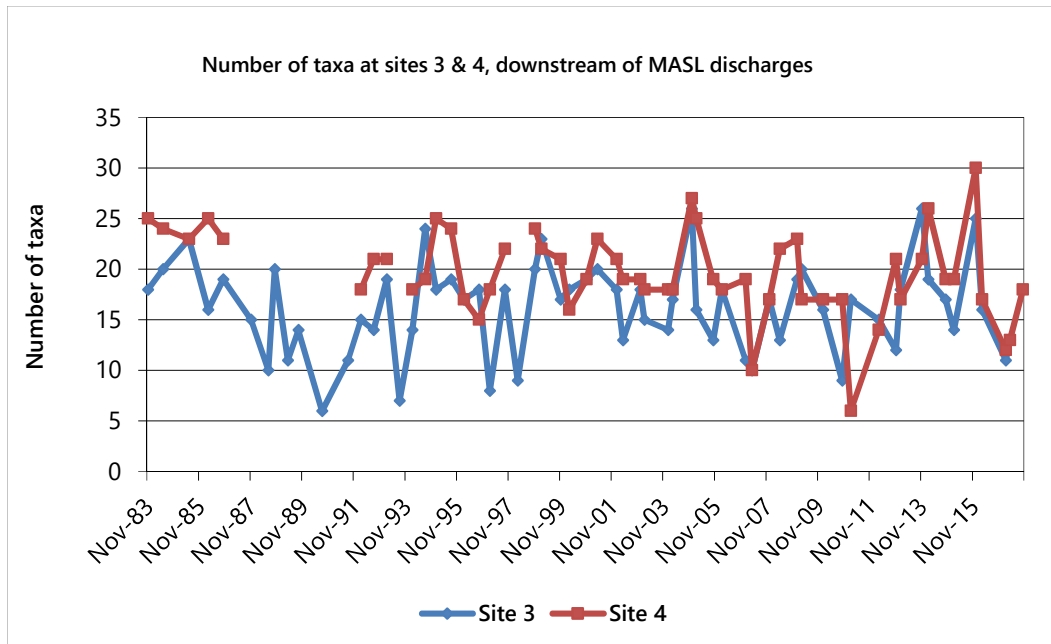
Macroinvertebrate communities at site 3 (closer to the swampy headwaters and MASL stormwater discharge) have generally contained slightly lower numbers of taxa than the communities at site 4 (site 3 median = 17, site 4 median = 19). In the current survey taxa numbers differed by four taxa between sites and were slightly lower than historic medians (by 3 and 1 taxa respectively).

Figure 4 Number of taxa at sites 3 and 4 in an unnamed tributary of the Mangaone Stream in relation to discharges from MASL

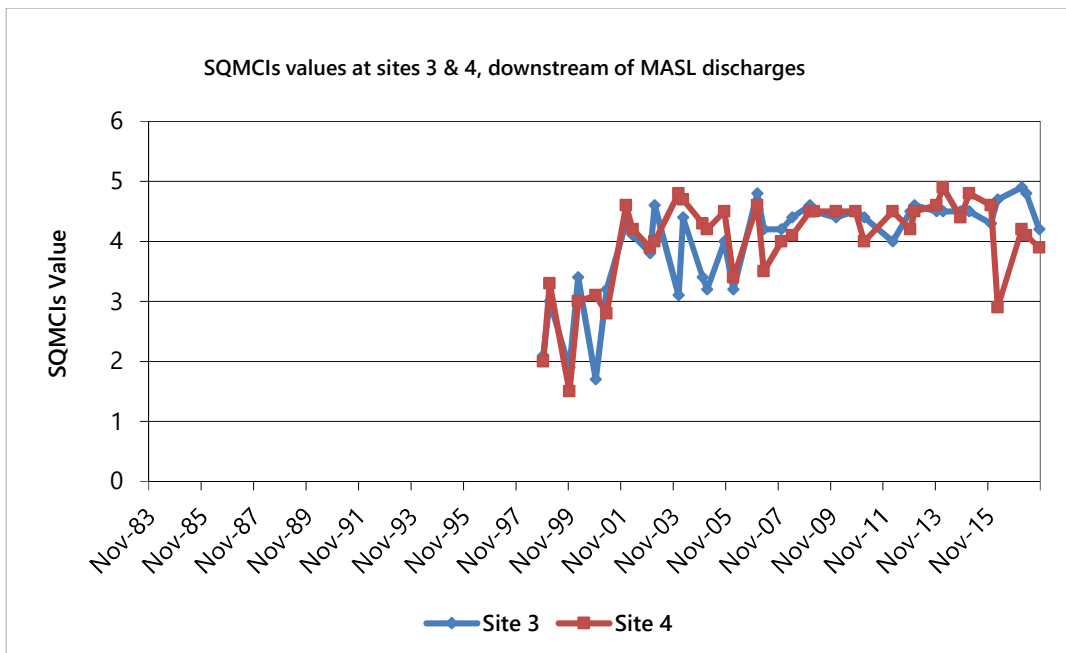
SQMCI_s values from both sites have generally varied between 4 and 5 units in more recent surveys and this trend has continued for both sites with scores not significantly different from each other.

Figure 5 SQMCI_s values at sites 3 and 4 in an unnamed tributary of the Mangaone Stream in relation to discharges from MASL

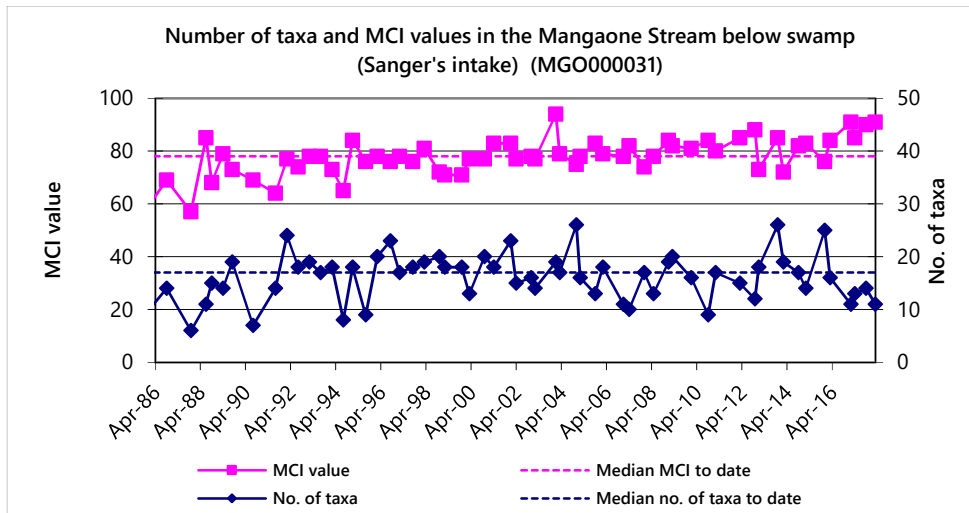
Figure 2 Taxa numbers and MCI scores recorded to date at site 3
Site 4 (MGO000033)

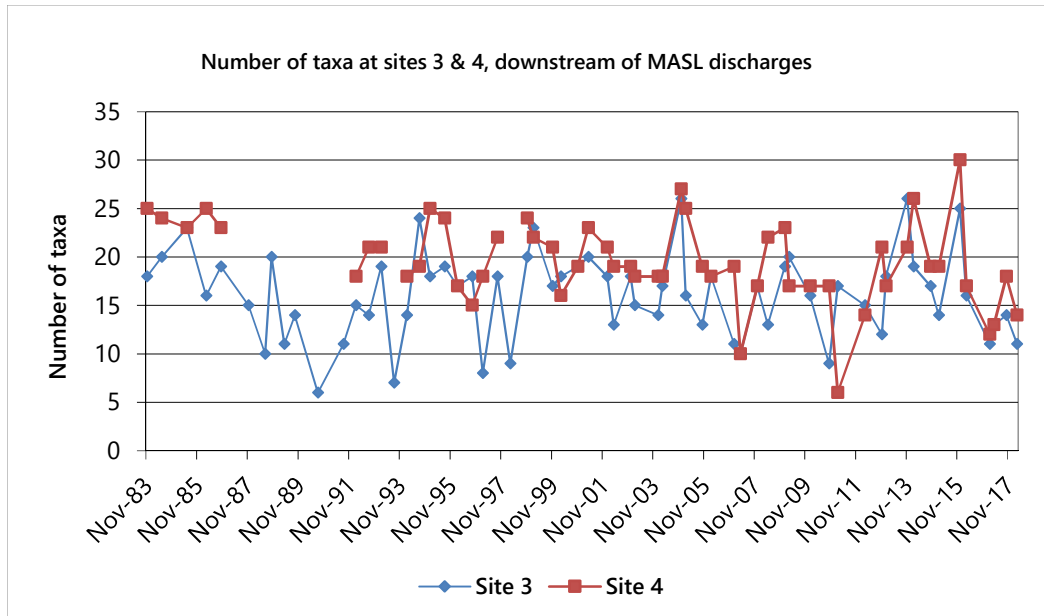
Macroinvertebrate communities at site 3 (closer to the swampy headwaters and MASL stormwater discharge) have generally contained slightly lower numbers of taxa than the communities at site 4 (site 3 median = 17, site 4 median = 19). In the current survey taxa numbers differed by three taxa between sites and were lower than historic medians (by 6 and 5 taxa respectively).

Figure 4 Number of taxa at sites 3 and 4 in an unnamed tributary of the Mangaone Stream in relation to discharges from MASL

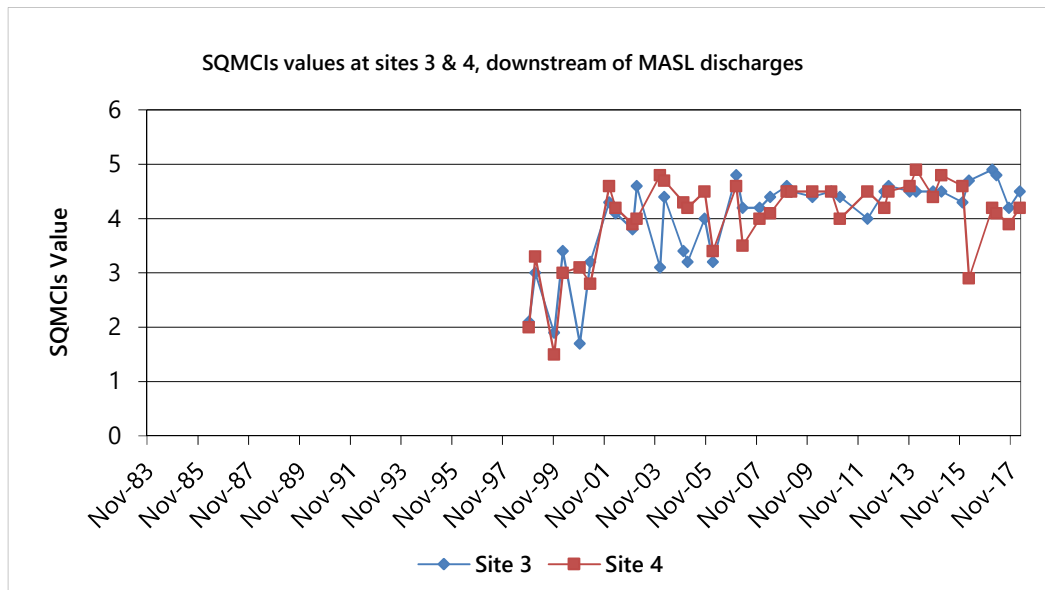
SQMCI_s values from both sites have generally varied between 4 and 5 units in more recent surveys and this trend has continued for both sites with scores not significantly different (Stark, 1998) from each other or historic medians.

Figure 5 SQMCI_s values at sites 3 and 4 in an unnamed tributary of the Mangaone Stream in relation to discharges from MASL
