South Taranaki District Council
Kaponga, Manaia, Patea, and Waverley WWTPs
Monitoring Programme
Annual Report
2019-2020

Technical Report 2020-20

ISSN: 1178-1467 (Online)
Document: 2474923 (Word)
Document: 2632088 (Pdf)
March 2021

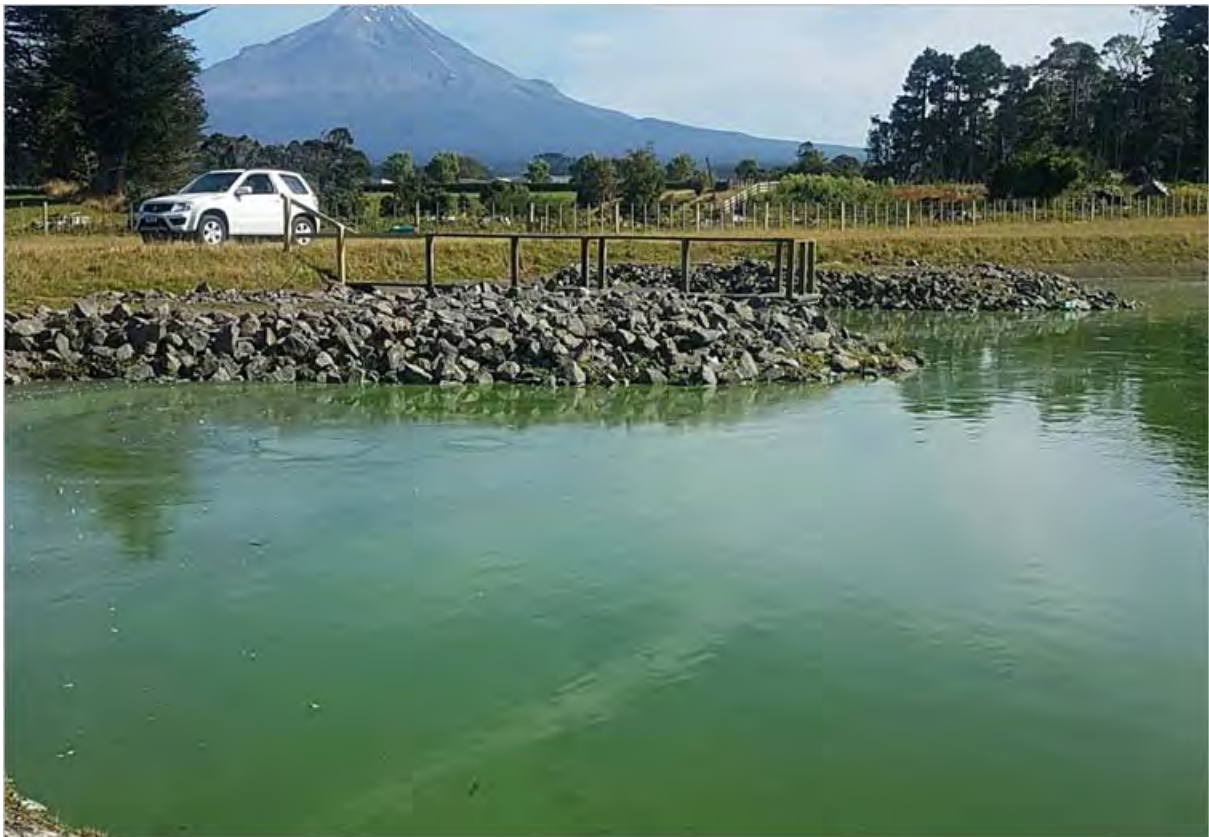
Photo 1 Kaponga WWTP

The Kaponga WWTP is a single oxidation pond system (constructed in 1971) that has been separated into two sections by a wooden dividing barrier. The pond is gravity-fed mainly domestic wastes from a population of approximately 330 people, although it was designed for a population of 650. A sludge survey performed by consultants for the consent holder (MWH, 2005) found that there had been a slow rate of sludge accumulation and at such a rate, it was estimated that the system would not require desludging for another 17 years. Sludge surveys will be repeated at five-yearly intervals (STDC, 2015). Issues of stormwater infiltration, improved mixing within the ponds' system, and reduction of the microfloral component of the treated wastewater discharge, were identified in consideration of upgrading the treatment system during the consent renewal process in the 2007-2008 period (CH2M Beca Ltd, 2006). Upgrades to the system were completed by late May 2008. Infiltration remedial work has a lesser priority for the Kaponga township collection system than elsewhere in South Taranaki.

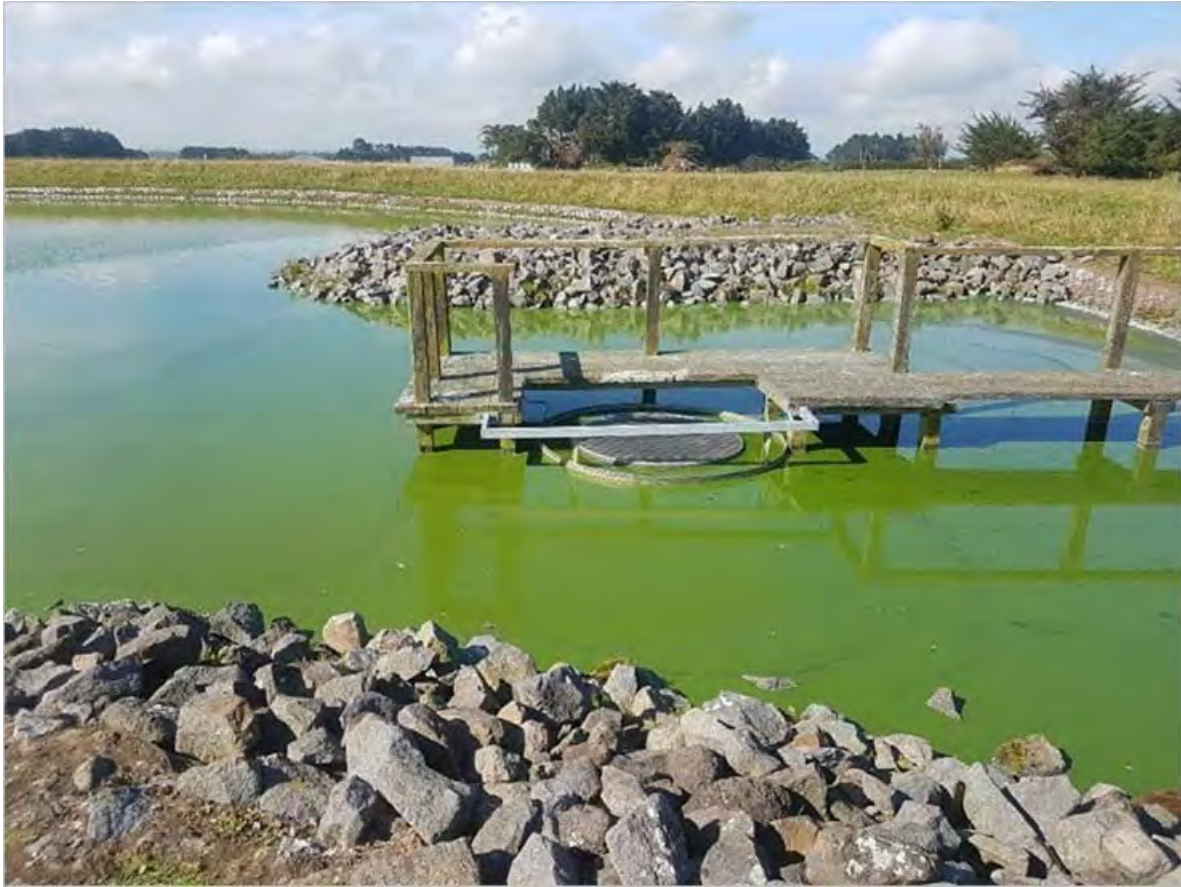
Photo 2 Algal bloom on the surface of the pond caused by high microfloral levels.

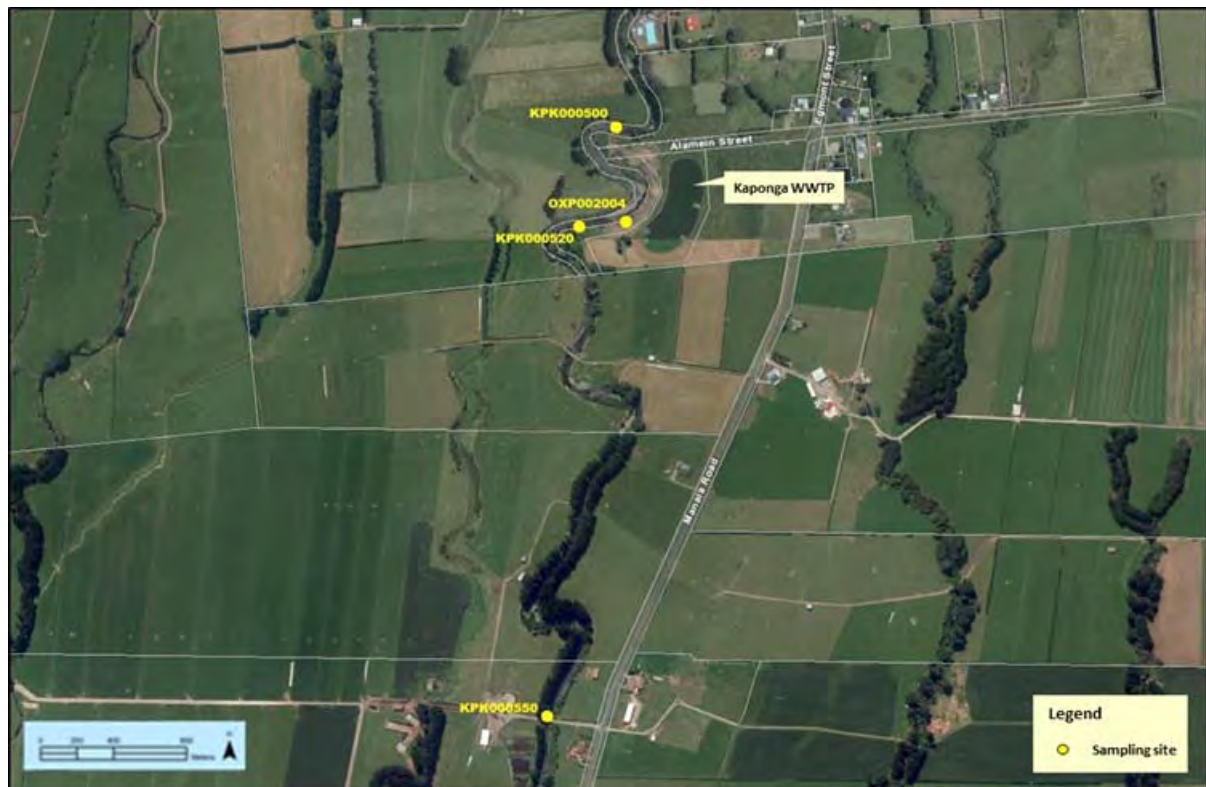
Figure 1 Aerial location map of sampling sites in relation to Kaponga WWTP

Monitoring of the impacts of the Kaponga WWTP on the receiving waters was measured using both chemical analyses of the receiving waters of the Kaipokonui River beyond the boundary of the mixing zone, and biological monitoring surveys at the same locations. Chemical sampling was carried out on three occasions during the 2019-2020 period (Section 2.1.3.1). One biomonitoring survey was conducted during summer 2020 (Section 2.1.3.2). The locations of sampling sites are listed in Table 5 and displayed in Figure 1 below.

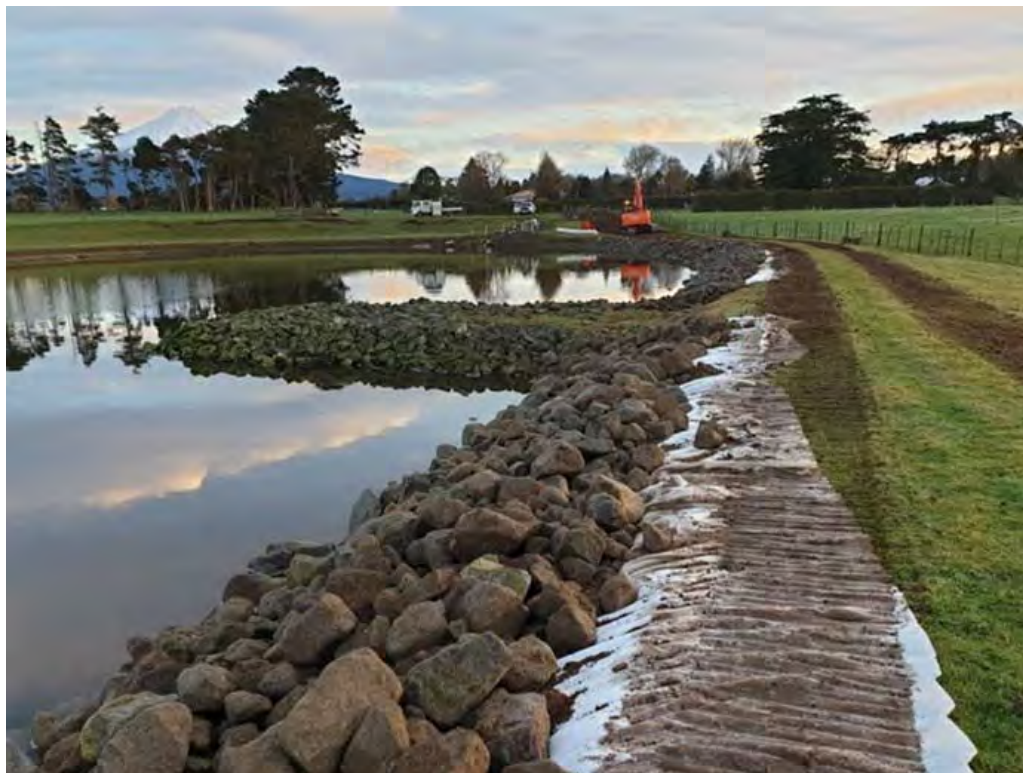
The Kaponga WWTP was well maintained and operated, and performed satisfactorily throughout the monitoring period. The refurbished wavebands, dividing wall, and replacement outlet grid have functioned successfully since the 1998-1999 monitoring period and continued to do so throughout the current period. A section of waveband was replaced during the 2019-2020 monitoring period (Photo 3)

Photo 3 Replacement of waveband July 2019

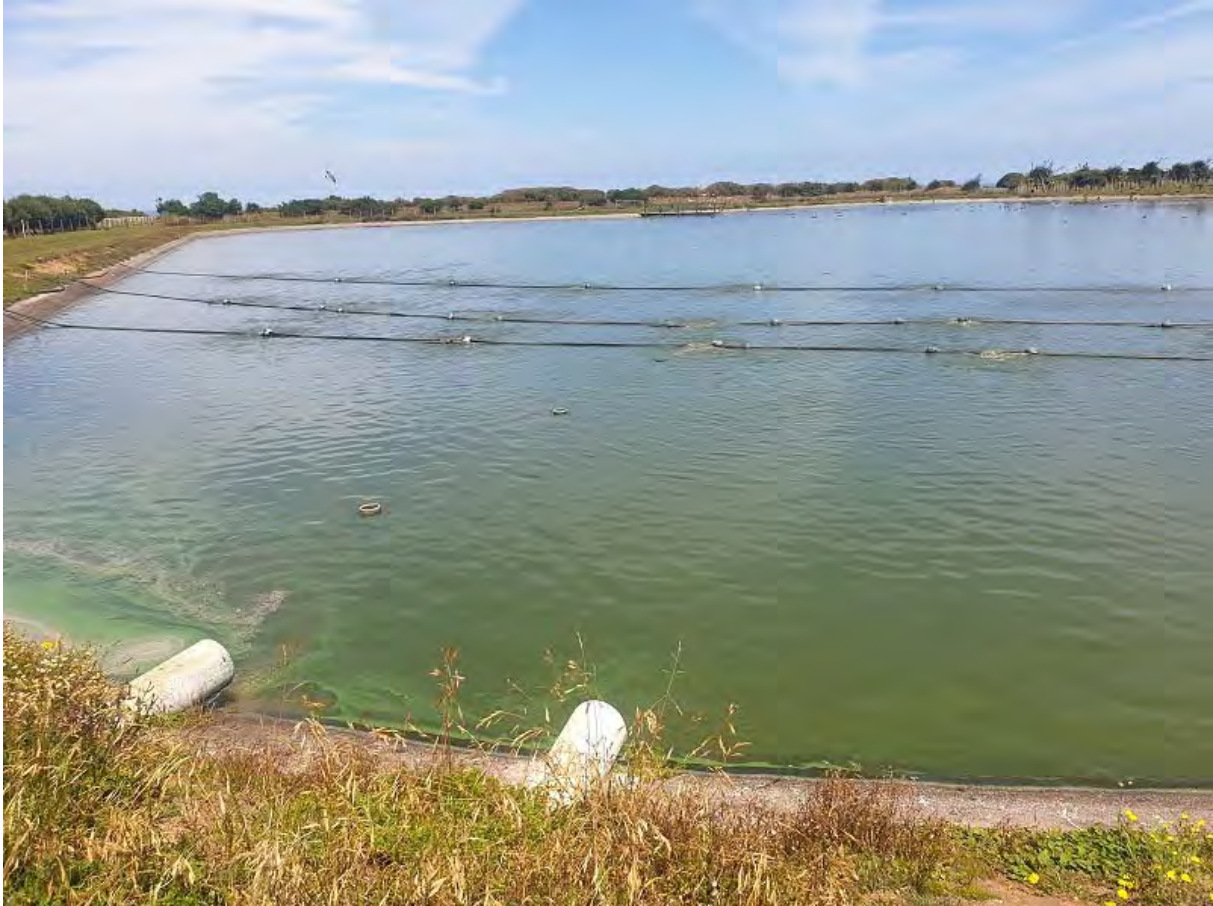
Photo 4 Manaia WWTP

The Manaia WWTP (Photo 4) is a single treatment oxidation pond (constructed in 1984), followed by twin wetlands (in parallel) receiving mainly domestic sewage together with trade wastes from the bakery industry. These trade wastes are currently un-regulated but with the proposed introduction of a planned trade waste by-law, restrictions and standards are intended to be imposed by the consent holder (STDC, 2013).

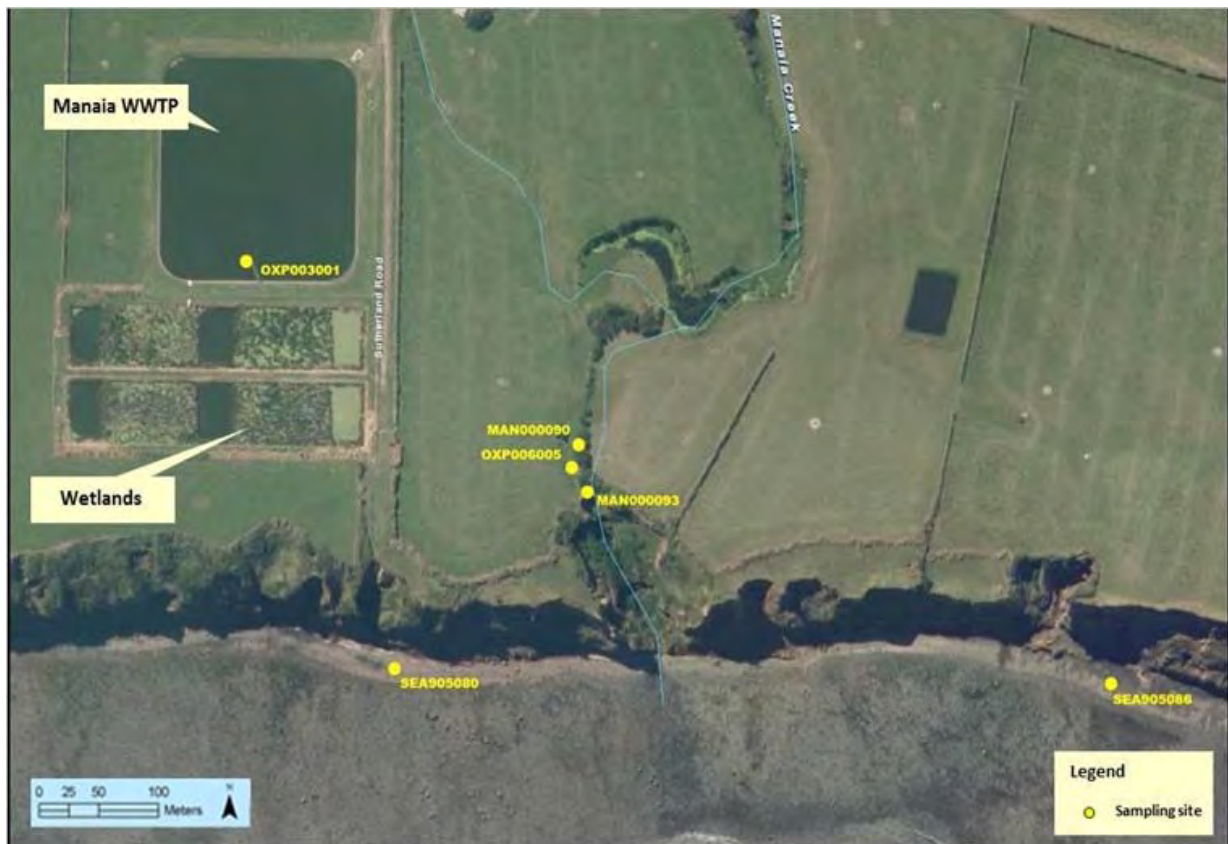
Figure 2 Aerial location map of sampling sites in relation to Manaia WWTP

Effluent monitoring was carried out from both the primary oxidation pond, adjacent to the outlet, and the final discharge from the wetlands for the purpose of monitoring the effectiveness of the treatment plant. Sampling sites for both effluent monitoring and receiving water monitoring are described in Table 9 and displayed in Figure 2. Measurements of dissolved oxygen levels (DO) and the microfloral component of the primary pond (Sections 3.3.1 and 3.3.2 respectively) were taken on each of the three inspections.

Monitoring of the impacts of the Manaia WWTP on receiving waters is measured using chemical analyses of the Manaia Creek upstream and downstream of the final wetlands discharge, and beyond the boundary of the mixing zone with the receiving waters of the Tasman Sea. An annual biological inspection is also carried out on the intertidal zone at the boundary of the mixing zone. Chemical sampling was carried out on three occasions during the 2019-2020 period (Section 3.4.1). One biomonitoring inspection was conducted during autumn 2020 (Section 3.4.2). The locations of sampling sites are listed in the previous section, in Table 9 and Figure 2.

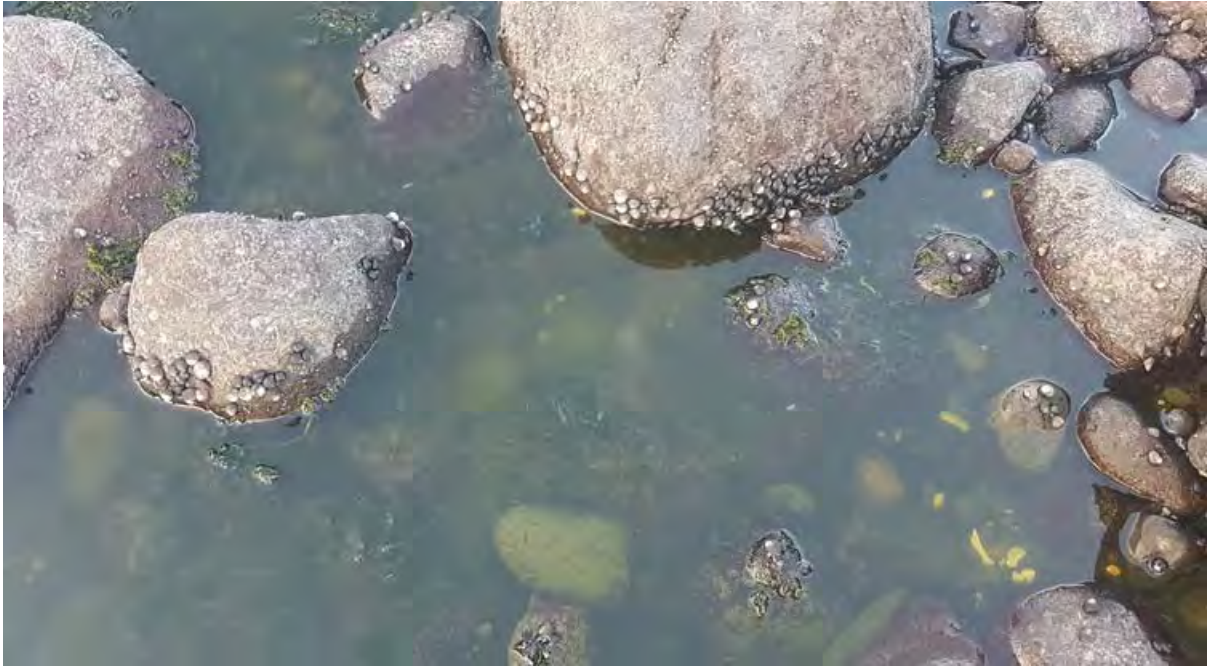
Photo 5 High intertidal zone (direct influence)

There was a low flow in Manaia Creek during the inspection. As it flowed onto the reef, the stream was turbid green in colour (Photo 5). This colouration was evident from the stream mouth to the low water mark, although it was less pronounced in the lower tidal zone. No foaming or surface scum was observed on the reef, and no sewage odours were detected. No discolouration, or any other visual effects or odours were noted in the tidal pools 50 metres west of the stream mouth.

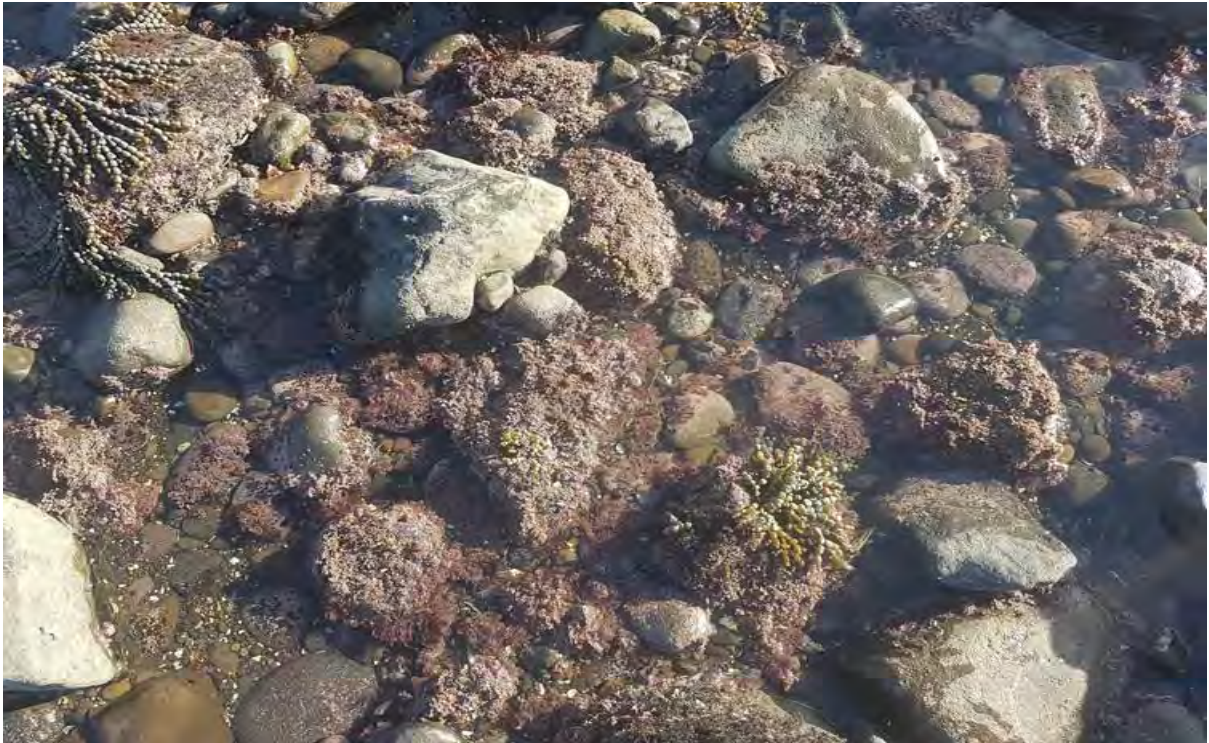
Photo 6 Low intertidal zone (approximately 50 metres west of the stream)

Manaia Creek appeared to have a pronounced effect on the intertidal reef ecology within its direct influence. At the high shore, the most notable effects were the discoloured pools, the high coverage of *U. intestinalis* and the high abundance of periwinkle and top shell gastropods. Further down the shore

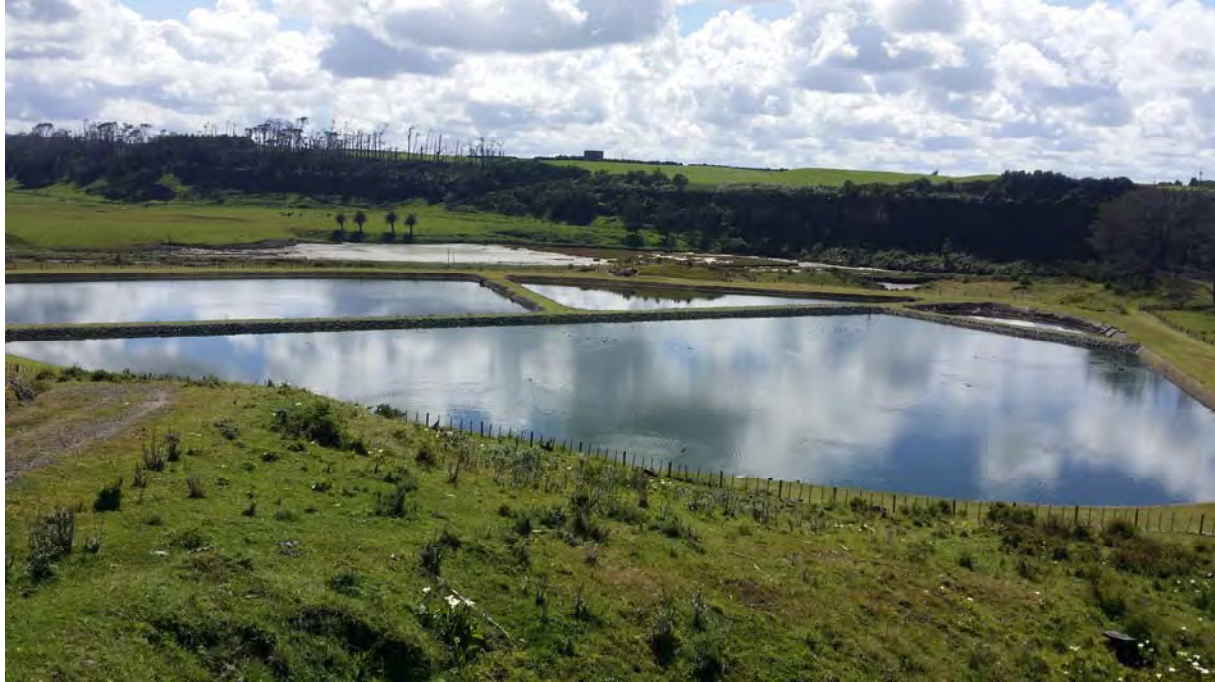
Photo 7 View of Patea WWTP

The Patea WWTP (constructed in 1973 for a population of 2,400) was originally comprised of a single large oxidation pond which was upgraded to a three cell system in 2008 (Photo 7). There are currently no significant industrial wastes being discharged into this system, which services a population of 1,098 (as measured in 2013). The nearby York Street pumping station has provision for river overflow via a separate outfall in the event of emergencies.

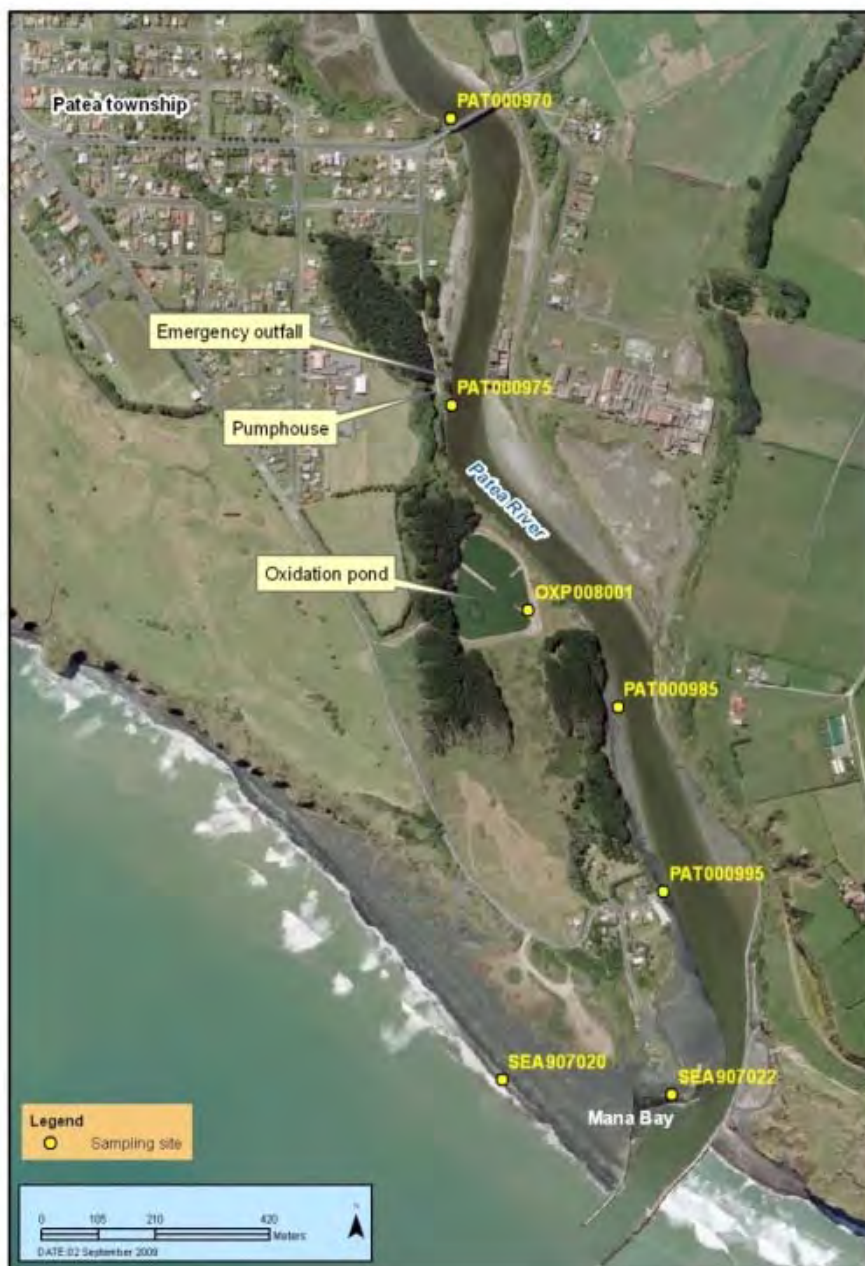
Figure 3 Map showing sampling sites in relation to Patea WWTP

Monitoring of the impacts on receiving waters is measured using both chemical analyses of the Lower Patea River, and contact recreational bacteriological quality surveys of the coastal marine area at the Patea Boat Ramp and the Tasman Sea at Mana Bay (Figure 3). Chemical sampling was carried out on two occasions during the 2019-2020 period (Section 4.4.1). Contact recreational bacteriological water quality monitoring (section 4.4.2) at the Patea Boat Ramp and Mana Bay was carried out by the Council on 18 separate occasions between early November 2019 and late March 2020 (TRC, 2020). The sampling sites are detailed in Table 19 and shown in Figure 3.

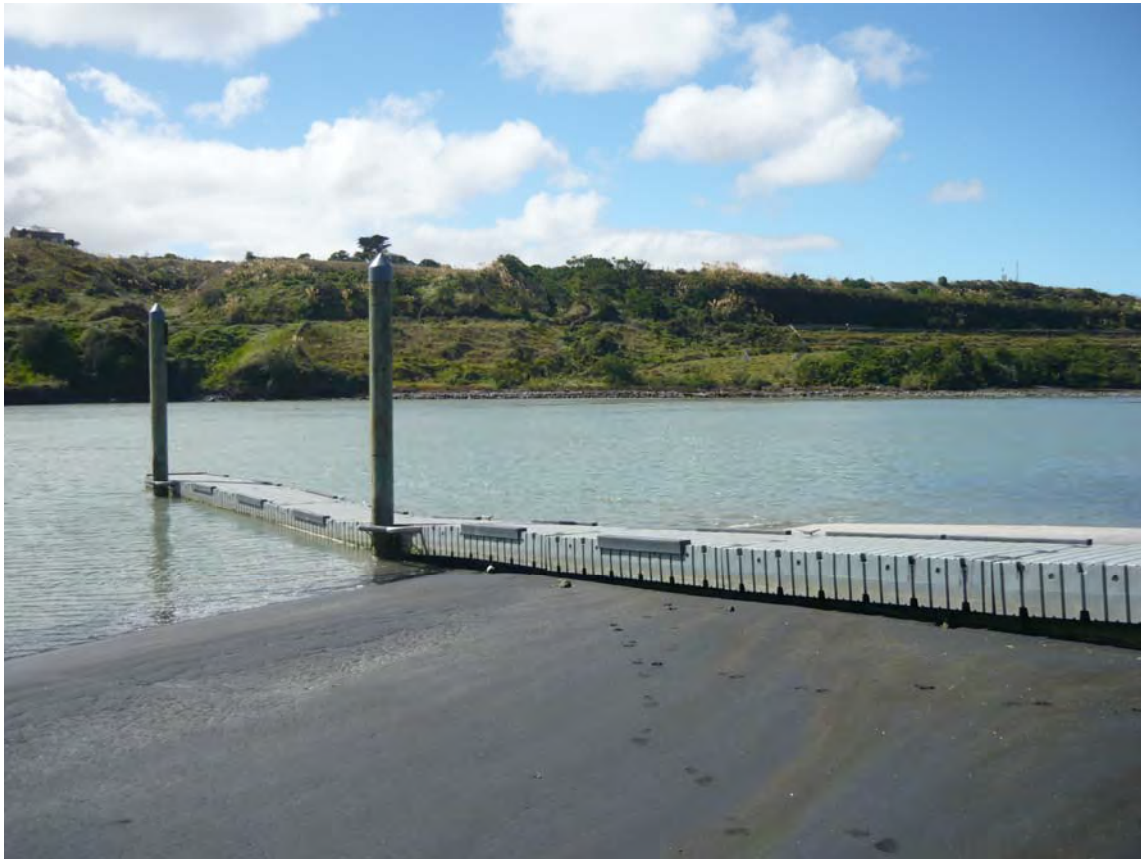
Photo 8 View of Patea boat ramp sampling site

Sampling at the two sites during the summer monitoring period occurred between early November 2019 and mid-March 2020 (the final two scheduled samples were not able to be collected due to Covid-19 restrictions). It was concentrated on high tide conditions (11 samples), but also included low tide conditions on seven other occasions. The results are summarised in Tables 21 and 22, and illustrated in Figures 4 and 5.

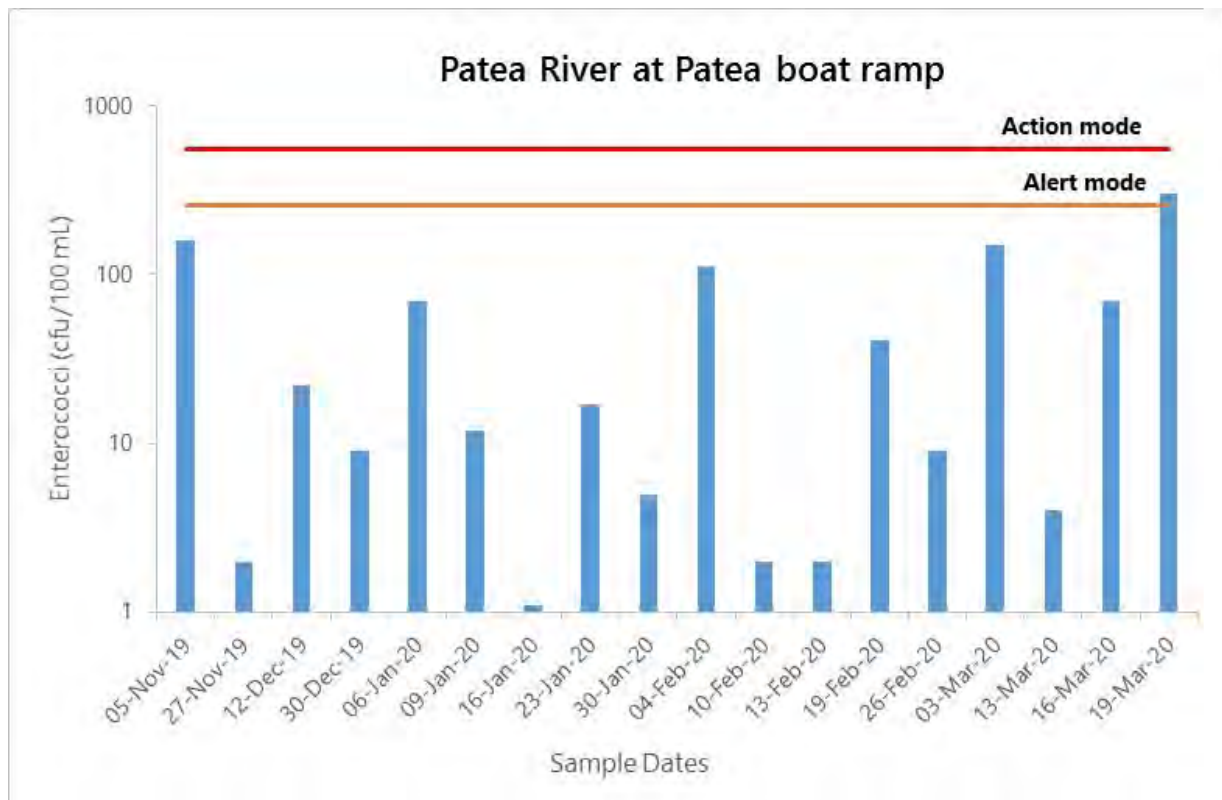
Figure 4 *E. coli* numbers for lower Patea River at the boat ramp

Bacteriological water quality was typical of the lower reaches of a large ringplain-eastern hill country catchment, with moderate numbers under river (freshwater) dominated conditions and fewer when influenced by saline penetration of the coastal seawater. The number of *E. coli* exceeded the 'Alert' limit on one occasion in March 2020, this occurred during a low tide run when there was the least dilution available. This data is indicative of relatively good bacteriological water quality conditions and within the expected range for this site. Very little bathing activity was noted during the 2019-2020 period at this site, which is used mainly for boating access and occasionally for fishing and walking. The Council had undertaken microbial source tracking (MST) using DNA marker techniques over the 2011-2012 period at this site and at the upstream site at SH3 bridge on two occasions (high and low tides) (see TRC, 2012). Faecal coliform bacteria were found to have been sourced predominantly from cattle on both occasions at the two sites while gulls contributed to populations at the boat ramp site under both tidal conditions. A faint trace of human source derivation was found (downstream of the Patea WWTP treated discharge) at the boat ramp site only under low tidal flow conditions.

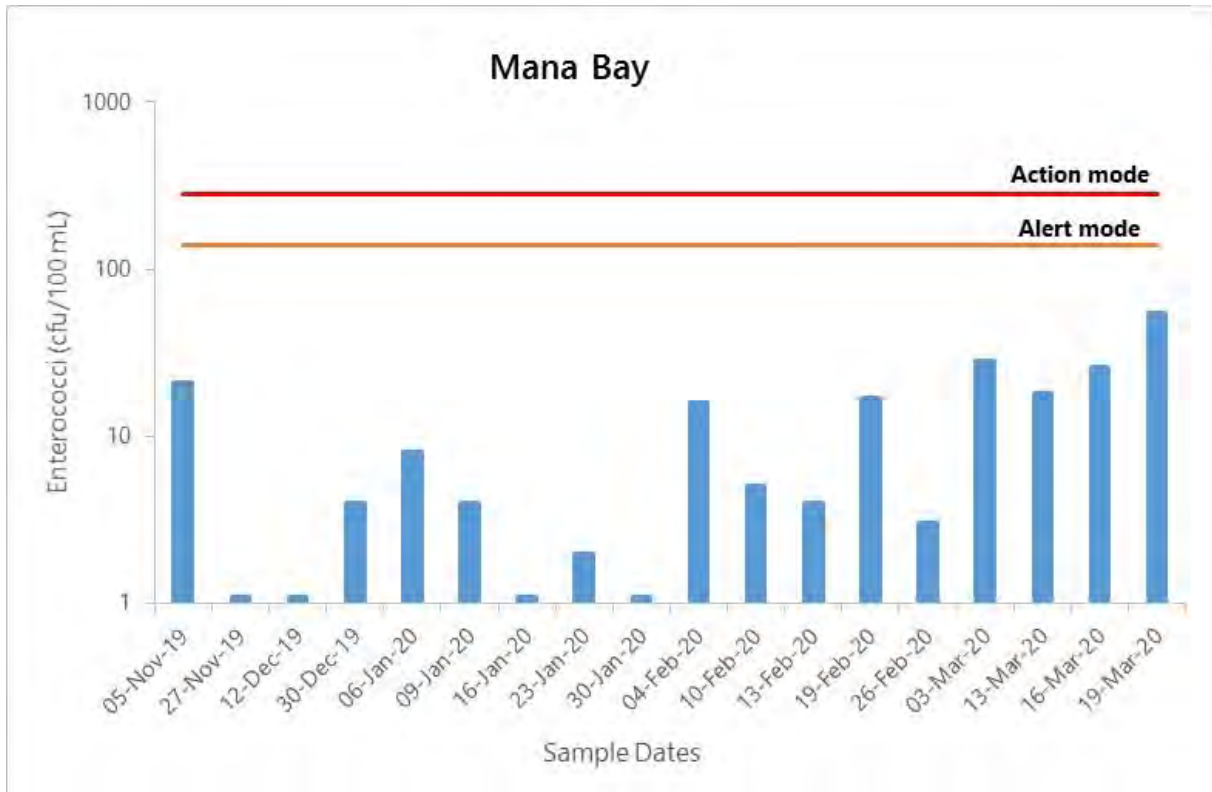
Figure 5 Enterococci numbers for Mana Bay

Water quality at Mana Bay was good throughout the season, with all samples below the 'Alert' level guideline. (Figure 5).

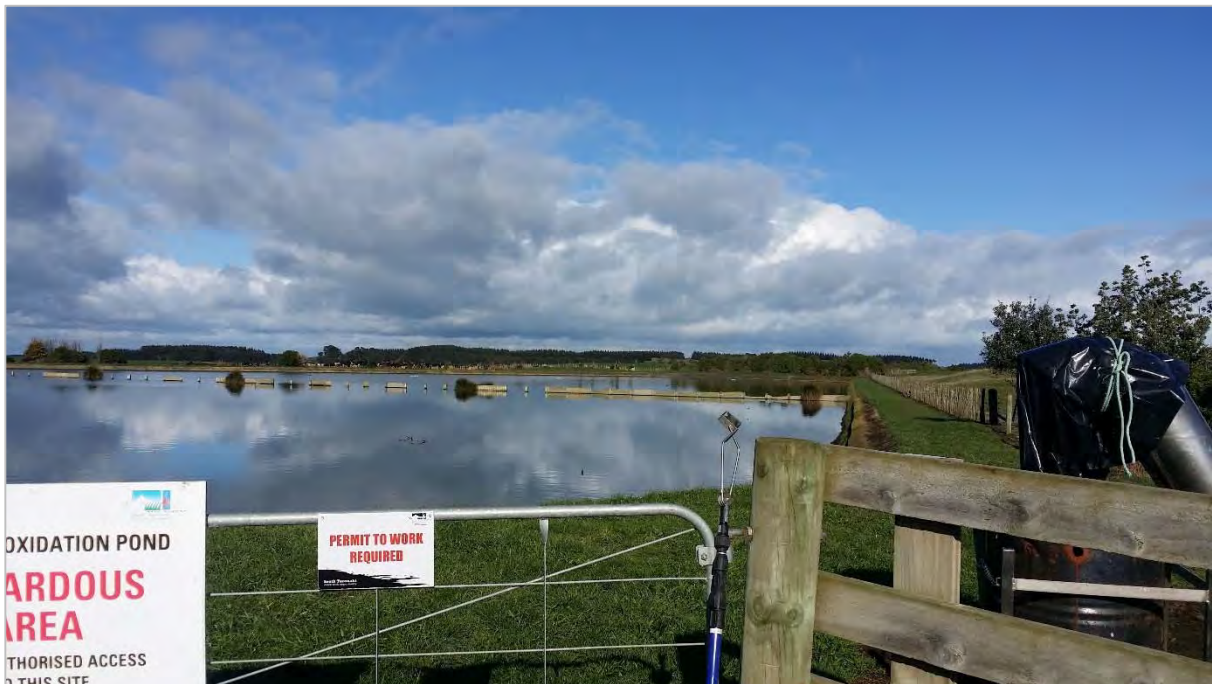
Photo 9 Waverley WWTP

The WWTP system was reconfigured during the 2008-2009 period with the existing outfall abandoned, the secondary pond converted to a primary pond with a new inlet design, repairs made to the dividing wall, and the primary pond converted to a secondary pond with a repositioned outlet connected into the original outfall to the Wairoa Stream. 'Sludge-bugs' were introduced into the system for the purpose of microbial sludge digestion in September 2013 and this was completed by December 2014 with more than 5000 cubic metres of sludge removed (STDC, 2015). Inlet flow monitoring was added in 2010. Mechanical screening of the incoming wastes was installed at the inlet during the latter half of the 2012-2013 period, which has associated telemetry alarming.

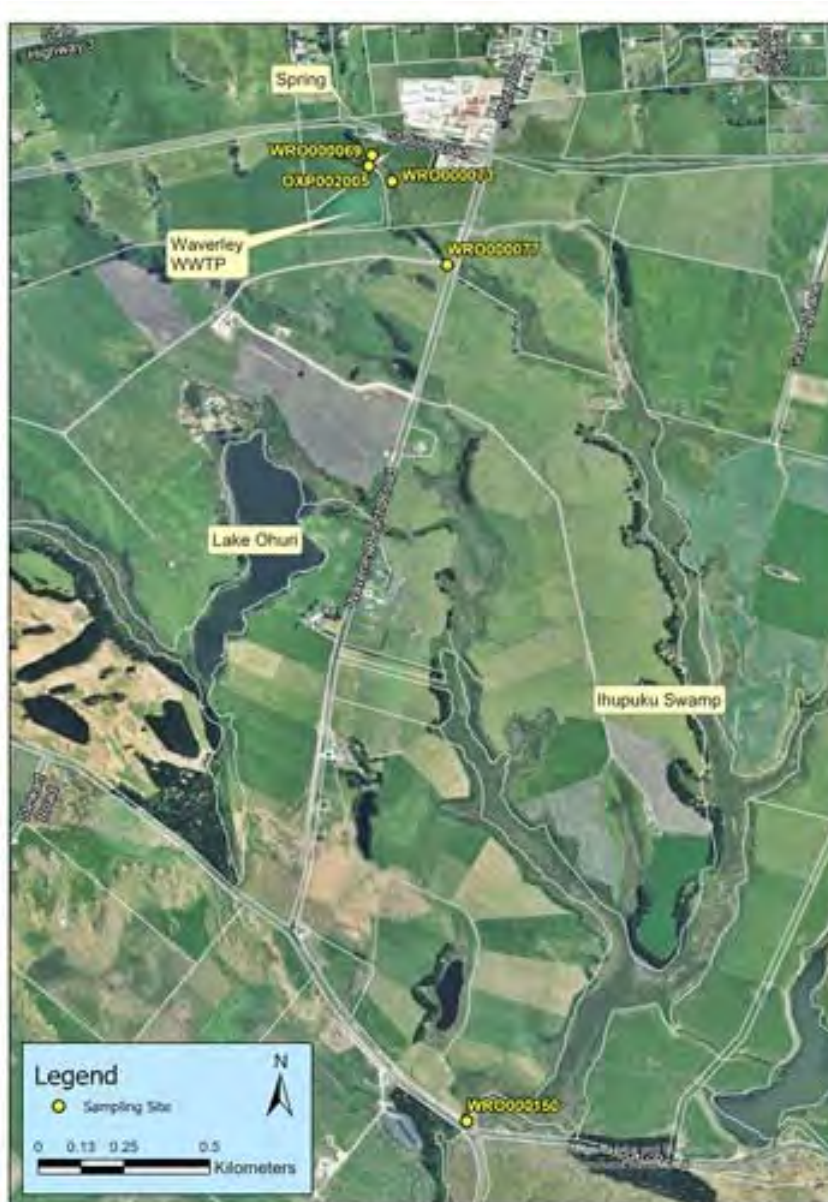
Figure 6 Aerial location map of sampling sites in relation to Waverley WWTP

Monitoring of the impacts of the Waverley WWTP on the receiving waters was measured using chemical analyses of the receiving waters of the unnamed tributary of the Wairoa Stream. Sampling was carried out on one occasion during the summer period, when stream flows were at a seasonal low. The locations of sampling sites are listed in Table 30 and displayed in Figure 6 below.
