Wai-iti Beach Retreat

Monitoring Programme

Annual Report

2020-2021

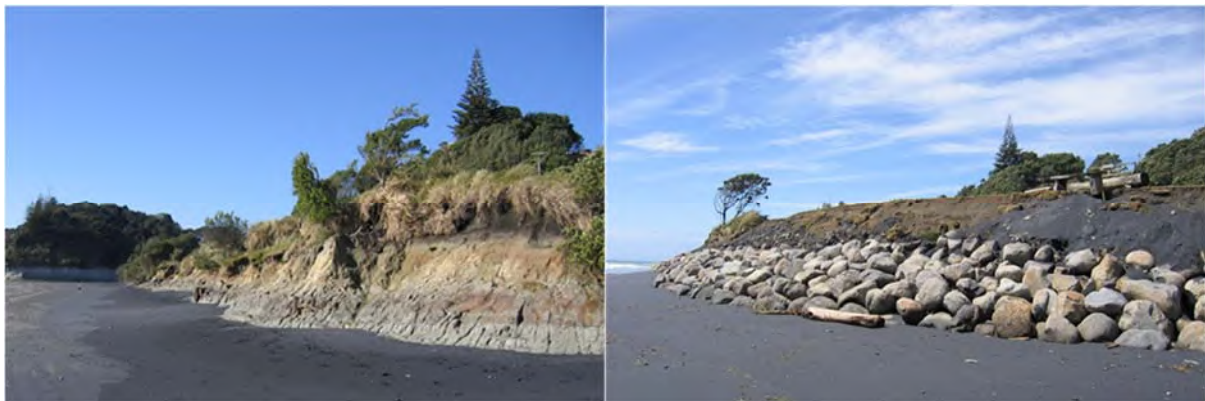
Photo 2 a) Erosion on Wai-iti foreshore prior to construction of the rock wall and b) rock wall facing north from stream (Nov 2005)

Over the summer and autumn months of 2004, rough seas combined with high tides reached the beach toe of the coastal banks and sand dunes that front the Wai-iti Beach Retreat. Fresh erosion scarps were cut into these banks for nearly the full beach frontage, where no system of protection previously existed (Photo 2a).

In 2005 an application was received for a resource consent to provide boulder rip rap protection, over a total distance of 293 m, from the stream at the south end of Wai-iti Beach to an area of existing large boulder protection in the north. This consent was granted in July 2005. To mitigate any possible end effects, the area between the public entrance and the river was also protected using the boulder rip rap method.

The rock wall looked to be in good condition with no scouring noted.

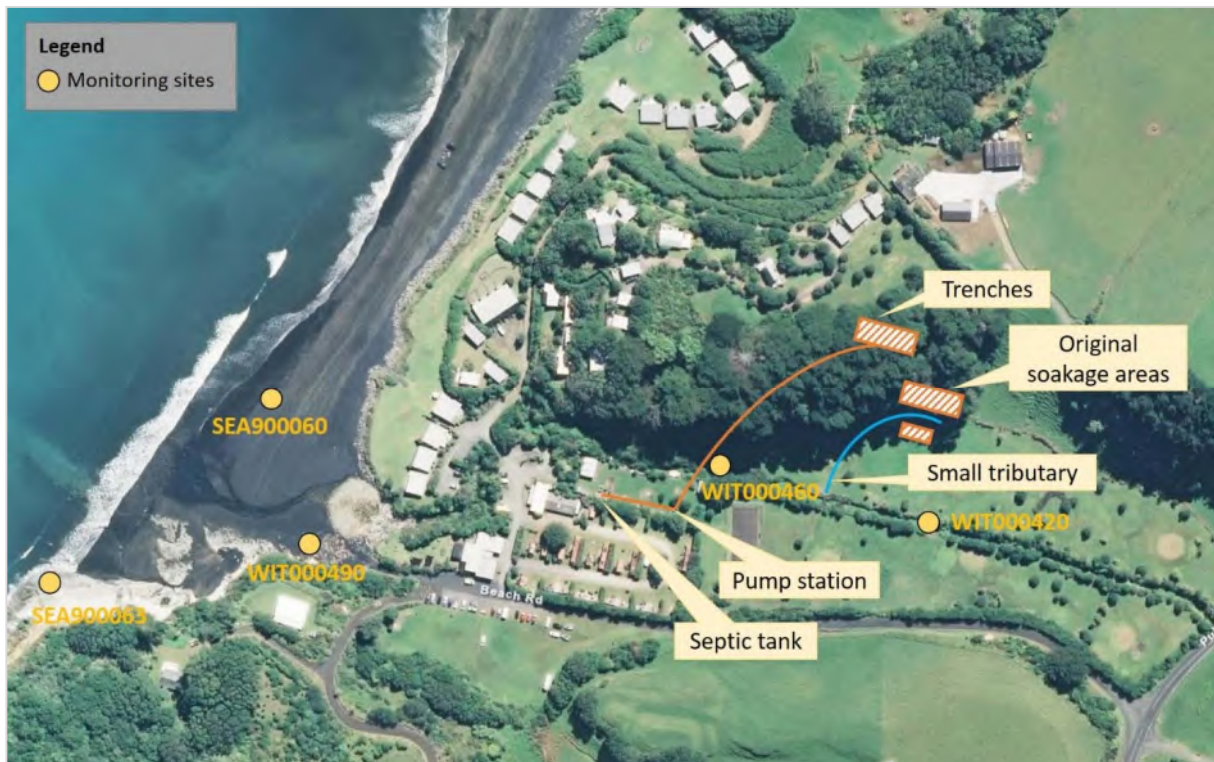
Figure 1 Locations of wastewater treatment system and sampling sites at the Wai-iti Beach Retreat

All wastewaters from the camping ground enter a septic tank of 143 m³ capacity. The effluent is then pumped via a 50 mm alkathene pipe across the Wai-iti Stream and into soakage trenches situated on a wooded hillside approximately 30 m from the stream.

Site location	Site code	GPS coordinates (NZTM)
Wai-iti Stream upstream of the Retreat	WIT000420	1727999-5690544
Wai-iti Stream approx. 10 m d/s of tributary	WIT000460	1727896-5690572
Wai-iti Stream adjacent beach entrance	WIT000490	1727686-5690533
Sea coast approx. 75 m north of stream mouth	SEA900060	1727667-5690609
Sea coast approx. 30 m south of stream mouth	SEA900063	1727555-5690516

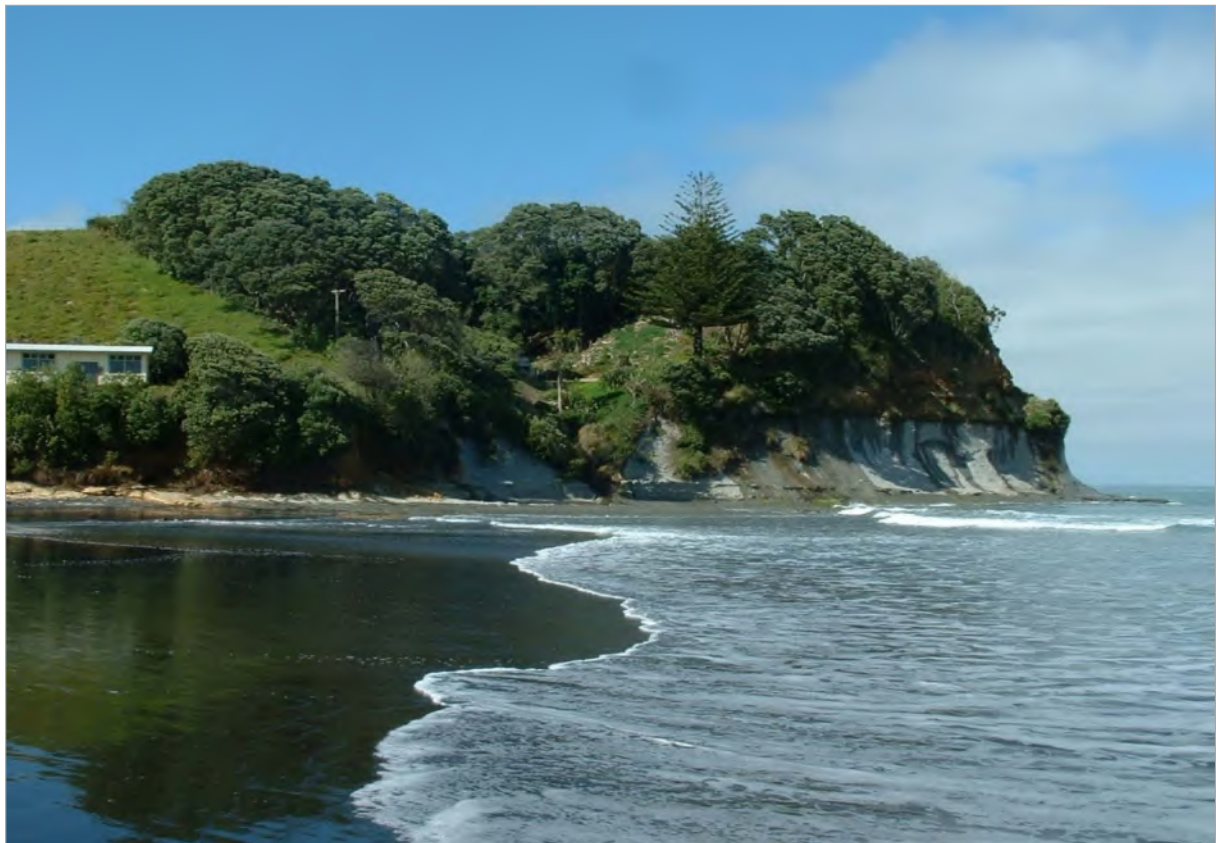
Photo 3 Wai-iti Beach, looking from site SEA900060 towards SEA900063, with the Wai-iti Stream entering from center-left

freshwater sites were all lower than historical medians. The enterococci count for the coastal site 75 m north of the stream was also found to be lower than its historical median.
