McKechnie Aluminium Solutions Ltd
Monitoring Programme
Annual Report
2018-2019

Technical Report 2019-12

Taranaki Regional Council
Private Bag 713
STRATFORD
March 2020

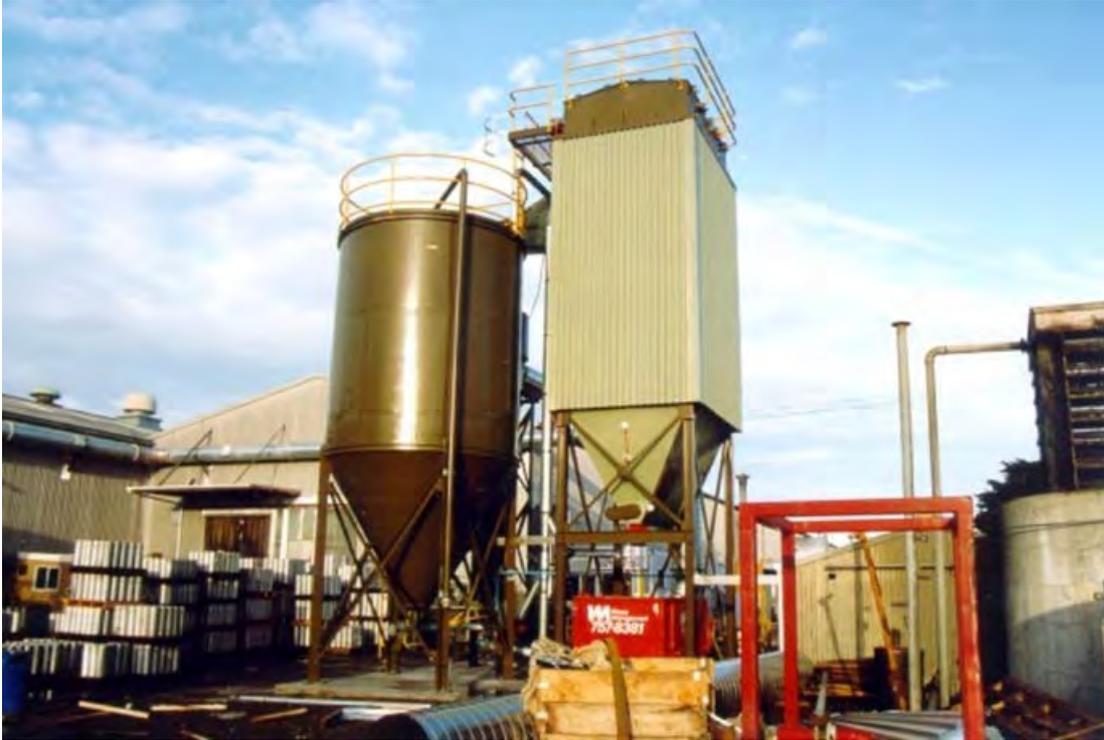
exhaust gases directly to the stacks if the incoming gases exceed the limits set. This avoids the superheated gases damaging the baghouse or its components. This type of discharge is still subject to conditions 1 and 2 of consent 4034-3, which require the consent holder to adopt the 'best practicable option' to minimise adverse effects upon the receiving environment from the discharges.

Photo 1 MASL baghouse

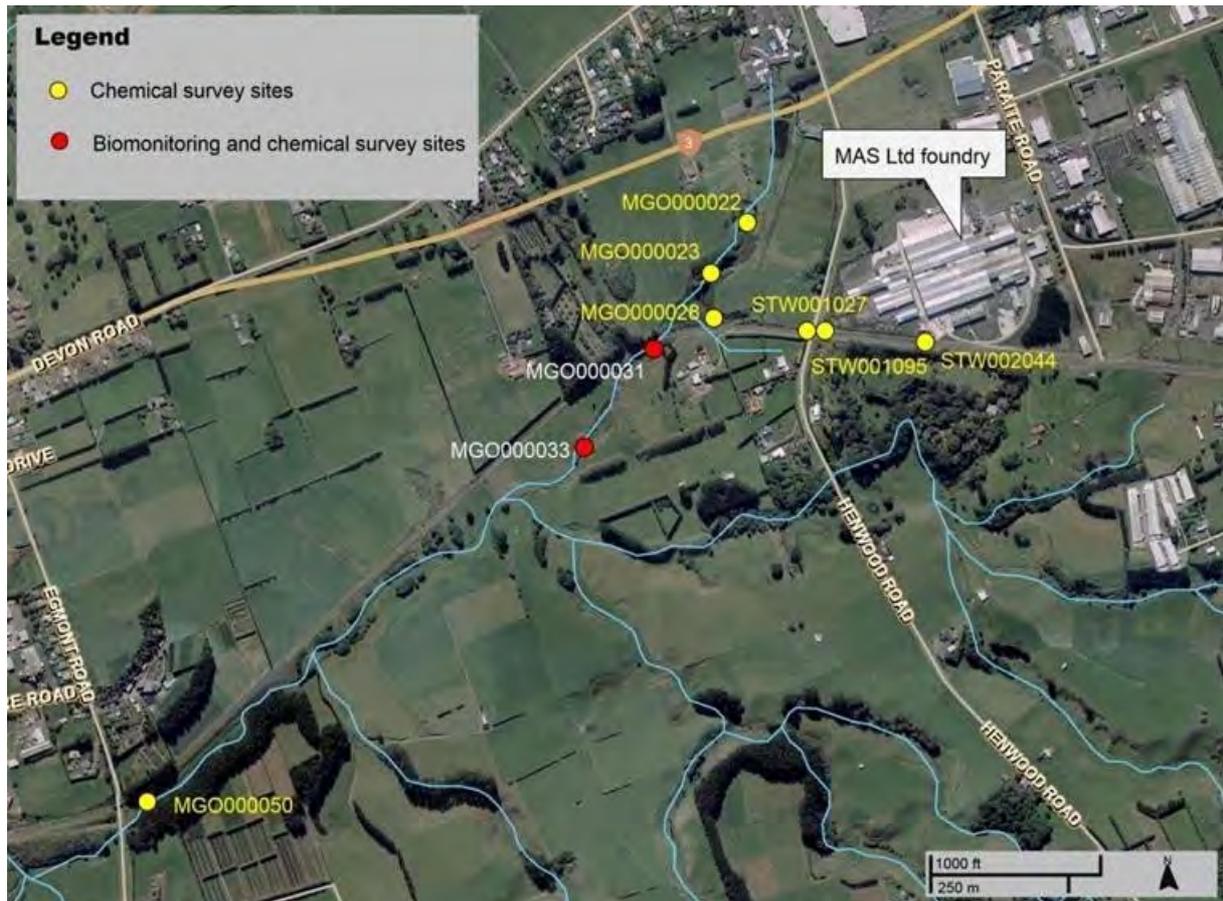
Figure 2 Location of the MASL plant in Bell Block and related water quality monitoring sites

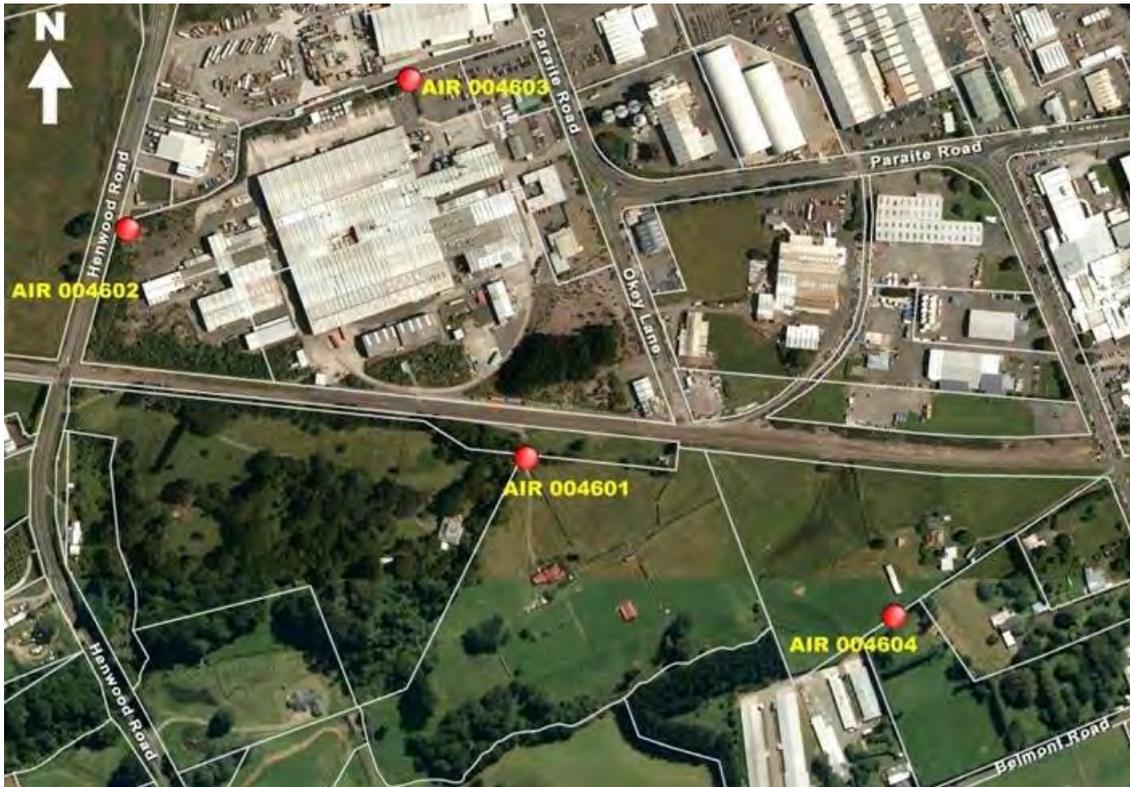
In the 2018-2019 period, gauges were deployed on one occasion at four locations in the vicinity of the foundry site for a period of 21 days from 6 to 27 March 2019. The locations of the monitoring sites around the foundry are shown in Figure 5.

Figure 5 Locations of dust deposition monitoring sites in relation to the MASL site
