McKechnie Aluminium Solutions Ltd
Monitoring Programme
Annual Report
2019-2020

Technical Report 2020-43

Taranaki Regional Council
Private Bag 713
STRATFORD
November 2020

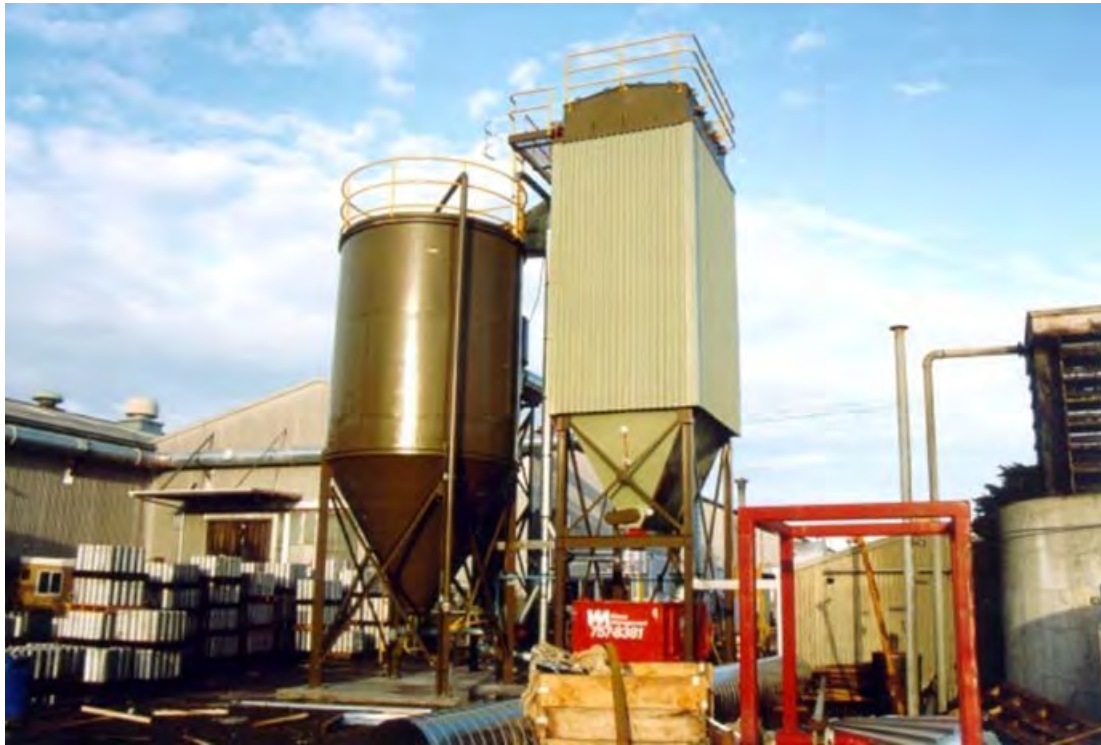
During past (historical) monitoring periods, there were frequent, but intermittent, plume discharges from the various sources to air. These varied in their impact offsite, depending on processing and weather conditions at the time of emission. Fugitive emissions have not been noted from vents on the aluminium building roof in recent monitoring periods. The baghouse controls have pre-set temperature limits, which

will divert the exhaust gases directly to the stacks if the incoming gases exceed the limits set. This avoids the superheated gases damaging the baghouse or its components. This type of discharge is still subject to conditions 1 and 2 of consent 4034-3, which require the consent holder to adopt the 'best practicable option' to minimise adverse effects upon the receiving environment from the discharges.

Photo 1 MASL baghouse

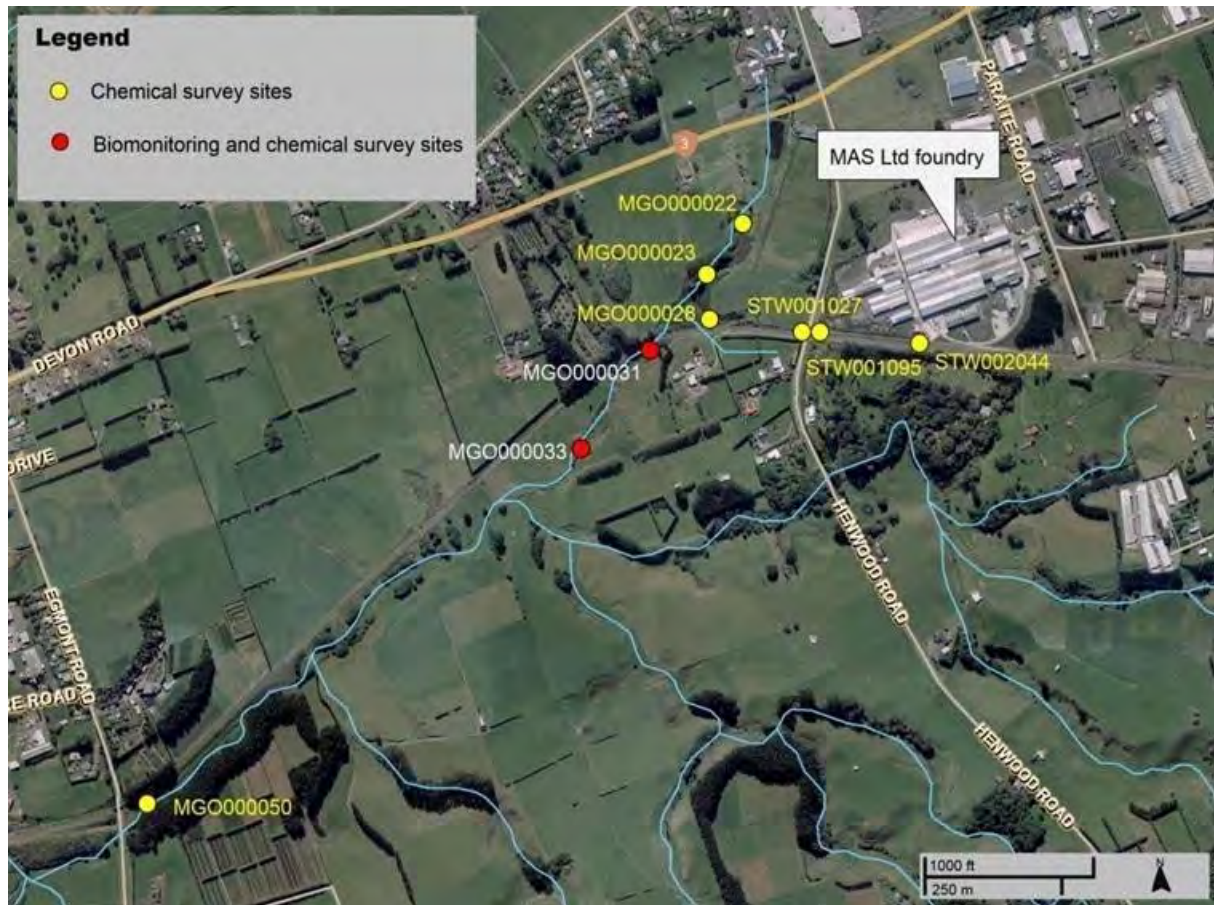
Figure 2 Location of the MASL plant in Bell Block and related water quality monitoring sites

Samples were taken by the Council from several permanent sampling points in dry conditions on 22 May 2020, and under wet weather conditions on 5 June 2020. The results are presented in Table 2.

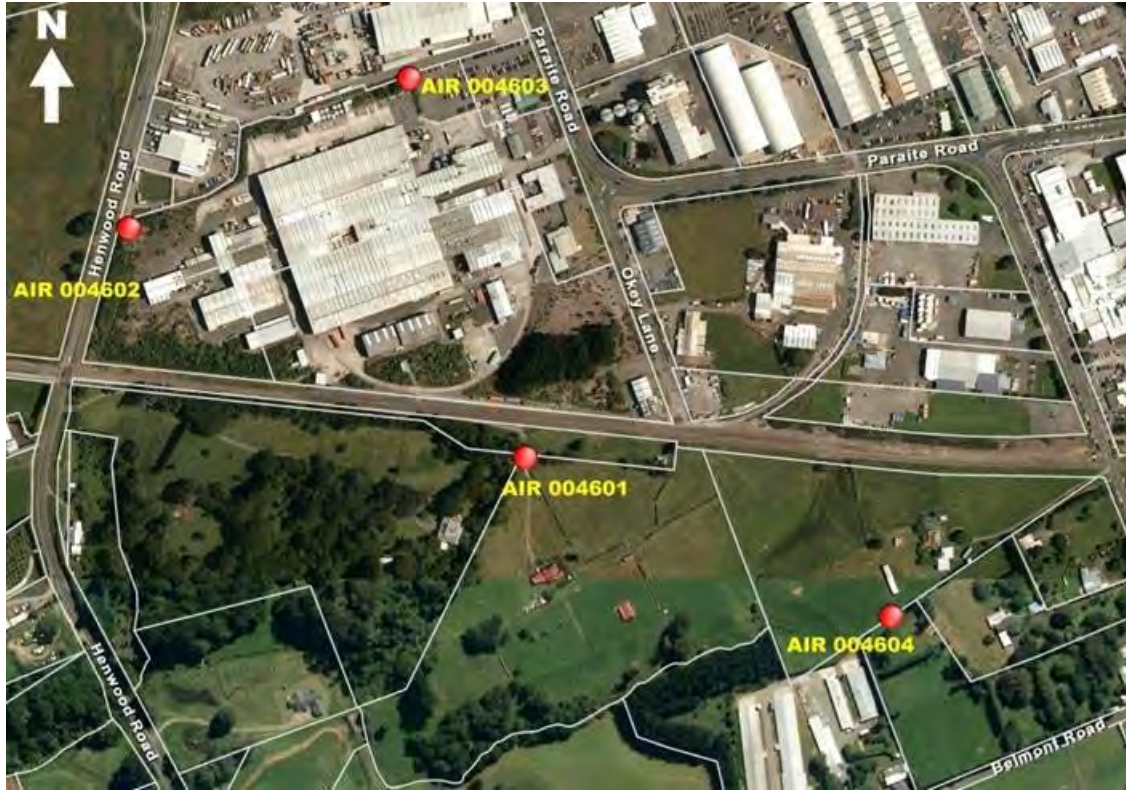
In the 2019–2020 period, gauges were deployed on one occasion at four locations in the vicinity of the foundry site for a period of 20 days from 24 January to 13 February 2020. The locations of the monitoring sites around the foundry are shown in Figure 5.

Figure 5 Locations of dust deposition monitoring sites in relation to the MASL site

The rates of particulate deposition were below the 130 mg/m²/day guideline value and complied with the MASL consent condition for depositions at the three sites surveyed beyond the property boundary. At 290 mg/m²/day, the particulate level at site AIR004603, within the MASL facilities, was well above the median of previous samples and well above the guideline value. This was not a breach of consent conditions as AIR004603 is within the site boundary. There was also likely to be a significant contribution of particulates from the heavy transport depot immediately to the north of this site.
