Taranaki Galvanizers Ltd
Monitoring Programme
Annual Report
2019-2020

Technical Report 2020-49

Taranaki Regional Council
Private Bag 713
STRATFORD
September 2020

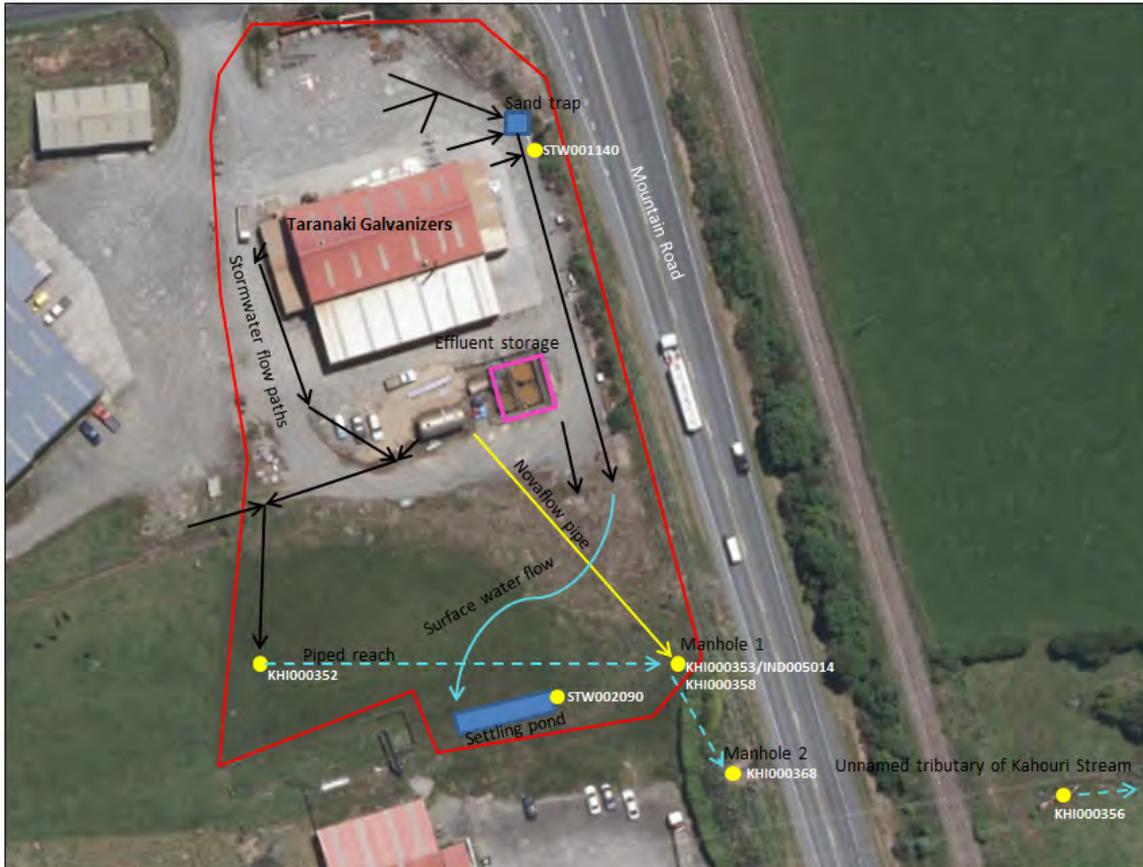
Figure 1 Taranaki Galvanizers site layout

The galvanising plant owned and operated by the Company is situated at the corner of State Highway 3 and Monmouth Road, approximately 1 km north of Stratford (Figure 1). Road access to the site is via Monmouth Road.

Stormwater from the southern side of the site either flows overland to a grated manhole (manhole 1 in Figure 1) on the south-eastern corner of the site or via a nova flow pipe that then discharges into this same manhole. The novaflow pipe conveys both site stormwater and some groundwater seepage from the southern end of the site and is therefore referred to as an industrial discharge as opposed to only a stormwater discharge. The piped unnamed tributary enters manhole 1 immediately above the point of discharge from the industrial discharge novaflow pipe (Photo 1).

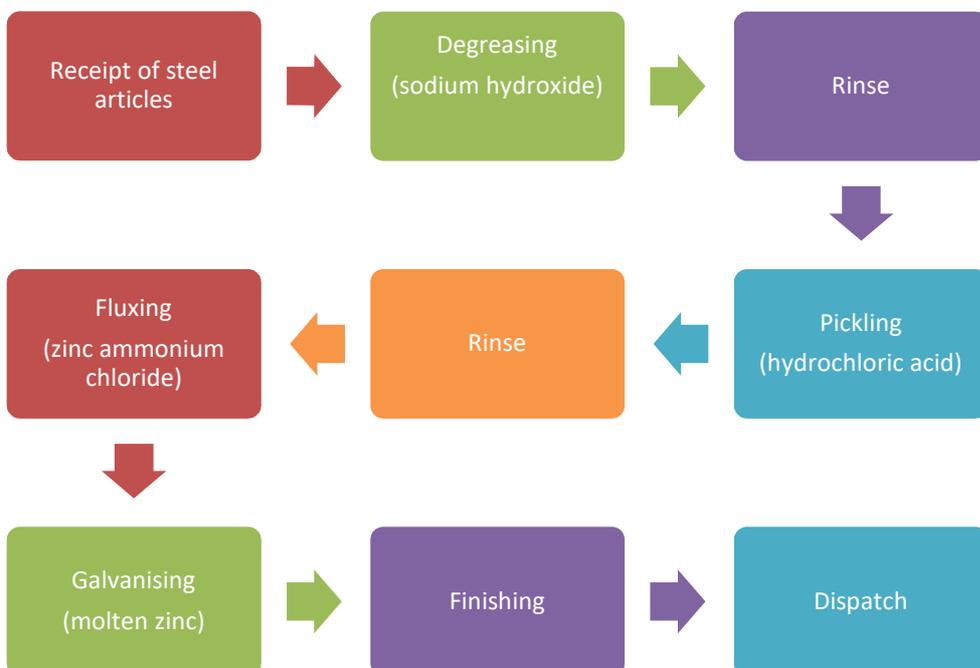
Figure 2 Hot-dip galvanising process undertaken at Taranaki Galvanizers

The Company utilise a hot-dip galvanising process which protects steel from corrosion by providing a thick, tough metallic zinc alloy coating. The process consists of various stages of preparation and treatment prior to completion of the process. A brief description of the process is given in Figure 2.

Articles of steel to be galvanised are initially immersed in a hot sodium hydroxide degreasing or stripping bath to remove any oil or grease contaminants. Oils removed from the surface of the steel remain on the

The next stage of the process involves the removal of mill scale, rust, paint and other oxides from the article being galvanised by 'pickling', or acid treatment, in hydrochloric acid. Again, the article is rinsed in water to remove any excess acid and to minimise the amount of acid carried over to the next stage in the process.

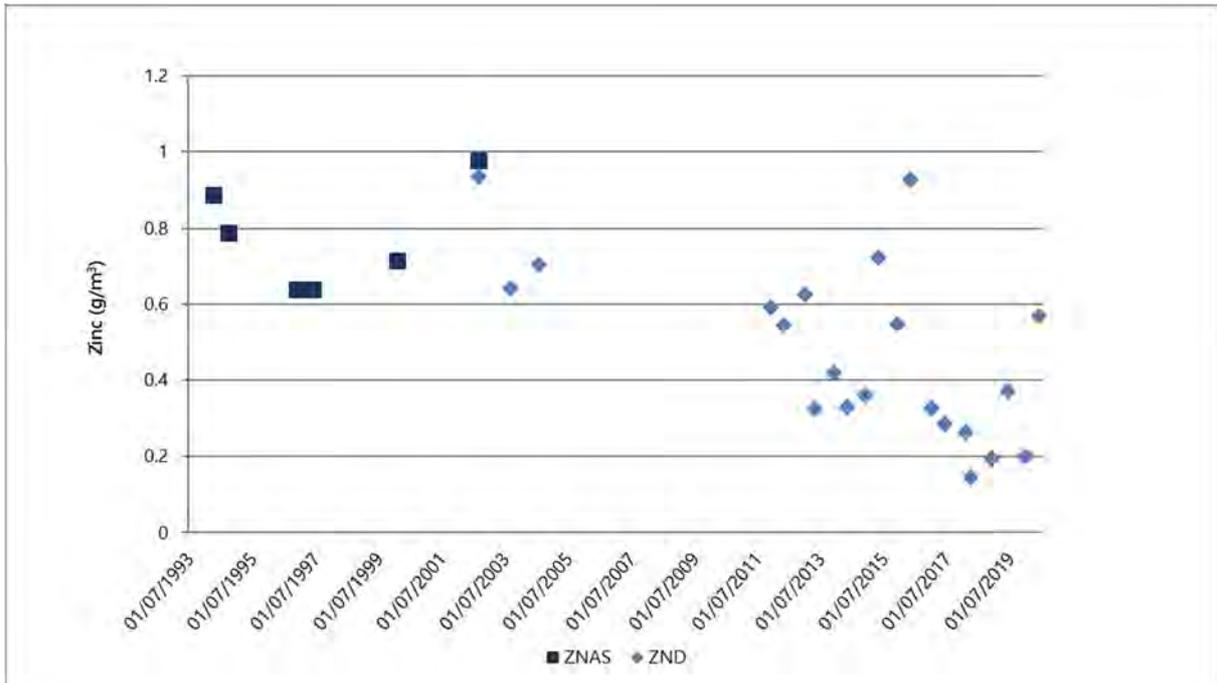
Figure 3 Zinc concentrations in the unnamed tributary of the Kahouri Stream immediately upstream of the Company's industrial discharge since 1994 (site KHI000353)

The Australian and New Zealand Guidelines for Fresh and Marine Water Quality (ANZECC, 2000) propose that for protection of 95% of species (the default value for ecological protection), zinc in fresh water should be less than 0.008 g/m^3 (at a hardness $30 \text{ g/m}^3 \text{ CaCO}_3$). For protection of 80% of species (the lowest level of ecological protection in the guideline), zinc in freshwater should be less than 0.031 g/m^3 . These numbers refer to chronic (on-going) exposure. Zinc concentrations recorded upstream of the Company's site by the two surveys were indicative of zinc contamination (Table 3). Elevated amounts of zinc across the two upstream sites highlights that the contaminated bore is likely to be still having an effect on water quality at the site. Sampling undertaken in the reported period, at site upstream 2 (KHI000353) showed that the latest concentrations of dissolved zinc (0.199 g/m^3 and 0.54 g/m^3) were slightly below the median of historical dissolved zinc concentrations (0.57 g/m^3) (Figure 3).

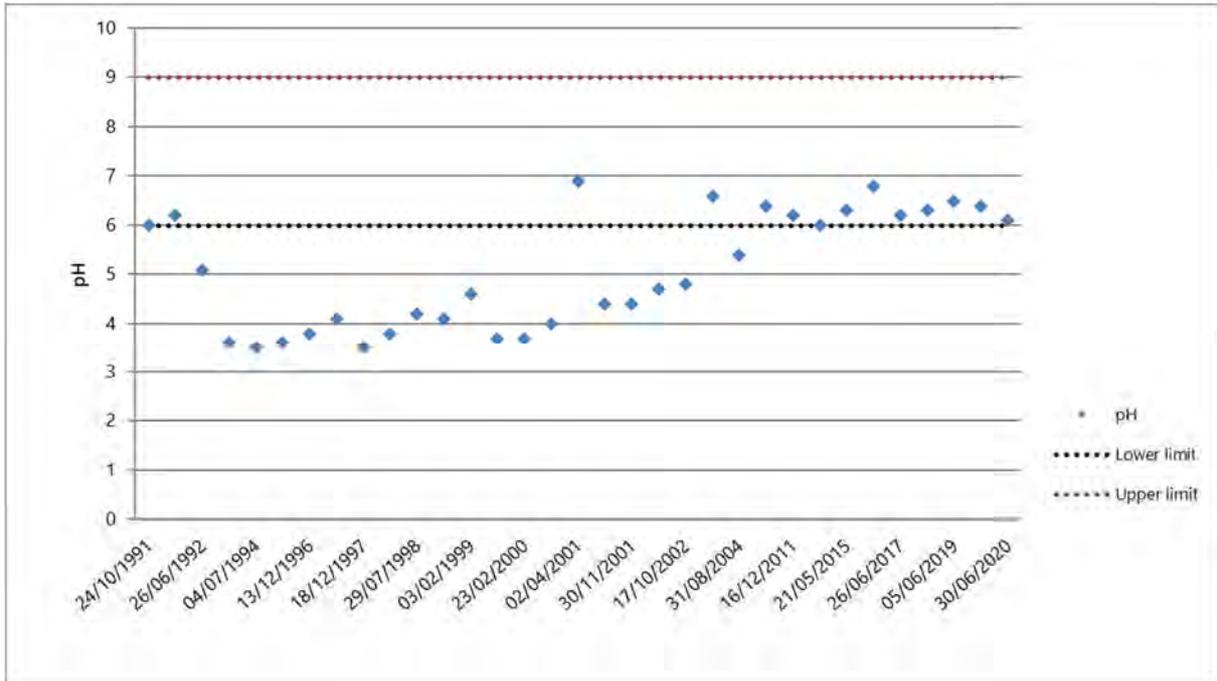
Figure 4 pH levels recorded in the discharge (IND005014) from the Company's site between October 1991 and June 2020

Special condition 4 of consent 4657-2 has specified limits on certain constituents of the discharges including; pH, hydrocarbons, suspended solids and zinc. Although historical discharges do not relate to this consent, these conditions can be a useful guide, to which comparisons can be made. Previous sampling records have shown that pH levels have increased markedly since the 1990's to within the lower end of the consented pH range in the last few years (Figure 4).

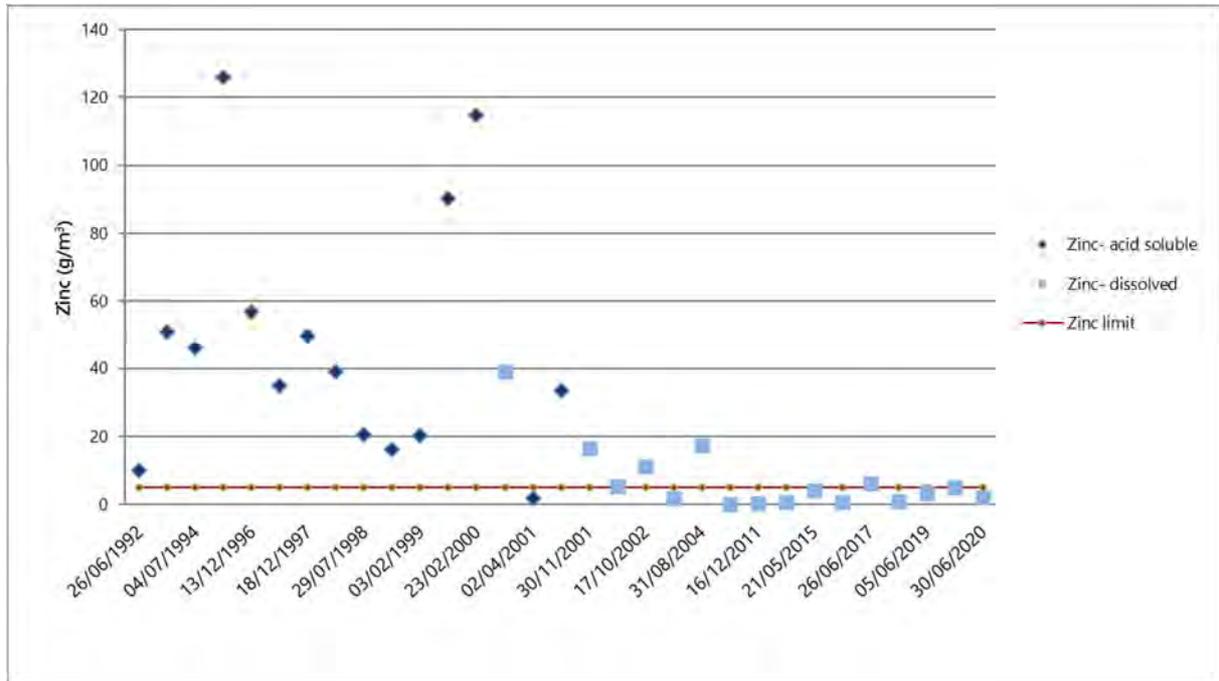
Figure 5 Zinc concentrations recorded in the discharge sample (IND005014) from the Company's site between June 1992 and June 2020

Dissolved zinc concentrations have decreased considerably over the last 12 years. However, the dissolved zinc result of 5.2 g/m³ recorded 17 June 2020, exceeded the consent limit by 0.2 g/m³, and had increased by 1.9 g/m³ since the previous sampling occasion (Figure 5). The historical disposal of galvanising waste materials into a bore on the Company's site is considered to be the most likely source of zinc contamination in this discharge; although zinc contamination in the stormwater discharge may have also contributed to this result. Additional follow-up sampling on 30 June 2020 showed dissolved zinc concentrations had returned to within the consented limit (2.3 g/m³).

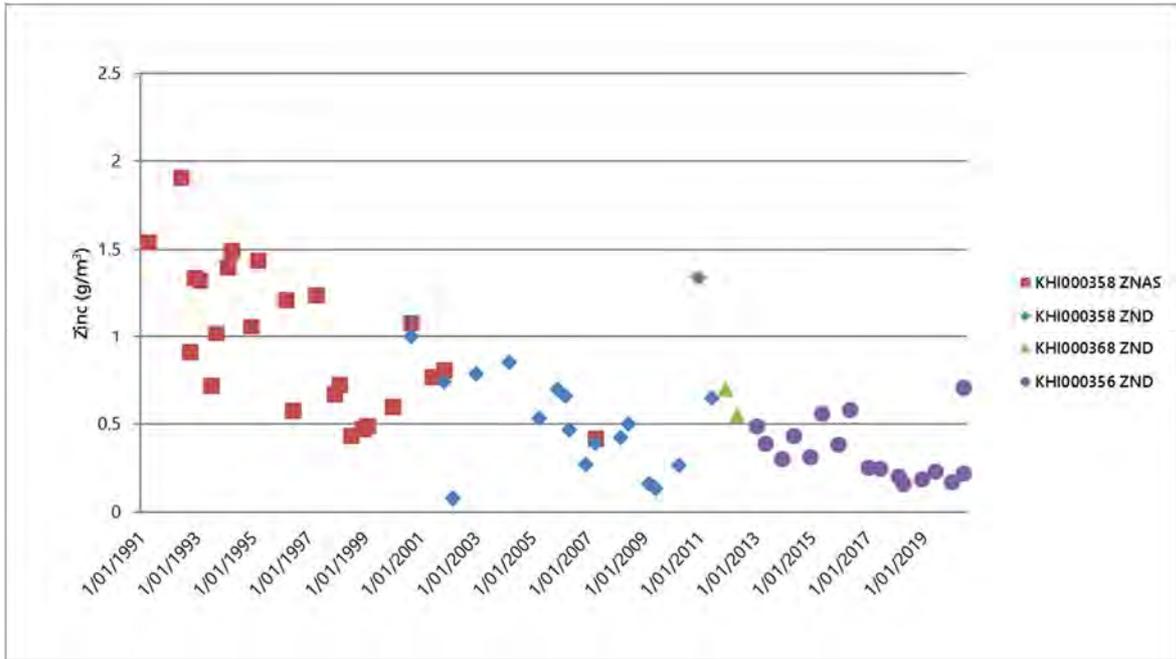
Figure 6 Zinc concentrations in the unnamed tributary of the Kahouri Stream downstream of the Taranaki Galvanizers industrial discharge since 1991

Results for the surveys carried out on 15 January 2020, 17 June 2020 and 30 June 2020 are presented above in Table 3 and below in Figure 6 and Figure 7.

Monitoring of the unnamed tributary of the Kahouri Stream has shown that zinc concentrations decreased through the 1990's, then remained relatively constant, varying between the detection limit of 0.005 g/m³ and 1 g/m³(Figure 6). Sampling at downstream site (KHI000356), on 17 June 2020 recorded a zinc concentration of 0.71 g/m³ which was the highest concentration recorded since 2010. However, repeat sampling on 30 June 2020 recorded a zinc concentration of 0.22 g/m, a result more typical of what has been recorded in recent years, and below the median zinc concentration for the site. Generally zinc concentrations have decreased over time, but it is considered likely that it will take some years before concentrations in the tributary are reduced significantly, due to the level of contamination (from the bore) under the Company's site.

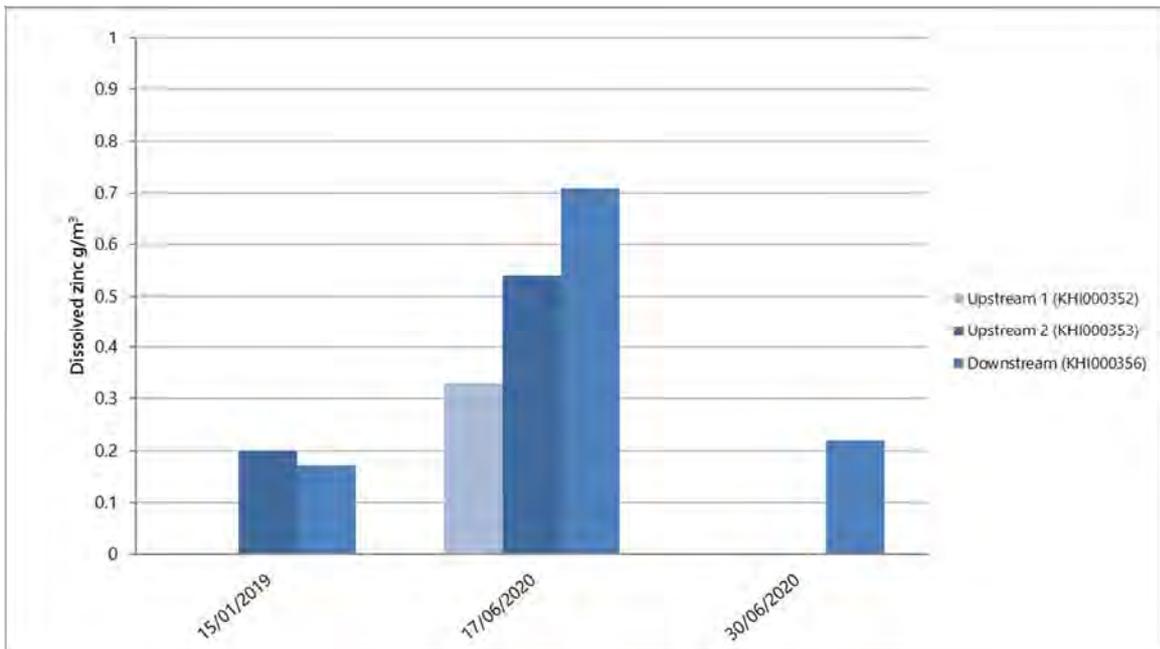
Figure 7 Dissolved zinc concentrations in the unnamed tributary of the Kahouri Stream upstream and downstream of the site

The results of the 15 January 2020 survey showed a decrease in zinc concentration of approximately 0.028 g/m³ between upstream site 2 (KHI000353) (0.199 g/m³) and the receiving waters site (KHI000356)(0.171 g/m³)(Figure 7).The results of the 17 June 2020 survey showed an increase in zinc concentration of approximately 0.21 g/m³ between upstream site 1 (KHI000352)(0.33 g/m³), and upstream site 2 (KHI000353)(0.54 g/m³), and a further increase of approximately 0.17 g/m³ between upstream site 2 and the receiving waters (KHI000356) (0.71 g/m³)(Figure 7). Seepage from the contaminated bore under the Company’s site is the most likely source of the contamination recorded upstream, while zinc contamination of the industrial and stormwater discharge have contributed to the elevated results recorded downstream.
