# McKechnie Aluminium Solutions Ltd

Monitoring Programme

Annual Report

Technical Report 2022-90

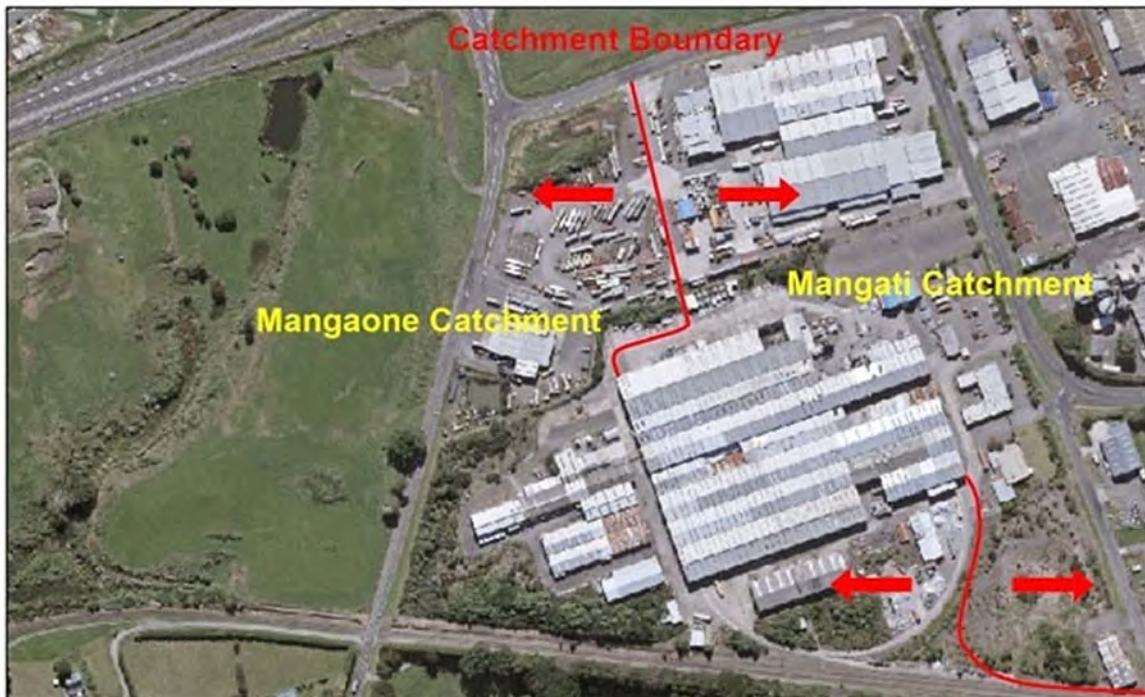
Figure 1 MASL foundry site, showing the boundary between Mangaone and Mangati Stream catchments

The MASL manufacturing plant extends across the boundary between two stormwater catchments (Figure 1). Drainage from the western side (3.9 ha) is to the eastern headwaters ('East Arm') of the Mangaone Stream, about four kilometres from where the stream enters the Waiwhakaiho River. Drainage from the eastern side (4.9 ha) is to the Mangati Stream. There are separate consents for stormwater discharges to the two catchments. This report relates to the western stormwater discharge. The eastern stormwater discharge, consent 3139, is monitored under the Mangati Stream Catchment Monitoring Programme.

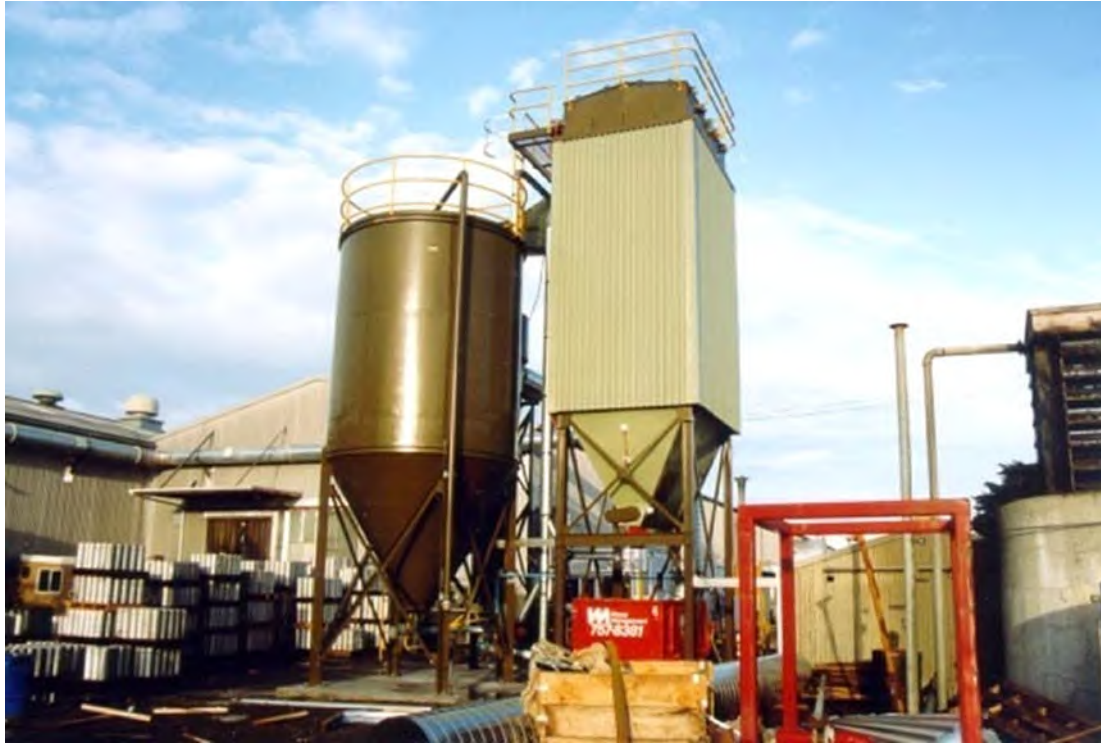
Photo 1 MASL baghouse

Discharges to air from the powdercoating facility are monitored under the foundry site consent. The potential effects from powdercoating are emissions of powder and odours into the air from the process. If solvents are used in the process there is also potential for air emissions to contain a toxic component. These effects can all be avoided by use of appropriate technology; in this case an exhaust fan followed by a baghouse. This technology is simple, robust and effective.

conditions at the time of emission. Fugitive emissions have not been noted from vents on the aluminium building roof in several years. The baghouse controls have pre-set temperature limits, which will divert the exhaust gases directly to the stacks if the incoming gases exceed the limits set. This avoids the superheated gases damaging the baghouse or its components. This type of discharge is still subject to conditions 1 and 2 of consent 4034-3, which require the consent holder to adopt the 'best practicable option' to minimise adverse effects upon the receiving environment from the discharges.

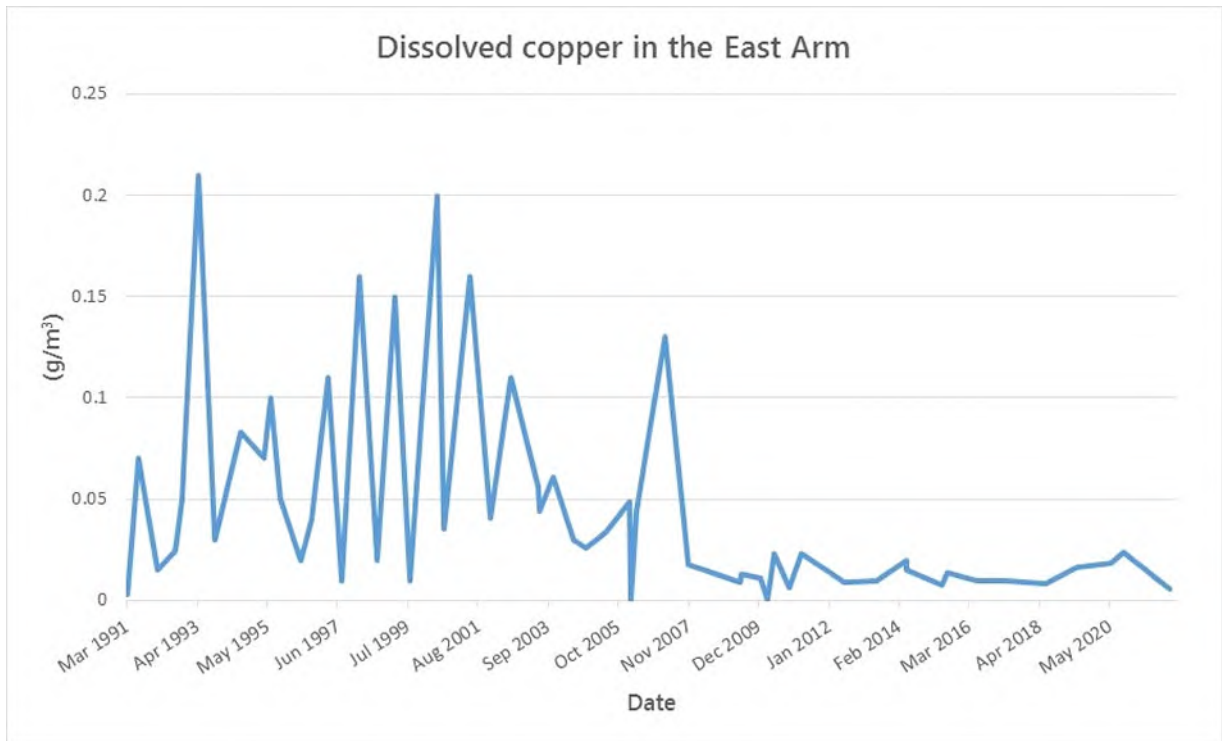
Figure 3 Levels of dissolved copper in the East Arm (site MGO000028)

Dry weather sampling runs are intended to determine long term trends in the quality of the receiving water. Historical metals concentration data available for dry weather runs was limited prior to the introduction of regular sampling at the start of the 1999-2000 monitoring period.

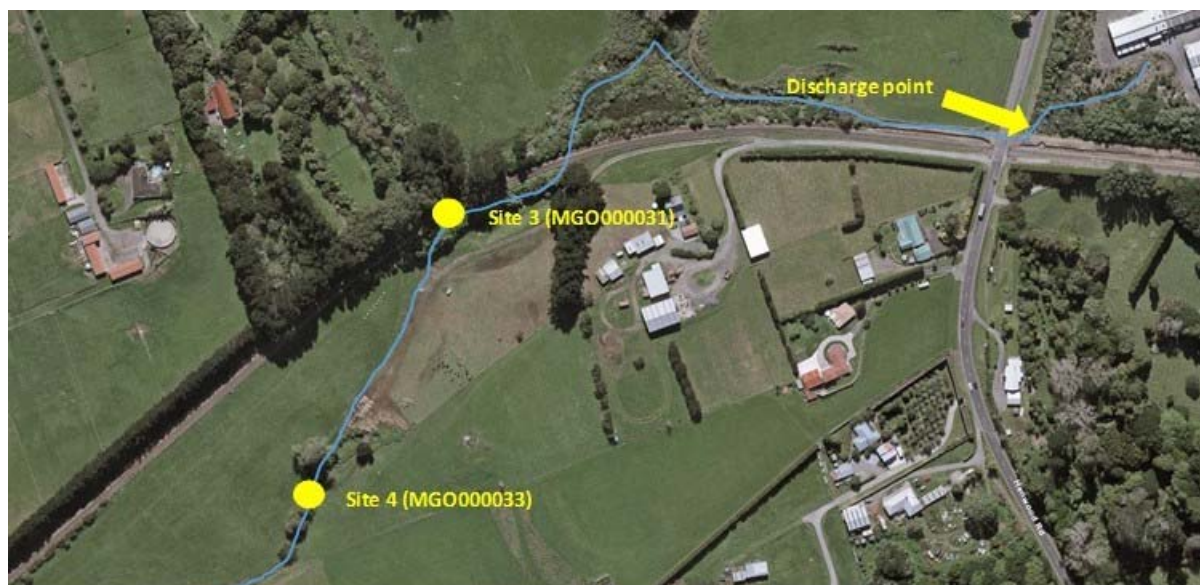
Figure 5 Biomonitoring sites in the Mangaone Stream in relation to the MASL stormwater discharge

The November survey found that the Mangaone Stream sites had low to moderate macroinvertebrate community richness (12-17 taxa). Taxa richness was lower than historical medians at both sites (by 3-4 taxa), but there was no indication of any recent acute toxic discharges affecting the macroinvertebrate community.

The April survey found that the Mangaone Stream sites had low macroinvertebrate community richness (10-13 taxa). Taxa richness was lower than the historical median at sites 4 (by seven taxa), but there was no indication of any recent acute toxic discharges affecting the macroinvertebrate community.

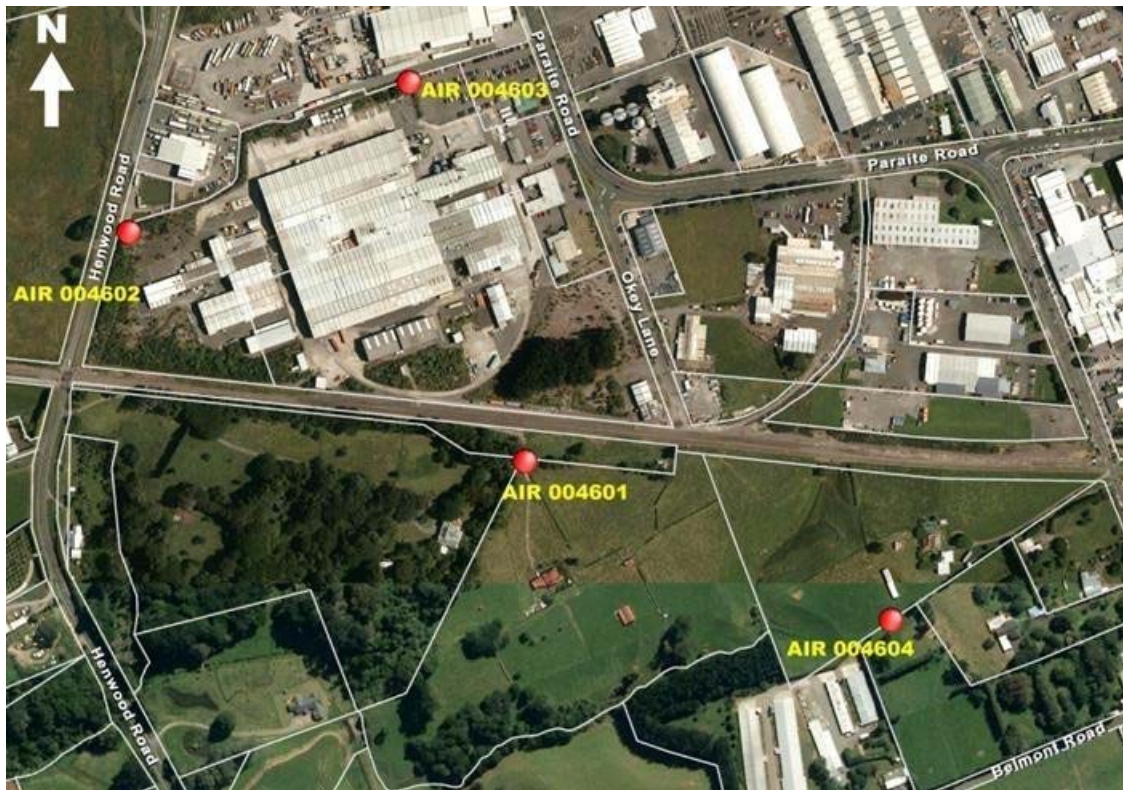
Figure 6 Locations of dust deposition monitoring sites in relation to the MASL site

In the 2021-2022 period, gauges were deployed on one occasion at four locations in the vicinity of the foundry site for a period of 21 days from 7 to 28 March 2022. The locations of the monitoring sites around the foundry are shown in Figure 6.
