# **McKechnie Aluminium Solutions Ltd**

## **Monitoring Programme**

### **Annual Report**

#### **Technical Report 2024-35**

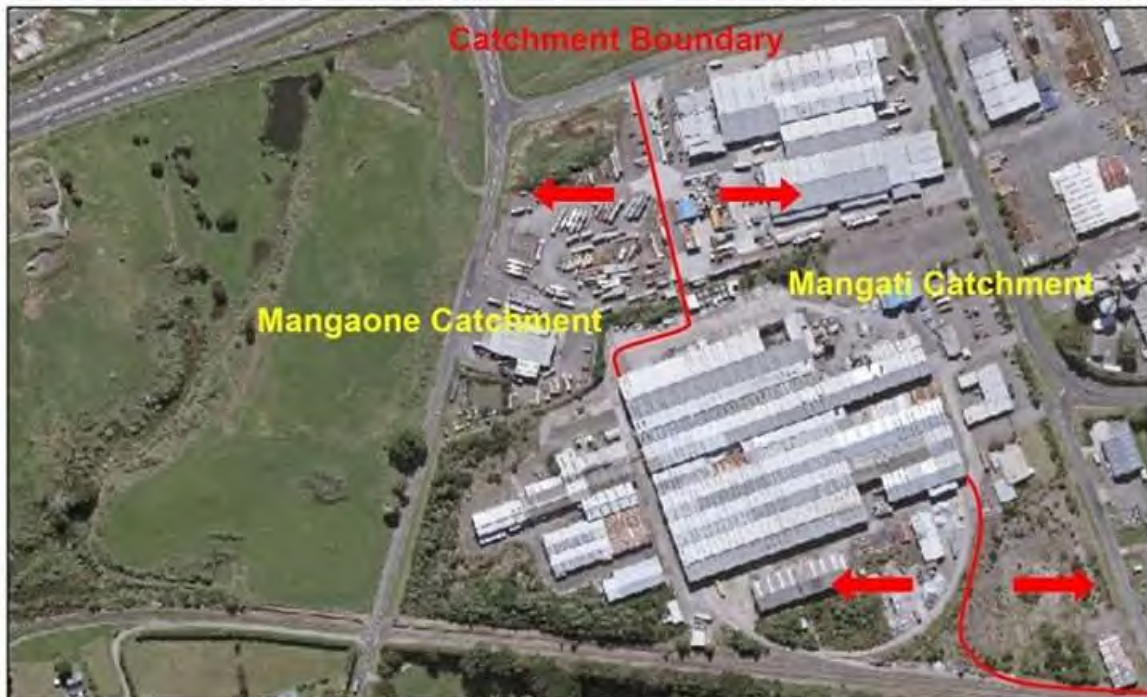
Figure 1 MASL foundry site, showing the boundary between Mangaone and Mangati Stream catchments

The MASL manufacturing plant extends across the boundary between two stormwater catchments (Figure 1). Drainage from the western side (3.9ha) is to the eastern headwaters ('East Arm') of the Mangaone Stream, about four kilometres from where the stream enters the Waiwhakaiho River. Drainage from the eastern side (4.9ha) is to the Mangati Stream. There are separate consents for stormwater discharges to the two catchments. This report relates to the western stormwater discharge. The eastern stormwater discharge, consent 3139, is monitored under the Mangati Stream Catchment Monitoring Programme.

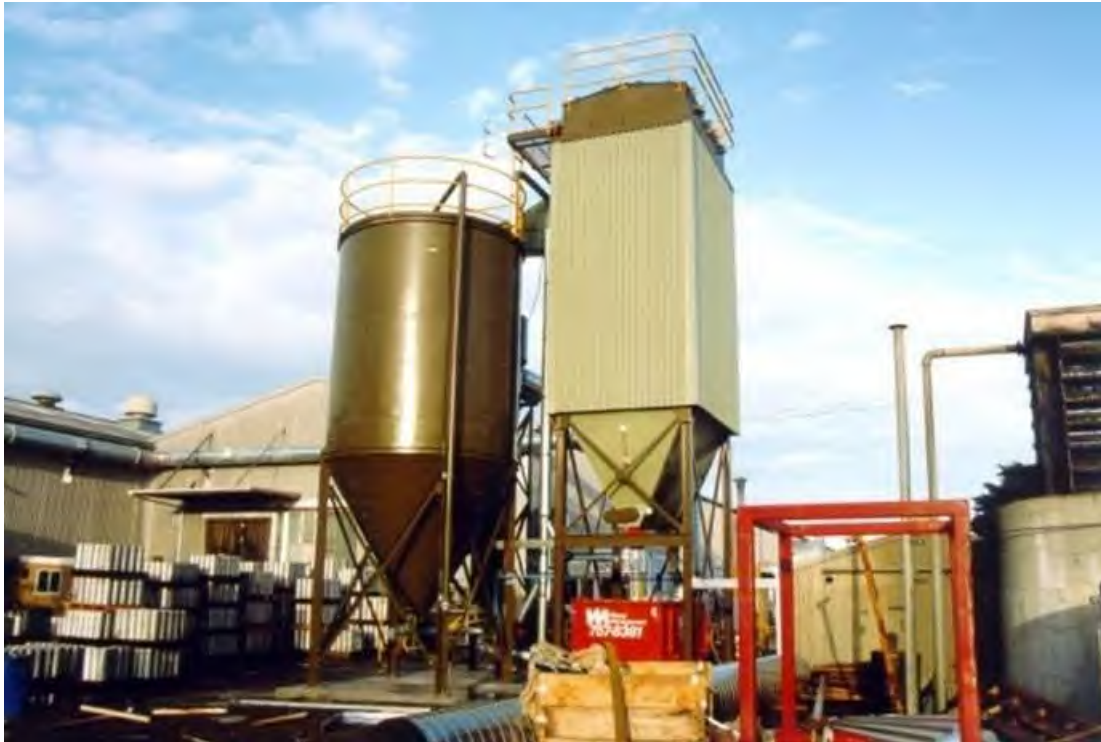
Photo 1 MASL baghouse

During past (historical) monitoring periods, there were frequent, but intermittent, plume discharges from the various sources to air. These varied in their impact offsite, depending on processing and weather conditions at the time of emission. Fugitive emissions have not been noted from vents on the aluminium building roof in several years. The baghouse controls have pre-set temperature limits, which will divert the

exhaust gases directly to the stacks if the incoming gases exceed the limits set. This avoids the superheated gases damaging the baghouse or its components. This type of discharge is still subject to conditions 1 and 2 of consent 4034-3, which require the consent holder to adopt the 'best practicable option' to minimise adverse effects upon the receiving environment from the discharges.

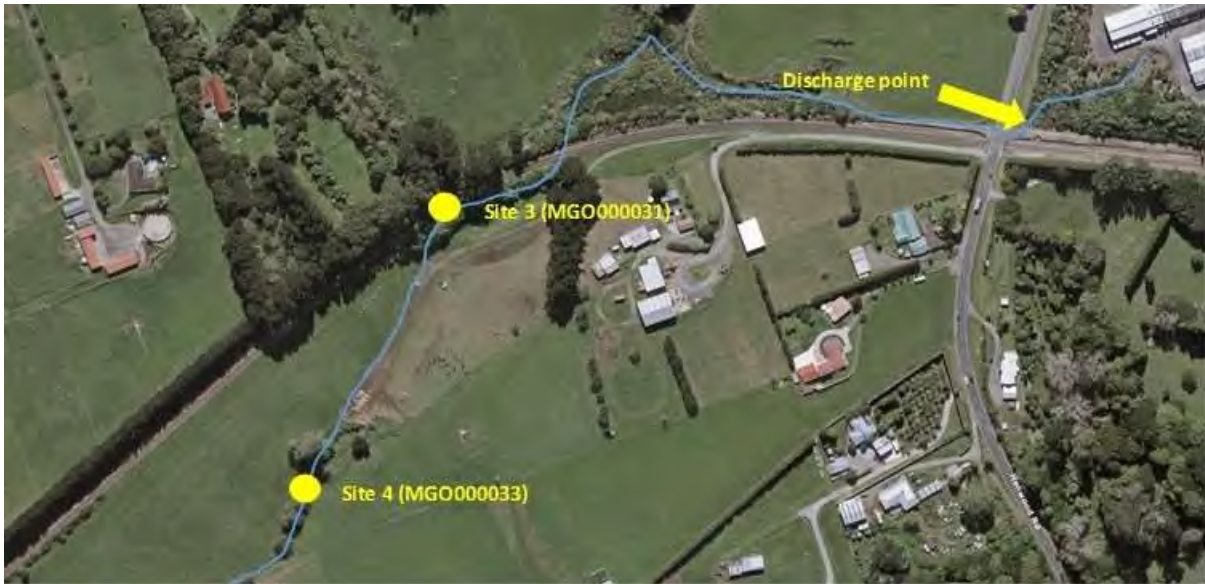
Figure 5 Biomonitoring sites in the Mangaone Stream in relation to the MASL stormwater discharge

The December survey found that the Mangaone Stream sites had a low to moderate macroinvertebrate community richness (13-20 taxa). Taxa richness was three taxa lower than historical medians at site 3, but 2 taxa more than historical medians at site 4.

The February survey found that the Mangaone Stream sites had low to moderate macroinvertebrate community richness (13-16 taxa). Taxa richness was lower than the historical median at both sites. There were four and three pollution sensitive EPT taxa (mayflies, caddisflies and stoneflies) recorded at site 3 and site 4 respectively.

score differences could be attributed to the habitat differences between sites. It is recommended that the sites be reviewed to try and find sites of similar characteristics to enable better comparison.

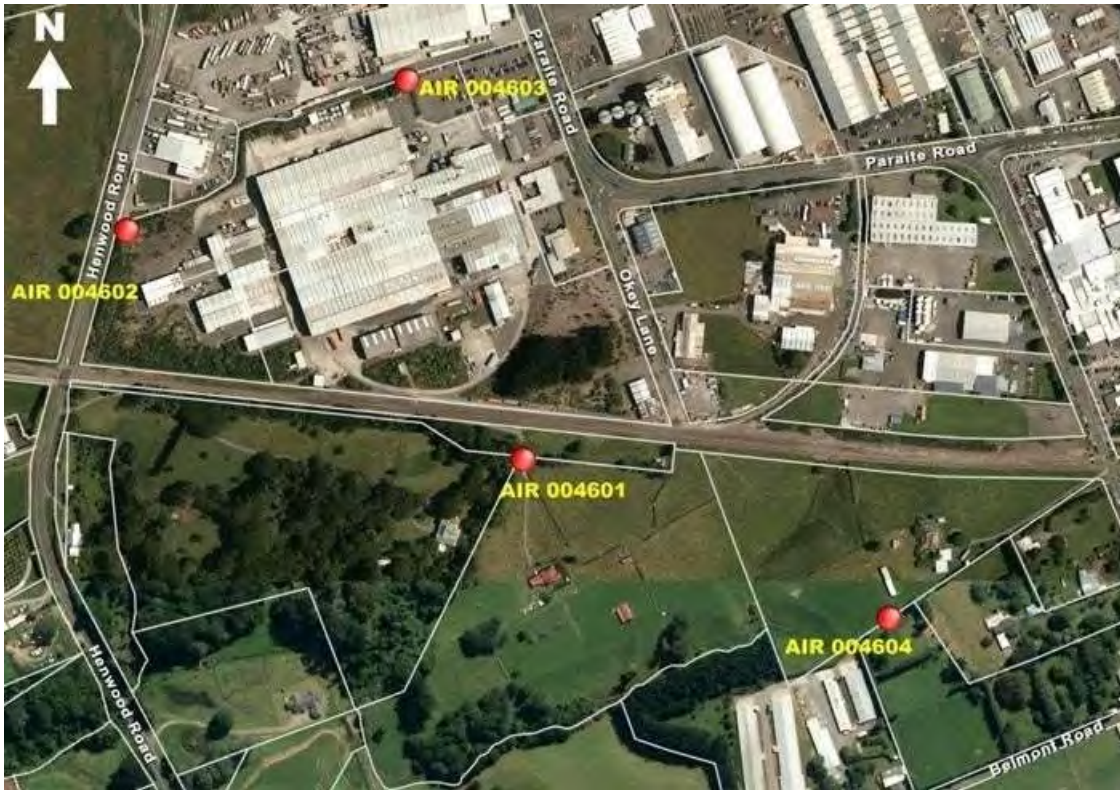
Figure 6 Locations of dust deposition monitoring sites in relation to the MASL site

In the 2023/24 period, gauges were deployed on one occasion at four locations in the vicinity of the foundry site for a period of 21 days from 3 to 24 April 2024. The locations of the monitoring sites around the foundry are shown in Figure 6.

The rates of particulate deposition were lower than historical medians at all sites except for at AIR004601. During the April 2024 deposition rate deployment, site AIR004601 marginally breached the consent conditions of less than 0.13g/m<sup>2</sup>/day sitting at exactly 0.13g/m<sup>2</sup>/day. Due to allowances for margin of error and an absence of any complaints, no non-compliance was issued.
