McKechnie Aluminium Solutions Limited
Monitoring Programme
Annual Report
2012-2013

Technical Report 2013 - 91

March 2014

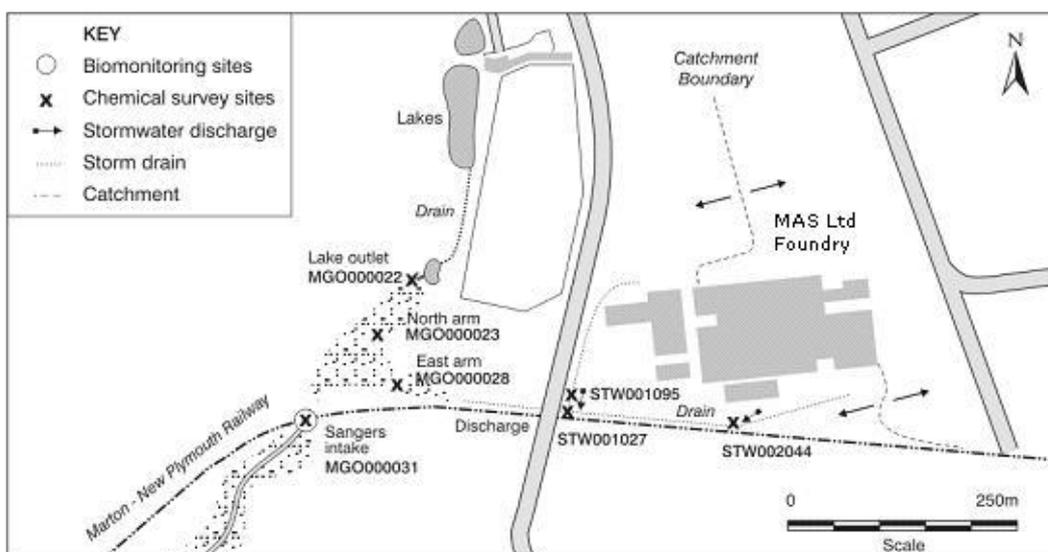
Figure 1 MAS Ltd foundry site, showing the boundary between Mangaone and Mangati stream catchments and water monitoring sites

The MAS Ltd manufacturing plant extends across the boundary between two stormwater catchments (Figure 1). Drainage from the western side (3.9 hectares) is to the eastern headwaters of the Mangaone Stream, about four kilometres from where the stream enters the Waiwhakaiho River. Drainage from the eastern side (4.9 hectares) is to the Mangati Stream. There are separate consents for stormwater discharges to the two catchments. This report relates to the western stormwater discharge. The eastern stormwater discharge, consent 3139, is monitored under the Mangati Stream Catchment Monitoring Programme.

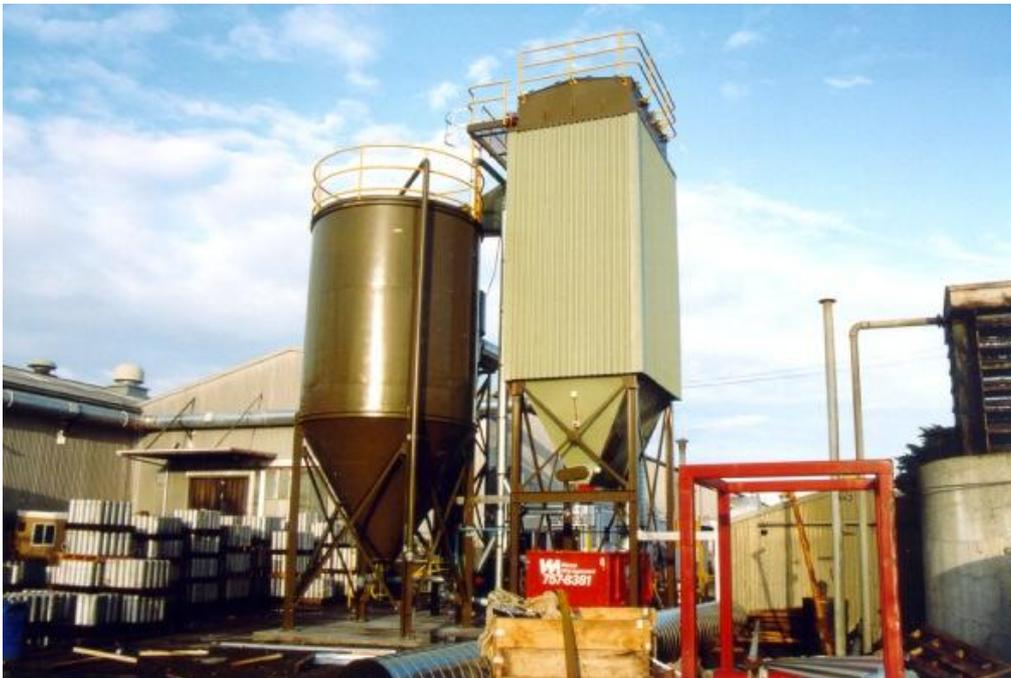
Photo 1 MAS Ltd Baghouse, 2006

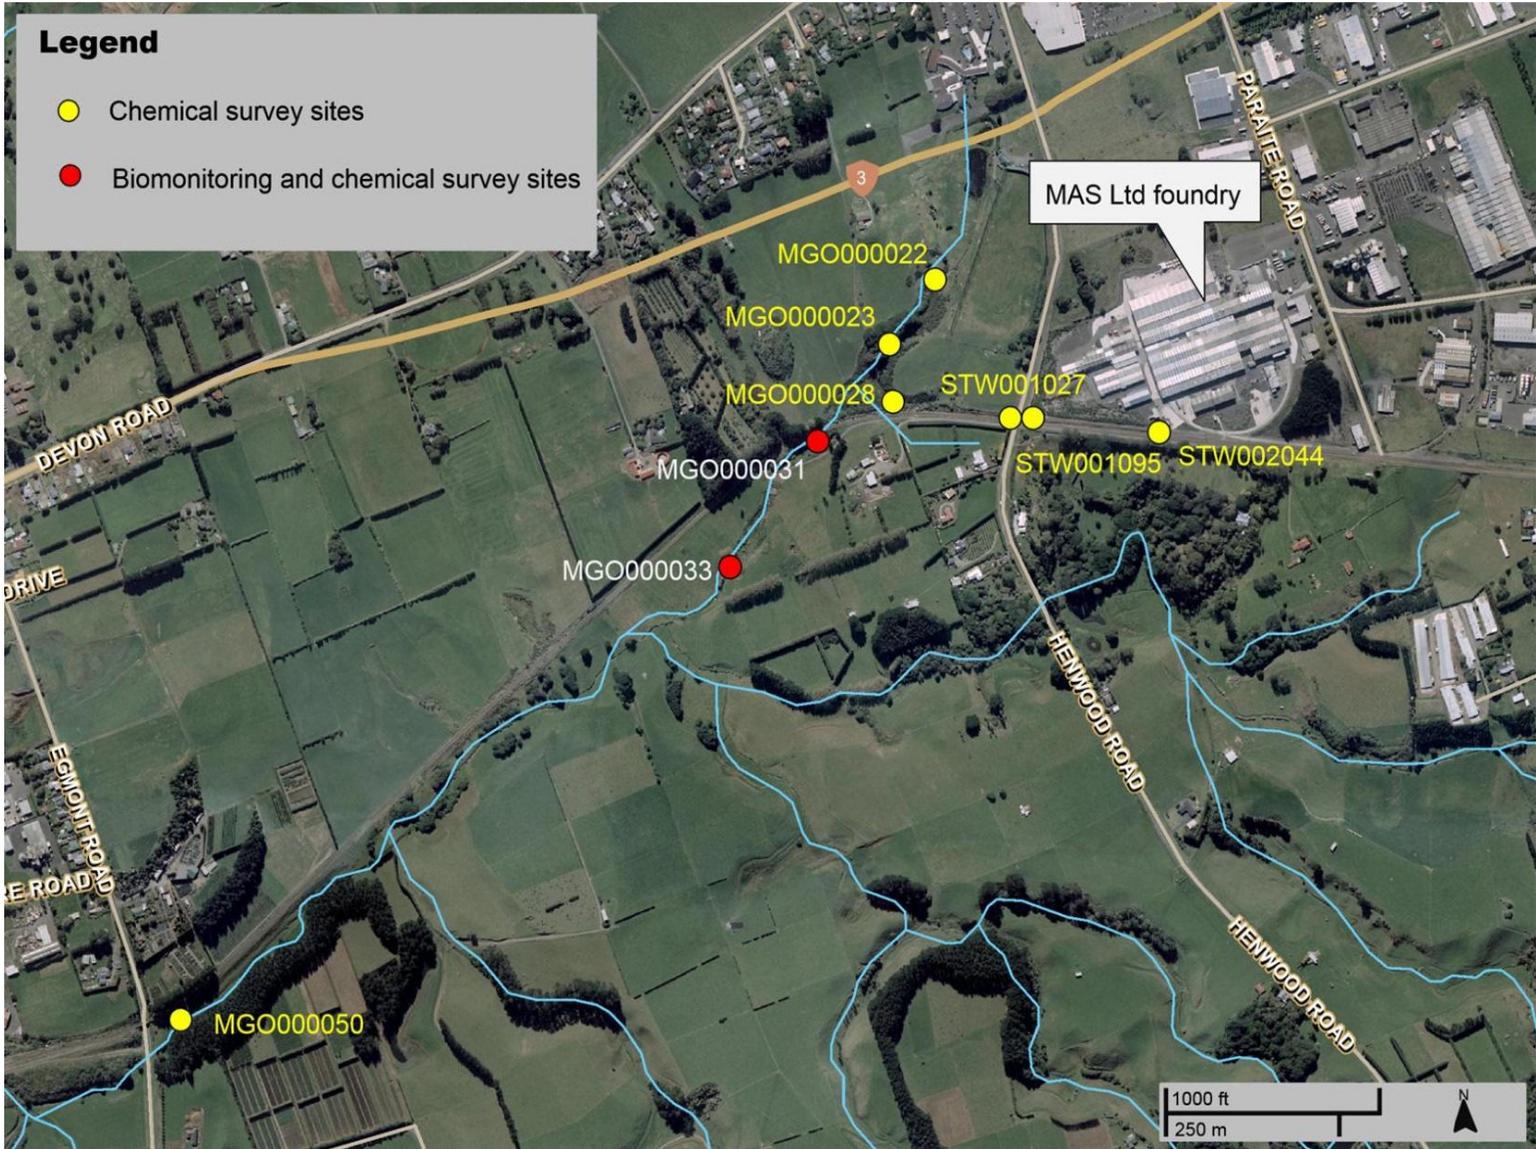
Figure 2 Location of MAS Ltd plant at Bell Block showing Council water monitoring sites

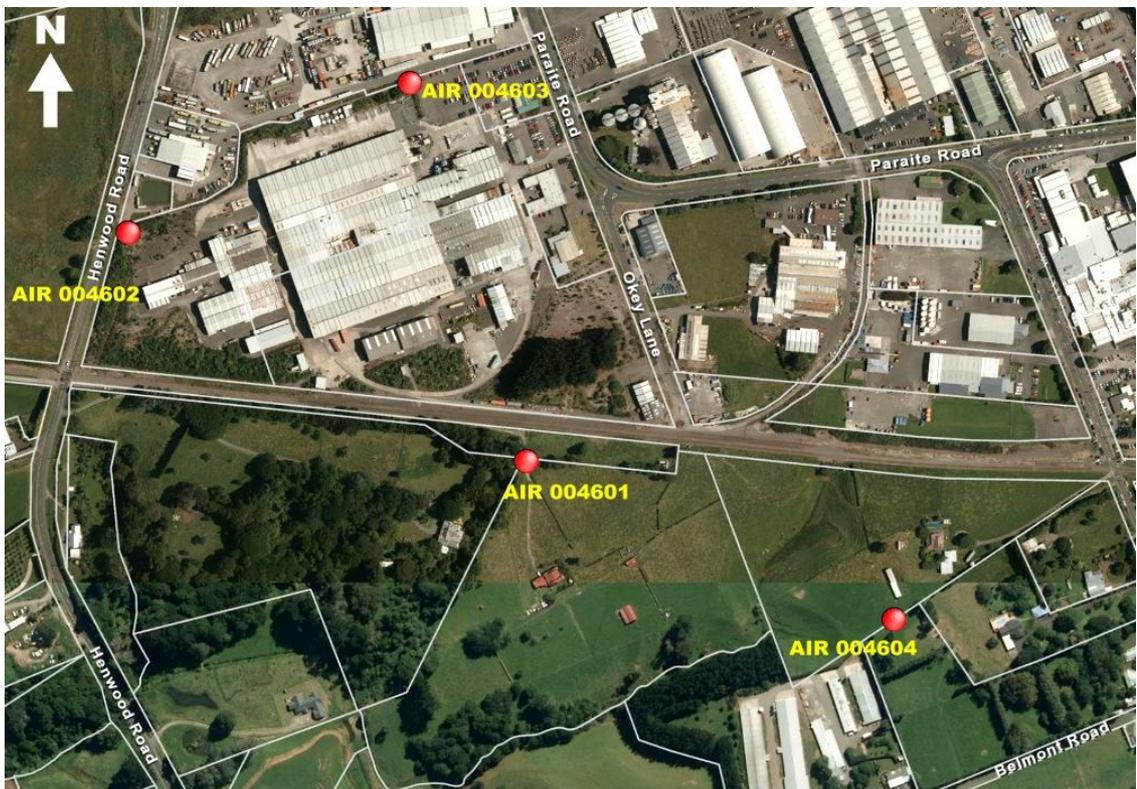
Figure 3 Locations of dust deposition monitoring sites

In the 2012-2013 period, gauges were deployed on one occasion at four locations in the vicinity of the foundry site for a period of 20 days. The locations of the monitoring sites around the foundry are shown in Figure 3 above.

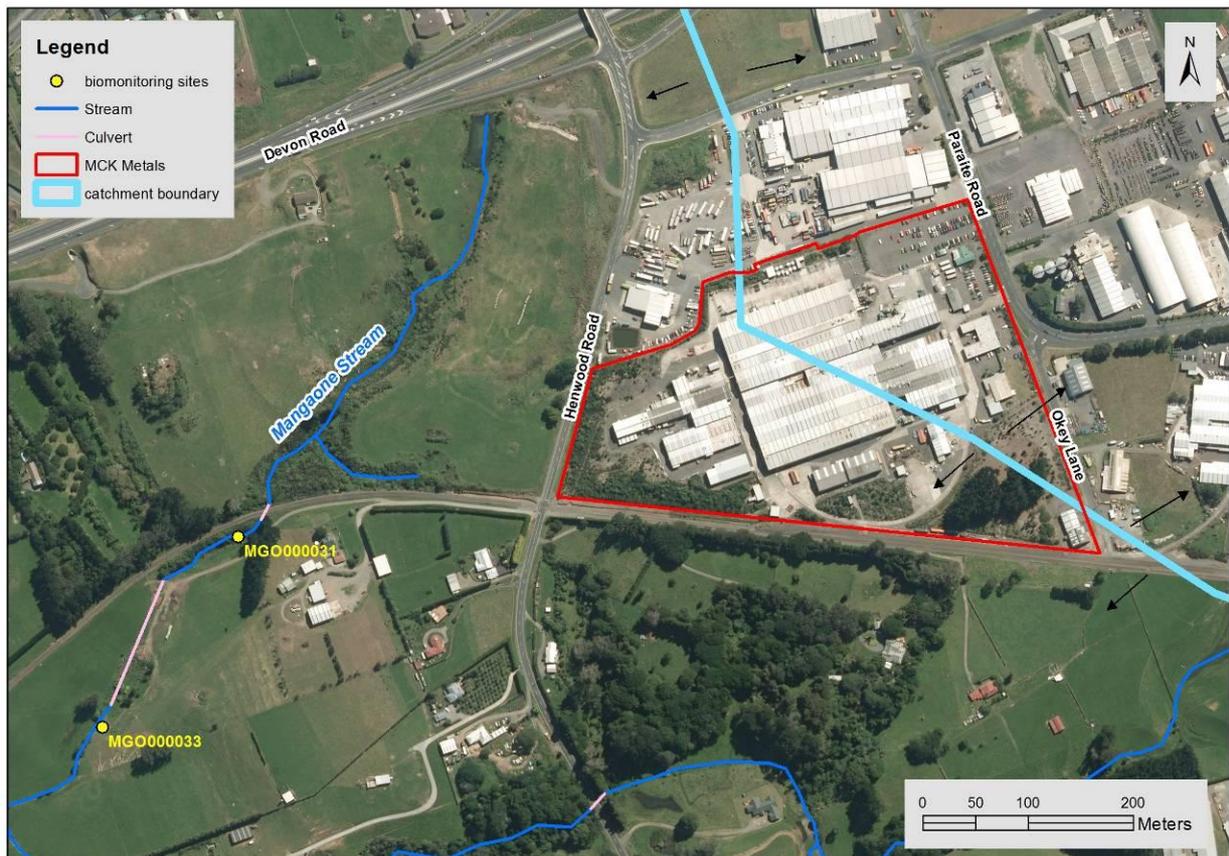
Figure 1 Biomonitoring sites in a tributary of the Mangaone Stream related to the stormwater discharge from MCK Metals Pacific

Swampy habitats further upstream (Figure 1) were sampled between 1983 and March 1998. Site 1 was located in the eastern arm of the swamp, which receives stormwater discharges from MCK Metals, however this habitat dried up periodically. Site 2 was located in the northern arm of the swamp, upstream of the confluence with the discharge from MCK Metals. Sampling was discontinued at site 2 because of difficulty with access to the site. This site was sampled again in the summer 2007 survey, but access was still extremely difficult. Habitat at this site differed markedly to that at sites 3 and 4. These factors have resulted in the removal of this site from future surveys.

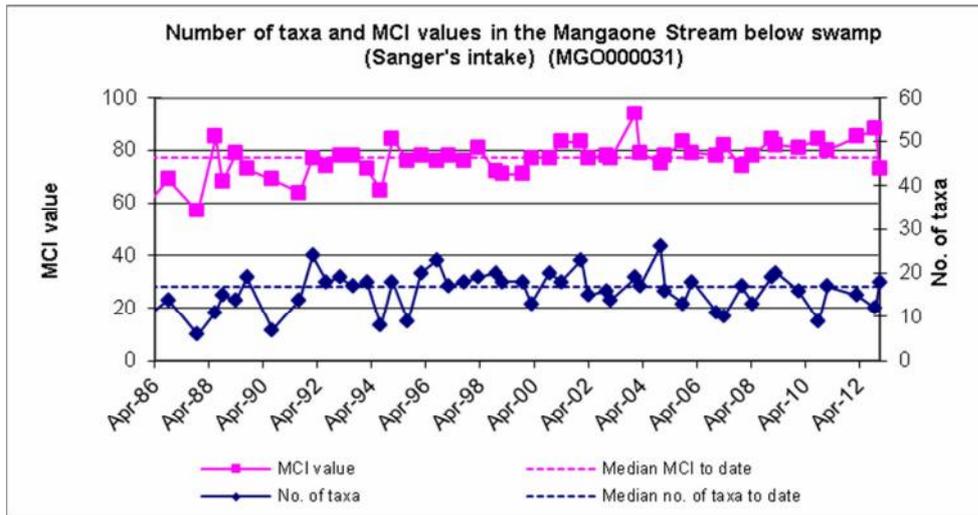
The moderate proportion of ‘tolerant’ taxa in the community (61% of richness) was reflected in the MCI score of 73 units which was five units less than the median of previously recorded scores, a statistically insignificant difference (Table 2 and Figure 2), and a score normally associated with weedy habitats that are in good condition. MCI scores have consistently been near to or above the median since 2000, although the current result is a sharp drop from that recorded in the most recent surveys (Figure 2). The SQMCI_s score of 4.6 was also typical of weedy habitats, and slightly higher than the long term median for this site due principally to the numerical dominance of two ‘moderately sensitive’ amphipod taxa.

Figure 2 Taxa numbers and MCI scores recorded to date at site 3

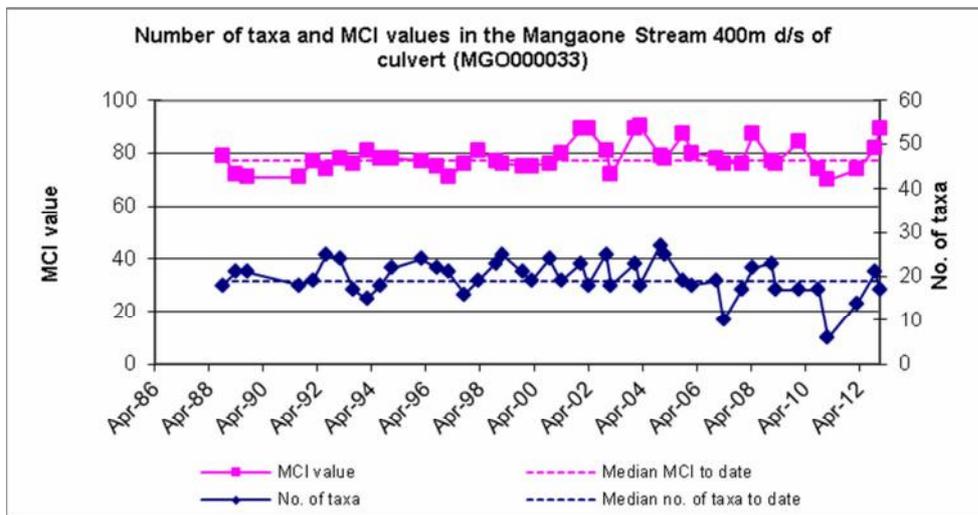
Community richness at site 4 (17 taxa) was two taxa lower than the median richness found by all previous surveys (Table 2, Figure 3) and similar to that recorded upstream in the current survey.

Figure 3 Taxa numbers and MCI scores recorded to date at site 4

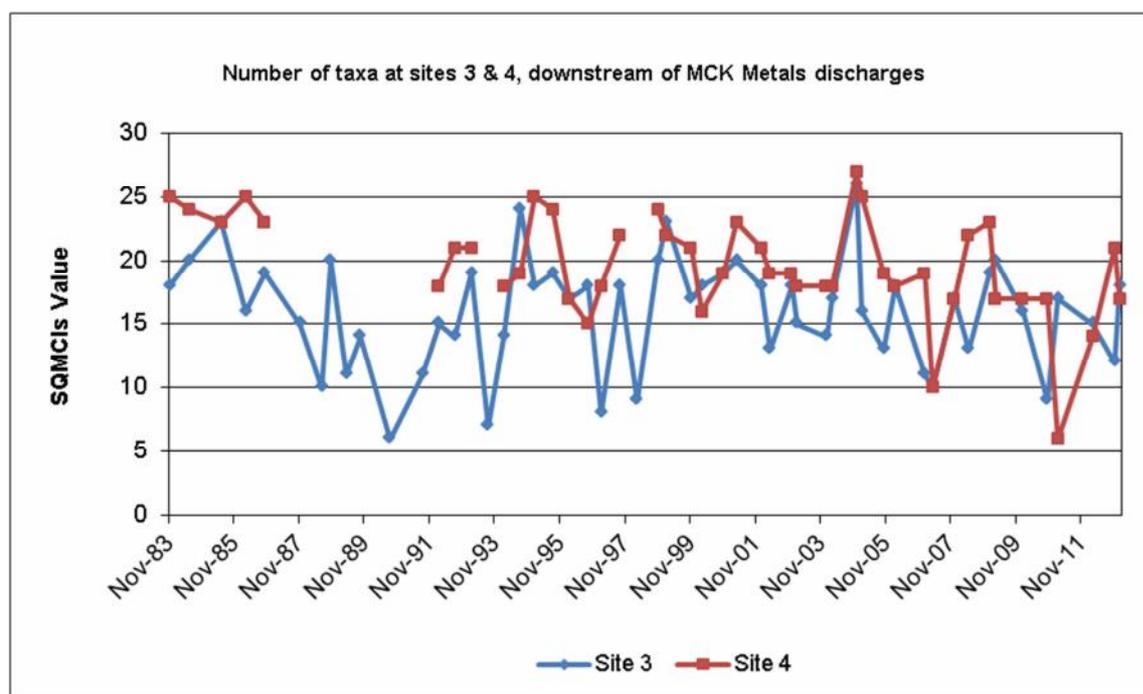
Figure 4 Number of taxa at sites 3 and 4 in an unnamed tributary of the Mangaone Stream in relation to discharges from MCK Metals Ltd

The absence of impacts from the MCK Metals stormwater discharge was also recorded at site 4, with the MCI score (89) being twelve units higher than the median, a statistically significant result, and reflecting the slightly lower proportion of ‘tolerant’ taxa present (41% of richness) in the community. The variability in numbers of taxa recorded at sites 3 and 4 in the Mangaone tributary to date is illustrated in Figure 4.

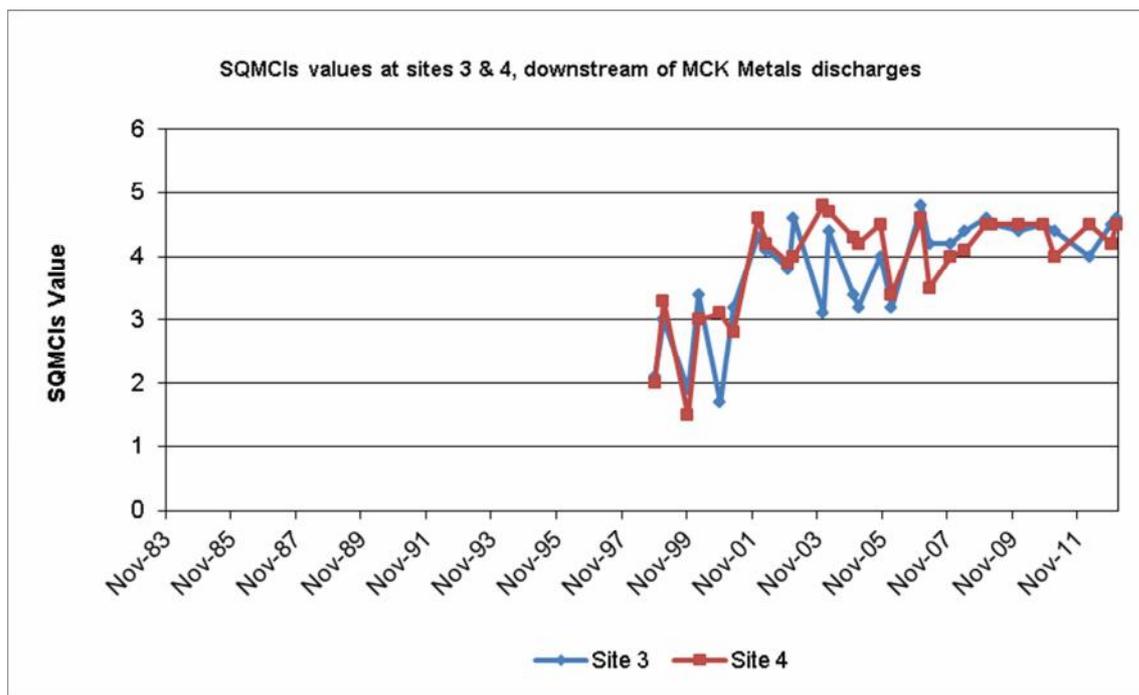
Figure 5 SQMCI_s values at sites 3 and 4 in an unnamed tributary of the Mangaone Stream in relation to discharges from MCK Metals Ltd

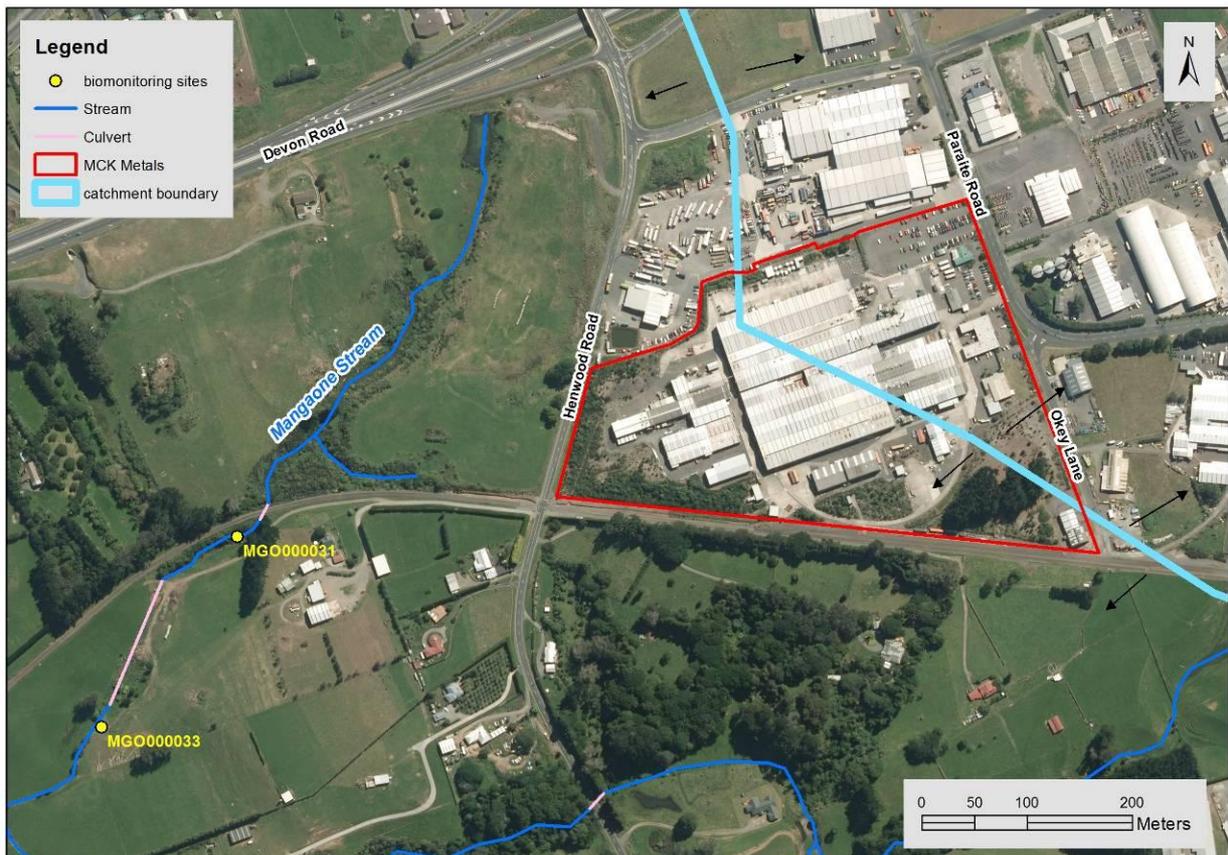
Figure 1 Biomonitoring sites in a tributary of the Mangaone Stream related to the stormwater discharge from MCK Metals Pacific

Swampy habitats further upstream (Figure 1) were sampled between 1983 and March 1998. Site 1 was located in the eastern arm of the swamp, which receives stormwater discharges from MCK Metals, however this habitat dried up periodically. Site 2 was located in the northern arm of the swamp, upstream of the confluence with the discharge from MCK Metals. Sampling was discontinued at site 2 because of difficulty with access to the site. This site was sampled again in the summer 2007 survey, but access was still extremely difficult. Habitat at this site differed markedly to that at sites 3 and 4. These factors have resulted in the removal of this site from future surveys.

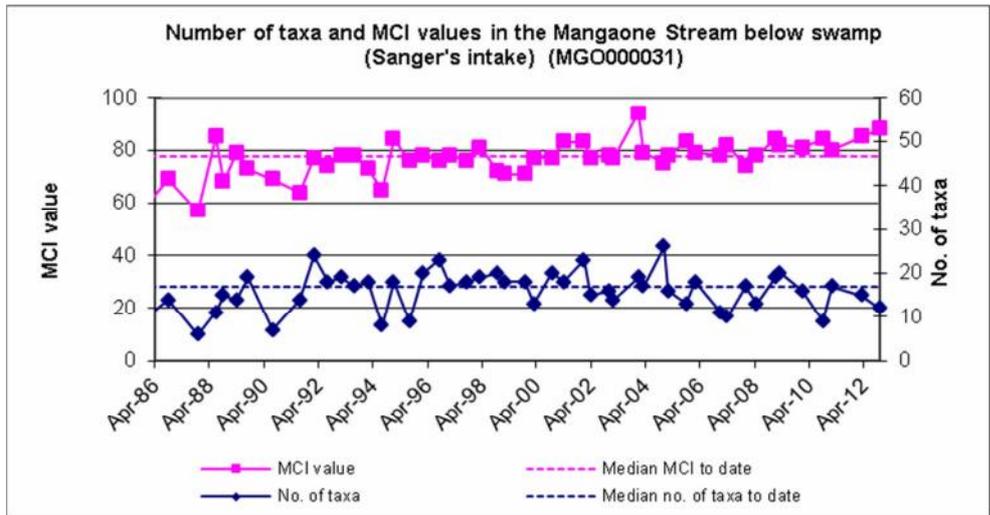
The moderate proportion of 'tolerant' taxa in the community (42% of richness) was reflected in the MCI score of 88 units which was statistically significantly higher than the median of previously recorded scores (by eleven units) (Table 2 and Figure 2), and a score normally associated with weedy habitats that are in good condition. MCI scores have consistently been near to or above the median since 2000 (Figure 2). The SQMCI_s score of 4.5 was also typical of weedy habitats, and slightly higher than the long term median for this site due principally to the numerical dominance of 'moderately sensitive' amphipods.

Figure 2 Taxa numbers and MCI scores recorded to date at site 3

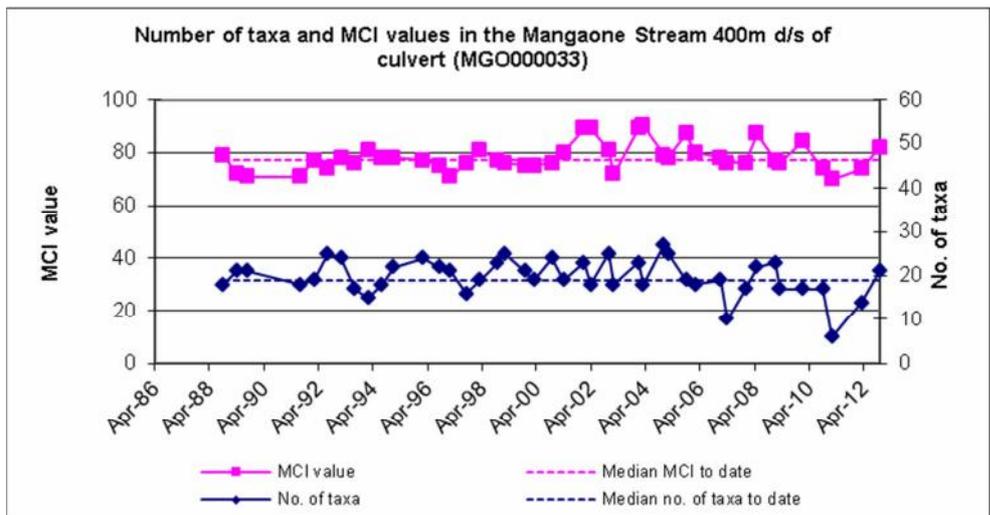
Community richness at site 4 (21 taxa) was two taxa higher than the median richness found by all previous surveys (Table 2, Figure 3) and nine taxa more than that recorded upstream in the current survey. Of note, is that this richness was 15 taxa more than that recorded at this site in the February 2011 survey, indicating continued recovery since the urea discharge. This result is slightly above average, and may indicate that the legacy of the urea discharge no longer exists.

Figure 3 Taxa numbers and MCI scores recorded to date at site 4

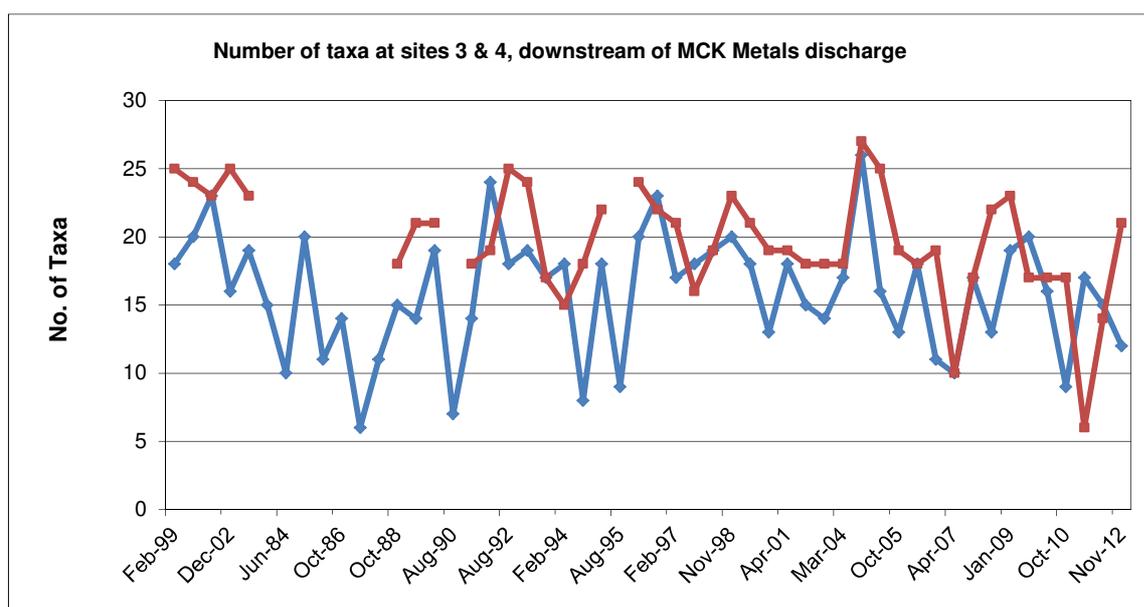
Figure 4 Number of taxa at sites 3 and 4 in an unnamed tributary of the Mangaone Stream in relation to discharges from MCK Metals Ltd

The absence of impacts from the MCK Metals stormwater discharge was supported by the MCI score (82) which was five units higher than the median, and reflected the slightly higher proportion of ‘tolerant’ taxa present (48% of richness) in the community. This MCI score, when assessed against the community present, also reflected continued recovery since the urea discharge. The variability in numbers of taxa recorded at sites 3 and 4 in the Mangaone tributary to date is illustrated in Figure 4.

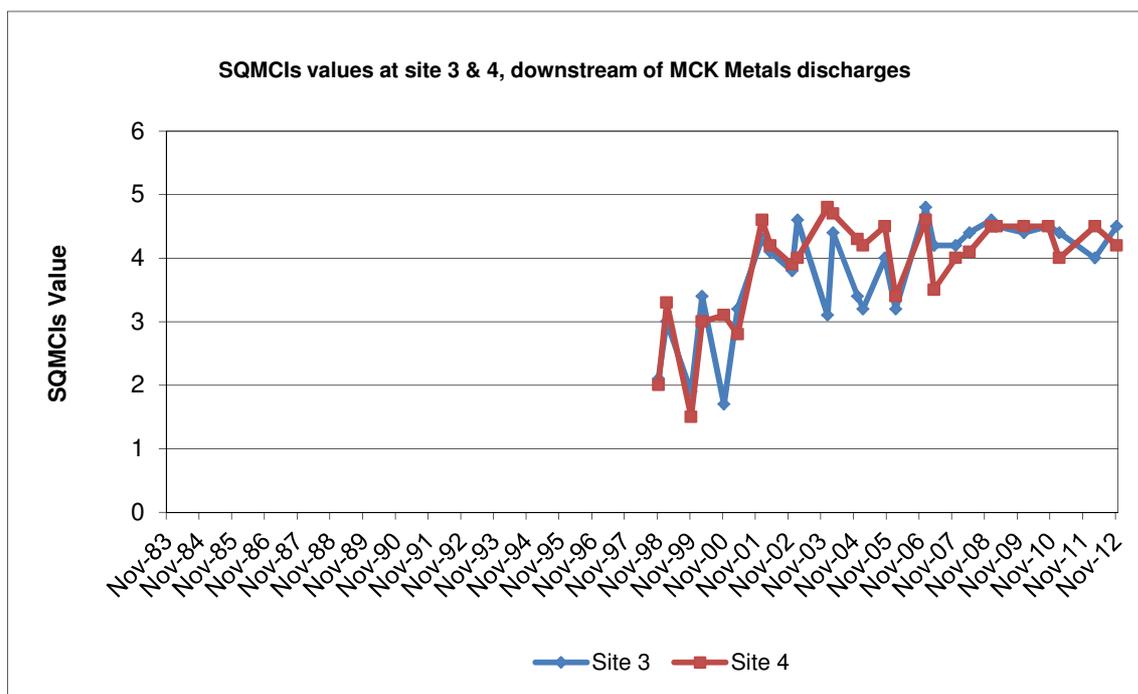
Figure 5 SQMCI₅ values at sites 3 and 4 in an unnamed tributary of the Mangaone Stream in relation to discharges from MCK Metals Ltd
